Arboricultural Report

Tree Condition Survey

**36 Tile Kiln Lane
Dartford
Kent
DA5 2BB**

**Date
22nd August 2023**

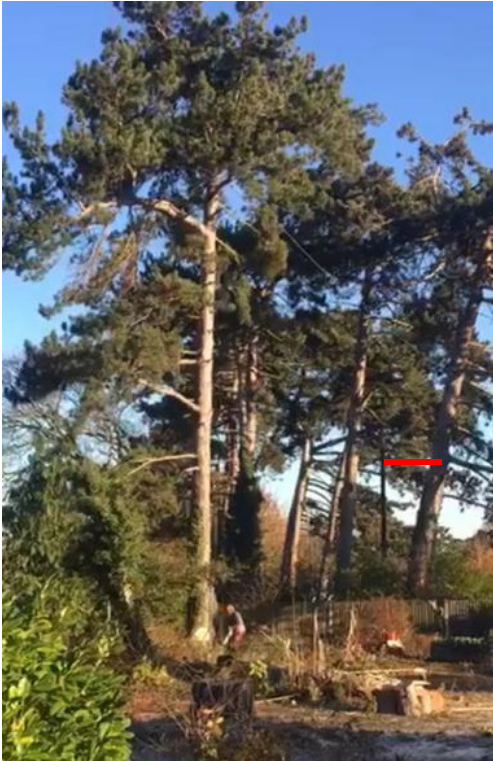
- Historically T1 and the surrounding trees established and matured as a group with multiple trees previously in the garden of 36 and in the land to the North. Looking at the historical photo provided there were 4 mature Pines removed in 2017 from number 36.

- This group of trees have grown in symbiosis with each other and will have adapted to wind conditions as a single unit.
- It is generally considered poor arboricultural practice to remove individual trees within a group as this will expose the remaining trees to unusual wind conditions with no time for their rooting areas to adapt which is clearly the case in this instance. This has been exacerbated by the retained trees being fully exposed to the predominant South-westerly winds which has led to the movement of T1.

Photo 1: 4 x Pine trees removed from 36 in 2017
(Picture courtesy of previous owner)

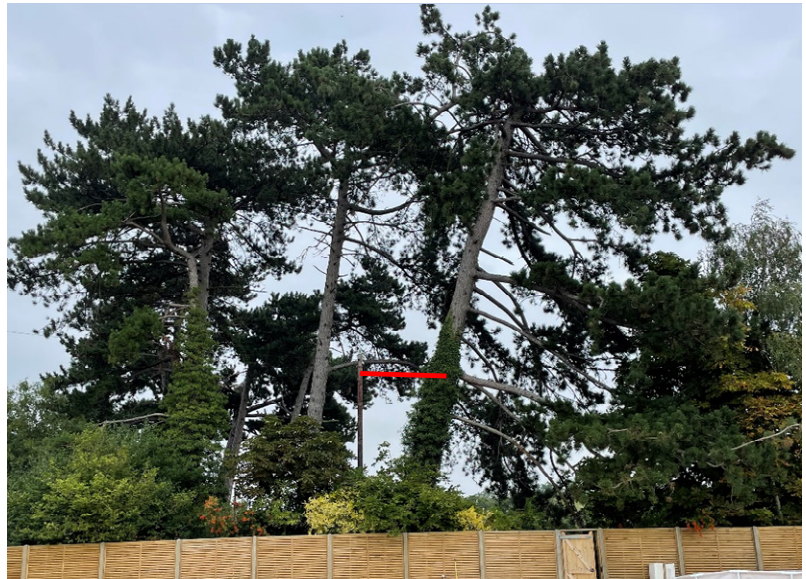
- Dense ivy at base up to 4m is obscuring the trunk. Diameter at 1.5m is 730mm. Trunk sounding and probe found no abnormalities at the base. Old decayed *Phaeolus schweinitzii* bracket fungus at base of root flare to the West – this is known to cause internal brown rot.
- The trunk has a current lean of 25 degrees off vertical and there is no evidence of adaptive growth on the stem or in the upper canopy. There has always been a slight lean with this tree due to historical pressure from neighbouring trees; however, looking at previous and current photos I estimate that the lean has increase by 9 degrees since 2017. This is clearly evident from looking at the vertical telephone pole that has been present since at least 2017.

- The excessive lean is identifiable by the pronounced downward sloping lateral limbs to the East with no evidence of adaptive growth in the trunk or upper canopy.
- Minor deadwood.
- All the trees are showing signs of been having previously reduced in height at around 16-17m.

- In my professional opinion the risk of whole tree failure in the future is considered high.

Photo 2: Pine tree T1 with current lean
which has increased since 2017.

- To remove the Pine T1
- I would recommend the remaining Pine trees be inspected by a competent arboriculturist.

- Within 3 months – High priority

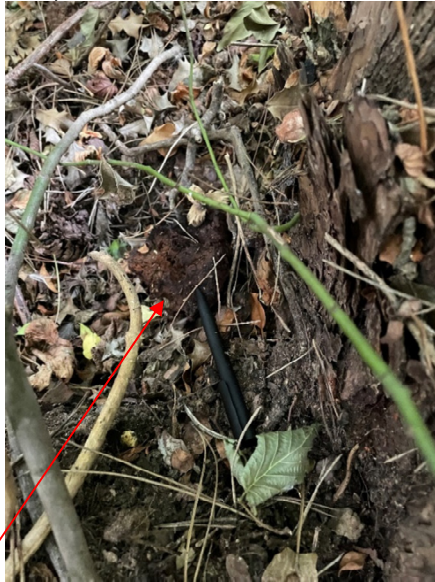
- The excessive movement has most likely lead to the opening of pathways for fungal fruiting bodies as evidence by the *Phaeolus* bracket at the base of T1.

Photo 3: *Phaeolus schweinitzii* bracket fungus at base of root flare to the West

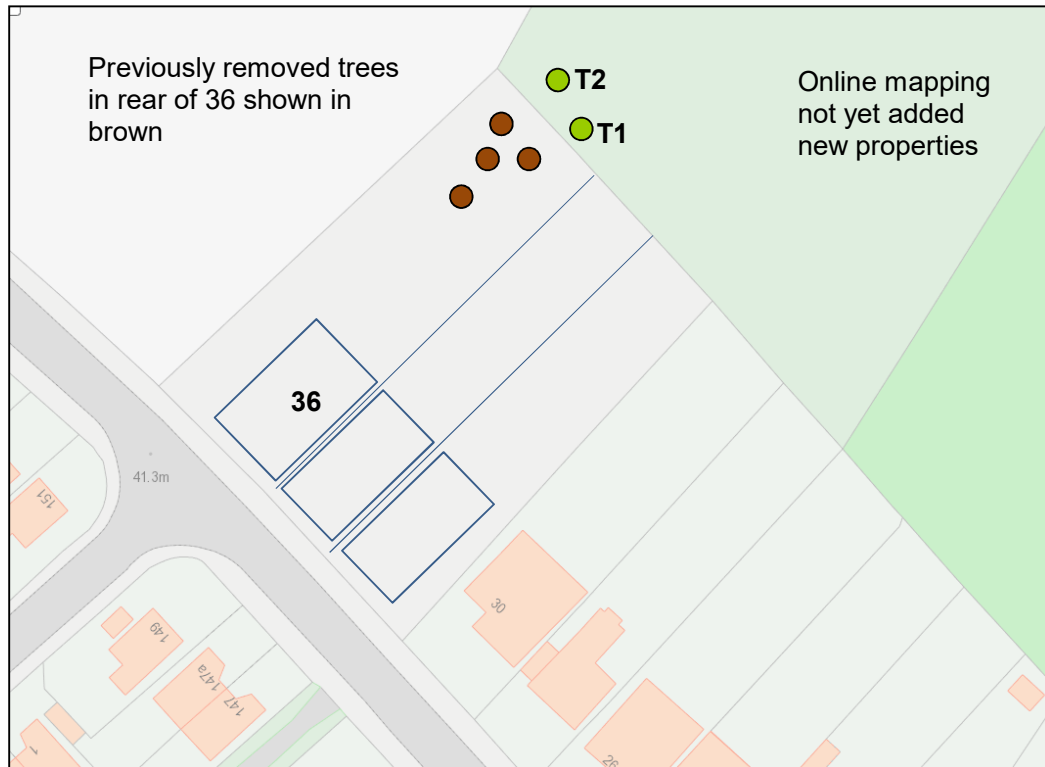
Map – 36 Tile Kiln Lane – not to scale

- T2 – Black Pine has a Root Protection Area of 4.2m (350DBH) and is 4.5m from the property. The new slab in the rear of 36 is outside its RPA.
