**PROPOSED FRONT ELEVATION**

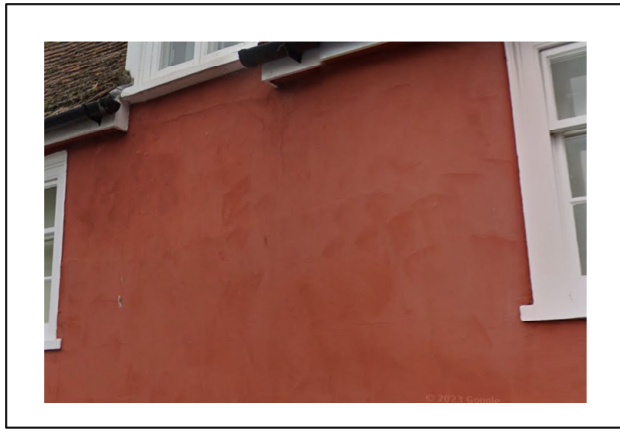
Render starting to crack around window frames and under dormer at the eaves.

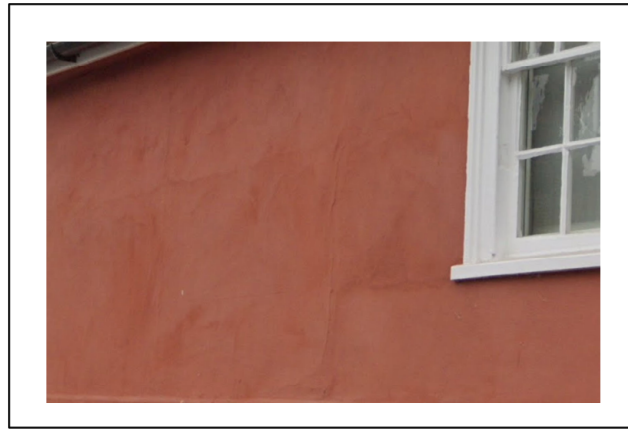
Render starting to crack around window frames

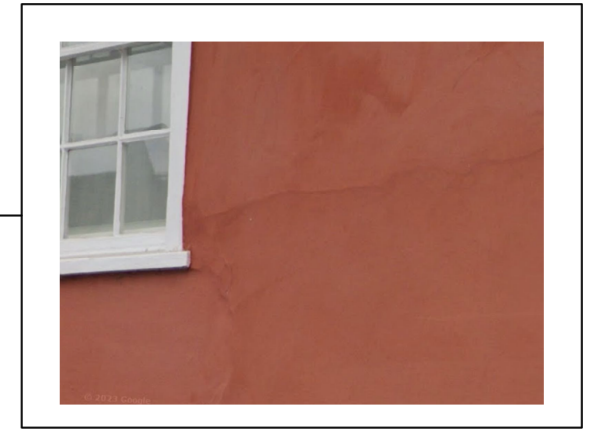
Render starting to crack around window frames

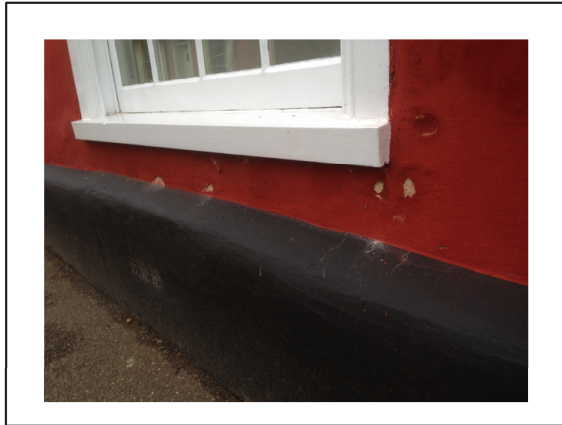
Noticeable damage to render under cill which will be repaired by proposal

Area to be replaced with a breathable lime render, painted to match existing

Fill voids with sheep's wool or hemp. Fix over with 25mm savolit directly to the frame. Apply lime based render comprised of 10-12mm of Warmcote insulated lime plaster with 8-10mm of Limecote chalk plaster. Finish with Silsan water repellent.

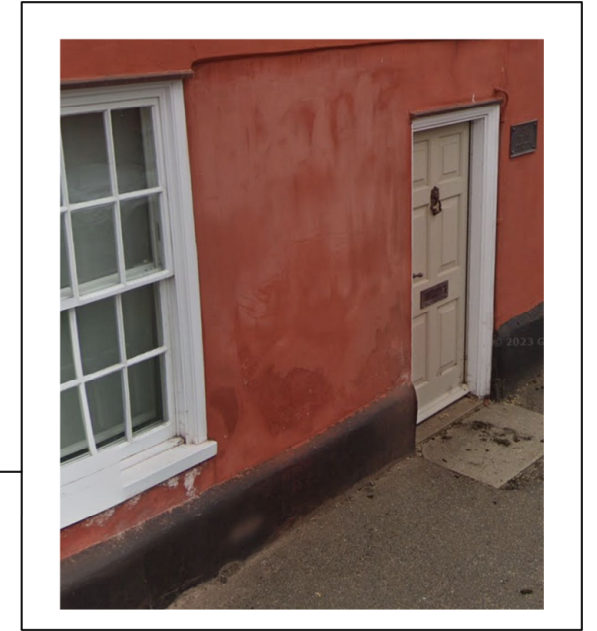
Paint fading and staining brick plinth caused by badly draining gully. To be repaired

Concrete plinth render removed and replaced with 10mm Rencote Limestone render
