SUBSIDENCE ENGINEER'S AND ANALYSIS OF SITE INVESTIGATION DATA REPORT

| Risk Address | 2 Northborough Road, London, SW16 4AX |

| Date of Report | 03 August 2023 |

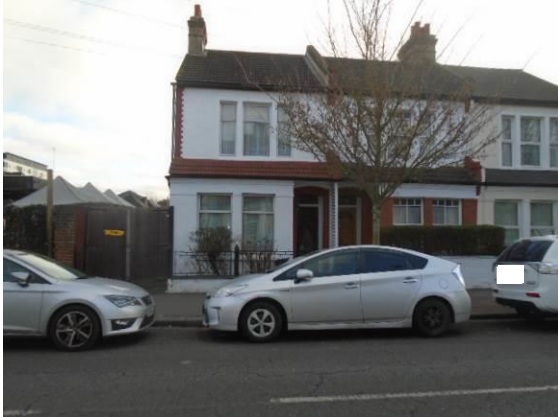
PHOTOGRAPH E1:

This photograph shows a general overview of the front elevation with the street tree in the foreground close to the party wall line of Nos 2 and 4 and is situated approximately 3 metres from the front elevation of the building.

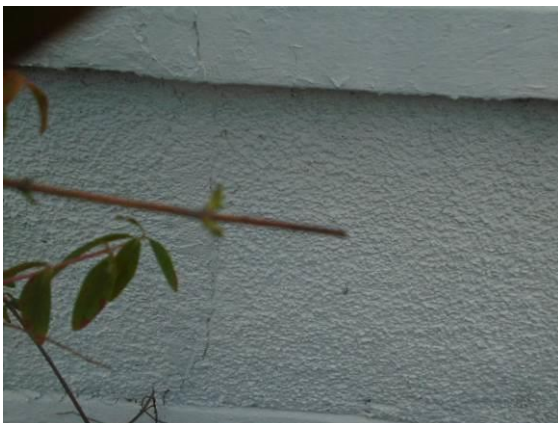
PHOTOGRAPH E2:

This photograph shows cracking in the render/Tyrolean rendering to the front elevation with the crack extending above into the windowsill.

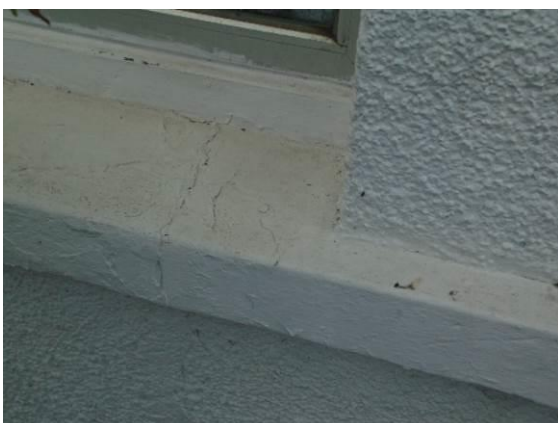
PHOTOGRAPH E3:

This photograph shows a view of the cracked windowsill on the front elevation.

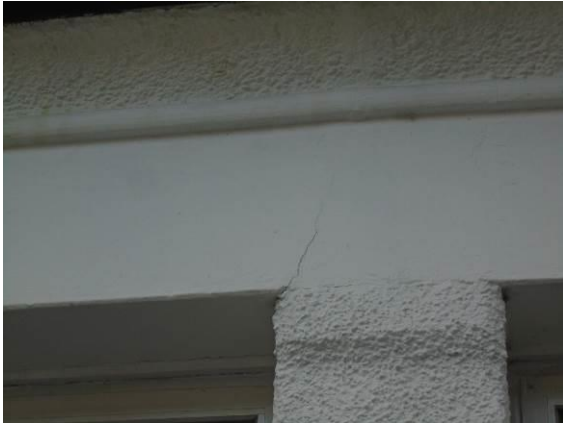
PHOTOGRAPH E4:

This photograph shows cracking above the ground floor windows to the stone lintel.

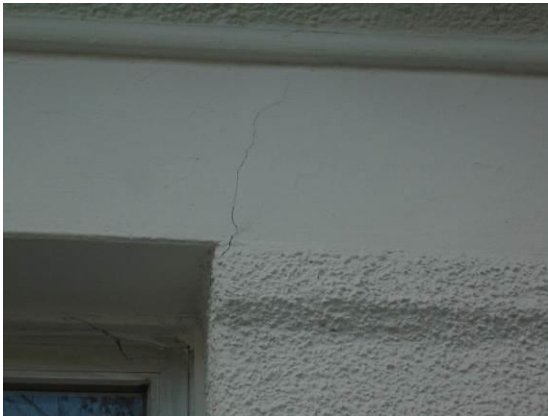
PHOTOGRAPH E5:

This photograph shows a further view of the crack in the stone lintel above the ground floor windows.

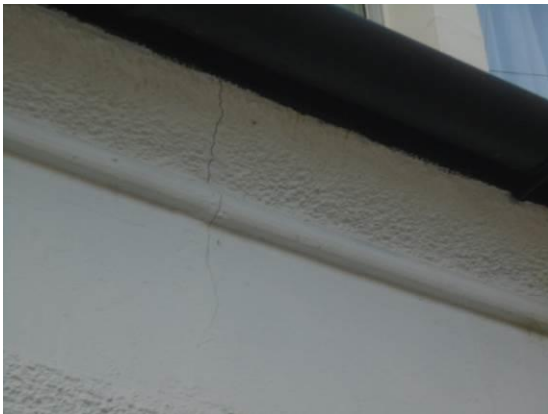
PHOTOGRAPH E6:

This photograph shows a crack through the covered section of the rendering extending down through the lintel above the ground floor windows.

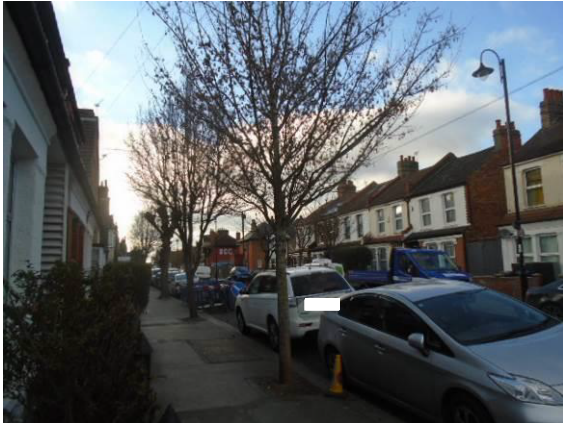
PHOTOGRAPH E7:

This photograph shows a side on view of the street trees.

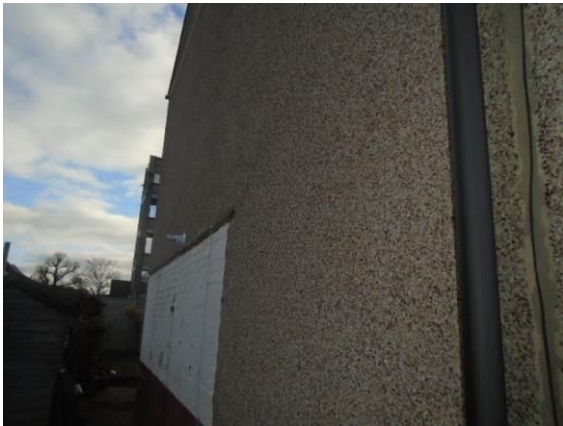
PHOTOGRAPH E8:

This photograph shows a view down the left-hand flank wall of the building. Note it appears the painted section at the rear of the flank wall was previously a lean-to which has now been removed.

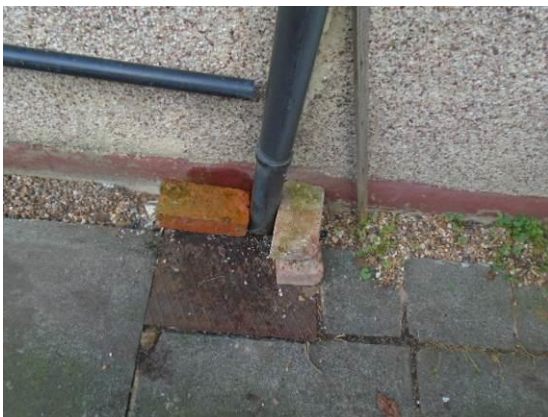
PHOTOGRAPH E9:

This photograph shows a metal drain cover over the gully on the front of the flank elevation.

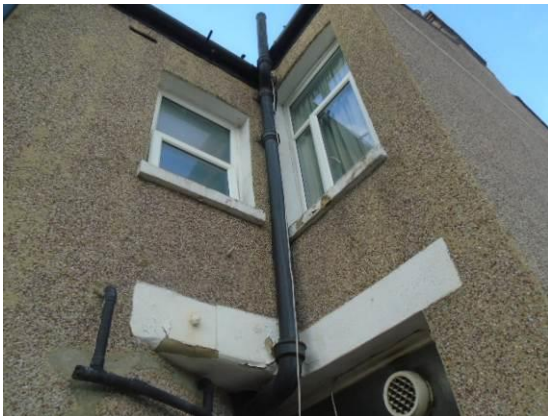
PHOTOGRAPH E11:

This photograph shows a view of the internal corner between the rear wall of the main house and the flank wall of the rear projection, all pebbledash rendered.

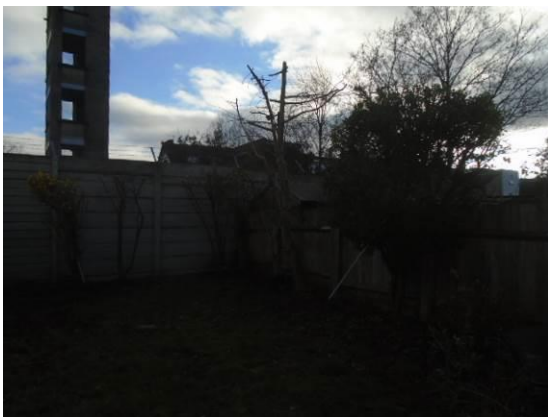
PHOTOGRAPH E12:

This photograph attempts to show a view of the vegetation in the rear garden which should be reduced.

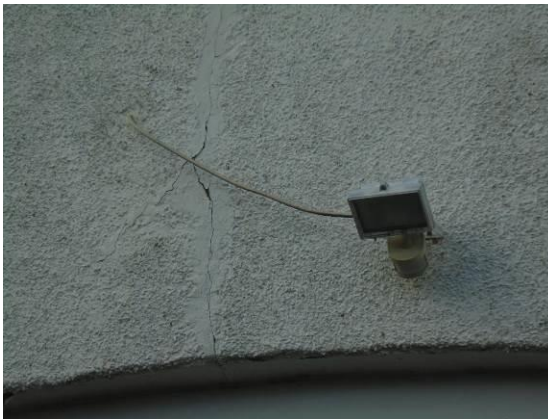
PHOTOGRAPH E14:

This photograph shows a re-opening of some crack damage above the ground floor rear door on the rear wall of the rear projection. Please note where filler repairs have been carried out previously to this crack.

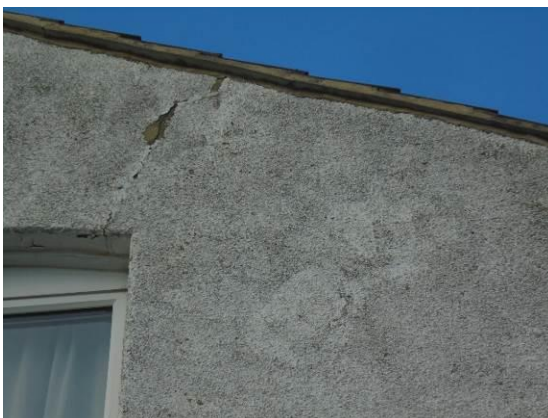
PHOTOGRAPH E15:

This photograph shows high level cracking above the first-floor window on the rear wall of the rear projection which appears to have opened up.

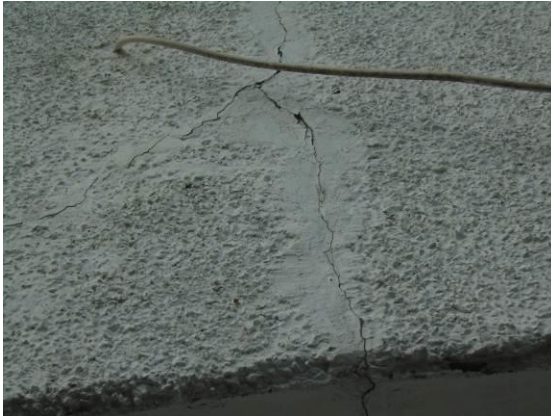
PHOTOGRAPH E16:

This photograph shows a closer view of the crack above the rear door of the rear projection where previous filler repairs can clearly be seen.

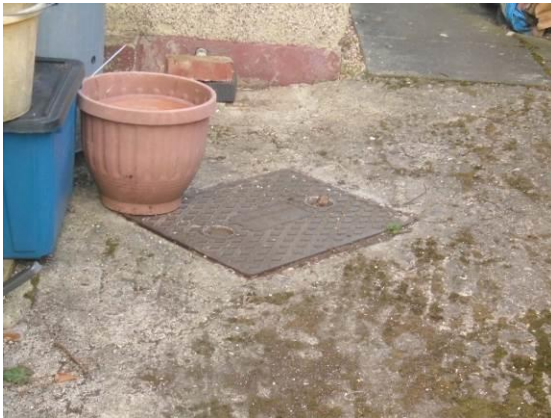
PHOTOGRAPH E17:

This photograph shows a general overview of the manhole situated close to the corner of the flank wall of the rear projection and the rear wall of the main house.

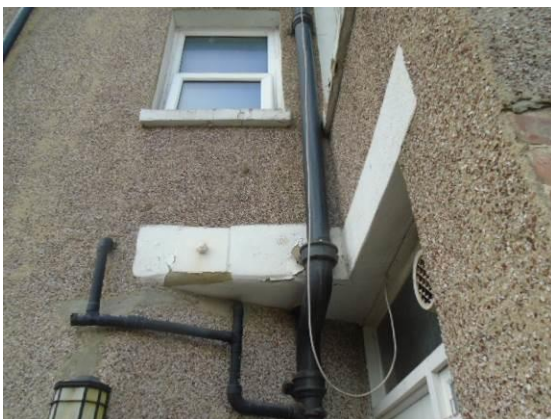
PHOTOGRAPH E18:

This photograph shows an upwards view of the internal corner between the rear wall of the main house and the flank wall of the rear projection. Crack damage is disguised by the soil pipe running up in the corner of this location.

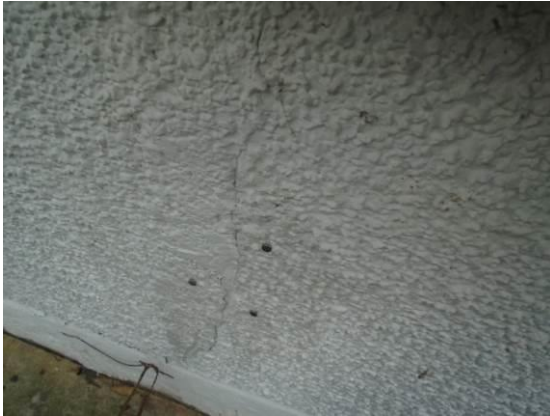
PHOTOGRAPH E19:

This photograph shows the monitor station to the crack on the front bay window.

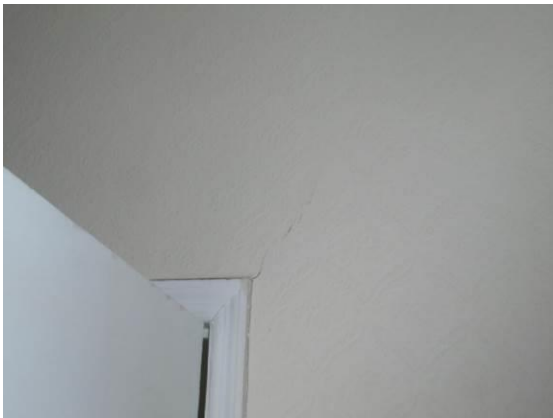
PHOTOGRAPH I02:

This photograph shows cracking above the door to the ground floor front reception room, suggesting that the front of the property has moved forward.

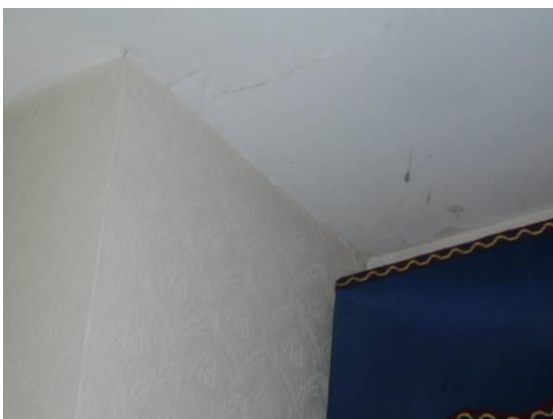
PHOTOGRAPH I03:

This photograph shows cracking in the ceiling across the bay in the ground floor front reception room.

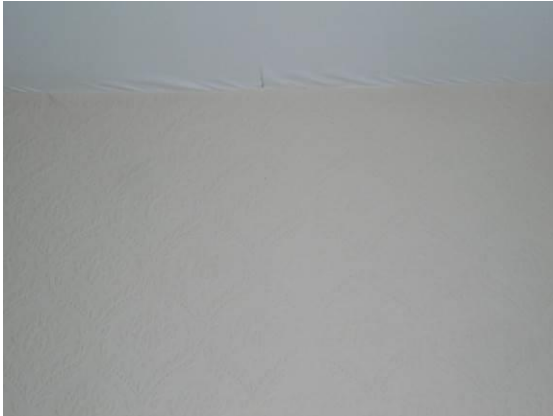
PHOTOGRAPH I04:

This photograph shows rucking of wallpaper to the junction of the wall/ceiling also within the ground floor front reception room.

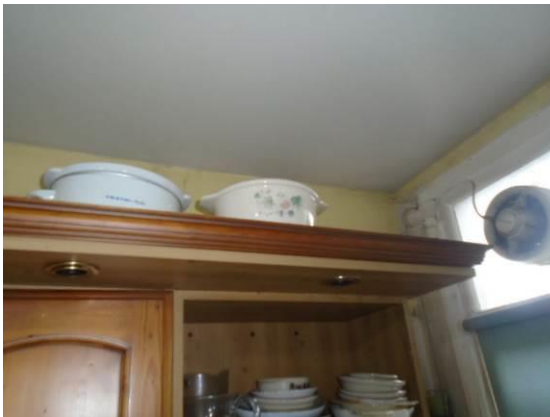
PHOTOGRAPH I08:

This photograph shows some minor crack damage above the kitchen units and local opening of the crack at the wall/ceiling junction within the kitchen area.

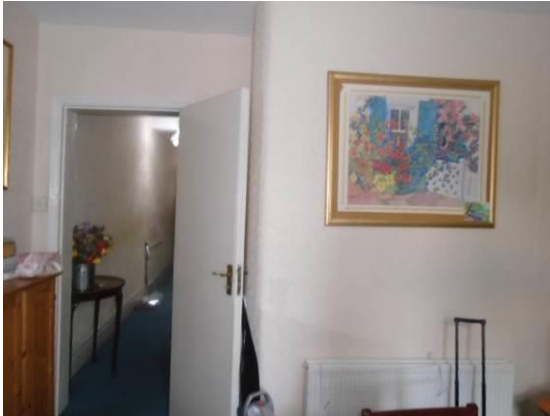
PHOTOGRAPH I10:

This photograph shows a view of the dining room looking back towards the hall. No obvious signs of any subsidence damage were noted in this room.

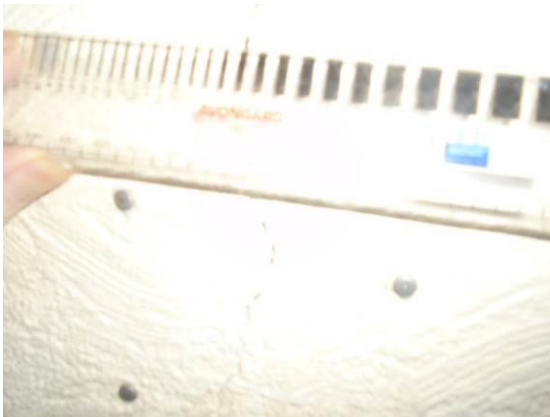
PHOTOGRAPH I11:

This photograph shows the crack damage to the wall covering on the party wall of the hall, stairs and landing with monitor studs affixed. Crack width is 2mm maximum at this point.

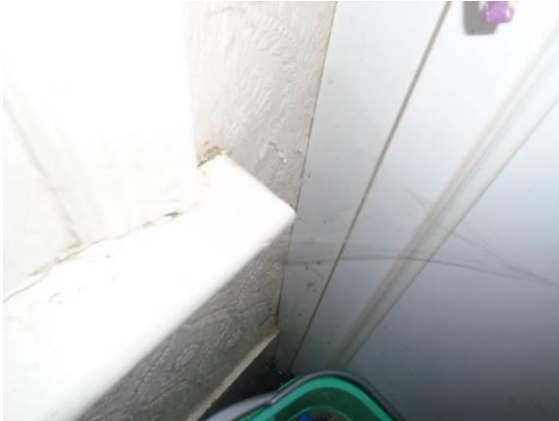
PHOTOGRAPH I13:

This photograph shows a diagonal crack below the window board towards the wardrobes on the front left-hand side of the first-floor bedroom.

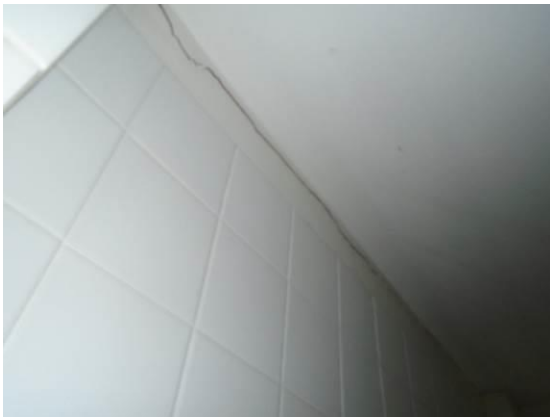
PHOTOGRAPH I17:

This photograph shows separation of the ceiling/tile junction within the bathroom. Note this cracking appears to be fresh.

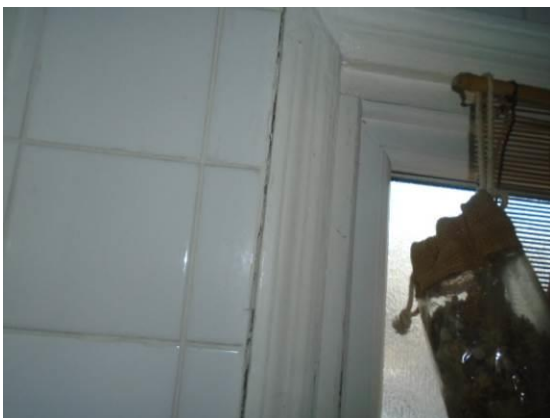
PHOTOGRAPH I18:

This photograph shows opening of joint between the window architrave and the tiles situated on the left-hand wall of the rear projection internally within the bathroom.

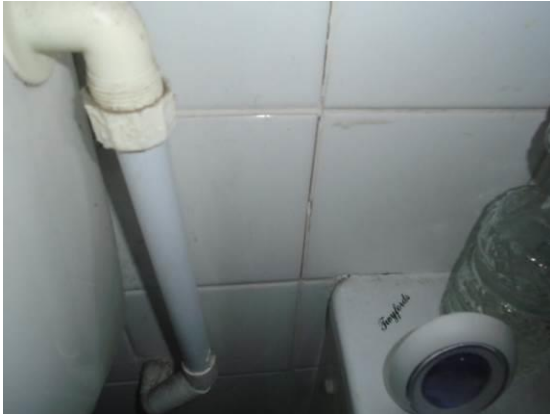
PHOTOGRAPH I19:

This photograph shows opening of grout joints between the tiles within the bathroom adjacent to the bath and the toilet cistern.
