Arboricultural Appraisal Report

Subsidence Damage Investigation at:

2 Northborough Road
London
SW16 4AX

CLIENT:	Graham High Group Ltd
CLIENT REF:	L/2022/76092/S/GS/BC
MWA REF:	SUB230810-14010
MWA CONSULTANT:	Mark Bisley (BSc Hons)
REPORT DATE:	18/09/2023

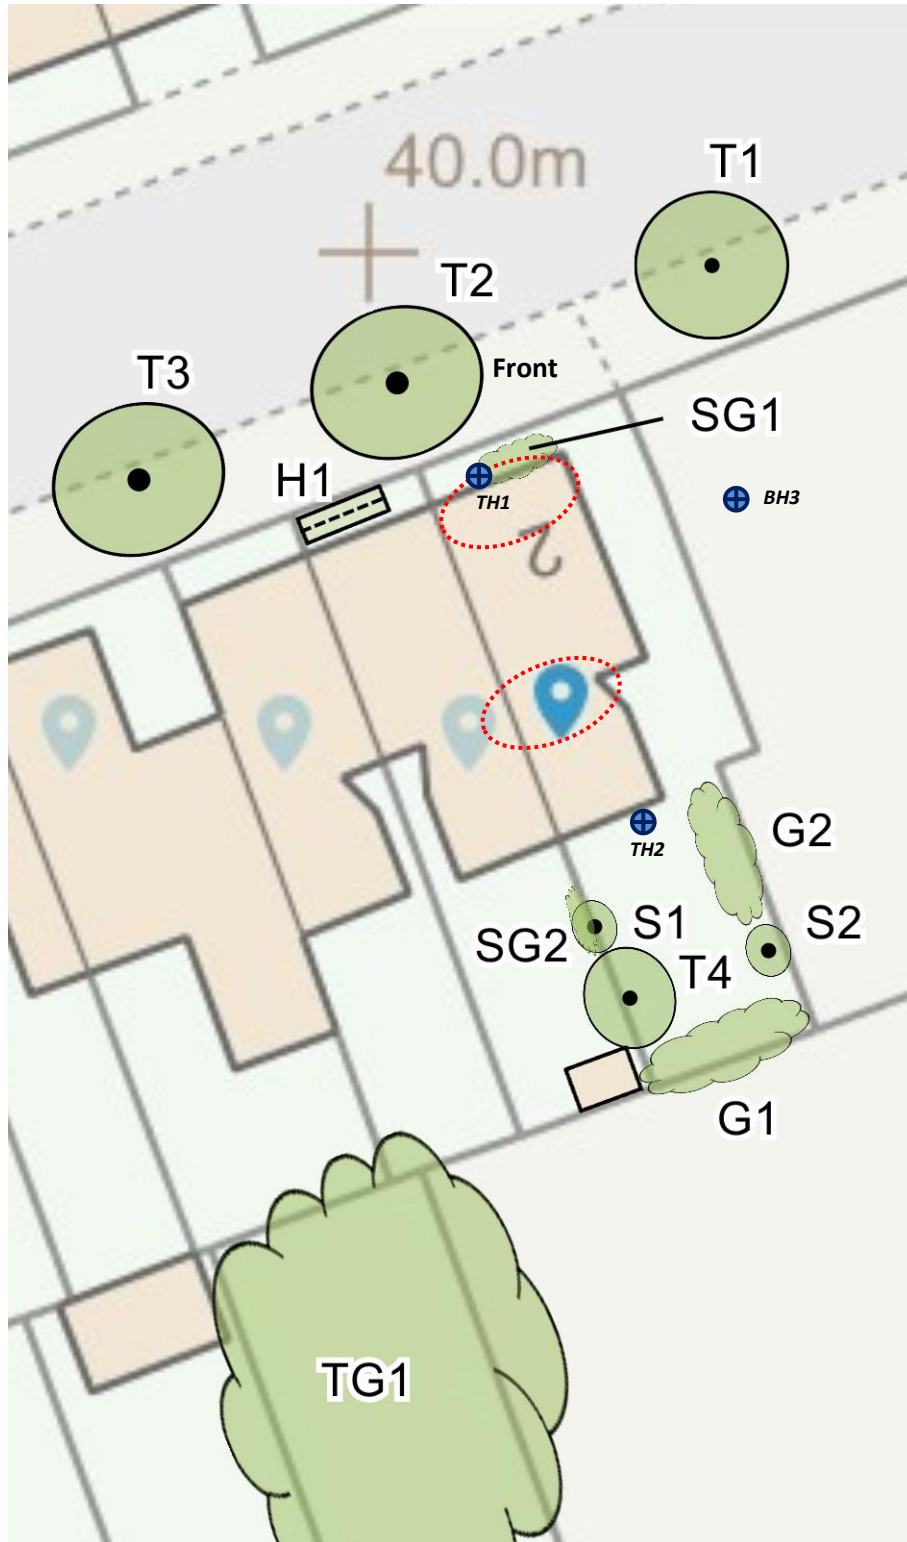
Site Plan

Approximate areas of damage

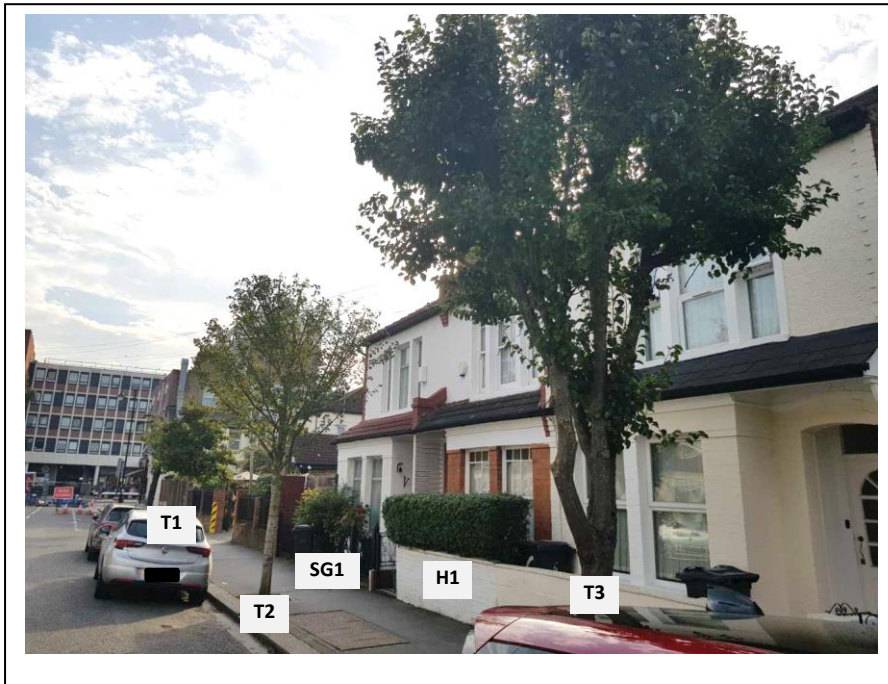
View of trees to front of dwelling

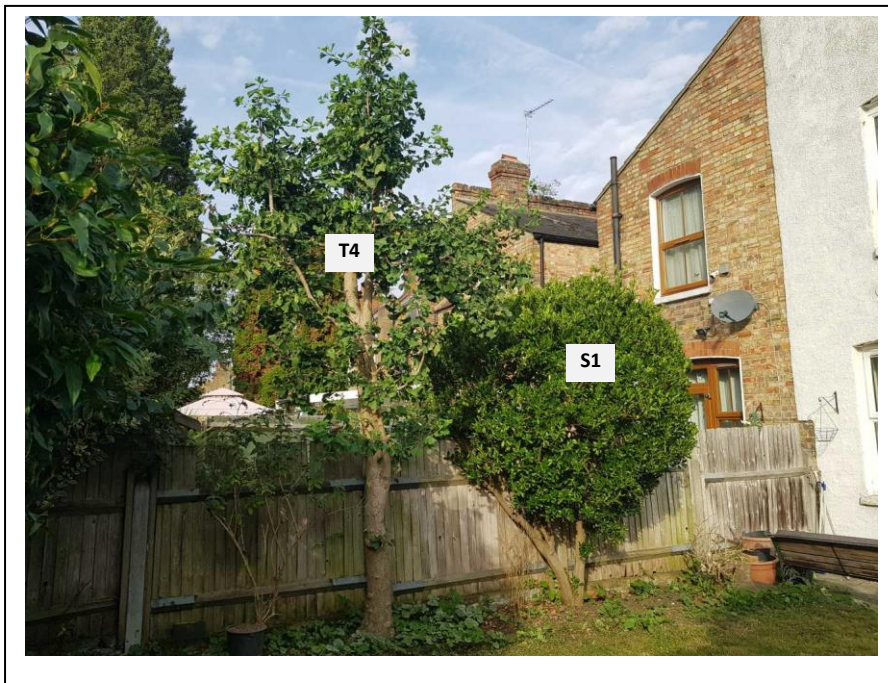
View of vegetation to rear right

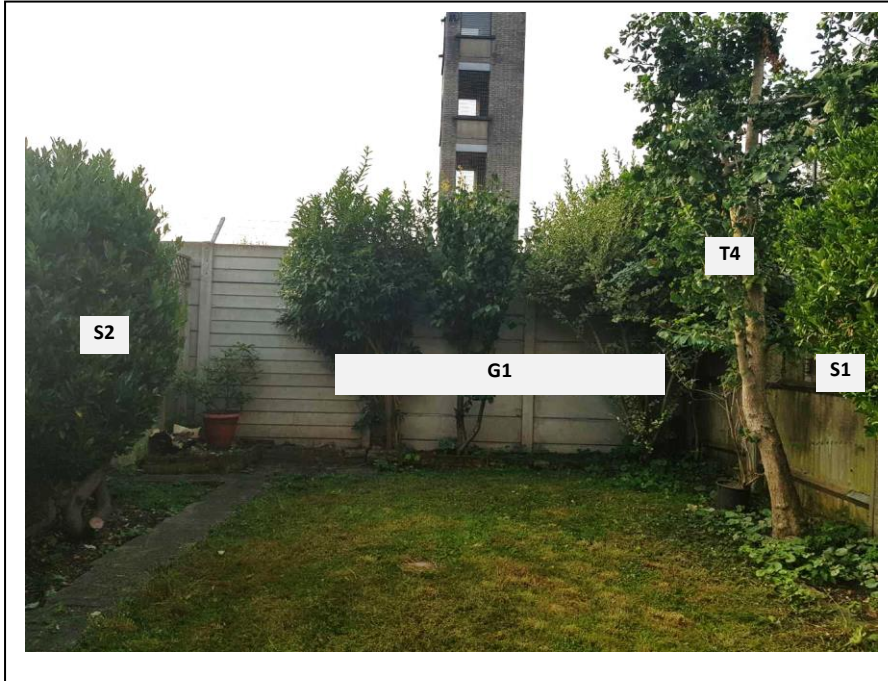
View of rear boundary

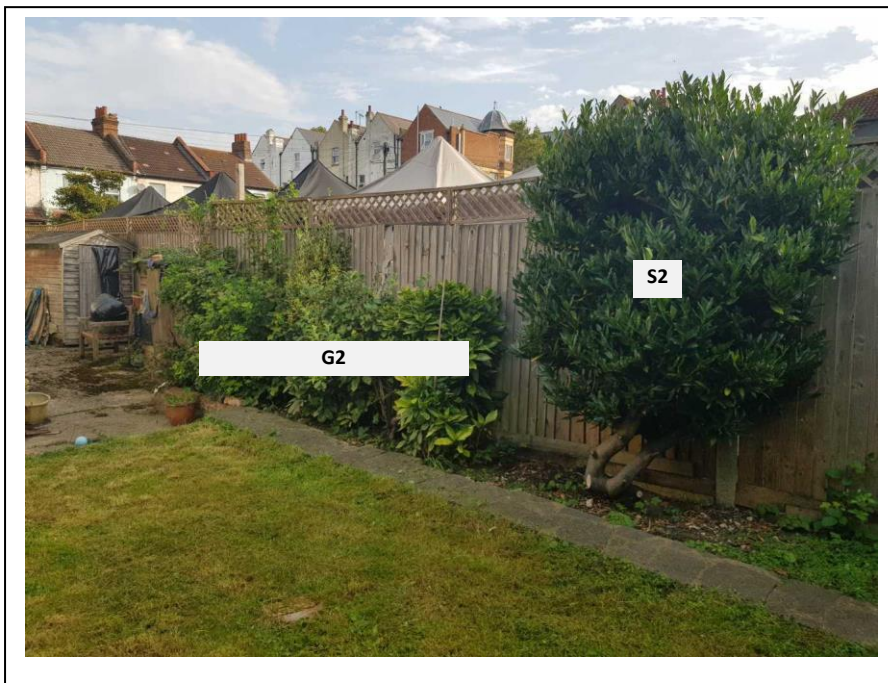
View of vegetation to rear left
