Arboricultural Report - 231129 24WinthorpeGrvLN63PL

Survey Schedule - 231129 24WinthorpeGrvLN63PL

Site Images - 231129 24WinthorpeGrvLN63PL

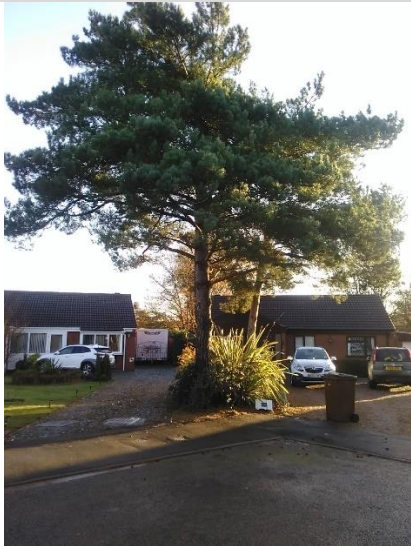
Tree T1 and T2 both stand within 0.6m of a neighbouring driveway to the north (see images 1-3). The driveway appears to have been resurfaced in the relatively recent past, and is now showing notable signs of deformation adjacent to the trees (see images 2 & 3). Aside from the trees themselves, no other potential causes for the damage were observed.

Image 1 – T1 in foreground with T3 in background

To maintain the current arrangement of surfacing and drainage, the removal of T1 and T2 would be the most cost effective solution. The removal of T3 would also likely be necessary as it has very poor form aesthetically, and will likely cause issue with adjacent surfacing in the long-term.

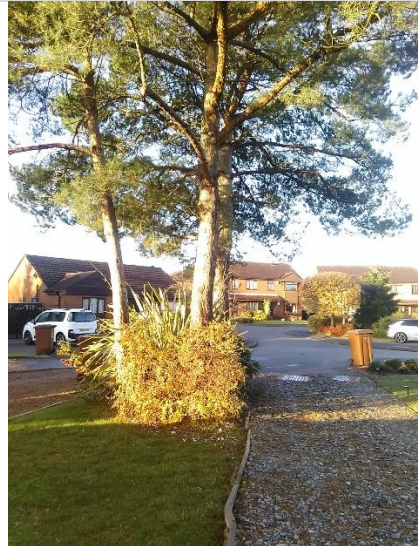
Tree T3 stands approximately 1m from the driveway of 24 Winthorpe Grove, and is currently having no effect on this surfacing. The tree is the subordinate in the group, suppressed to the N, with a slender, asymmetrical in form (see images 2 & 5).

Image 2 – T3 & T2 (left to right) with T1 in background

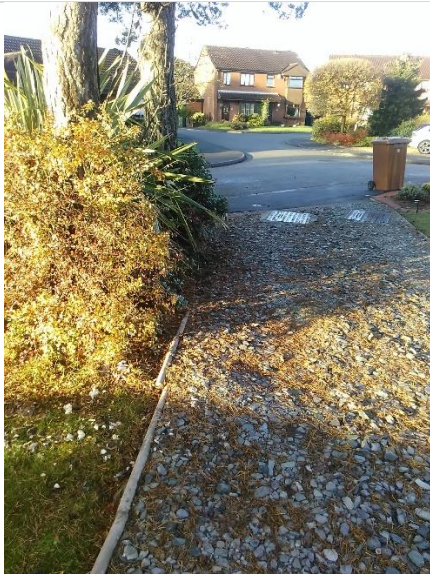
Image 3 – Deformation of neighbouring driveway to N

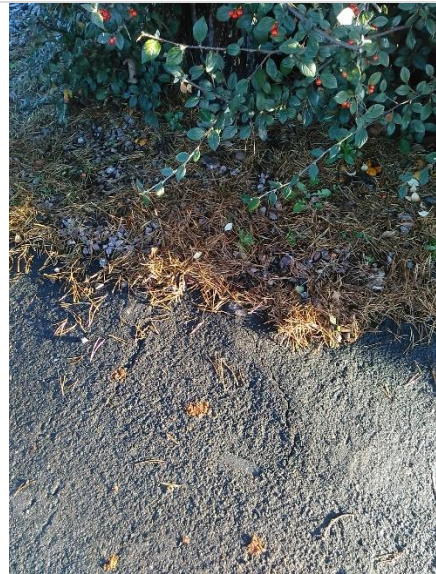
Tree T1 is also causing deformation to adjacent surfacing to the SW (see image 4), and is likely associated with a crack system extending 4m to the SW towards a surface water drain (see image 5).

Image 4 – Cracks in pavement to SW of T1

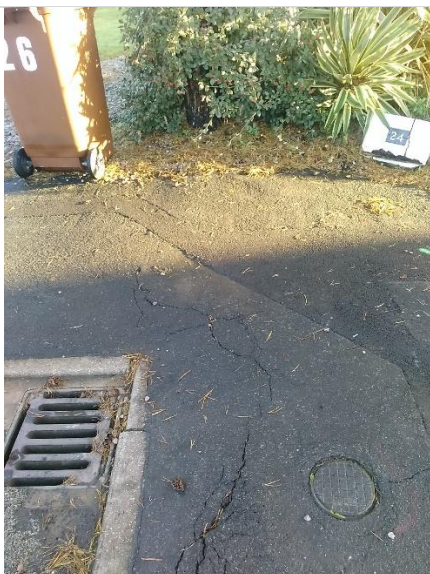
Regarding the cracks extending towards the drain to the SW of T1, it is highly likely the tree is the causal factor. If the tree is the causal factor, damage to drainage infrastructure will become almost a certainty in the long-term.

Image 5 – Crack in pavement adjacent to drain to SW of T1

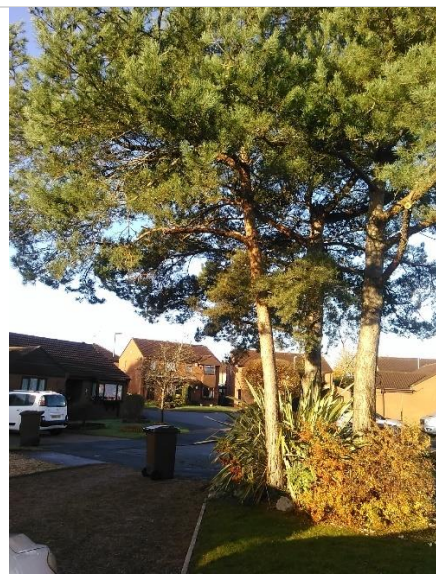
Image 5 – T3 & T2 (left to right) with T1 in background
