Tree Condition Assessment – Pumphouse Wood 01/12/2023

Surveyor – Kevin Feeney

Brief – Tree Condition Assessment of high risk zones as part of regular inspection.

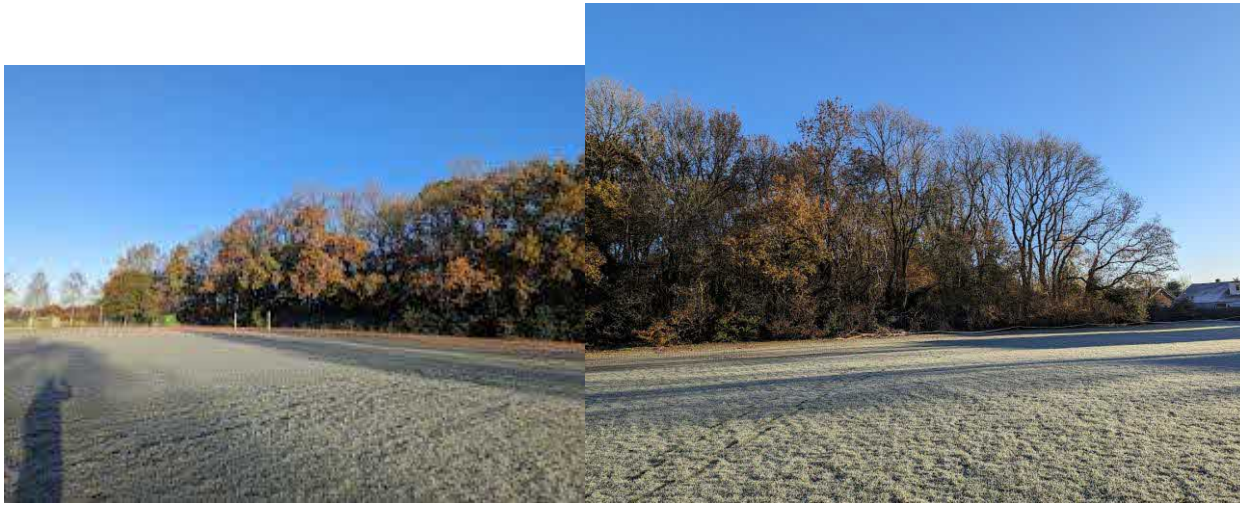
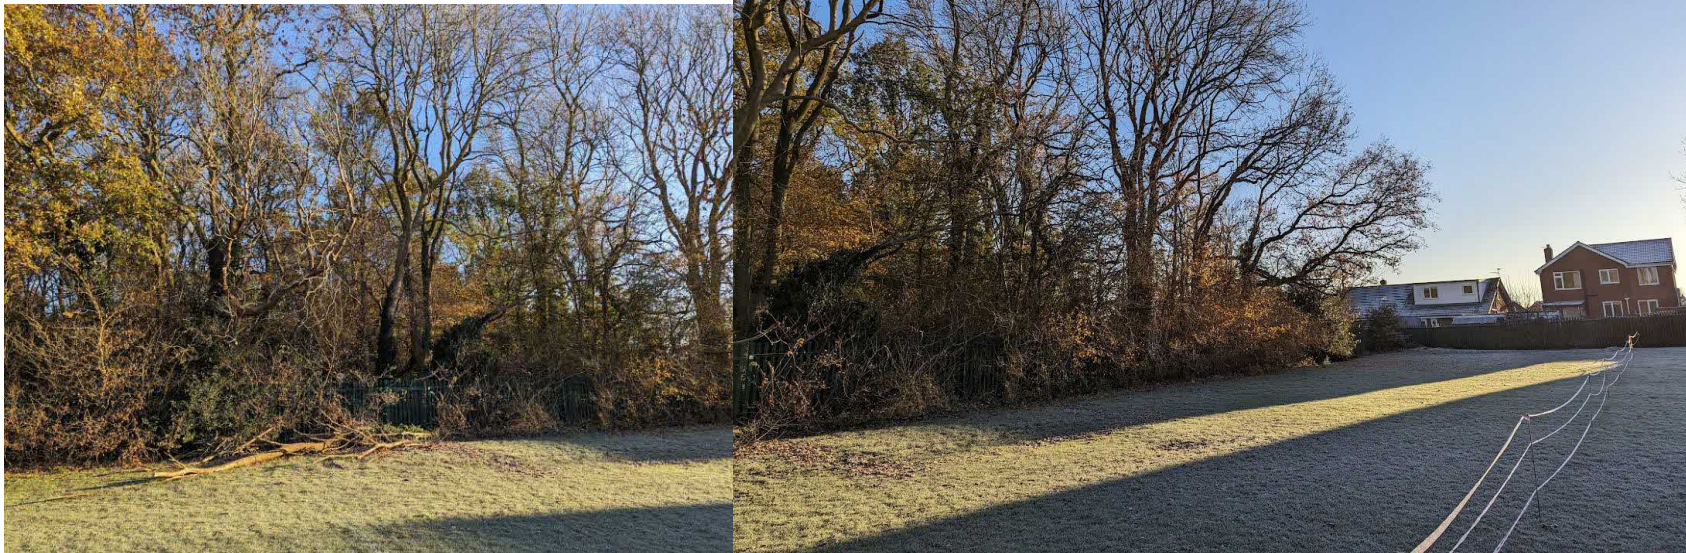
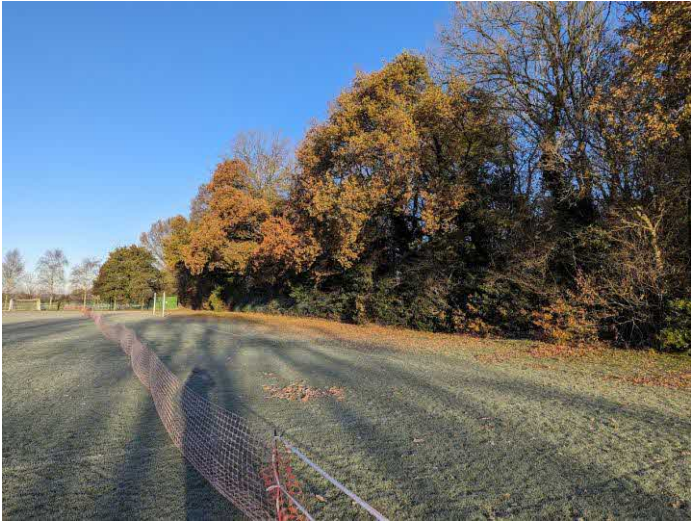
ANNEX C – Tree Photos

Title	Grid reference	SPECIES	Age Class	Description	Recommendations	Priority
Group 1	SJ63437585	Ash (<i>Fraxinus excelsior</i>), Oak (<i>Q.robur</i>), Elm (<i>Ulmus sp'</i>)	M	Height 26m. Line of 28 trees all located within five meters of woodland boundary with Barnton Primary School playing fields. Entire woodland comprises 80% ash trees in upper canopy future plan to clear fell woodland following felling license application and public consultation. Clear fell is necessary for majority of woodland as remaining trees will be subject to windthrow, further discussion required throughout 2024. Initial Primary school has been asked to create a 15 meter buffer from the woodland due to the number of ash trees presenting ash dieback with 40-60% loss in canopy. Initial talks with harvesters indicates that school boundary trees will require tops removing, this would also reduce risk to school and allow sport activities which generate income to continue.	Reduce all trees within 5 meters of boundary with school to monolith to reduce fall risk, this includes ash, oak and elm species and has been discussed with primary school and parish council. Further remedial action to take place in 2024	High
