## 24 Mill Way, Bradninch Application

### Technical Note: Internal & External Building Inspection Summary

#### FPCR Environment and Design Ltd

30<sup>th</sup> November 2023

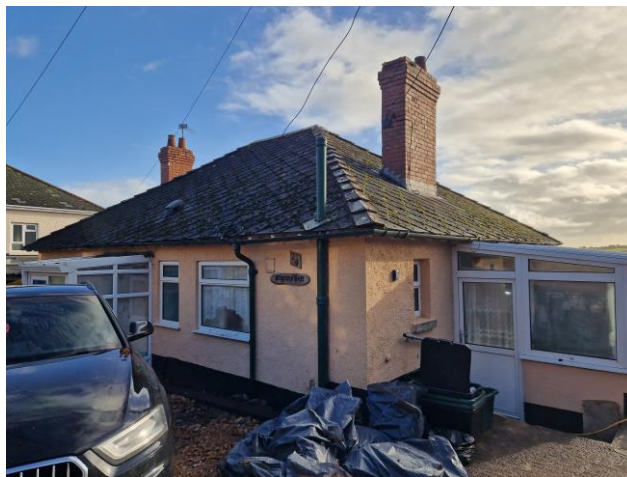
**Photo 1: View northeast from front of 24 Mill Way; hipped roof, dual chimneys, PVC conservatory and porch**

- 3.5 Obvious potential roost features were not visible during the external inspection. The fibre composite shingles were intact and well fitted, with no signs of damage. Similarly, there were no soffits or fascia boarding that may have offered opportunities for access to bats, with the cast iron painted guttering affixed directly to the wall under the eaves, with little gap. The concrete/cement capping tiles over the roof ridge and hips were slightly raised in a few places; however, the gaps underneath were not found to be large enough for bats to access, being less than 7mm across.

3.6 Given the lack of potential features suitable to support roosting bats on the exterior of the property, the building was assessed to be of **negligible** potential for roosting bats. Consequently, roosting bats are not considered a material constraint to the proposed extension and no further survey is required.
