# Tree Survey Report

SHELL UK  
WOODBANK  
CULTS  
ABERDEEN

January 2020

Struan Dalglish Arboriculture  
The Bothy  
Drumoak  
Aberdeenshire  
AB31 5EP

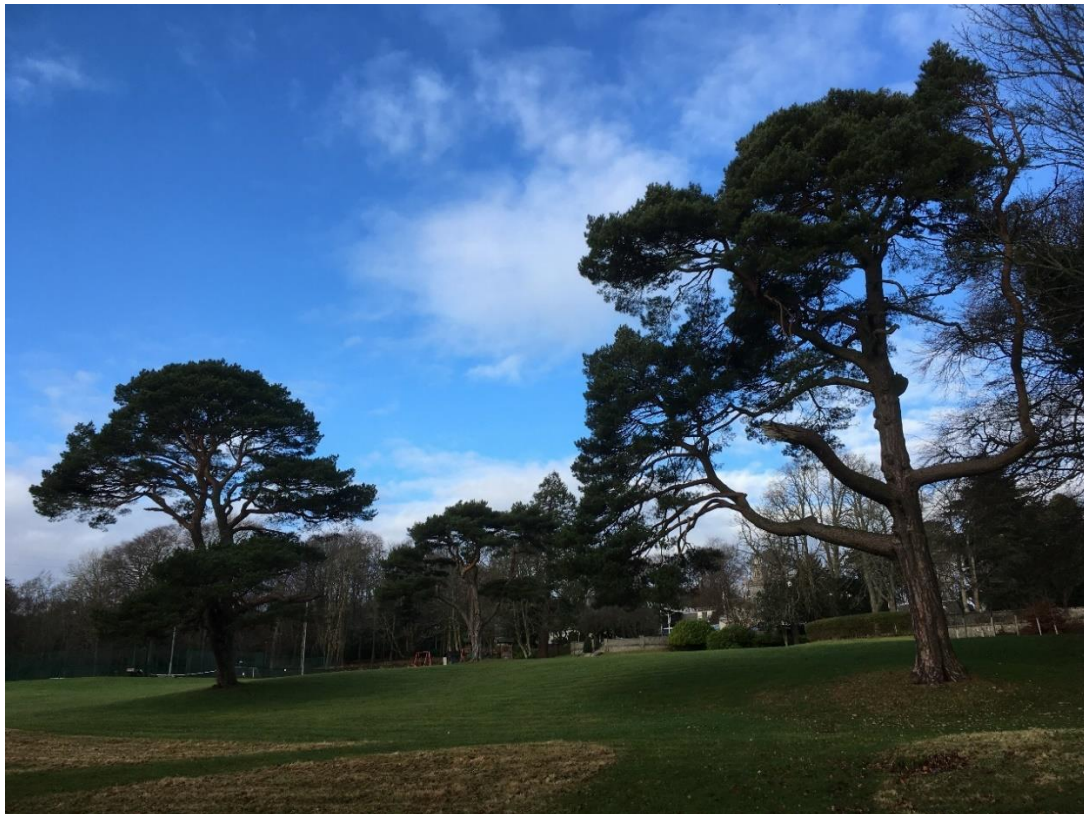
Photo 1 – 3 open grown Scots pines form prominent landscape features within parkland south of hotel.

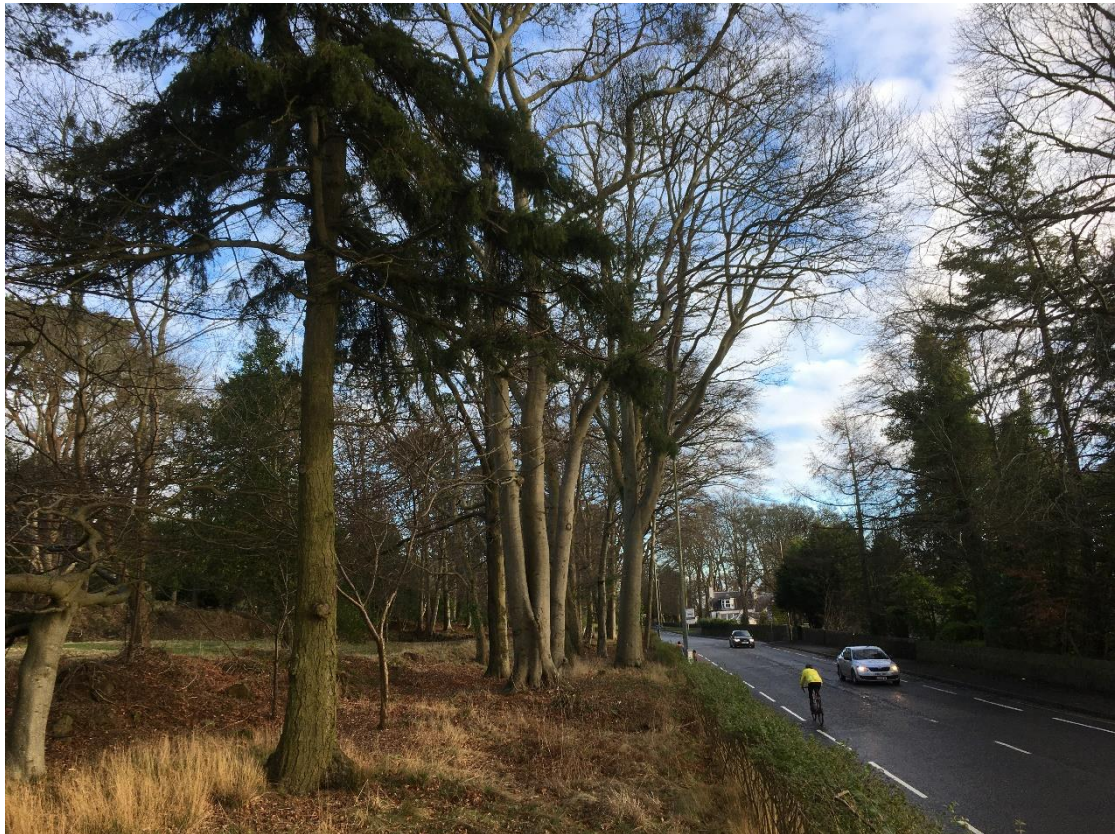
Photo 2 – A dense strip of mature trees line and overhang the busy North Deeside Road.

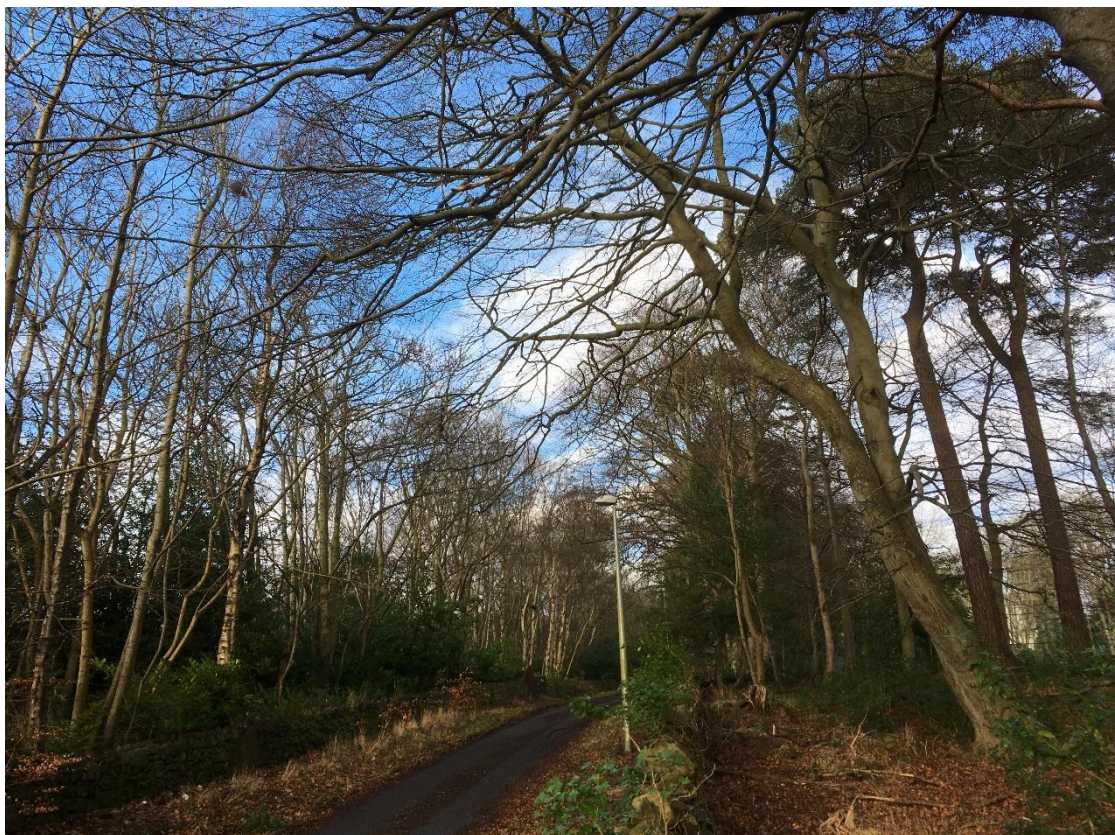
Photo 3 – Mature trees overhanging the presently less frequently accessed Baird's Brae.

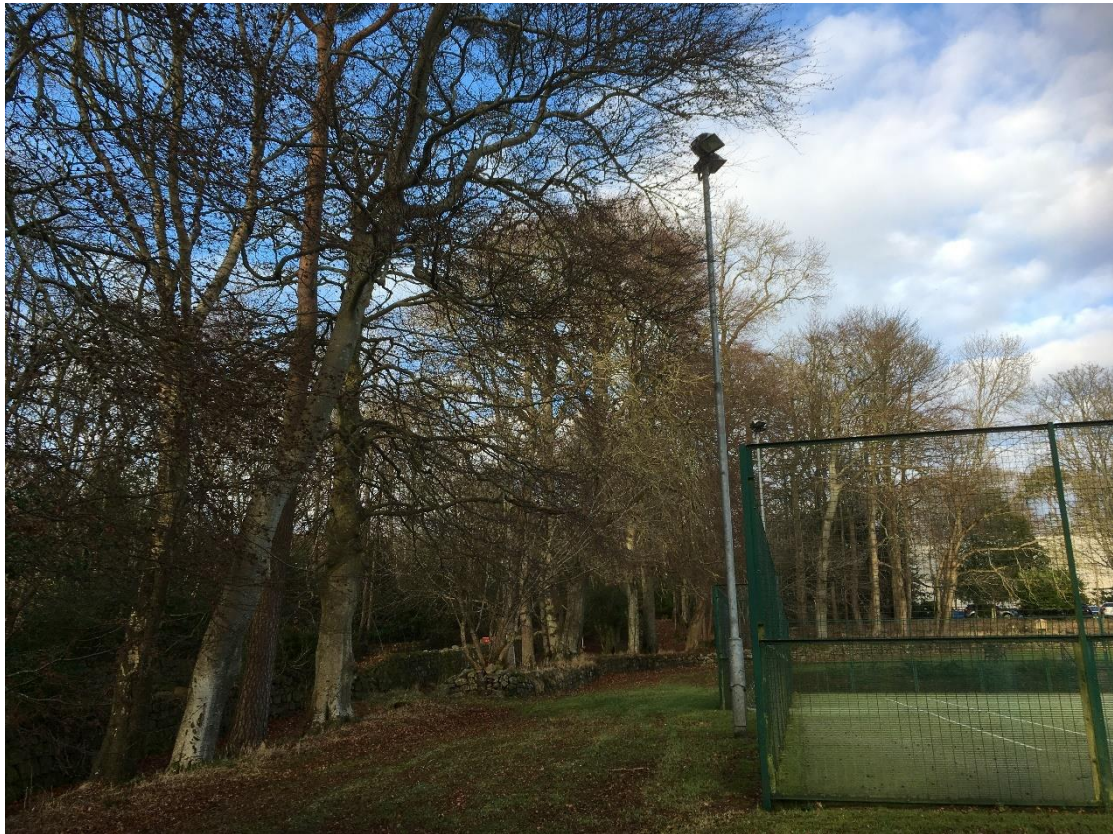
Photo 4 – Mature trees lean towards the frequently used tennis courts.

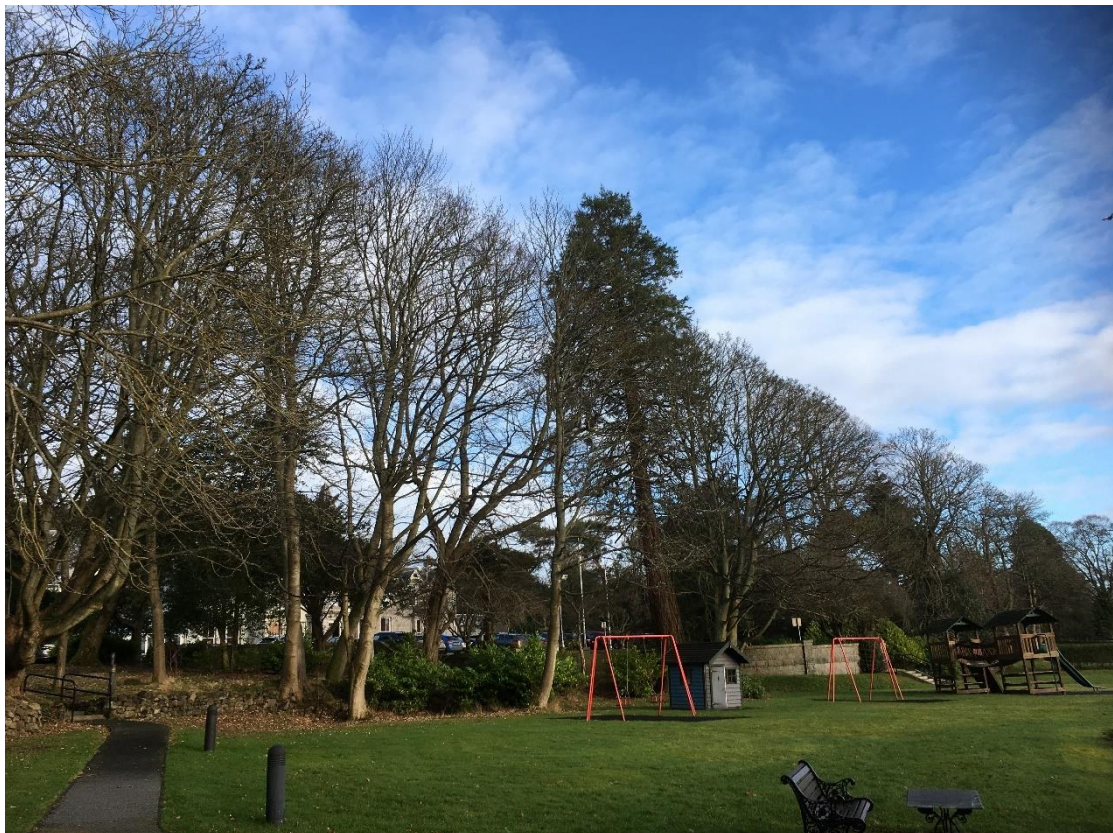
Photo 5 – A strip of mature trees is present next to the children's play area.

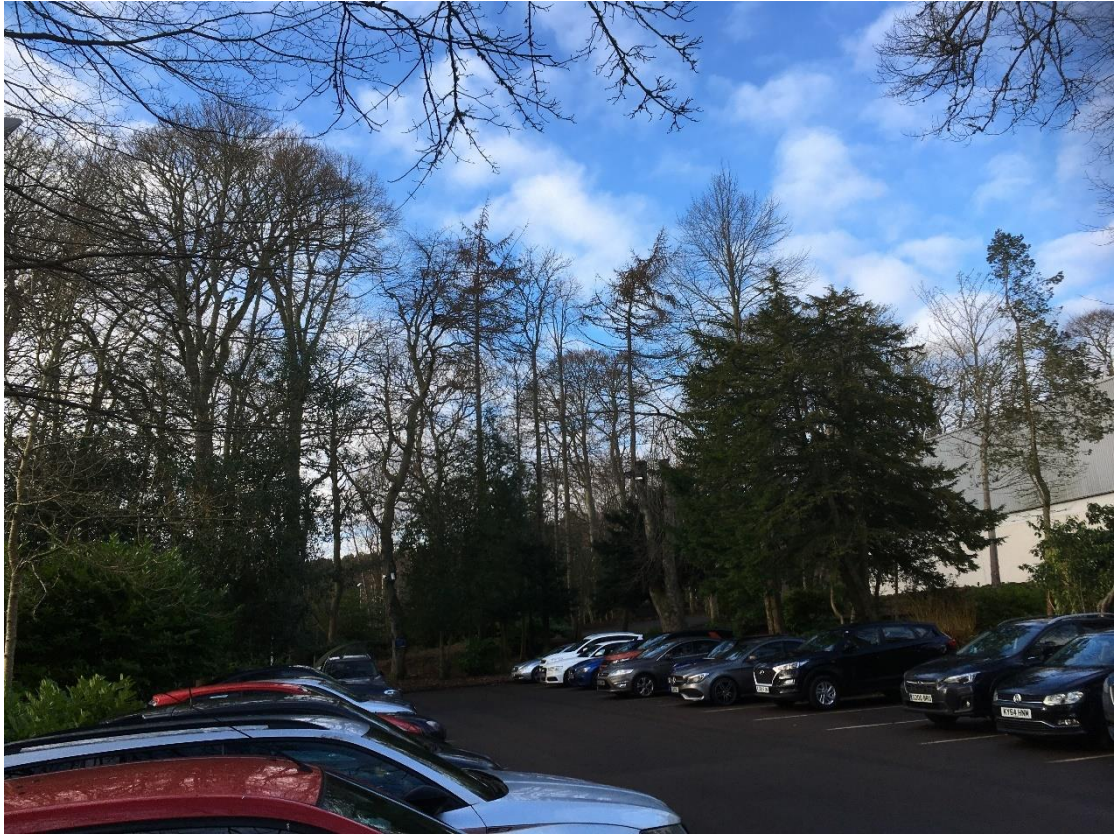
Photo 6 – Dense trees including several large, mature individuals surround the frequently used car park.

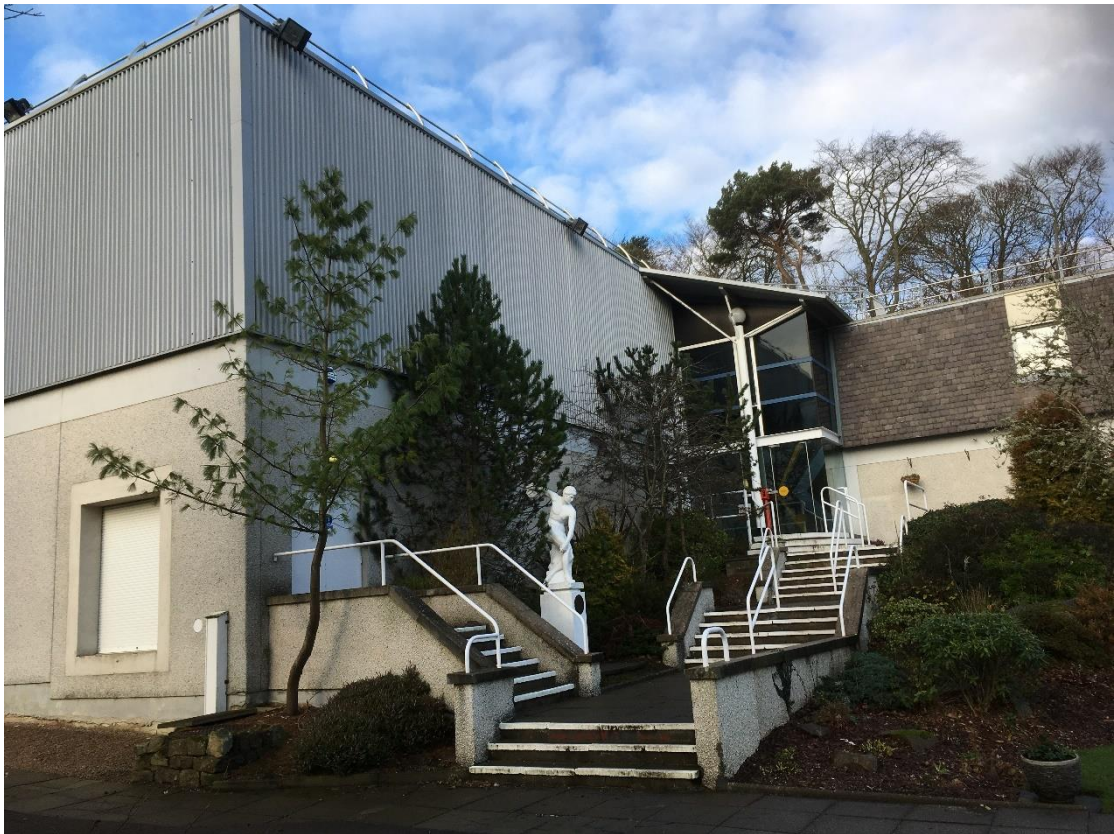
Photo 7 – Young pine trees grow against wall at Sports Centre. These presently provide some screening but will soon out-grow their location and alternate planting should be considered.

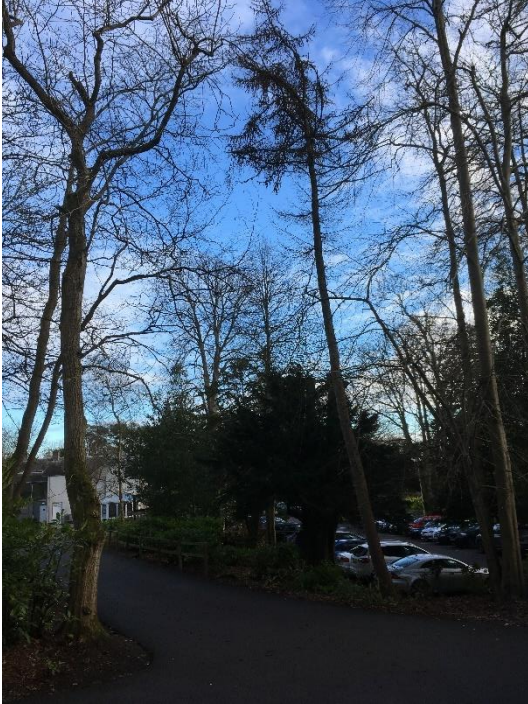
Photo 8 – Spindly larch 2388 to be removed.

**Larch 2388** is exposed and leaning next to the car park. The tree appears to be at high risk of blowing over or snapping during strong winds and **removal with 3 months has been recommended**.

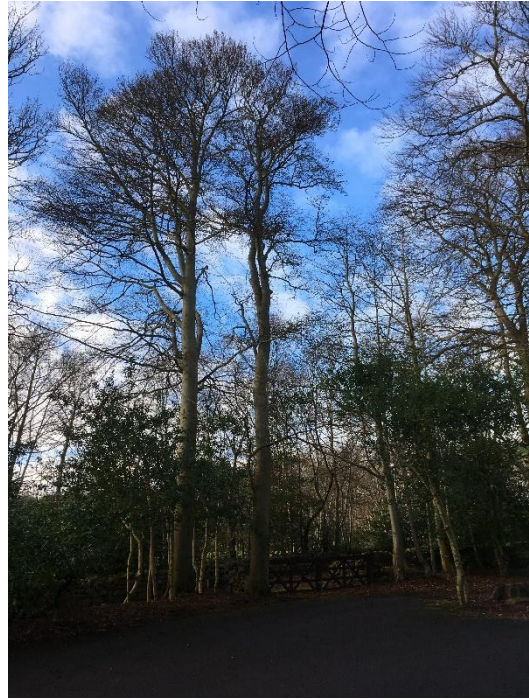
Photo 9 – Beech 2415 (centre) with Kretzschmaria wood decay fungus at base. Overhangs Bairds Brae.

Small patches of the fungus were noted at the base of **beech tree 2415 and sycamore 2430**. This type of decay tends to be progressive and badly affected trees are often at high risk of failure.

Both trees occur in a relatively sheltered locations away from frequently accessed areas. While their retention in the short term may be possible the trees should be closely monitored for signs of deterioration and **removal within the next 5 years is considered likely to be required**.

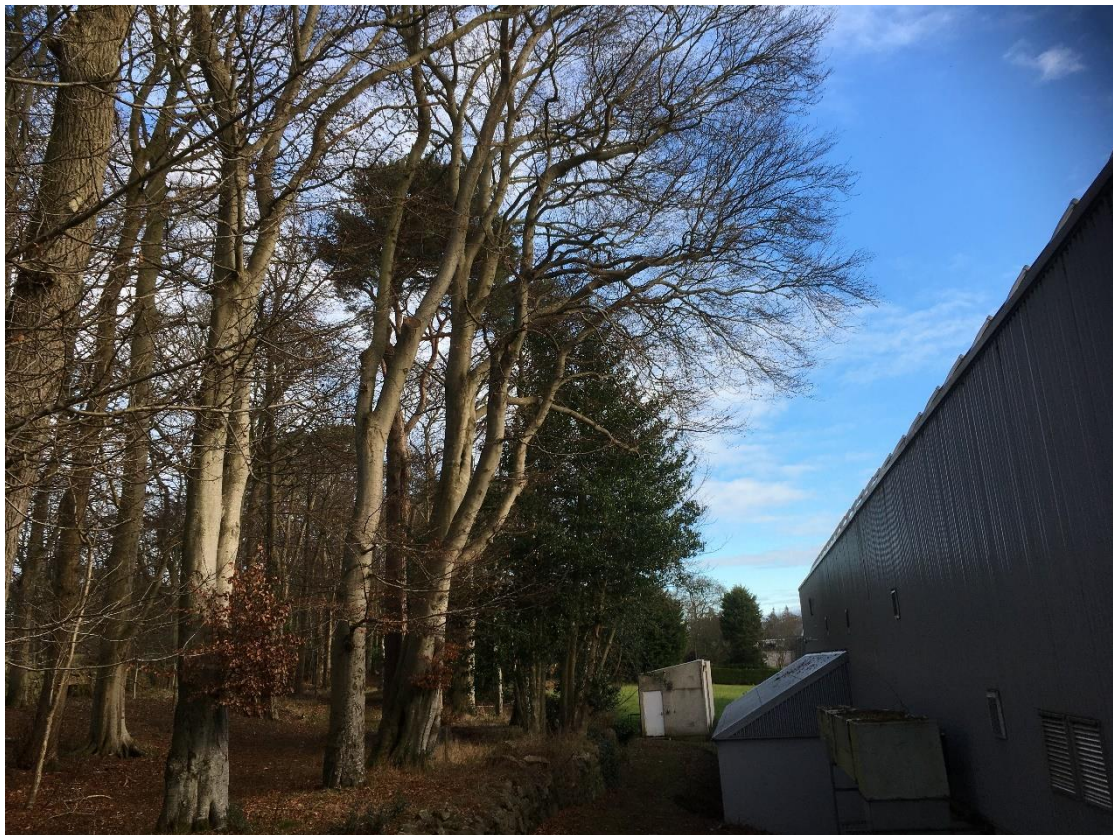
Photo 10 – Mature tree close to rear of sports complex. Includes severely decayed horse chestnut 2482 where removal has been recommended.

**Horse chestnut 2482** is severely decayed and has shed a co-dominant leader. The remaining tree is at high risk of failure and **removal within 3 months** has been recommended.

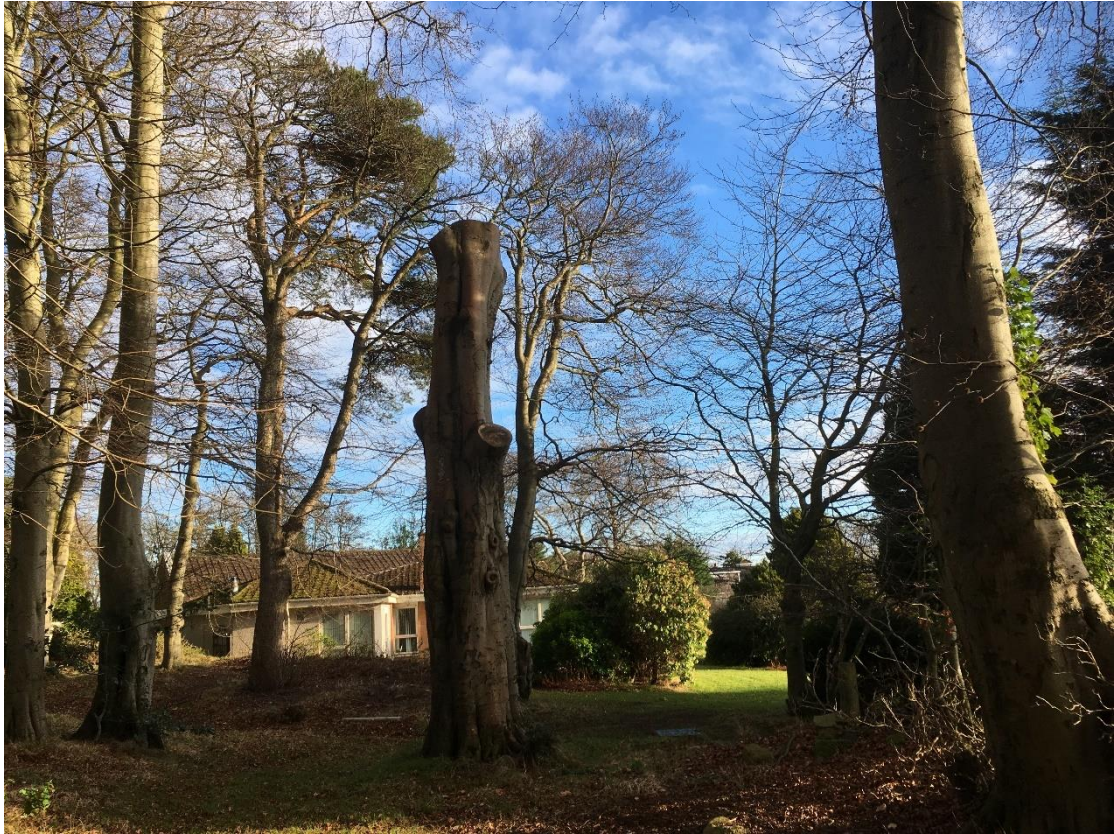
Photo 11 – Previous tree safety work on decayed beech 2521 have been completed.

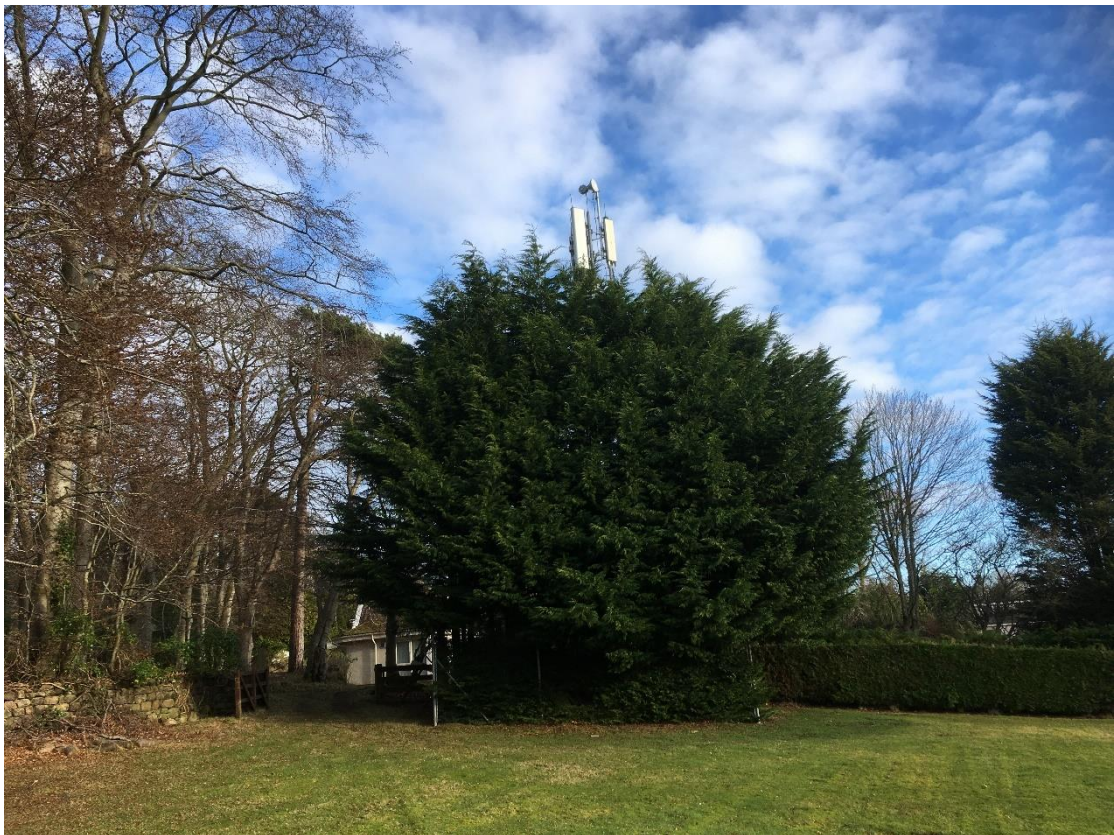
Photo 12 – Leyland cypress hedge 2593a screen the phone mast. The hedge is overgrown and requires to be clipped to encourage a dense and compact form.

Leyland cypress (*Cupressocyparis leylandii*) hedging was recorded surrounding the phone mast 2593a and lining the eastern boundary adjacent to The Marcliffe Hotel, 2560a.

These hedges are becoming overgrown and regular clipping has been recommended to encourage the development of a dense and manageable form.

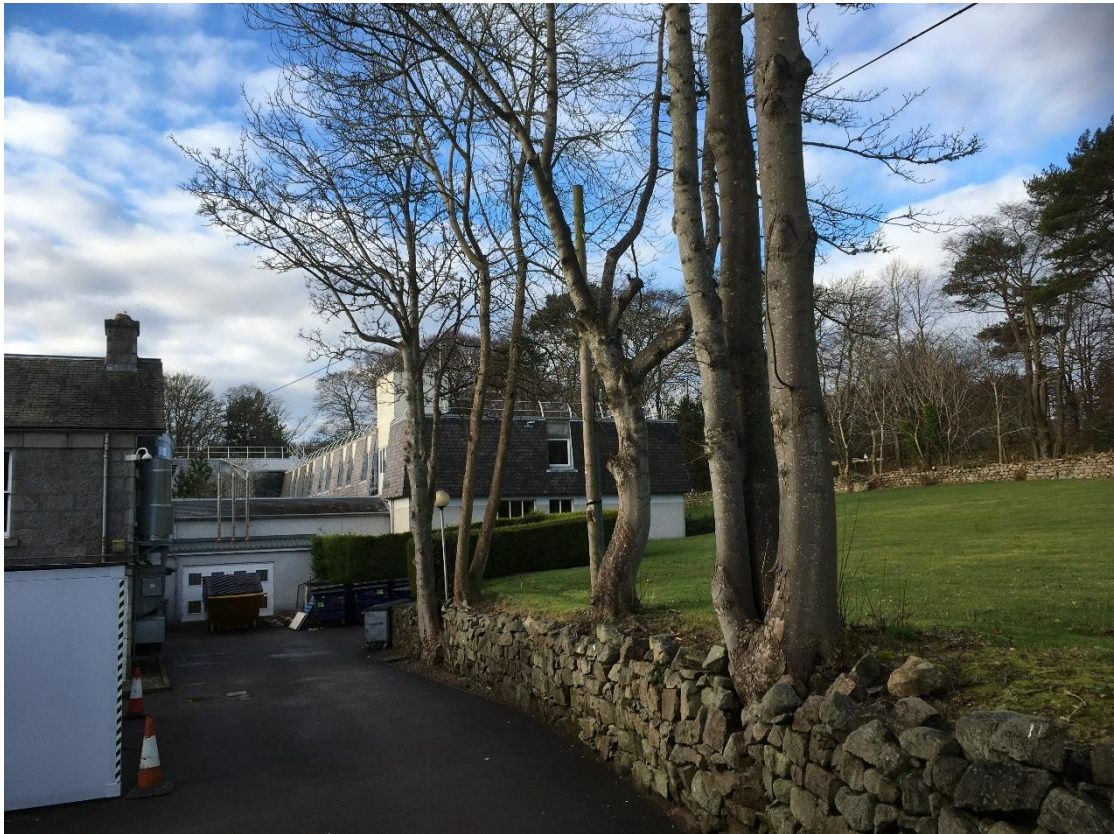
Photo13 – Semi mature trees 2595 to 2598 growing from wall and displacing stones.

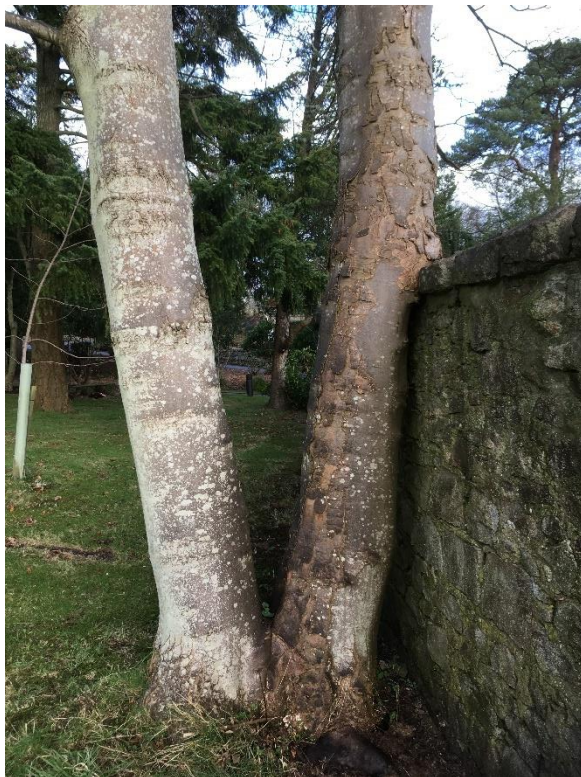
Photo 14 – Twin stemmed sycamore 2633. Co-dominant stem should be removed to protect wall.

**Sycamore 2633** has a twin stem growing against the wall around the car park. The removal of the stem has been recommended to protect the wall.

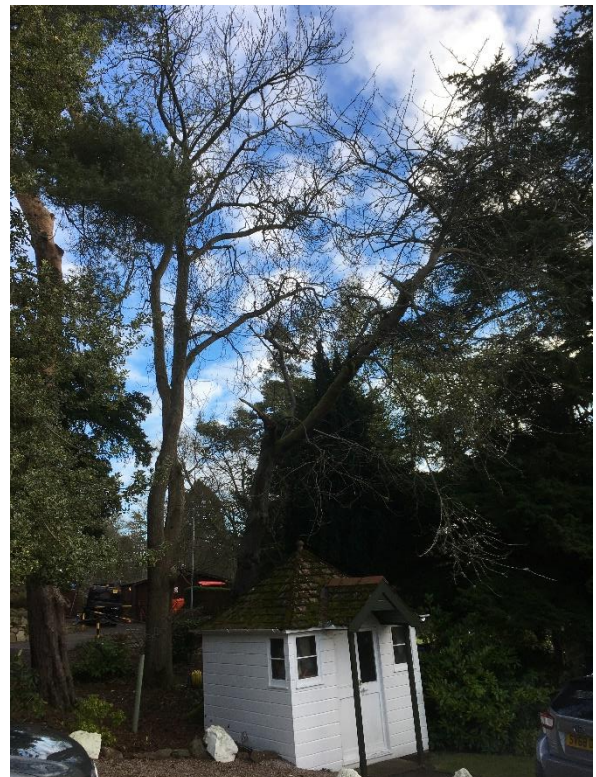
Photo 15 – Wild cherry 2604 is in very poor condition overhanging hut and should be removed

**Wild cherry 2604** is very poorly formed and has shed large branches. It overhangs a wooden hut next to the car park and **removal within 3 months is recommended**.

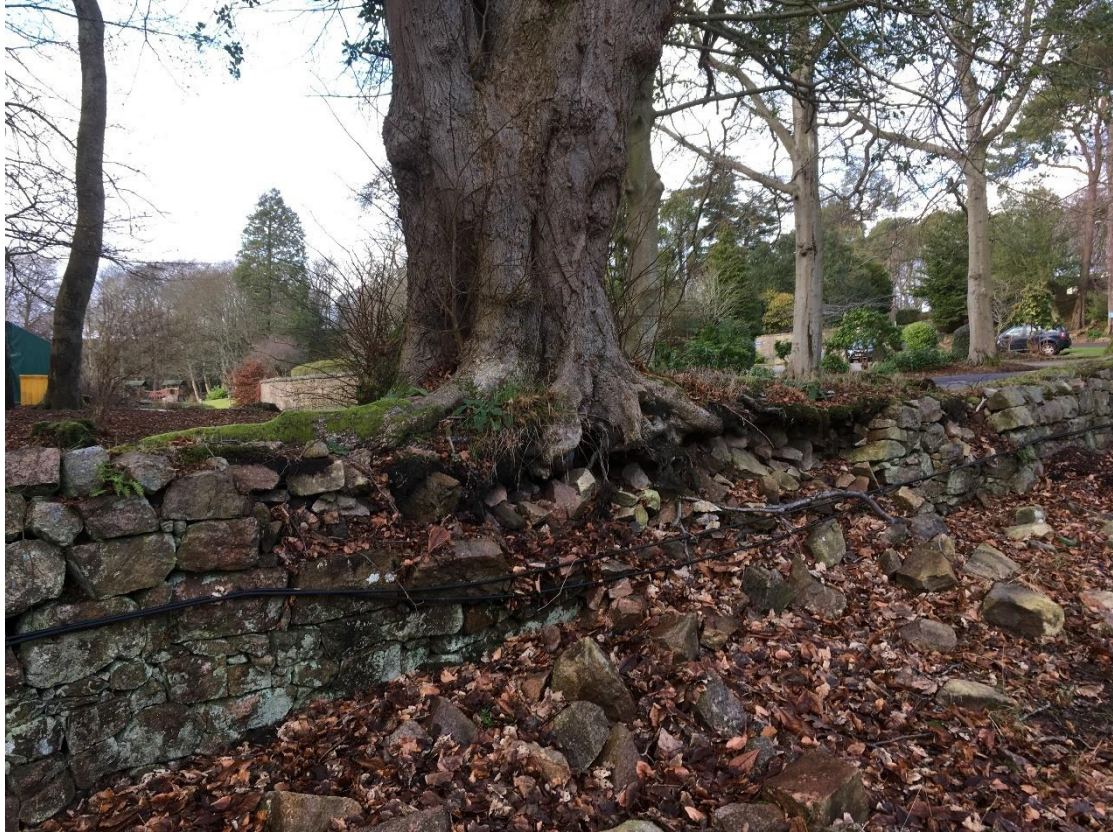
Photo 16 – Large and mature limes 2666, 2668 and 2671 grow from edge of ha ha wall next to driveway. The stone at the base of each tree have fallen from the wall, exposing the roots. The trees are tall with some poorly formed limbs. A 20% crown reduction has been recommended to reduce the risk and encourage the development of a more compact crown.

**Lime trees 2666, 2668 and 2671** grow from the edge of low, stone retaining wall next to the driveway. The walls are in poor condition and tree roots severely exposed where stones have been displayed. Signs of root decay are present, and the trees are tall with some poorly formed branches. It is recommended pruning to reduce the height and spread of the crown be undertaken to reduce the potential of storm damage.

As a species lime tend to respond favourably to pruning and the trees are likely to regenerate vigorously from the pruning wounds. This new growth can be poorly attached

and should not be allowed to become excessively large. Periodic pruning to maintain the trees at the new, lower height is likely to be required on approximately a 10-yearly cycle.

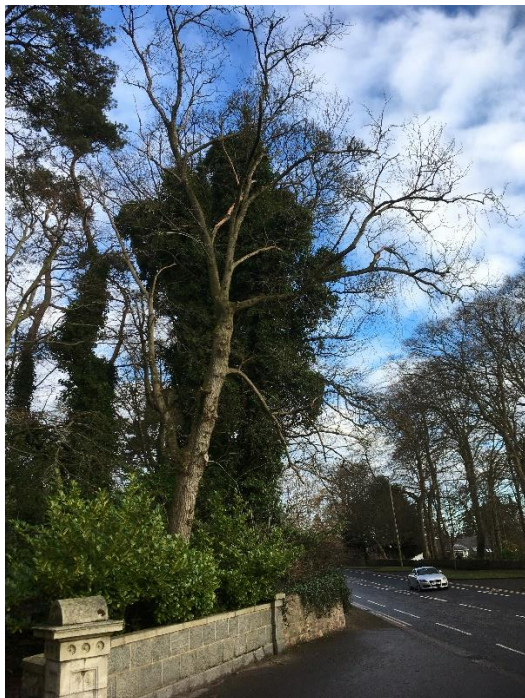
Photo 17 – Wych elm 2694 displays signs of infection with Dutch elm disease. Surrounding elm trees have all been removed since the time of the previous survey, presumably due to infection by the disease.

The disease is a significant issue on the site and has spread to infect four trees since the time of the previous survey in October 2014. This includes **wych elms 2329, 2491, 2493 and 2694.**

The trees all occur adjacent to frequently accessed areas and felling has been recommended. To restrict the spread of disease to other parts of the city branch wood should be chipped and spread on site. Trunk wood should be safely stacked and retained on site.
