# Asbestos Report

## Targeted Refurbishment Survey

Site: Old Barn  
The Pines, Frostenden Corner, Frostenden,  
Suffolk, NR34 7JA

On Behalf of: Julie Catterall  
Commissioned by: Julie Catterall  
Survey Date: 15/06/2023  
Report Issue Date: 19/09/2023  
Project Number: P-00217  
Surveyor(s): Roger Fleuty  
Assistant Surveyor:

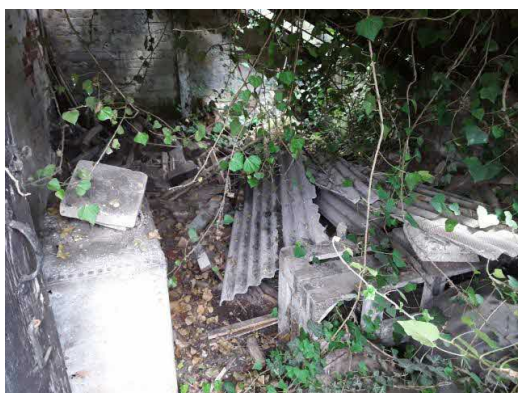
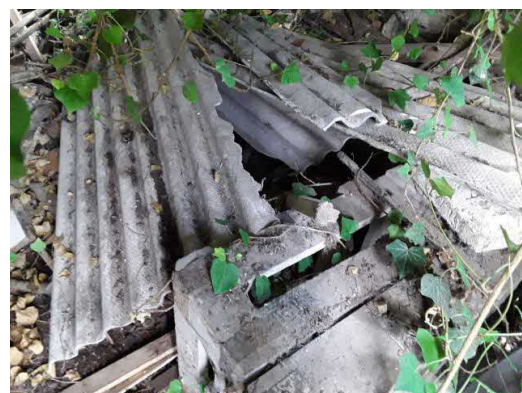
Floor:	Ground Floor	Sample Ref:	S001-CMP
		Lab Ref:	B0823/192
Location:	001 - Lean-to	Identification:	Sampled
Reported:	19/09/2023	Asbestos Type:	Chrysotile
Updated:		Condition:	Medium Damage
Quantity:	10 m <sup>2</sup>	Product:	Cement Product
Item	Loose cement roof sheets		
Sample Notes	Discarded damaged roof sheets		
Access:	Can be reached by hand

Material Assessment (MA) Score		MA Score	MA Risk Rating
Product Type:	1	<b>4</b>	<b>VERY LOW</b>
Extent of Damage:	2		
Surface Treatment:	0		
Asbestos Type:	1

Recommendation:	Remove under 'Controlled Conditions'
Recommendation Comments:	Any works to be undertaken must be by a Licensed Asbestos Removal Contractor in accordance with the Control of Asbestos Regulations 2012.

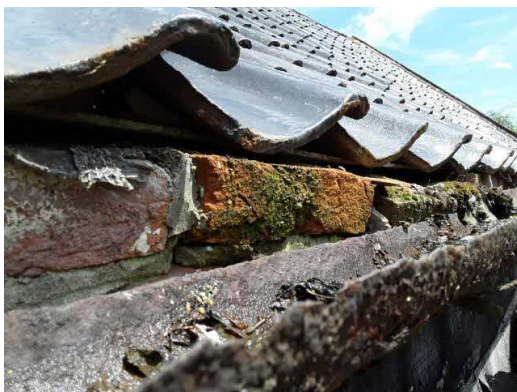
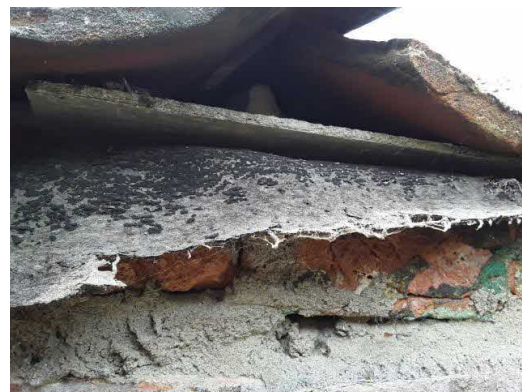
Floor:	Ground Floor	Sample Ref:	S003-CMP
		Lab Ref:	B0823/192
Location:	002 - Barn	Identification:	Sampled
Reported:	19/09/2023	Asbestos Type:	Chrysotile
Updated:		Condition:	Low Damage
Quantity:	4 lin m	Product:	Cement Product
Item	Cement Strip		
Sample Notes	Strip along top of wall above doors		
Access:	Can be reached by hand

Material Assessment (MA) Score		MA Score	MA Risk Rating
Product Type:	1	<b>3</b>	<b>VERY LOW</b>
Extent of Damage:	1		
Surface Treatment:	0		
Asbestos Type:	1

Recommendation:	Remove under 'Controlled Conditions'
Recommendation Comments:	Any works to be undertaken must be by a Licensed Asbestos Removal Contractor in accordance with the Control of Asbestos Regulations 2012.

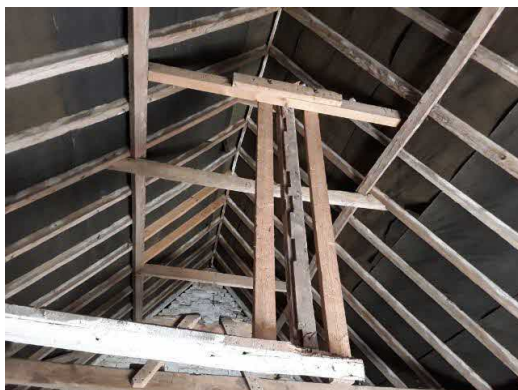
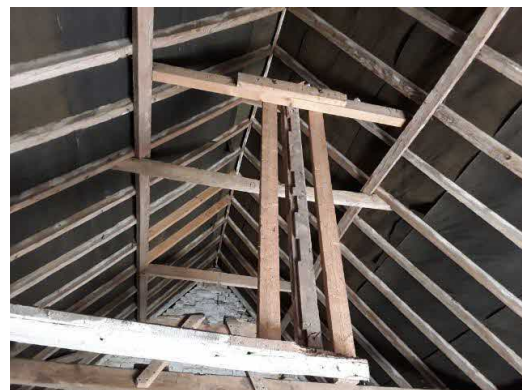
Floor:	Ground Floor	Sample Ref:	S002-BTP
		Lab Ref:	B0823/192
Location:	002 - Barn	Identification:	Sampled
Reported:	19/09/2023	Asbestos Type:	NAD
Updated:		Condition:	N/A
Quantity:	50 m <sup>2</sup>	Product:	Bituminous Product
Item	Bitumen underfelt		
Sample Notes	Bitumen underfelt to roof		
Access:	Can be reached by hand

Material Assessment (MA) Score		MA Score	MA Risk Rating
Product Type:	N/A	<b>0</b>	-
Extent of Damage:	N/A		
Surface Treatment:	N/A		
Asbestos Type:	N/A

Recommendation:	No Action Required
Recommendation Comments:	No asbestos detected in sample

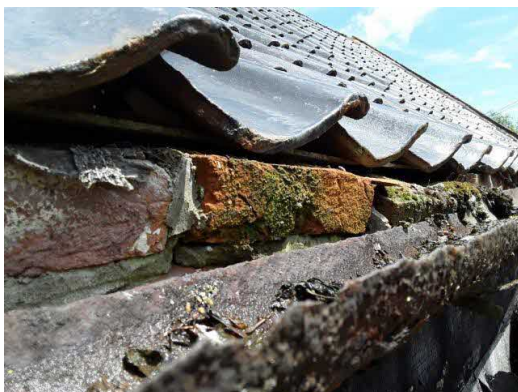
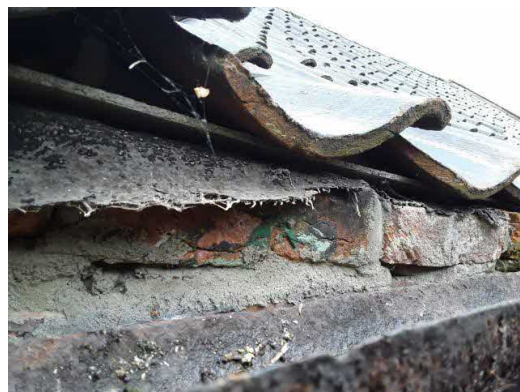
Floor:	Ground Floor	Sample Ref:	S005-BTP
		Lab Ref:	B0823/192
Location:	002 - Barn	Identification:	Sampled
Reported:	19/09/2023	Asbestos Type:	NAD
Updated:		Condition:	N/A
Quantity:	16 lin m	Product:	Bituminous Product
Item:	Bitumen roof underfelt		
Sample Notes:	Bitumen underfelt along top of wall		
Access:	Can be reached by hand

Material Assessment (MA) Score		MA Score	MA Risk Rating
Product Type:	N/A	<b>0</b>	-
Extent of Damage:	N/A		
Surface Treatment:	N/A		
Asbestos Type:	N/A

Recommendation:	No Action Required
Recommendation Comments:	No asbestos detected in sample

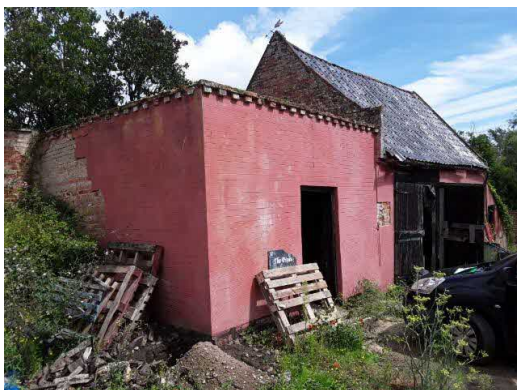
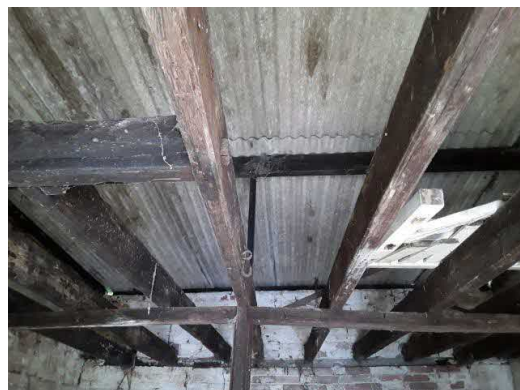
Floor:	Ground Floor	Sample Ref:	S004-CMP
		Lab Ref:	B0823/192
Location:	003 - Shed	Identification:	Sampled
Reported:	19/09/2023	Asbestos Type:	Chrysotile
Updated:		Condition:	Low Damage
Quantity:	10 m <sup>2</sup>	Product:	Cement Product
Item	Cement roof sheets		
Sample Notes	Corrugated sheets to roof		
Access:	Can be reached by hand

Material Assessment (MA) Score		MA Score	MA Risk Rating
Product Type:	1	<b>3</b>	<b>VERY LOW</b>
Extent of Damage:	1		
Surface Treatment:	0		
Asbestos Type:	1

Recommendation:	Remove under 'Controlled Conditions'
Recommendation Comments:	Any works to be undertaken must be by a Licensed Asbestos Removal Contractor in accordance with the Control of Asbestos Regulations 2012.
