23715/H&S/ZH

7<sup>th</sup> November 2023

**CARNBOOTH HOUSE HOTEL, 80 BUSBY ROAD, GLASGOW, G76 9EH**

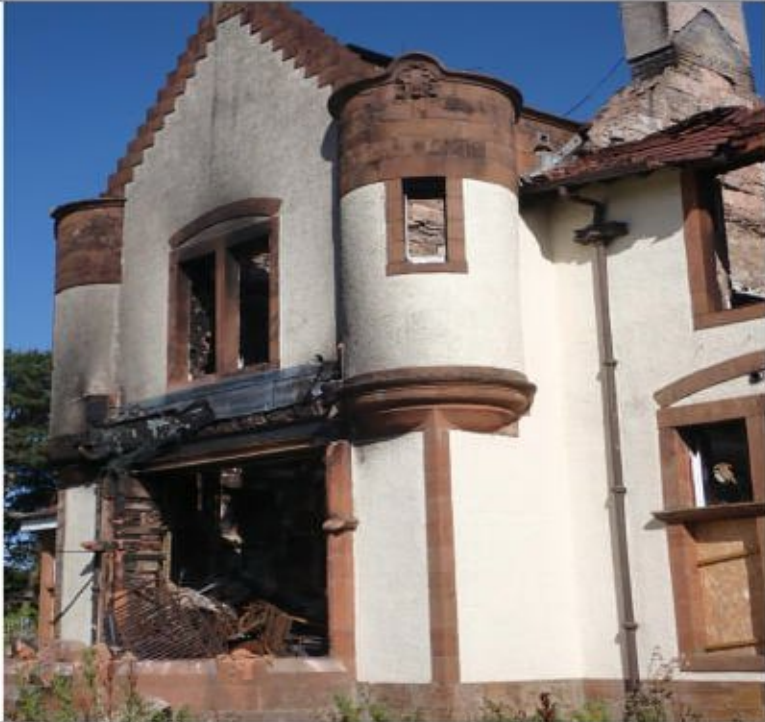
**Photograph 1:**  
Taken on the southwest facing elevation looking onto the window opening to the former conferencing suite.

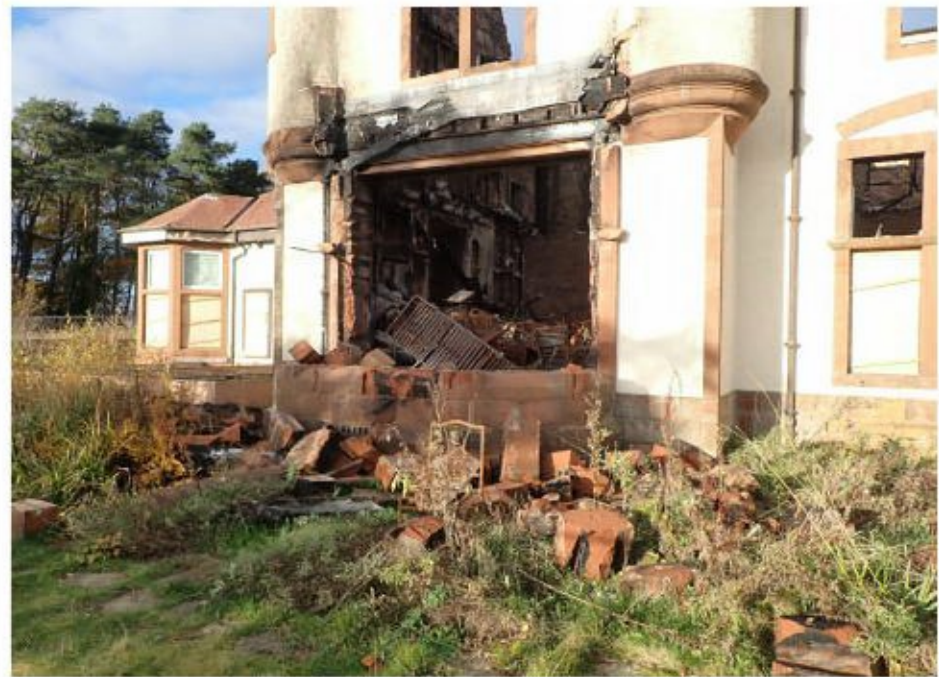
I draw your attention to the report I issued on the 21<sup>st</sup> of August in the immediate aftermath of the fire event. I believe you have reviewed the contents of this report and passed it on to the local authority planning department. Since I issued this report, sections of the southwest and southeast facing elevations have partially collapsed. Please refer to the photographs contained below.

**Photograph 2:**  
Taken on the southwest facing elevation looking onto the window opening to the former conferencing suite shows the masonry that collapsed suddenly in early September.

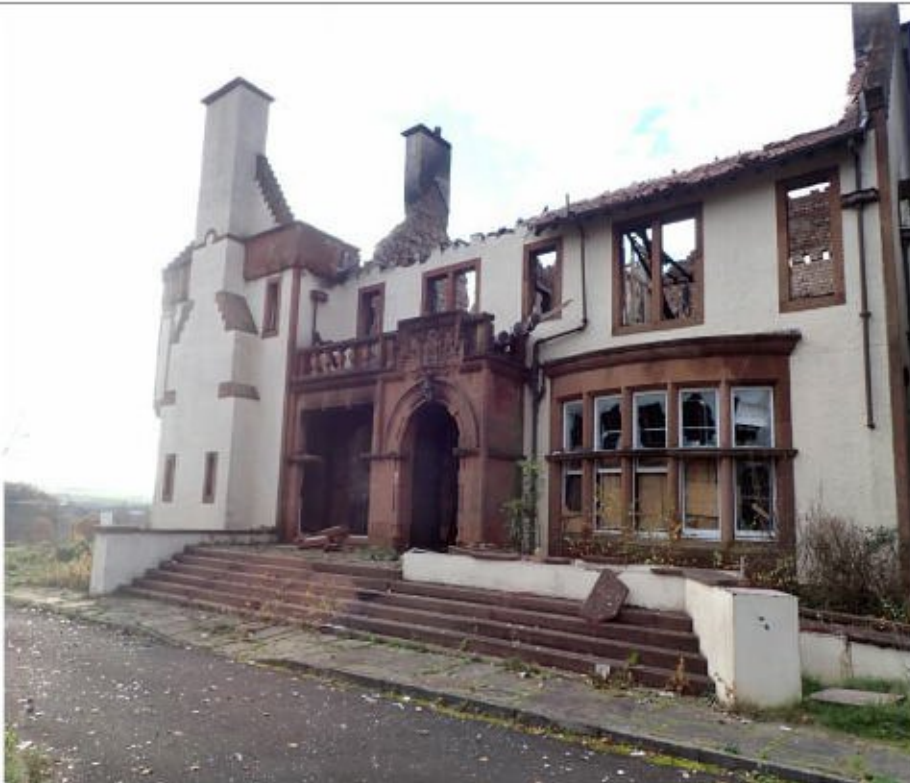
**Photograph 3:**  
Taken on the southeast facing elevation looking onto the red sandstone arched main entrance to the former hotel.

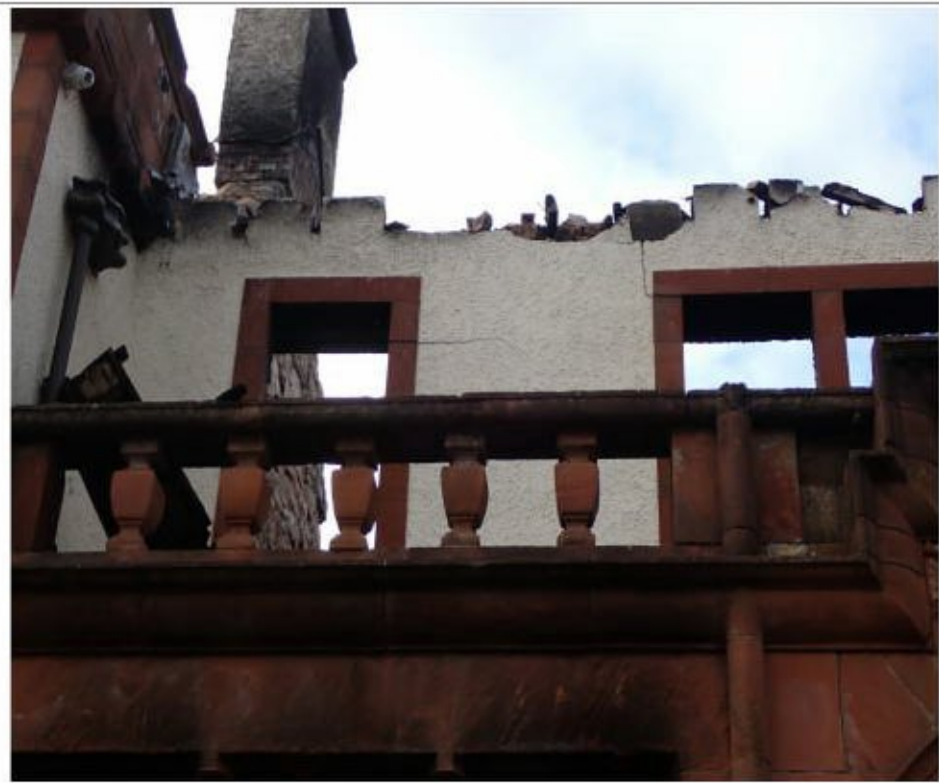
I had highlighted in my report that these sections of masonry had been exposed to extremely high temperatures during the fire in middle of August and as such there were cracked lintels that were in a precarious condition. On my recent inspection, I have picked up stress cracking in the masonry wall panel directly above the arched entrance into the former hotel and at the corner of the southeast and southwest facing elevations. These have become more pronounced in the period since I conducted my first inspection in mid-August.

**Photograph 4:**  
Taken on the southeast facing elevation looking onto the wall panel directly above the red sandstone arched main entrance to the former hotel. Note the cracking that emanates from the lintels of both windows.

Due to the extensive damage to the structural engineering integrity of the property, this is now a full take down operation. I am now of the considered professional opinion that the existing perimeter random rubble walls and internal brick partitions cannot be temporarily propped and salvaged for reintegration into the remediation works even if comprehensive repairs are carried out. It would not be possible to justify the existing structural engineering elements that remain standing against accepted codes of practice or British Standards that must be adhered to in order to prove a structural reinstatement is safe and the load paths are functional.
