Hampshire
Ecological Services
Consultant Ecologists

28/11/2023

Preliminary Roost Appraisal (internal/ external bat assessment) at the Rum Store, Royal Clarence Yard, Gosport, Hants.

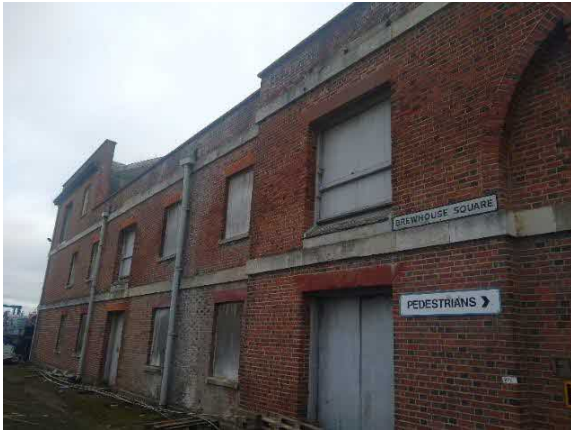
Type/Name	Building
Description	A two-storey building with a pitched, slate roof. There is also a single storey, flat roofed extension. Part of the roof of the building has collapsed in on itself.
No. of storeys	2(1)
Roof type	Flat, some areas pitched, others collapsed
Roof cladding	Slate or flat and unknown
Wall type	Brick, cavity
Exterior	Many gaps due to damaged brickwork and missing cement
Photos	<p>North elevation</p>

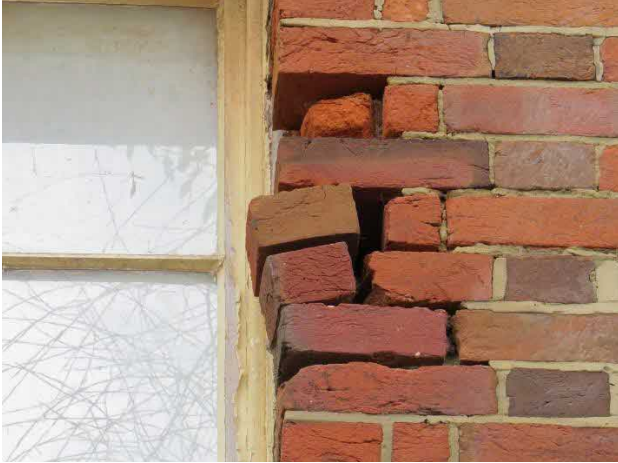
There are numerous gaps in the brickwork of the building due to missing mortar and damaged bricks. These gaps potentially provide occasional external roosting locations for crevice-dwelling species of bat such as pipistrelles.

Photo 1. An example of the damaged brickwork on the building.

No bats or evidence of roosting bats was found. However bats frequently move around and adopt new roosting site. Given the mobility of bats, it is recommended that an endoscope inspection of the brickwork by a bat-licenced ecologist is undertaken immediately prior to works to check for any temporary roosting bats. It is not anticipated that bats will be encountered, however in the unlikely event that bats, or evidence of bats (such as droppings), are encountered then all a site-specific European Protected Species (EPS) mitigation licence will be obtained from Natural England before work can proceed.

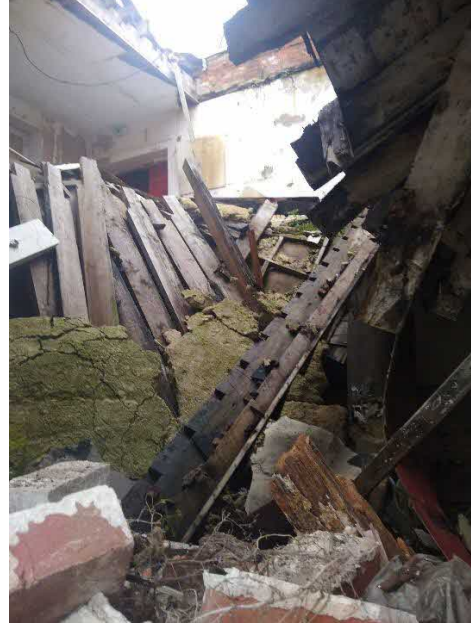
No bats or evidence of bats (such as droppings) were observed during the survey. However large sections of the roof have collapsed which restricted safe access to many internal areas.

The interior of the building provides suitable nesting habitat for feral pigeons with the collapsed area of roof providing internal access to the building.

Photo 2. The section of roof that has collapsed.
