The Rum Store
Royal Clarence Yard
Structural Report

Project Number: 01887

22 February 2023

Revision R2

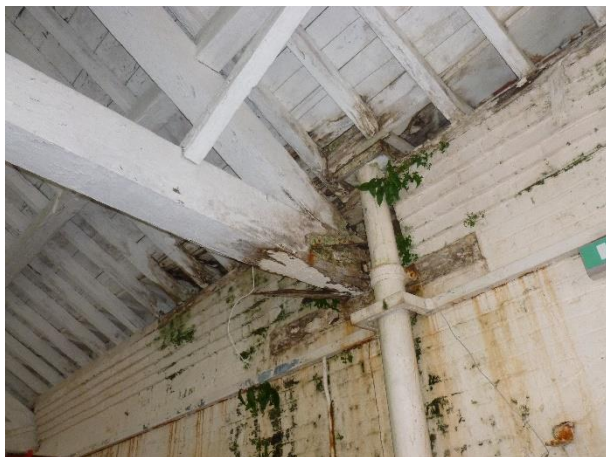
- 3.1 The roof structure of the east range has generally been kept dry due to the covering of slate on the pitched roof. The problems with this roof are at the bearings of the main trusses where water ingress has occurred due to poor maintenance of the valley gutter and the parapet gutter and hoppers on the west side. This has caused decay in the truss tie-beams in a number of locations as well as the wallplate and rafters local to the gutter. One truss has decayed and dropped to such an extent that the longitudinal bracings to the purlins have dropped out. **This truss was propped with acrows in 2021. Some other trusses have also been propped. Other trusses in areas of water-ingress should also be propped until the gutter and hoppers have been overhauled and the extent of timber decay can be properly assessed. The wallplate will need to be replaced in a number of locations and the rafters will have to be paired-up where their ends are decayed.**

Truss Condition 2021

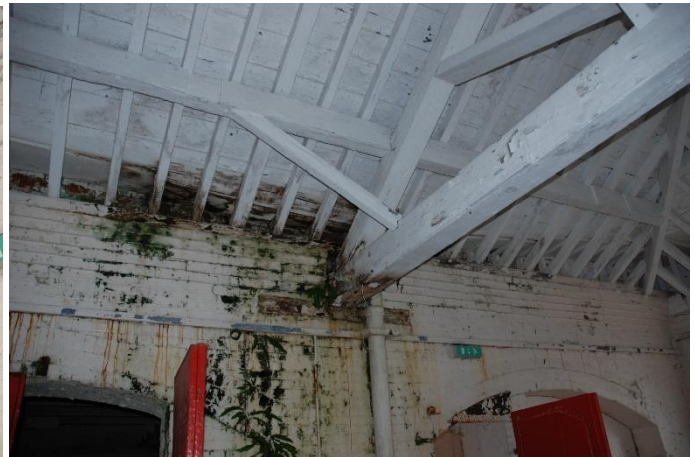
Truss Condition 2023

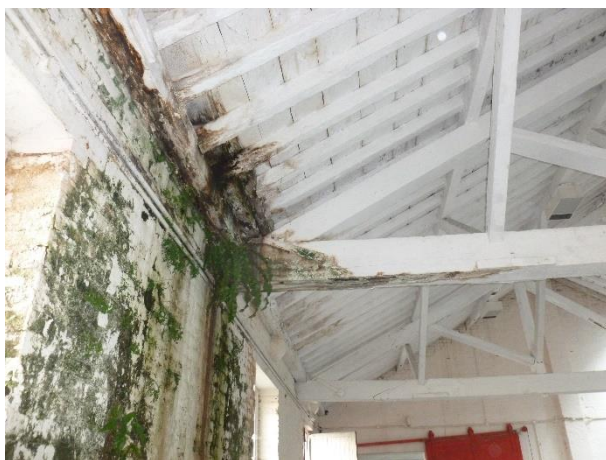
Truss Condition 2021

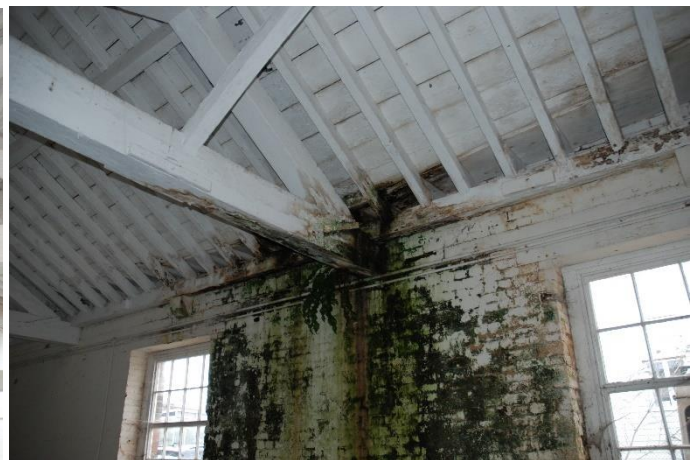
Truss Condition 2023

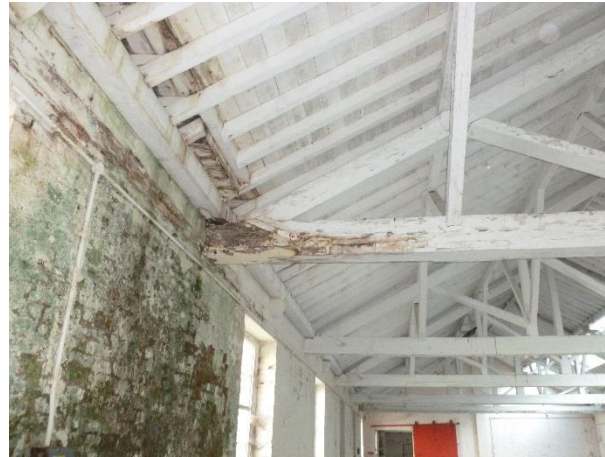
Truss condition 2021

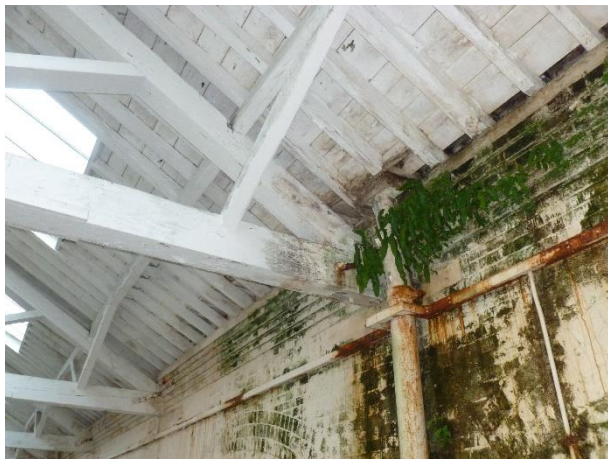
Truss condition 2021

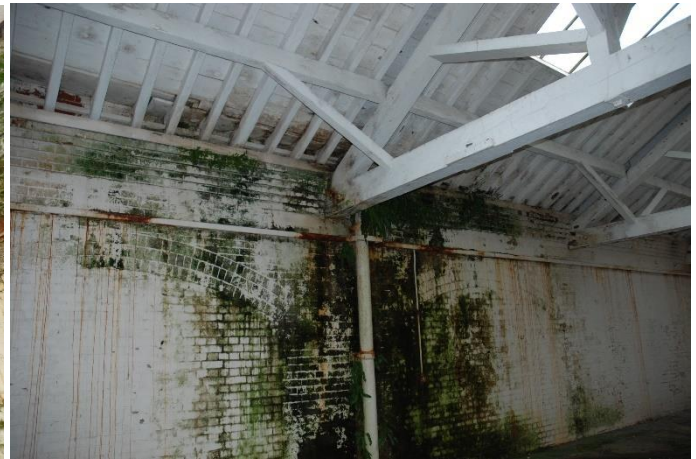
Truss Condition 2023

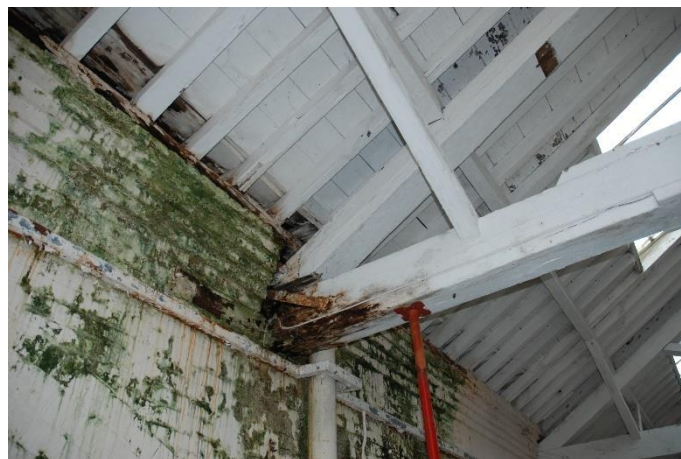
Truss condition 2023

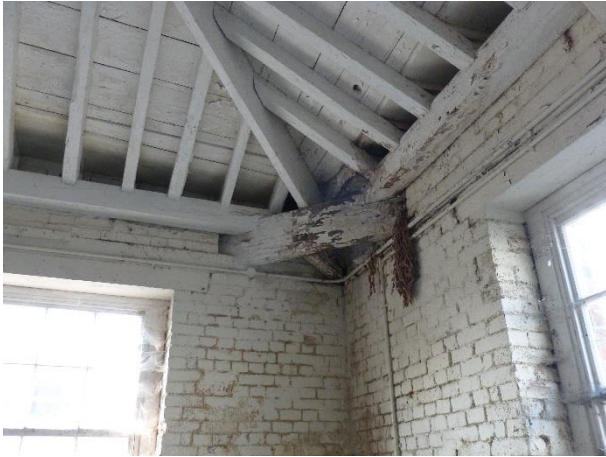
- 3.2 The dragon-tie in the south-west corner is decayed. **The extent of decay will need to be assessed when the parapet gutter has been overhauled but it is likely that it will need to be replaced and the hip rafter will need to be repaired. The condition has not changed significantly since 2021.**

Dragon tie 2021

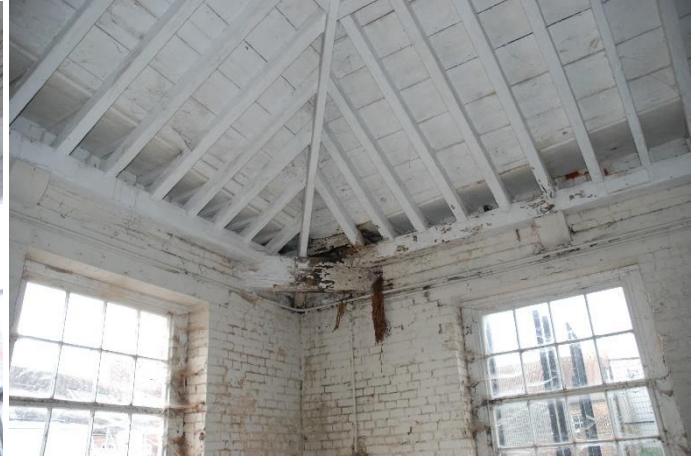
Dragon Tie 2023

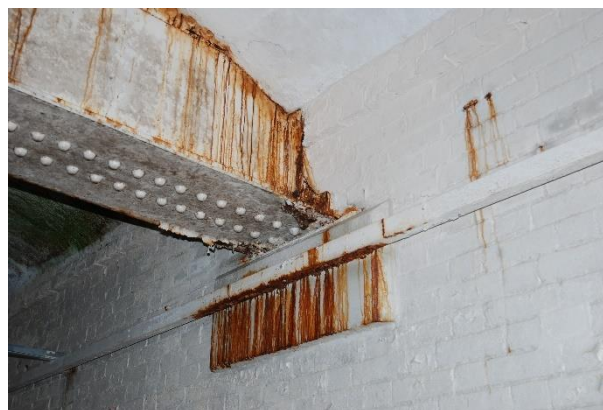
- 3.3 The central range exhibits signs of water ingress through the roof. At first-floor level corrosion of the embedded steel beams of the roof has caused cracking in the brickwork. The roof was not originally flat and would have originally been a floor. The flat roof coverings have obviously failed and water is penetrating the structure. Some of the arches over window and door openings have failed under the load from the floor beams. **The roof coverings should be replaced as soon as possible to allow the structure to dry out. The failed arches will need to be strengthened with stainless steel bar. The cracking is not significantly worse than in 2021.**

Roof of central section in 2021

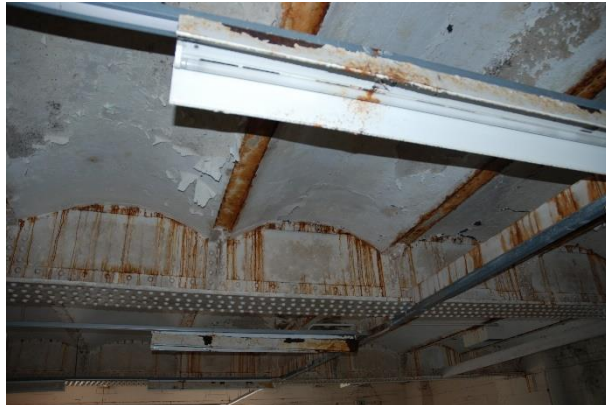
Roof of central section 2021

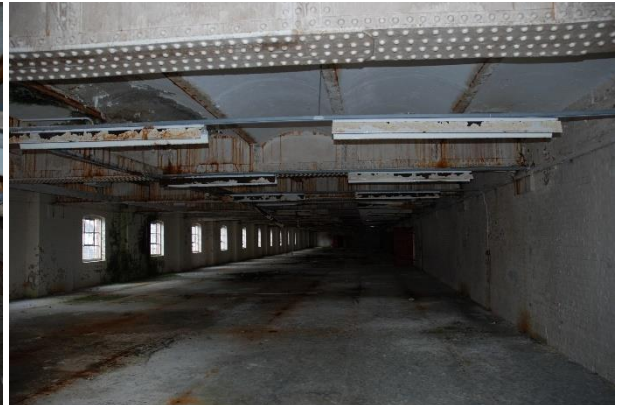
Roof of central section 2023

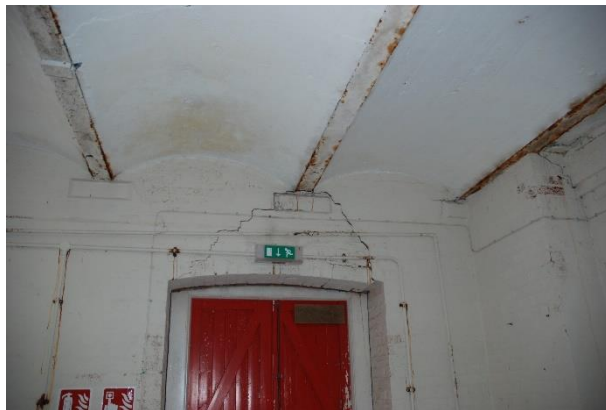
Cracking in 2021

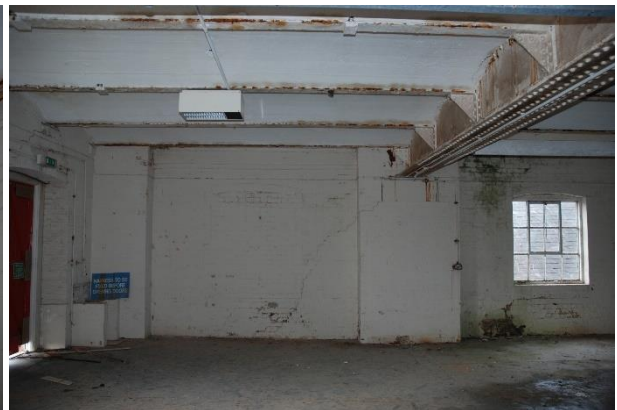
Cracking in 2023

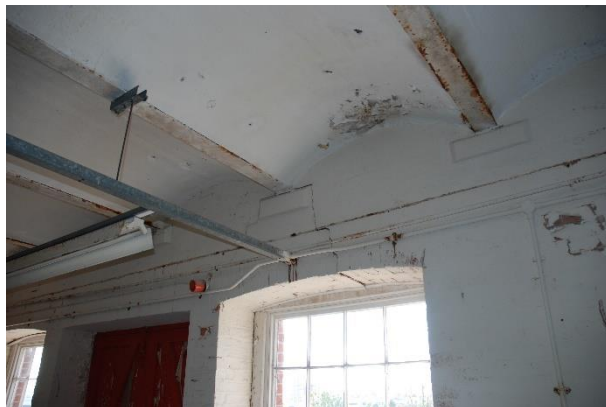
Crack over window in 2021

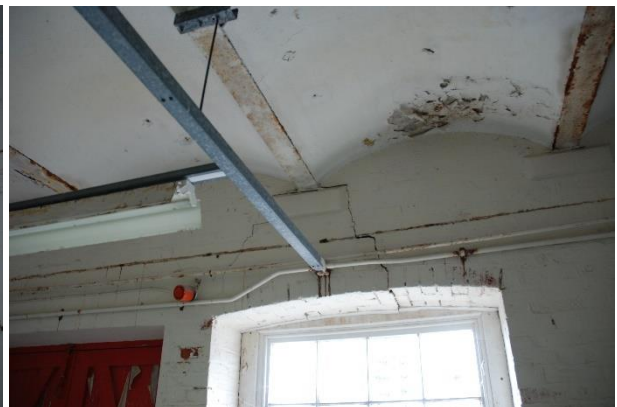
Crack over window in 2023

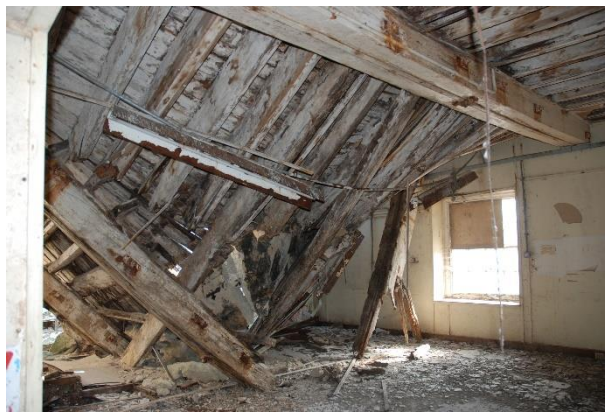
3.4 In 2021 there were two major collapses to the roof of the west section with several other carriage beams fractured or close to collapse. Since then, a further collapse has occurred towards the south end. Generally, this roof is in very poor condition with the extent of decay in both the beams and joists likely to be such that they will need to be replaced. **This roof is now in such a poor condition that it is unlikely that any of the structure can be saved. Collapsed sections of roof should be removed to avoid exerting undue forces to the outside walls. However, this will need to be carried out in a controlled manner due to the fragile nature of the first floor.**

Collapsed roof in 2021

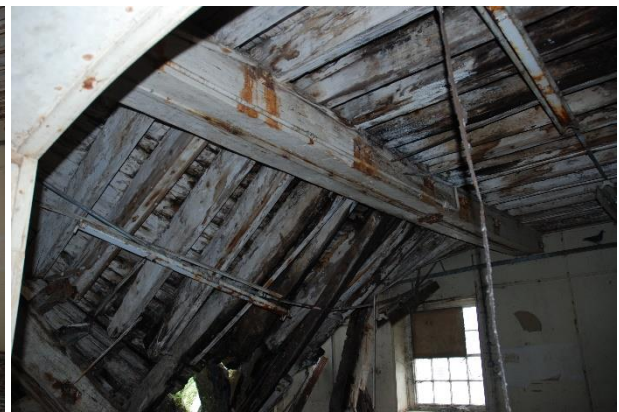
Collapsed roof in 2023

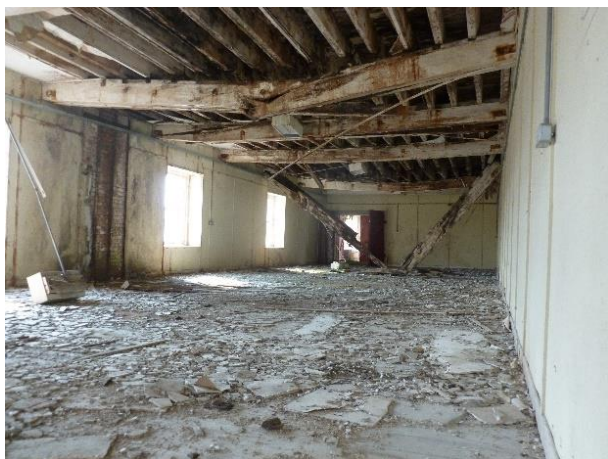
Partially collapsed roof in 2021

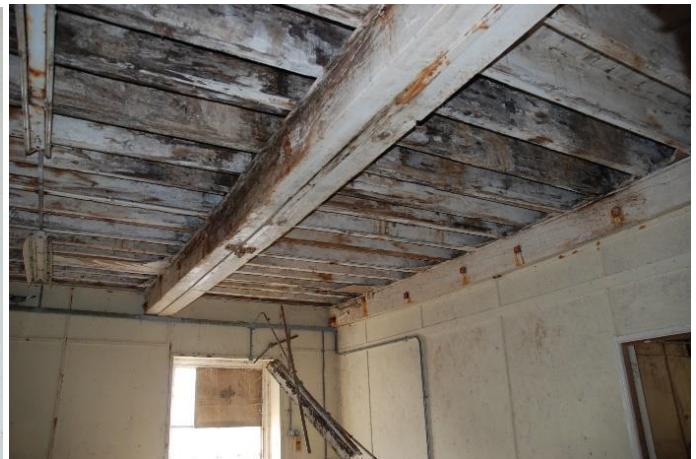
Partially collapsed roof in 2023

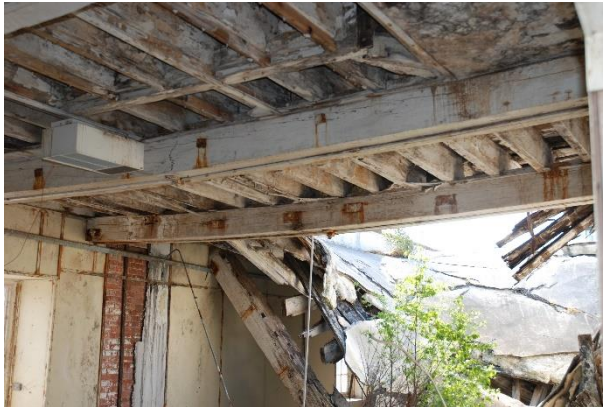
Collapsed roof in 2021

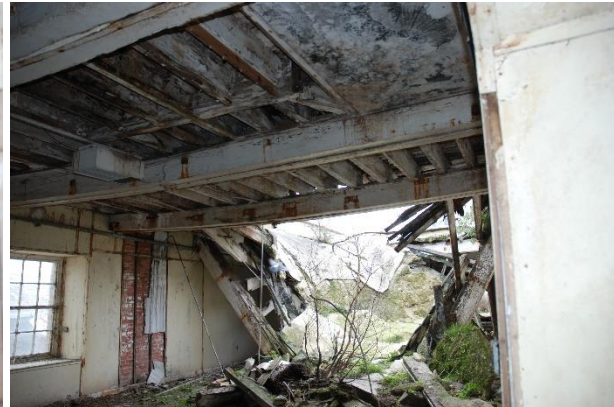
Collapsed roof in 2023

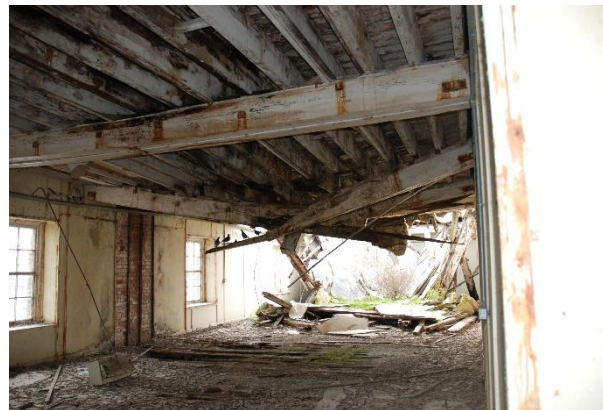
New collapse in 2023

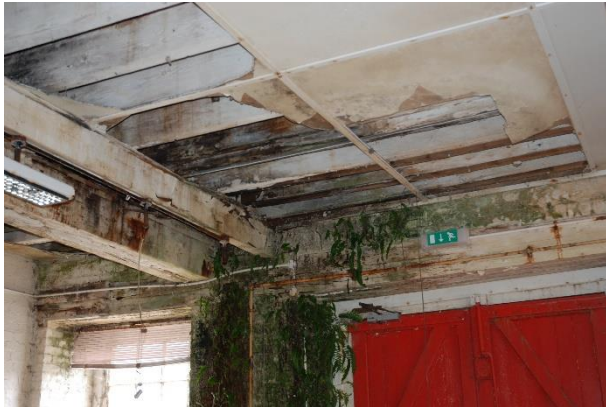
- 3.5 The first-floor structure is also in poor condition due to the water coming through the collapsed roof and the weight of the collapsed structure above. There is one major area of collapse at the north end of the east range which is below a collapsed section of roof. However, the floor must be considered to be at risk of collapse under the other section of roof collapse. The floor beams have generally not collapsed because they have been reinforced with steel channels to the sides throughout. The timber lintel over the door to the furniture store office and the floor beam bearing onto it are in poor condition **and they are likely to need to be replaced. In the short-term they should be propped.**

Lintel over door in 2021

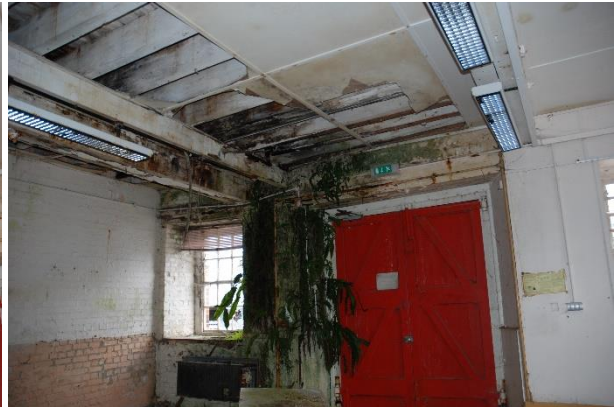
Lintel over door in 2023

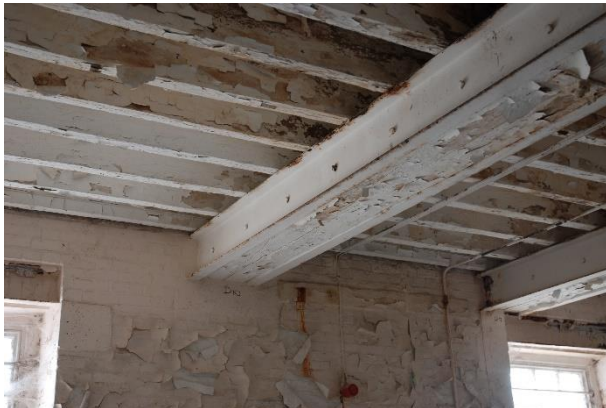
Floor beam in 2021

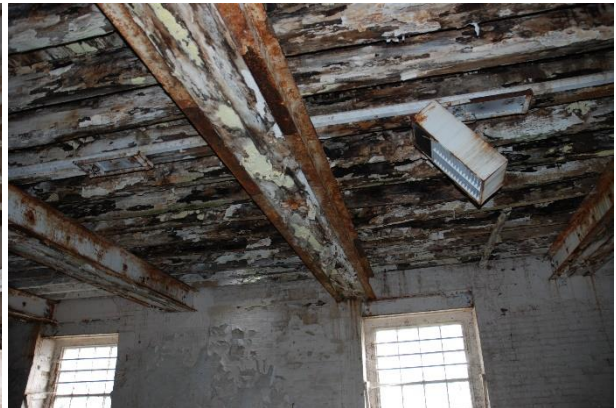
Floor condition in 2023

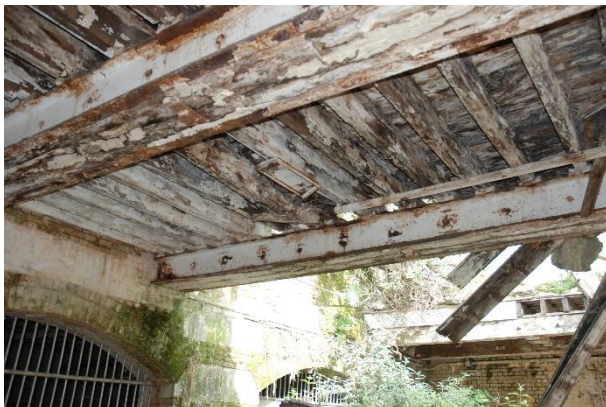
Floor condition in 2021

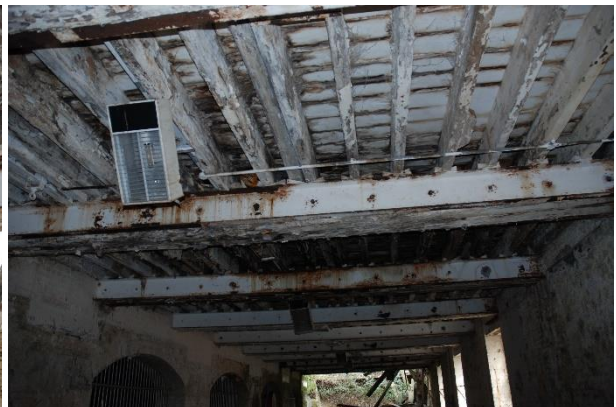
Floor Condition in 2023

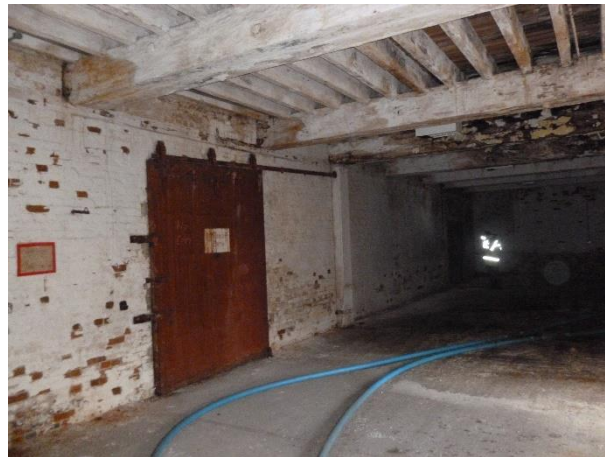
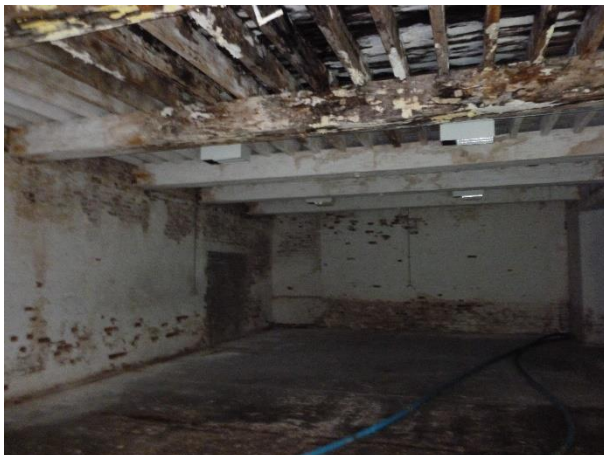
- 3.6 The section of the building to the north is accessible from the main range of buildings. Part of the first floor was in a condition such that it was not deemed safe to access it at this time so the roof structure and the third floor were not inspected. However, the condition of the floor in the north west corner suggests that the roof is not in good condition. **Similar to the other areas the floor and roof beams are now in a condition such that they will need to be replaced.**

Floor beam condition in 2021

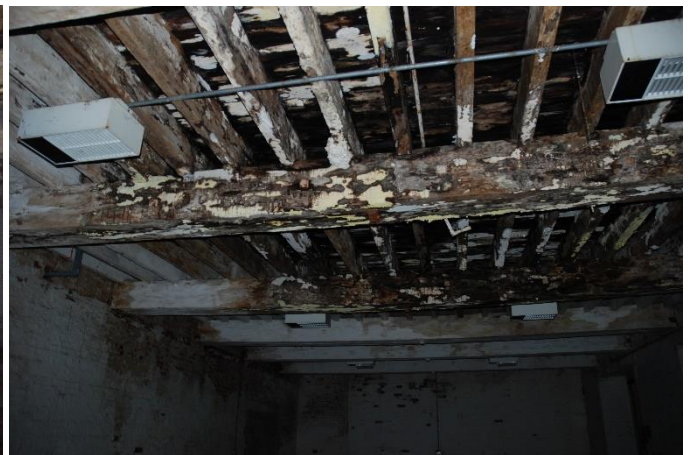
Floor beam condition in 2023

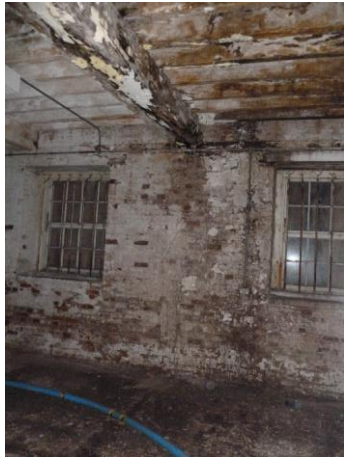
Floor in 2021

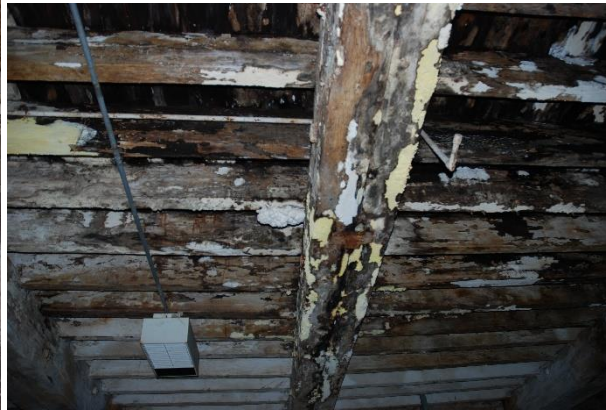
Floor in 2023

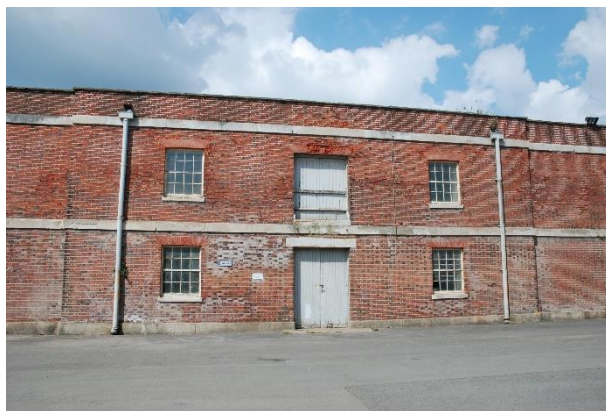
- 3.7 The brickwork to the east elevation is in fair condition except for the softer rubbing bricks in the flat brick arches. These arches have been re-faced in a number of locations and **similar repair work may be required to others in the future**. The stone bands are eroded to varying degrees along their length. There is no significant bowing of the wall to this elevation. The mortar joints are also eroded and the elevation will require repoint

East elevation in 2021

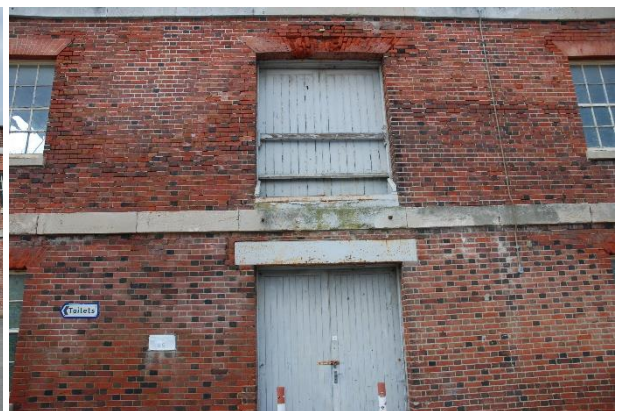
East elevation in 2023

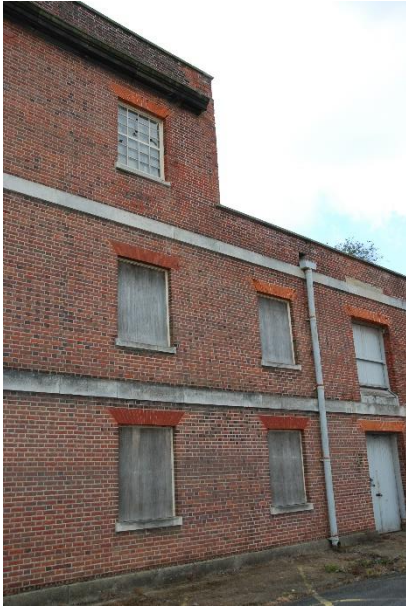
- 3.8 The brickwork to the north elevation is in fair condition again except for the flat brick arches. These arches have been re-faced in a number of locations and **similar repair work may be required to others in the future.**

North elevation 2021

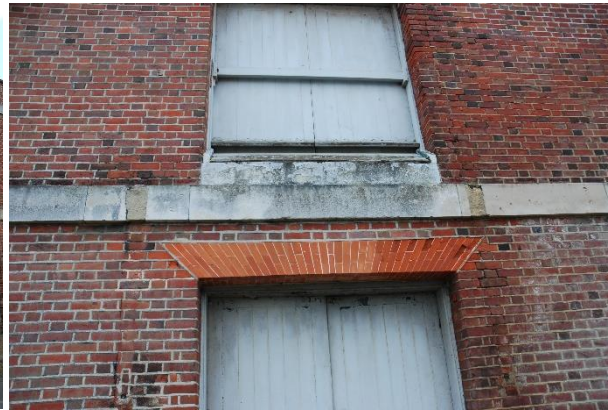
North elevation 2023

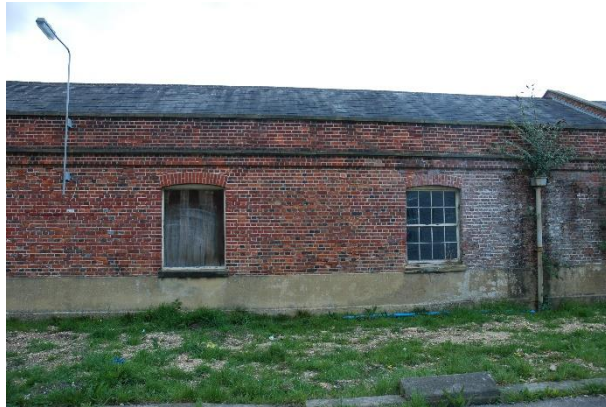
- 3.9 The brickwork to the west elevation is in poorer condition, particularly in the areas of the hoppers and at the south end where the brickwork and the mortar joints are severely eroded. **In time the wall will need to be repointed in lime mortar with loose cement and lime mortar removed. The condition of the wall has not deteriorated significantly since 2021.**

West elevation in 2021

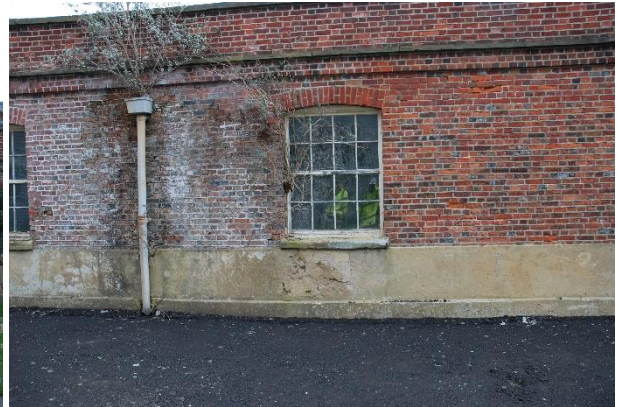
West elevation in 2023

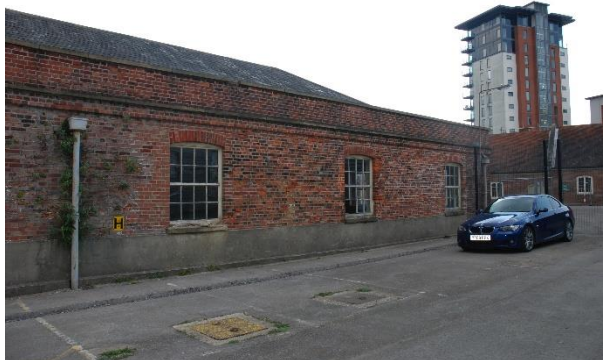
West elevation in 2021

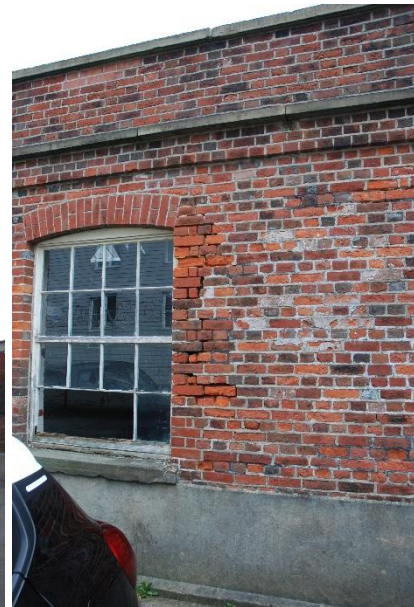
West elevation in 2023

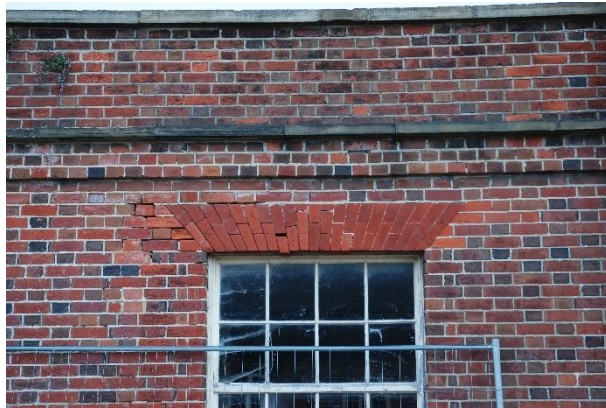
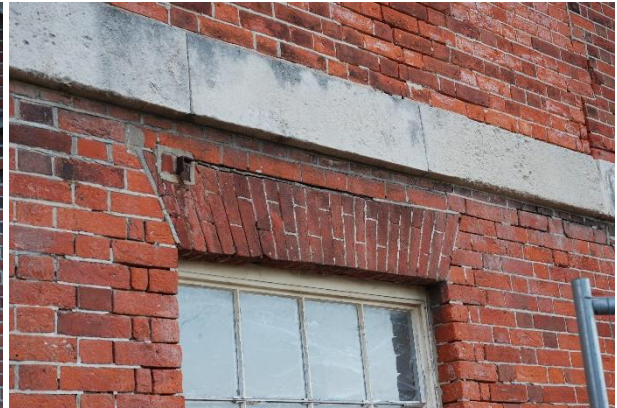
3.10 The brickwork to the south elevation is in poor condition. One flat brick arch has dropped a brick, one has dropped and others have been re-faced. The mortar joints are severely eroded, particularly in the south east corner where there is little mortar left. **The flat brick arch lintels need to be strengthened and the wall repointed in lime mortar. The south-east corner should be repointed as a priority. The condition of this wall has deteriorated slightly further since 2021 and repointing of this wall should be given priority during repair works.**

South wall in 2021

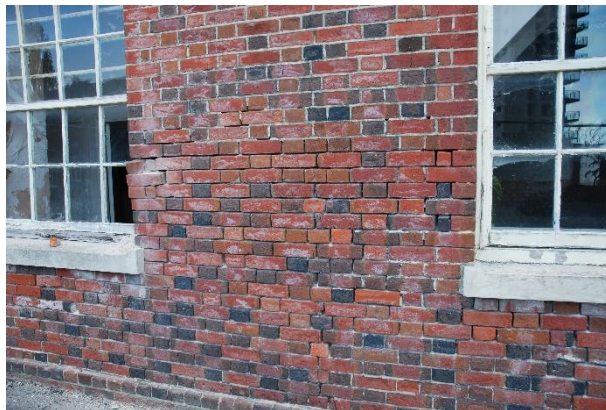
South wall in 2021

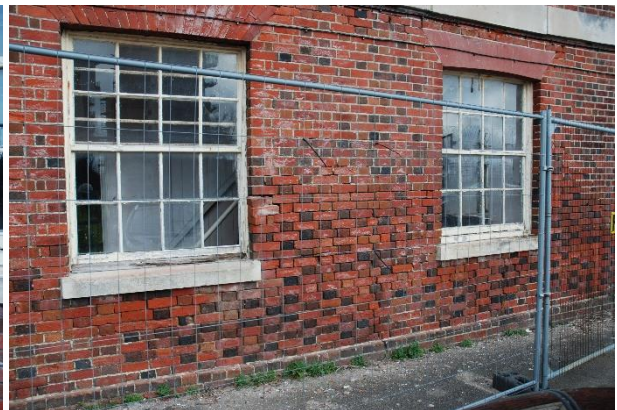
South wall in 2023

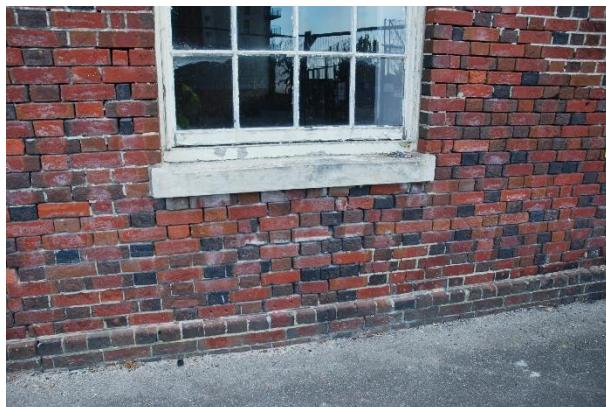
South wall in 2021

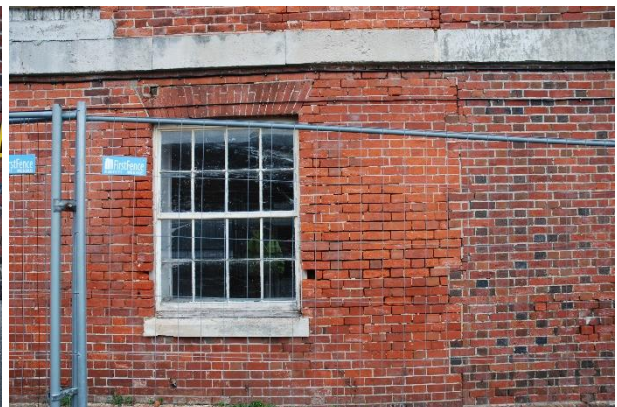
South wall in 2023
