## Chapel Cottage Window Schedule 06-06-23

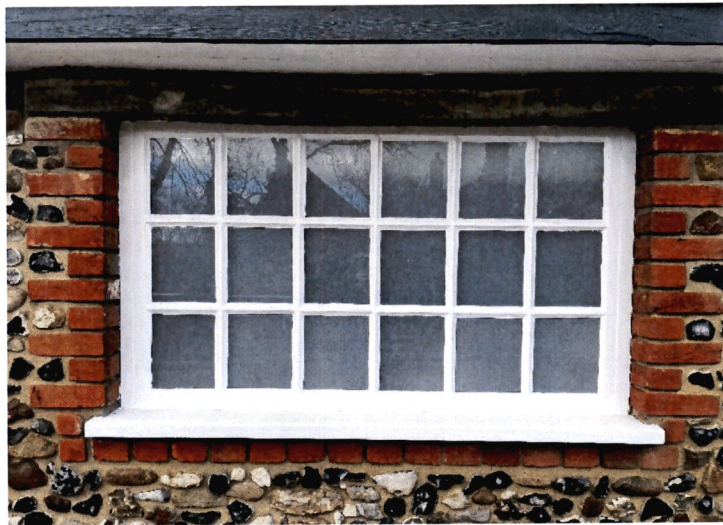
W-01  
Ground  
Floor Lobby  
(Road  
Noise)

Window Number (See drawing for location)	Approx Height mm (Not inc sill)	Approx Width mm	Image
			Fixed single glazed window c40 years old. Very poor thermally and acoustically. Room is cold in winter and traffic noise is very loud.

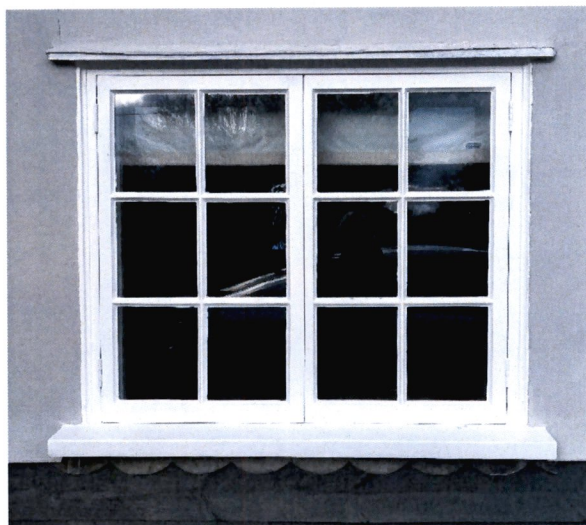
W-02  
Lounge  
(Road  
Noise)

Casement window, c40 years old. Rotten sill and windows. Have been significantly filled. Not watertight or draughtproof and acoustically very poor. Road noise is a problem.

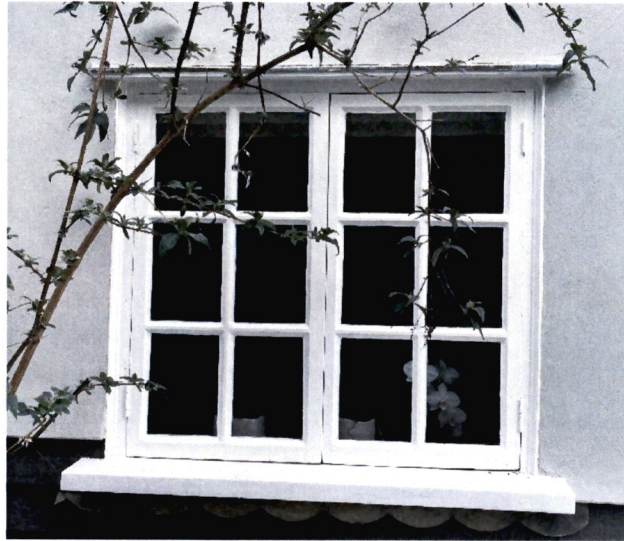
W-03  
Dining Room

Casement window, c40 years old. Rotten sill and windows. Have been significantly filled. Not watertight or draughtproof.

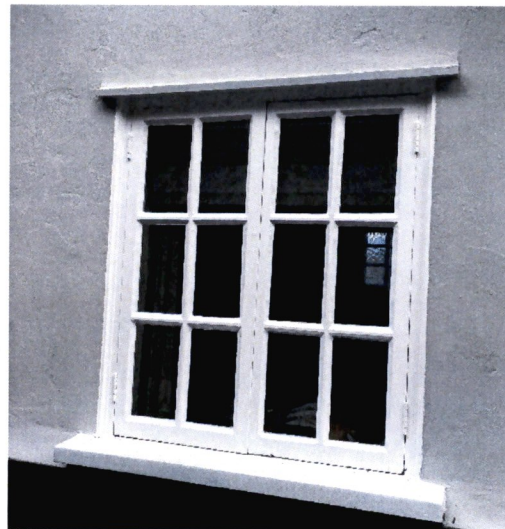
W-04  
Study

Casement window, c40 years old. Rotten sill and windows. Have been significantly filled. Not watertight or draughtproof.

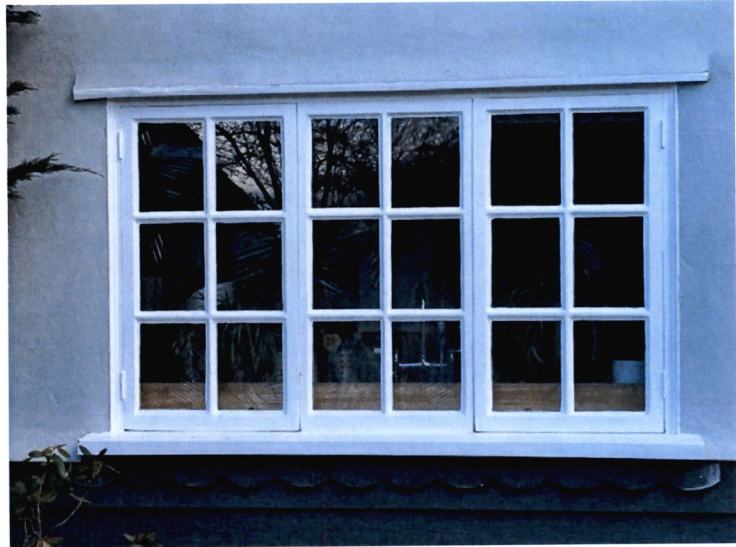
W-05  
Utility

Casement window with fixed centre panel c40 years old. Rotten sill and windows. Have been significantly filled, needs new internal sill. Very draughty. Difficult to access as behind worksurface.

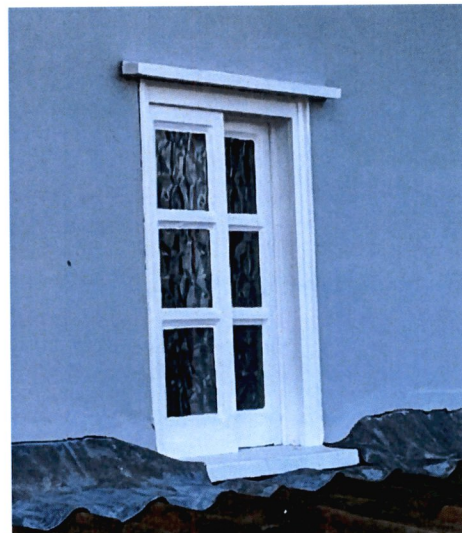
W-06  
Study  
(Obscure)

Sliding window c40 years old. Difficult to access from outside for cleaning. Draughty.

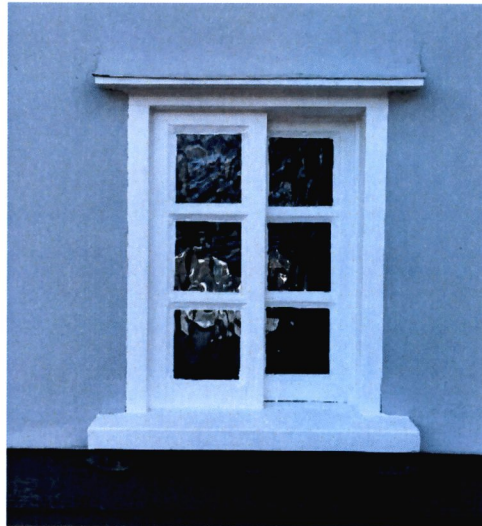
W-07  
Lounge  
(Obscure)

Sliding window c 40years old, no internal sill. Painted shut.

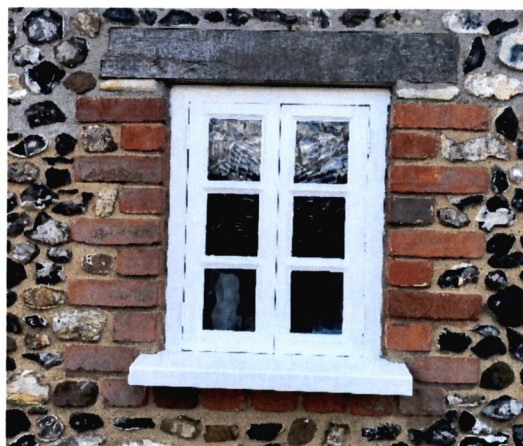
W-08  
Downstairs  
WC  
(Obscure)

Casement window c 40 years old. Very draughty, poor security.

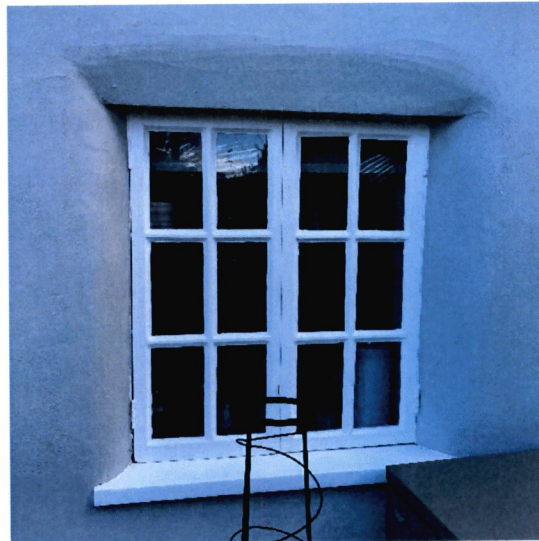
W-11  
Kitchen  
(Facing Rear Garden)

Casement window c40 years old, not airtight. Difficult to access as behind sink.

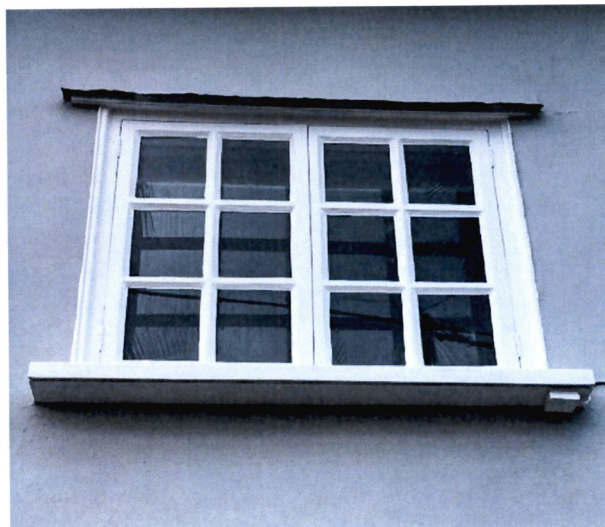
W-14  
Dressing Room/  
Bedroom 5  
(Road Noise)

Casement window, c40 years old. Rotten sill and windows. Have been significantly filled. Not watertight or draughtproof.

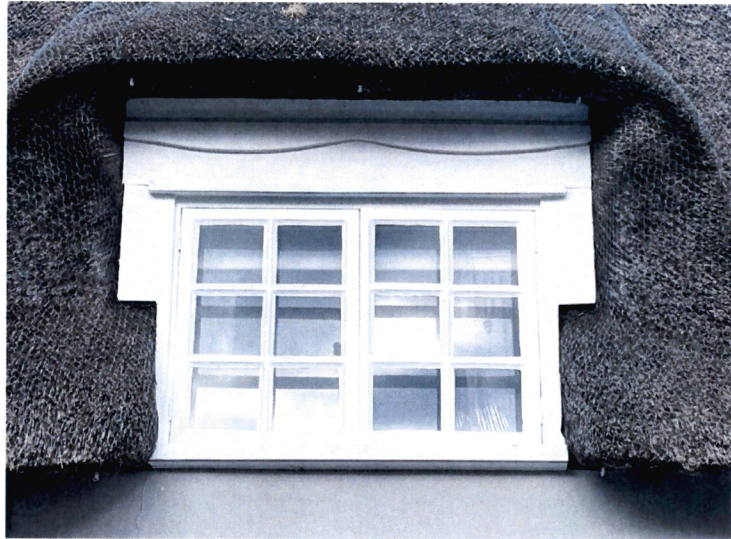
W-15  
Bedroom 1  
(Road Noise)  
790  
1030

Casement window, c40 years old. Rotten sill and windows. Have been significantly filled. Not watertight, soundproof or draughtproof.

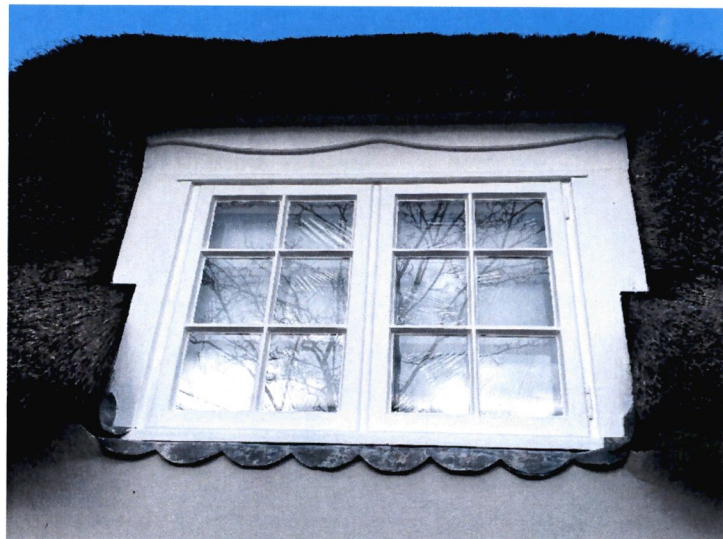
W-16  
Dressing Room/  
Bedroom 4  
830  
1210

Casement window, c40 years old. Rotten sill and windows. Have been significantly filled. Not watertight, soundproof or draughtproof.

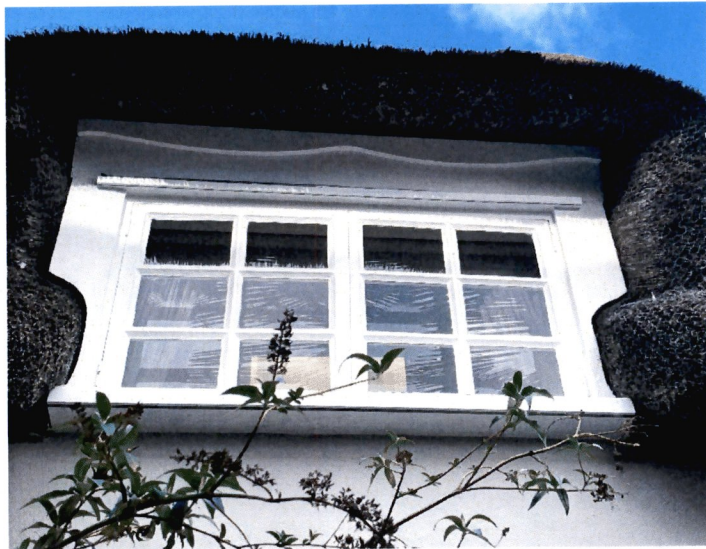
W-17  
Bathroom      790      1040

Casement window, c40 years old. Rotten sill and windows. Have been significantly filled. Not watertight, soundproof or draughtproof.

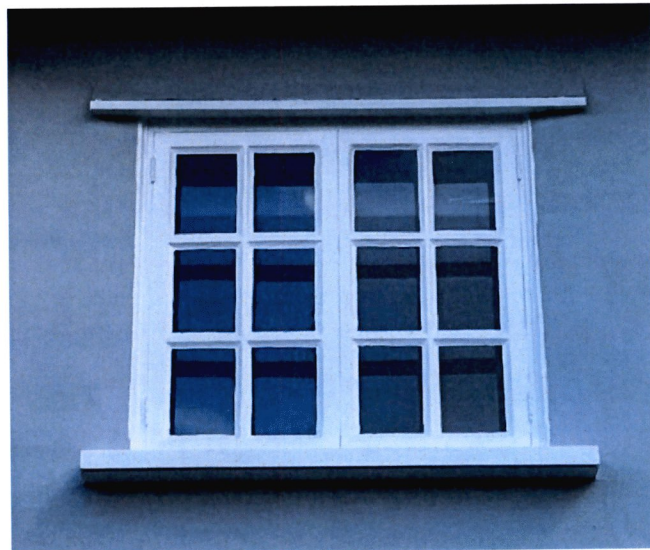
W-18  
Bedroom 3      880      890

Casement window, c40 years old. Rotten sill and windows. Have been significantly filled. Not watertight, soundproof or draught proof.

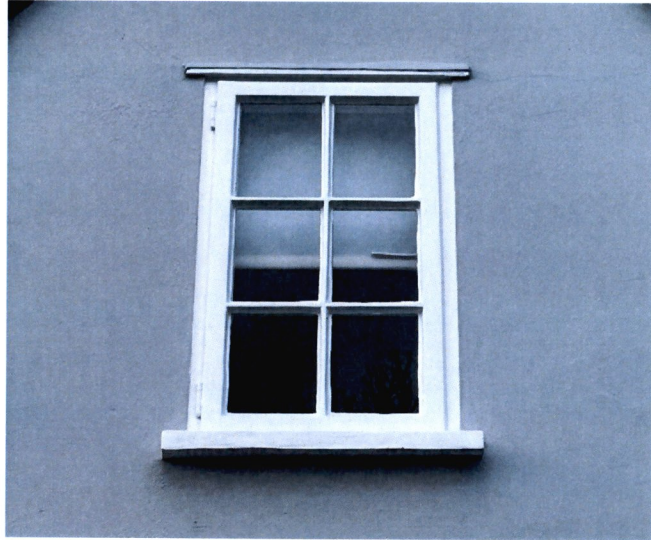
W-19  
Study/  
Dressing  
Room  
(Road  
Noise)

Casement window, c20 years old. Has been significantly filled.  
Not soundproof or draught proof.

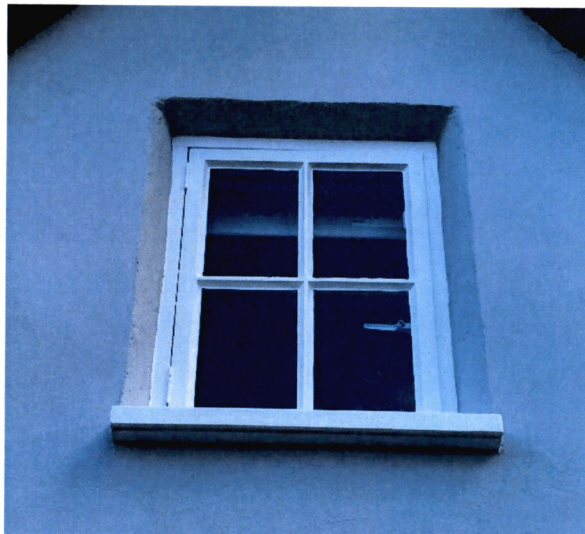
W-21  
Bedroom 2

Casement window, c20 years old. Has been significantly filled.  
Not soundproof or draught proof.

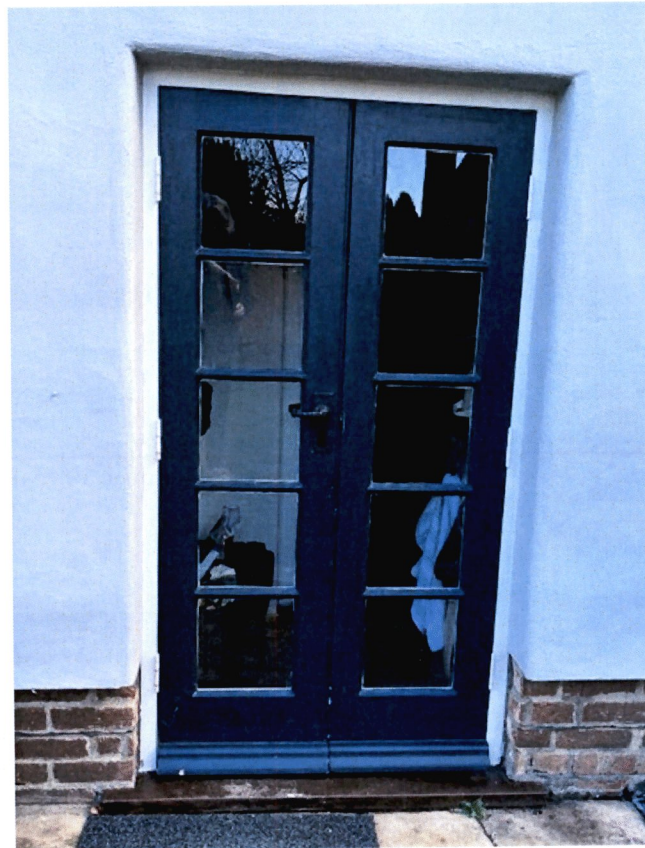
D-05 French Window/ Door
-----------------------------------

Door leafs are very narrow and difficult to get through, rotten  
doorstep and doors. Very draughty with poor thermal  
retainment.

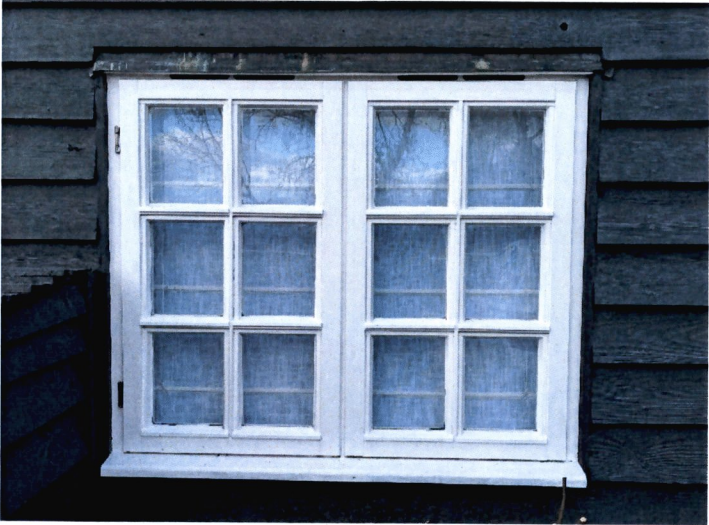
W-09  
Music  
Room  
Front

Casement window c 20 years old. Poor thermal retainment.

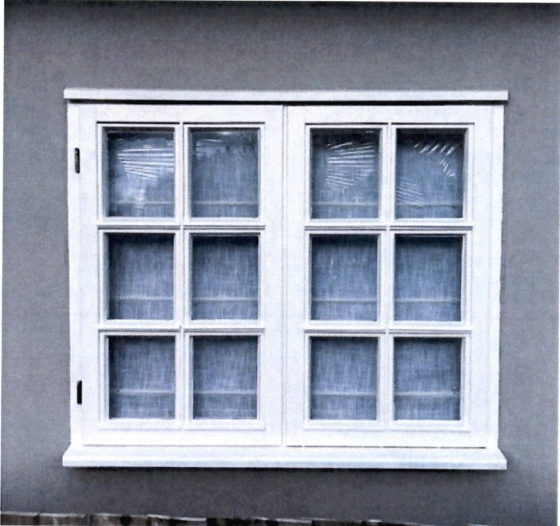
W-10  
Music  
Room  
(Facing VH)

Casement window c 10 years old. Poor thermal retainment.

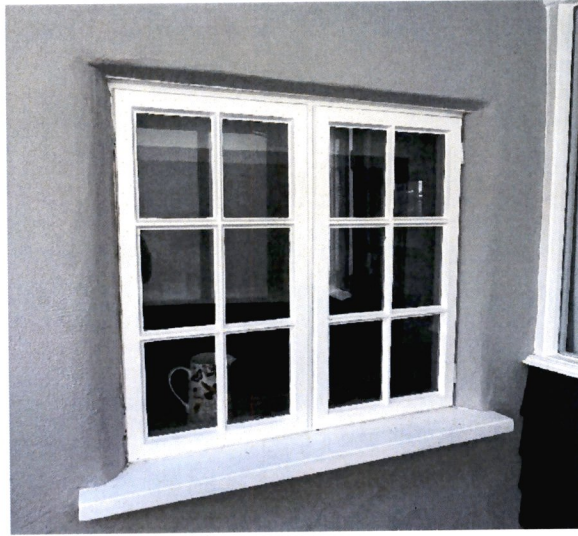
W-12  
Kitchen      926      1013

Casement window c 20 years old. Poor thermal retainment.

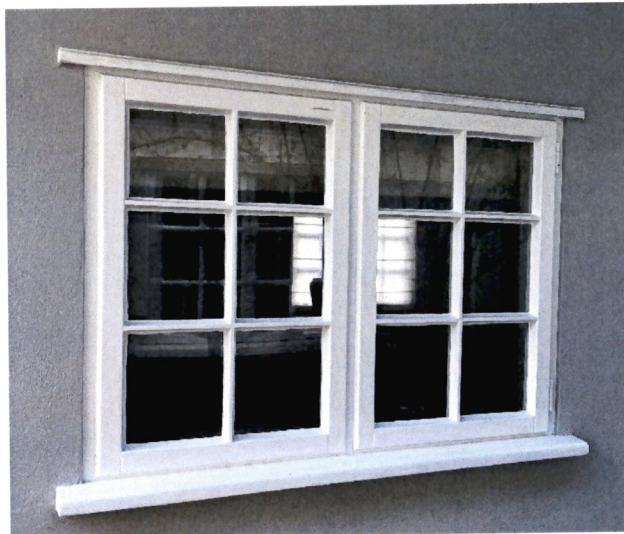
W-13  
Music  
Room      857      1176

Casement window c 20 years old. Poor thermal retainment.

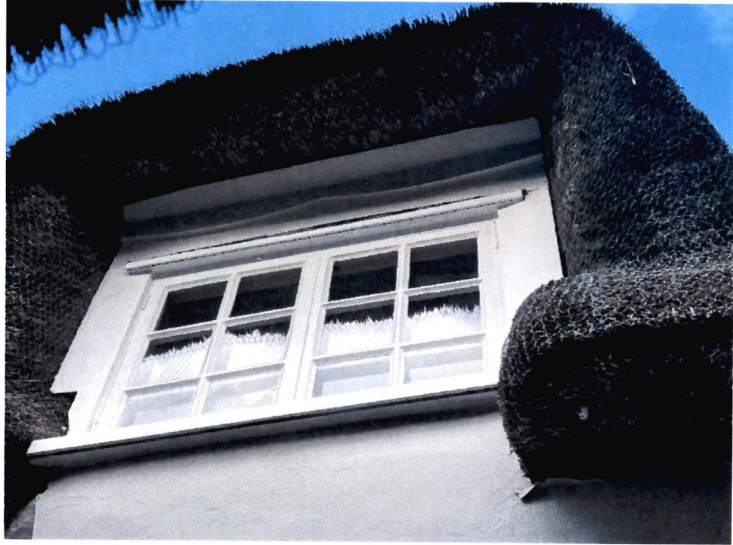
W-20  
Bedroom 2      1152      858

Casement window, c20 years old. Poor Thermal retainment
