**ARBORICULTURAL SAFETY
SURVEY**

**Bramhope Village Scout Group
Leeds Road
Bramhope
Leeds
West Yorkshire
LS16 9BQ**

21322/EW

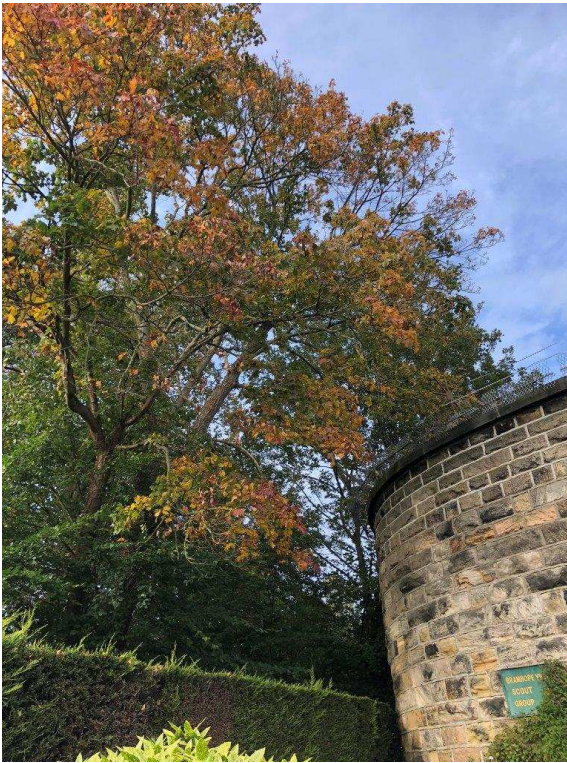
Photo 1: T1- reduction away from vent tower

- 5.4.1 The recommended works to **T1** and **T9** should be undertaken as a matter of **high priority**.
 - 5.4.2 The recommended works to the remaining trees are of either **moderate** or **low priority**.

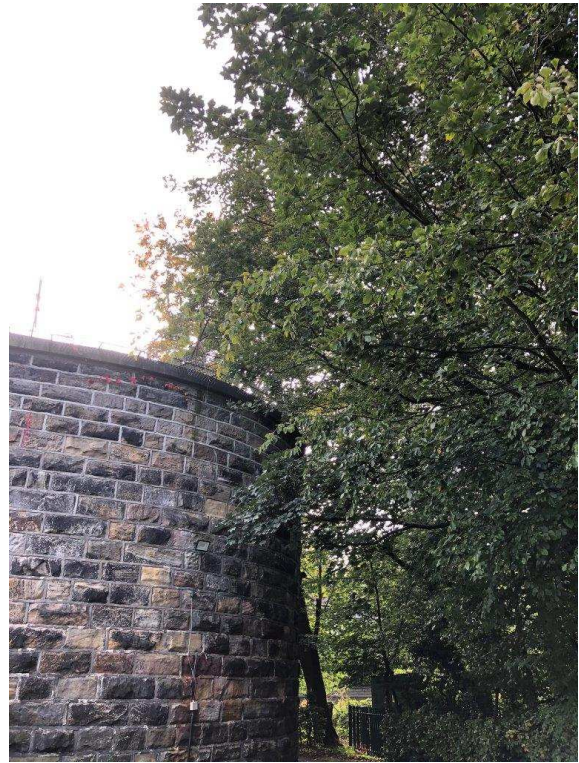
Photo 2: T9 - reduction away from vent tower

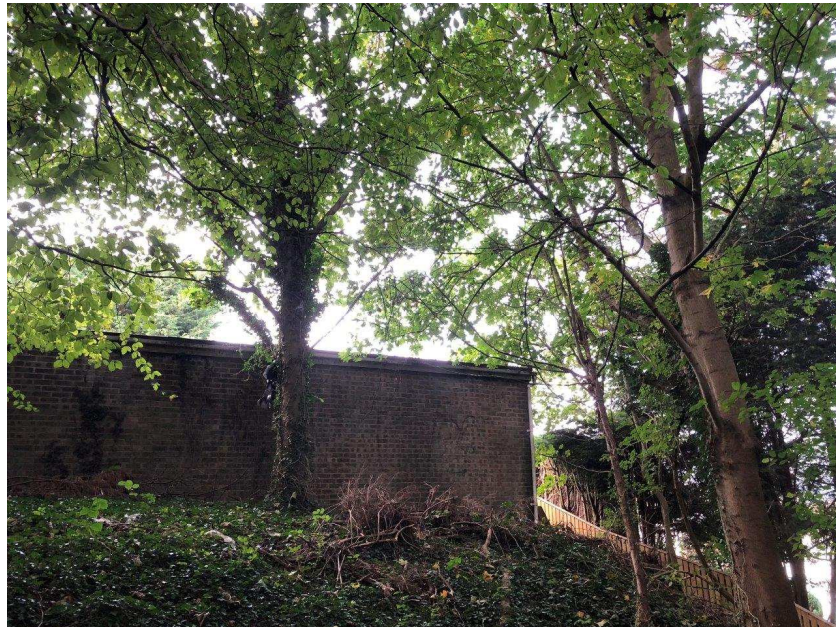
Photo 3: T7 & T8 reduction away from building

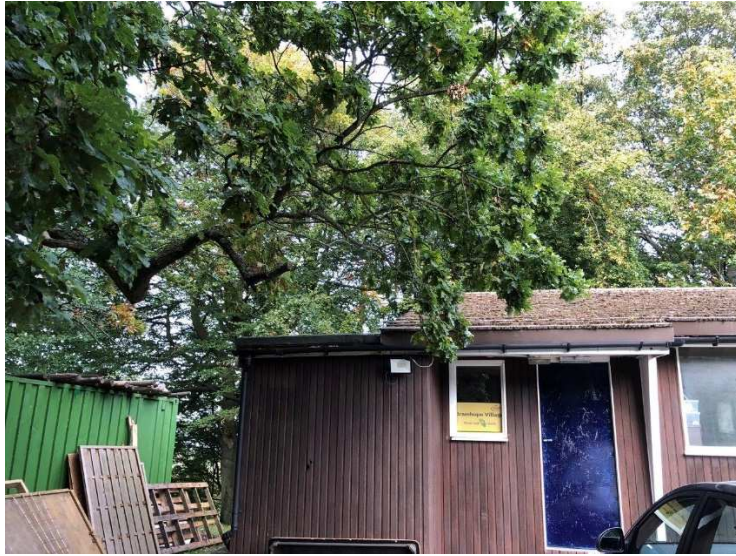
<i>Acer pseudoplatanus</i>													
T 11	Mature	English Oak	13	2	71	15	Multi-stemmed at 4m. Stem to the west has cavity approximately 1m along with good surrounding wound wood. Crown overhangs the container and scout hut, one lower limb extends over the entrance porch. Deadwood stub from snapped-out limb at approximately 6m. Minor deadwood throughout. Previous reduction work has left two stubs.	GOOD	GOOD	40+	MOD	Reduce limb extending over porch entrance by approximately 2m.	MOD	B	2
		<i>Quercus robur</i>													
T 12	Mature	Sycamore	17	5	68	17	Single-stemmed tree located on steep incline with good buttressing providing stability. Very long primary limb extending over the footpath by 11 metres - end loaded with the potential to snap out.	GOOD	GOOD	20-40	LOW	Reduce limb extending over the footpath by approximately 4m cutting back to closest union to the main stem (approximately 7m from main stem).	LOW	B	2

Photo 4: T11 - Reduction work

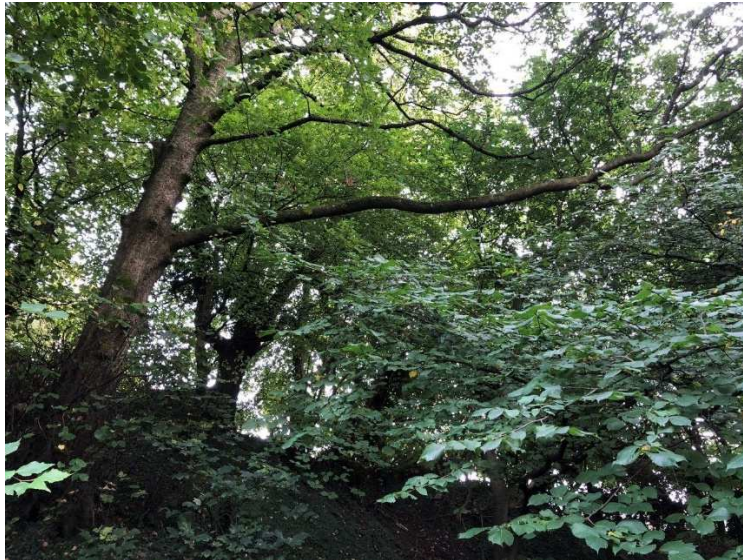
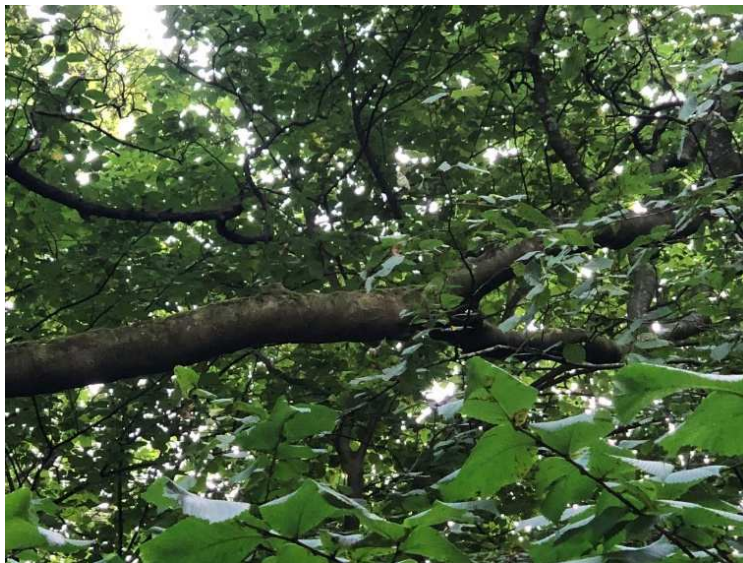
Photo 5: T12 - Reduction of lower limb

Photo 6: T12 - Reduction point

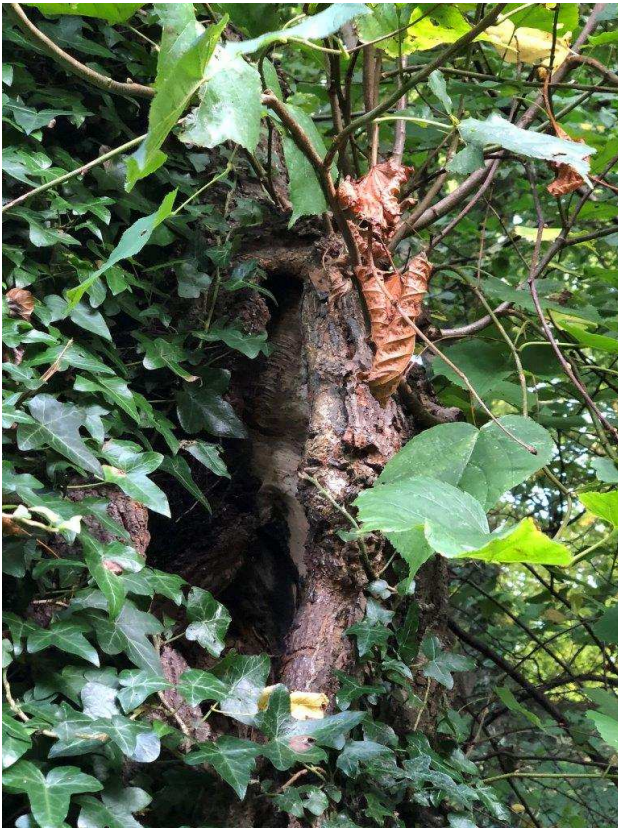
<i>Acer pseudoplatanus</i>													
T 13	Over-mature	Lime	18	6	#80	8	Main stem forks at approximately 4m to 5m. Stem leans slightly towards the woodland. Ivy up the main stem, prevented a detailed inspection. Large cavity at 2m with some swelling and wound wood surrounding, cavity appears quite deep and historic. Located adjacent to the footpath and within falling distance of adjacent property. Large amount of weight in the canopy. Decay stub at main union.	FAIR	FAIR	<10	MOD	Reduce crown by approximately 4m to relieve weight. Sever Ivy.	MOD	B	2
		<i>Tilia sp.</i>													
T 14	Mature	Sycamore	17	4	80	13	Twin-stemmed from approximately 3m and overhanging the boundary. Minor bark wounds to the basal area - small areas of exposed wood with decay. Appears to be some decay forming at the main union and an area of exposed wood just below the union.	FAIR	FAIR	10-20	HIGH	Monitor annually.	MOD	B	1

Photo 7: T13 - Decay cavity to main stem

- 5.8 A full detailed inspection of **T3**, **T4** and **T13** was inhibited by the presence of Ivy, epicormic shoots or by restricted limited access (as detailed at **Appendix 1**). These trees should be re-inspected for defects once the Ivy/epicormic shoots has been removed or during the next biennial inspection.

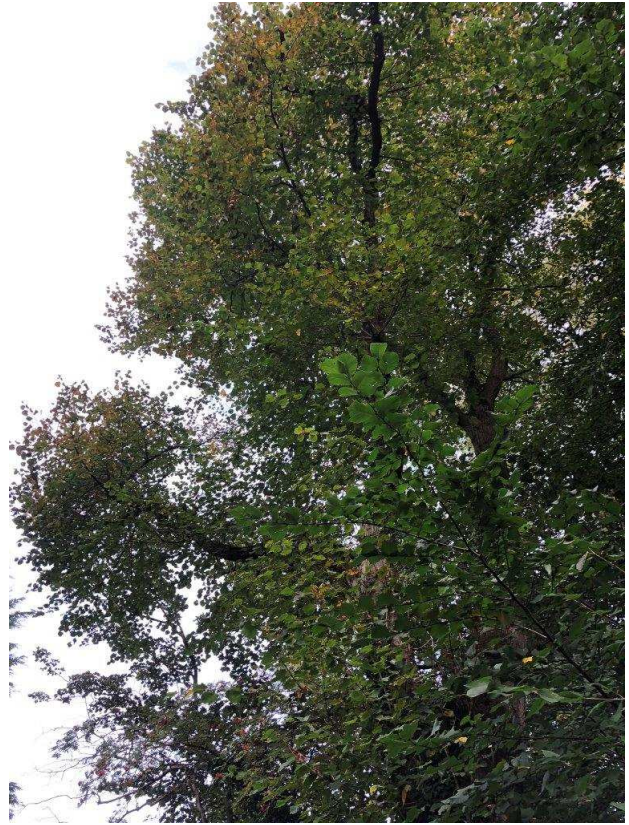
Photo 8: T13 Reduction of canopy

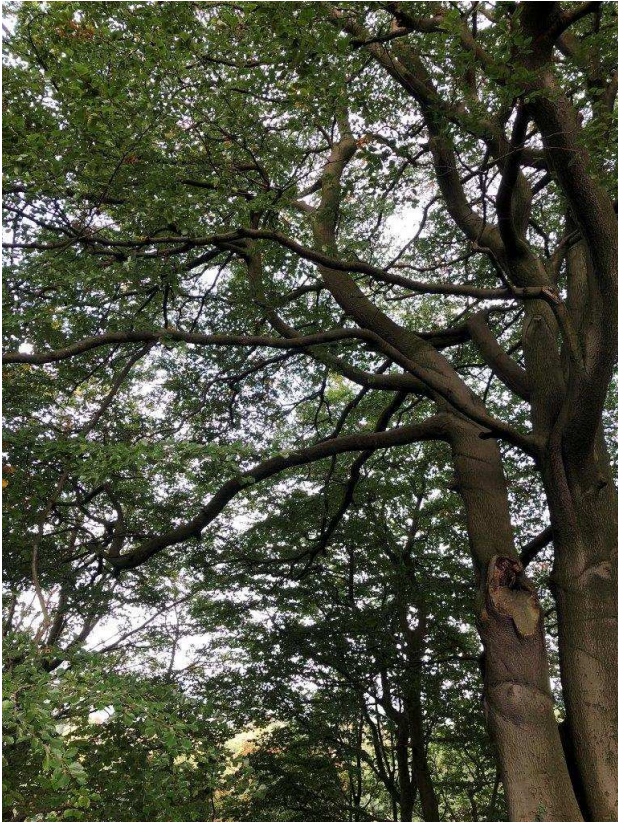
Photo 9: T16, Canopy reduction

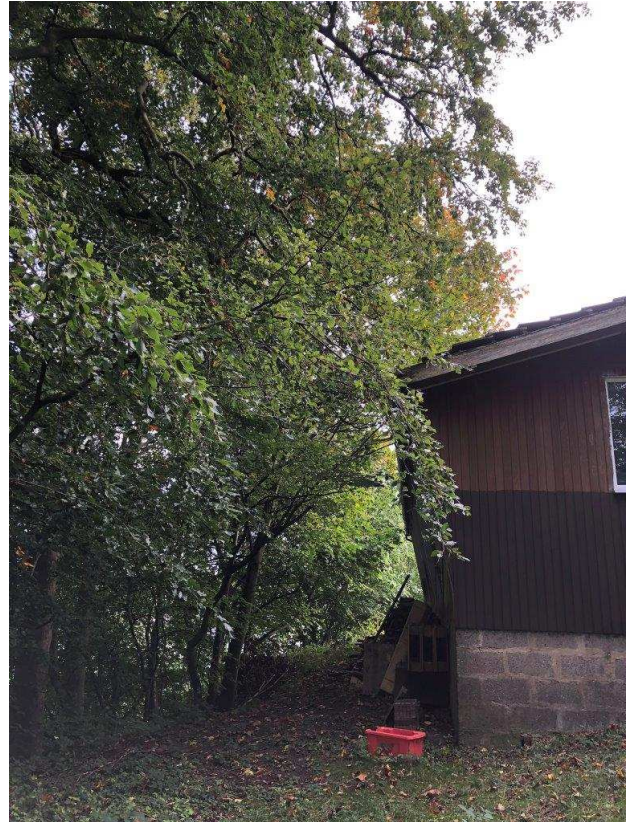
T 20	Mature Beech <i>Fagus sylvatica</i>	16	1	62	14	Single-stemmed tree located on steep incline, compensatory buttressing to the lower side. Canopy overhangs and is touching the scout hut roof and the guttering. Minor epicormic growth to the lower stem. No significant defects noted.	GOOD	GOOD	40+	MOD	Reduce canopy tips by approximately 2m to give clearance from the building.	LOW	B	2
G 21	Young to semi-mature Mixed species <i>Detail in observations</i>	10	1	22	8	Group of small Sycamore and Elm. Growing along the top of the steep incline. All trees are overhanging and touching the roof of the scout hut.	FAIR	FAIR	20-40	LOW	Remove Sycamore, approximately 3m away from the building to prevent future issues. Reduce canopies of Elm trees to give 2m clearance from the building.	LOW	B	2
T 22	Mature Sycamore <i>Acer pseudoplatanus</i>	17	6	66	10	Single-stemmed tree located on steep incline with an upright form. Epicormic growth at the base, which has been previously cut and now sprouting again. Good buttressing to the lower side. Canopy displaying good vitality. Minor deadwood throughout. No significant defects noted.	GOOD	GOOD	20-40	MOD	No action required.	N/A	A	2

Photo 10: T20 Canopy reduction to clear building

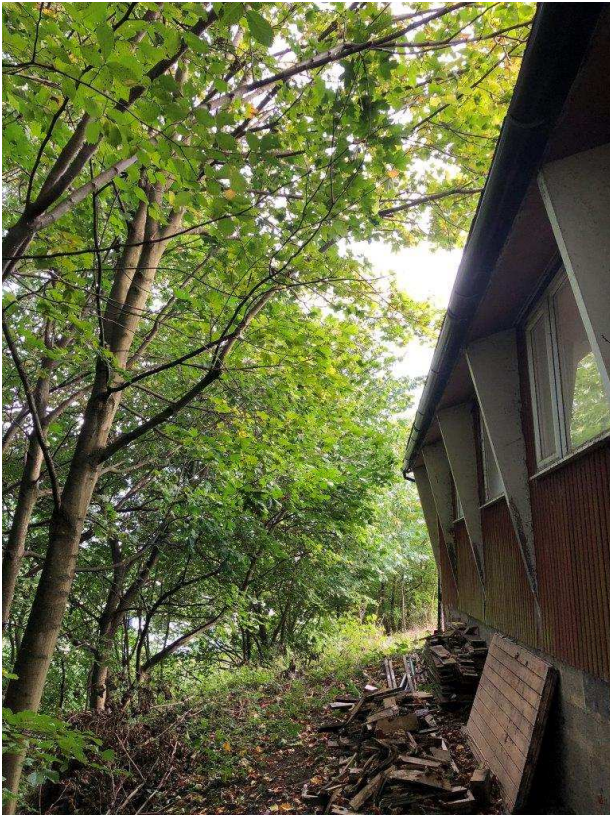
Photo 11: **G21** – Fell Sycamore & crown reduction of Elm

- 5.3 **Two** trees (**T28** and a Sycamore within **G21**) have been recommended for removal for arboricultural reasons, as detailed at **Appendix 1**. Removal of **T28** should be carried out as a matter of **moderate priority**, **G21** as a matter of **low priority**.

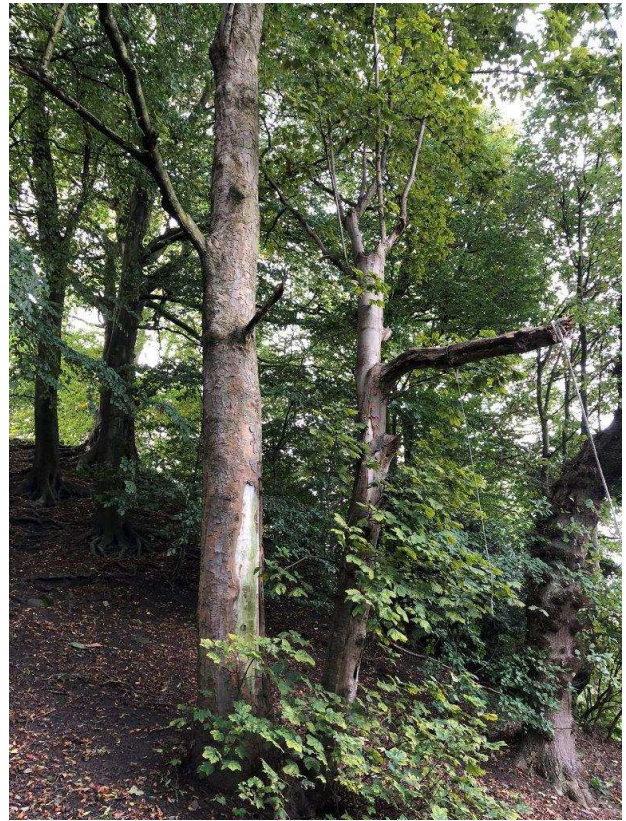
T 25	Mature Sycamore <i>Acer pseudoplatanus</i>	16	6	63 37	7	Twin-stemmed from the base. Larger stem has large area of exposed wood from 0.5m to 2.5m. Good upright form. Deadwood branch at 4.5m. Smaller stem is moribund and has been topped at approximately 4.5m with regrowth. Large extensive decay column from the base upwards.	FAIR	FAIR	20-40	MOD	Reduce moribund stem to leave 2m habitat stem.	MOD	B	2
T 26	Early-mature English Oak <i>Quercus robur</i>	15	7	68	12	Single-stemmed tree, historic cambial restriction near the base of the stem. Dense epicormic buds forming all the way up the stem to approximately 9m. Main stem has an upright form. Dominant primary limb extends off to the northeast. Minor deadwood and deadwood stubs throughout. Acceptable condition at present.	FAIR	GOOD	20-40	MOD	No action required.	N/A	A	2
T 27	Mature Sycamore <i>Acer pseudoplatanus</i>	14	1.5	50	13	Single-stemmed tree, large primary limb at 3m, extending out to the south/southeast. Main stem appears to have previously snapped out at approximately 5m and primary limb is becoming the new leader. Decay likely at point of snap out. Canopy appears acceptable at present. Minor deadwood throughout.	FAIR	FAIR	10-20	MOD	No action required.	N/A	A	2

Photo 12: **T25** - Reduction of moribund stem

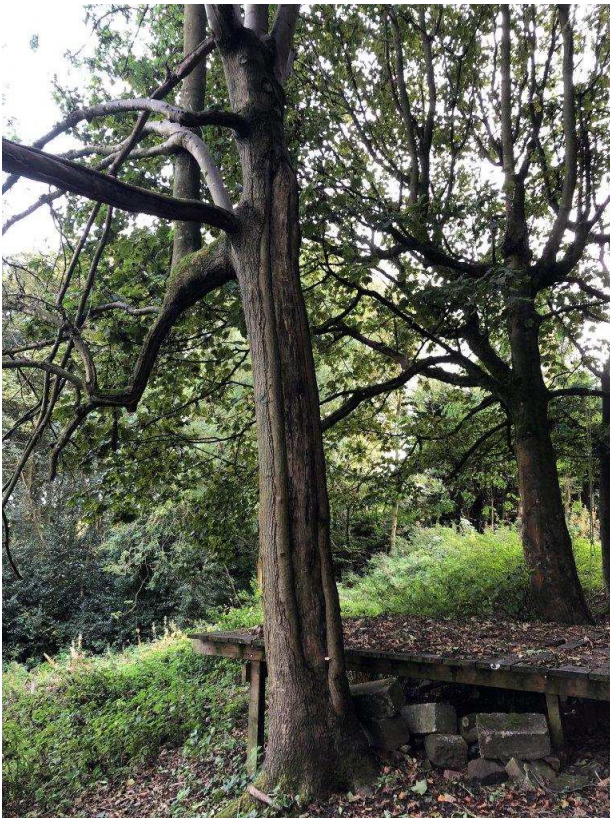
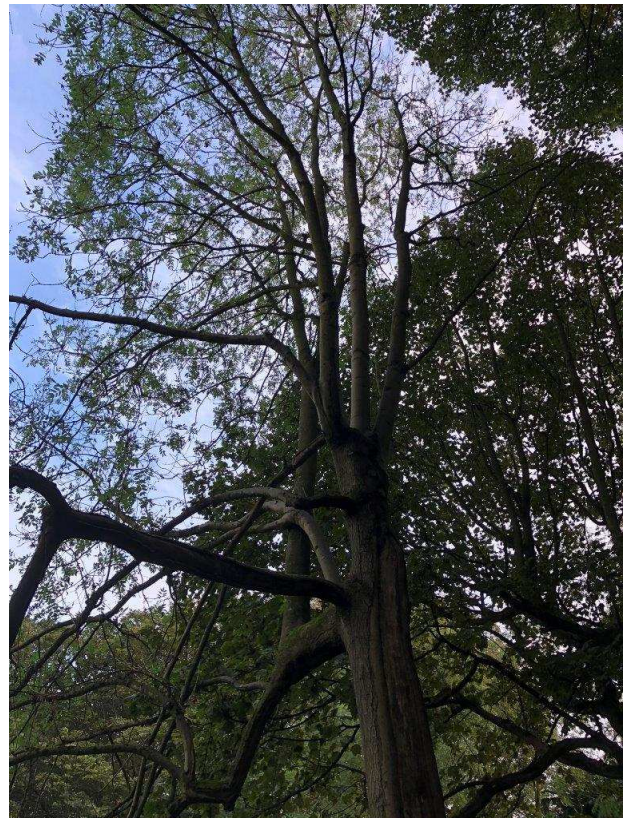
T 28	Mature Ash <i>Fraxinus excelsior</i>	13	1	52	5	Single-stemmed tree with large decay column from 0.5m to 4m. Large area of exposed wood with some surrounding wound wood. Previously topped at 5m with regrowth. Canopy is sparse. Deadwood throughout. Poor form.	POOR	POOR	<10	MOD	Reduce main stem - leaving approximately 3m habitat stem.	MOD	R	N/A
G 29	Young to Early-mature Mixed species <i>Details in observations</i>	to 18	0	45 avg.	n/a	Other trees within the site that had no defects currently worthy of note. These trees will however require inspecting during the routine biennial surveys. Species include Ash, Beech, Oak, Sycamore, Hawthorn, Elder, Cappadocian Maple, Norway Maple, Horse Chestnut and Lime. Ivy and epicormic growth observed on some stems.	GOOD	GOOD	40+	MOD	Epicormic growth and Ivy requires removal as stated on the plan at Appendix 5 .	LOW	B	2

Photo 13: **T28** - to be removed

Photo 14: **T28** - to be removed
