223022.100

STRUCTURAL FEASIBILITY REPORT

EXISTING STRUCTURE

5 ACRES, UPCHURCH

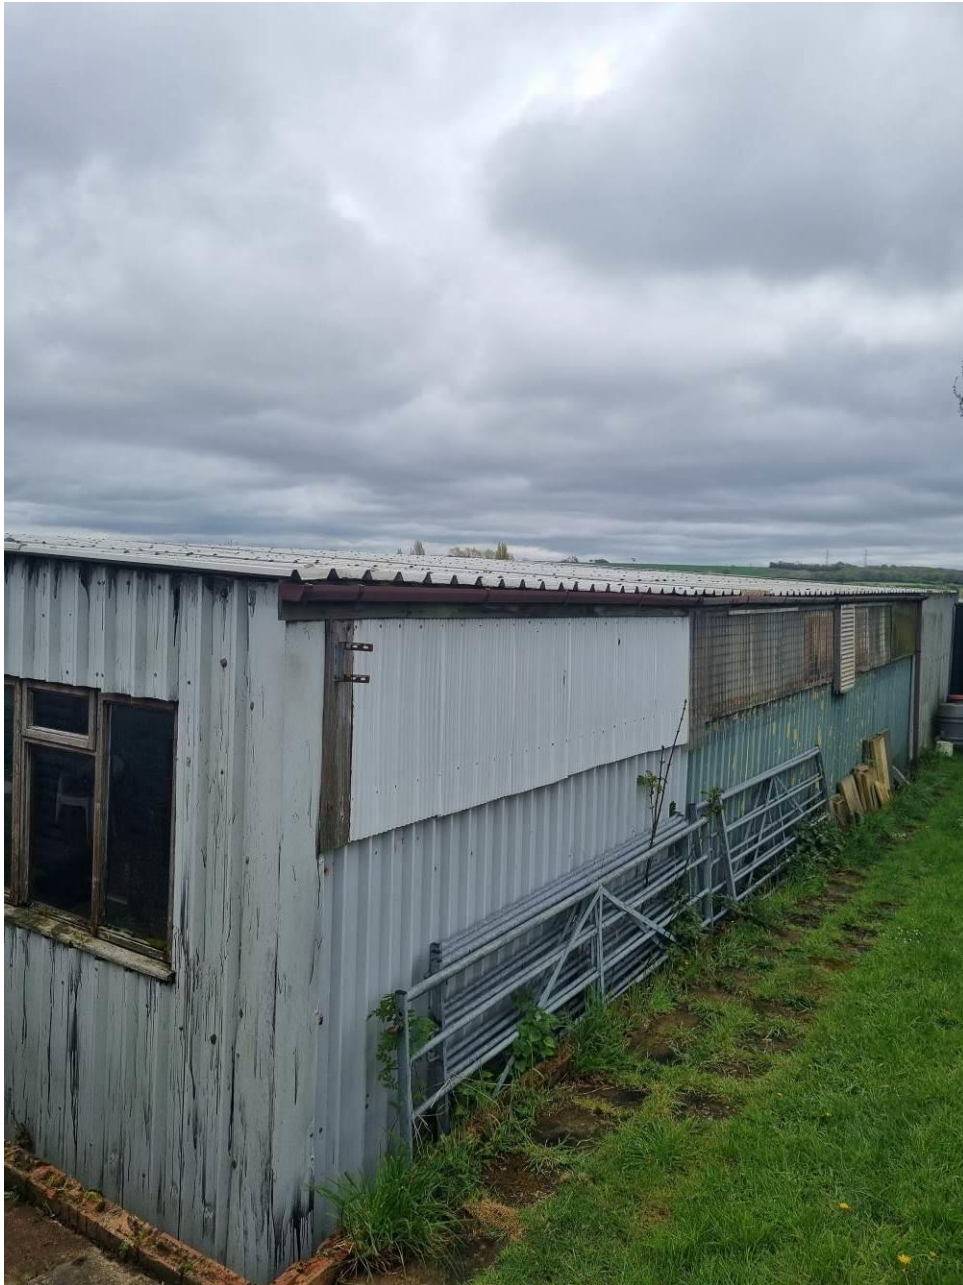
Photograph No. One

Photographs showing typical condition of barn
