PROJECT: **Allen Gallery**

SHEET: **Ground Floor Plan with condition and repair**

DRAWING NO: **A1124 -PRA-ZZ- 00 -DR- A - 20101**

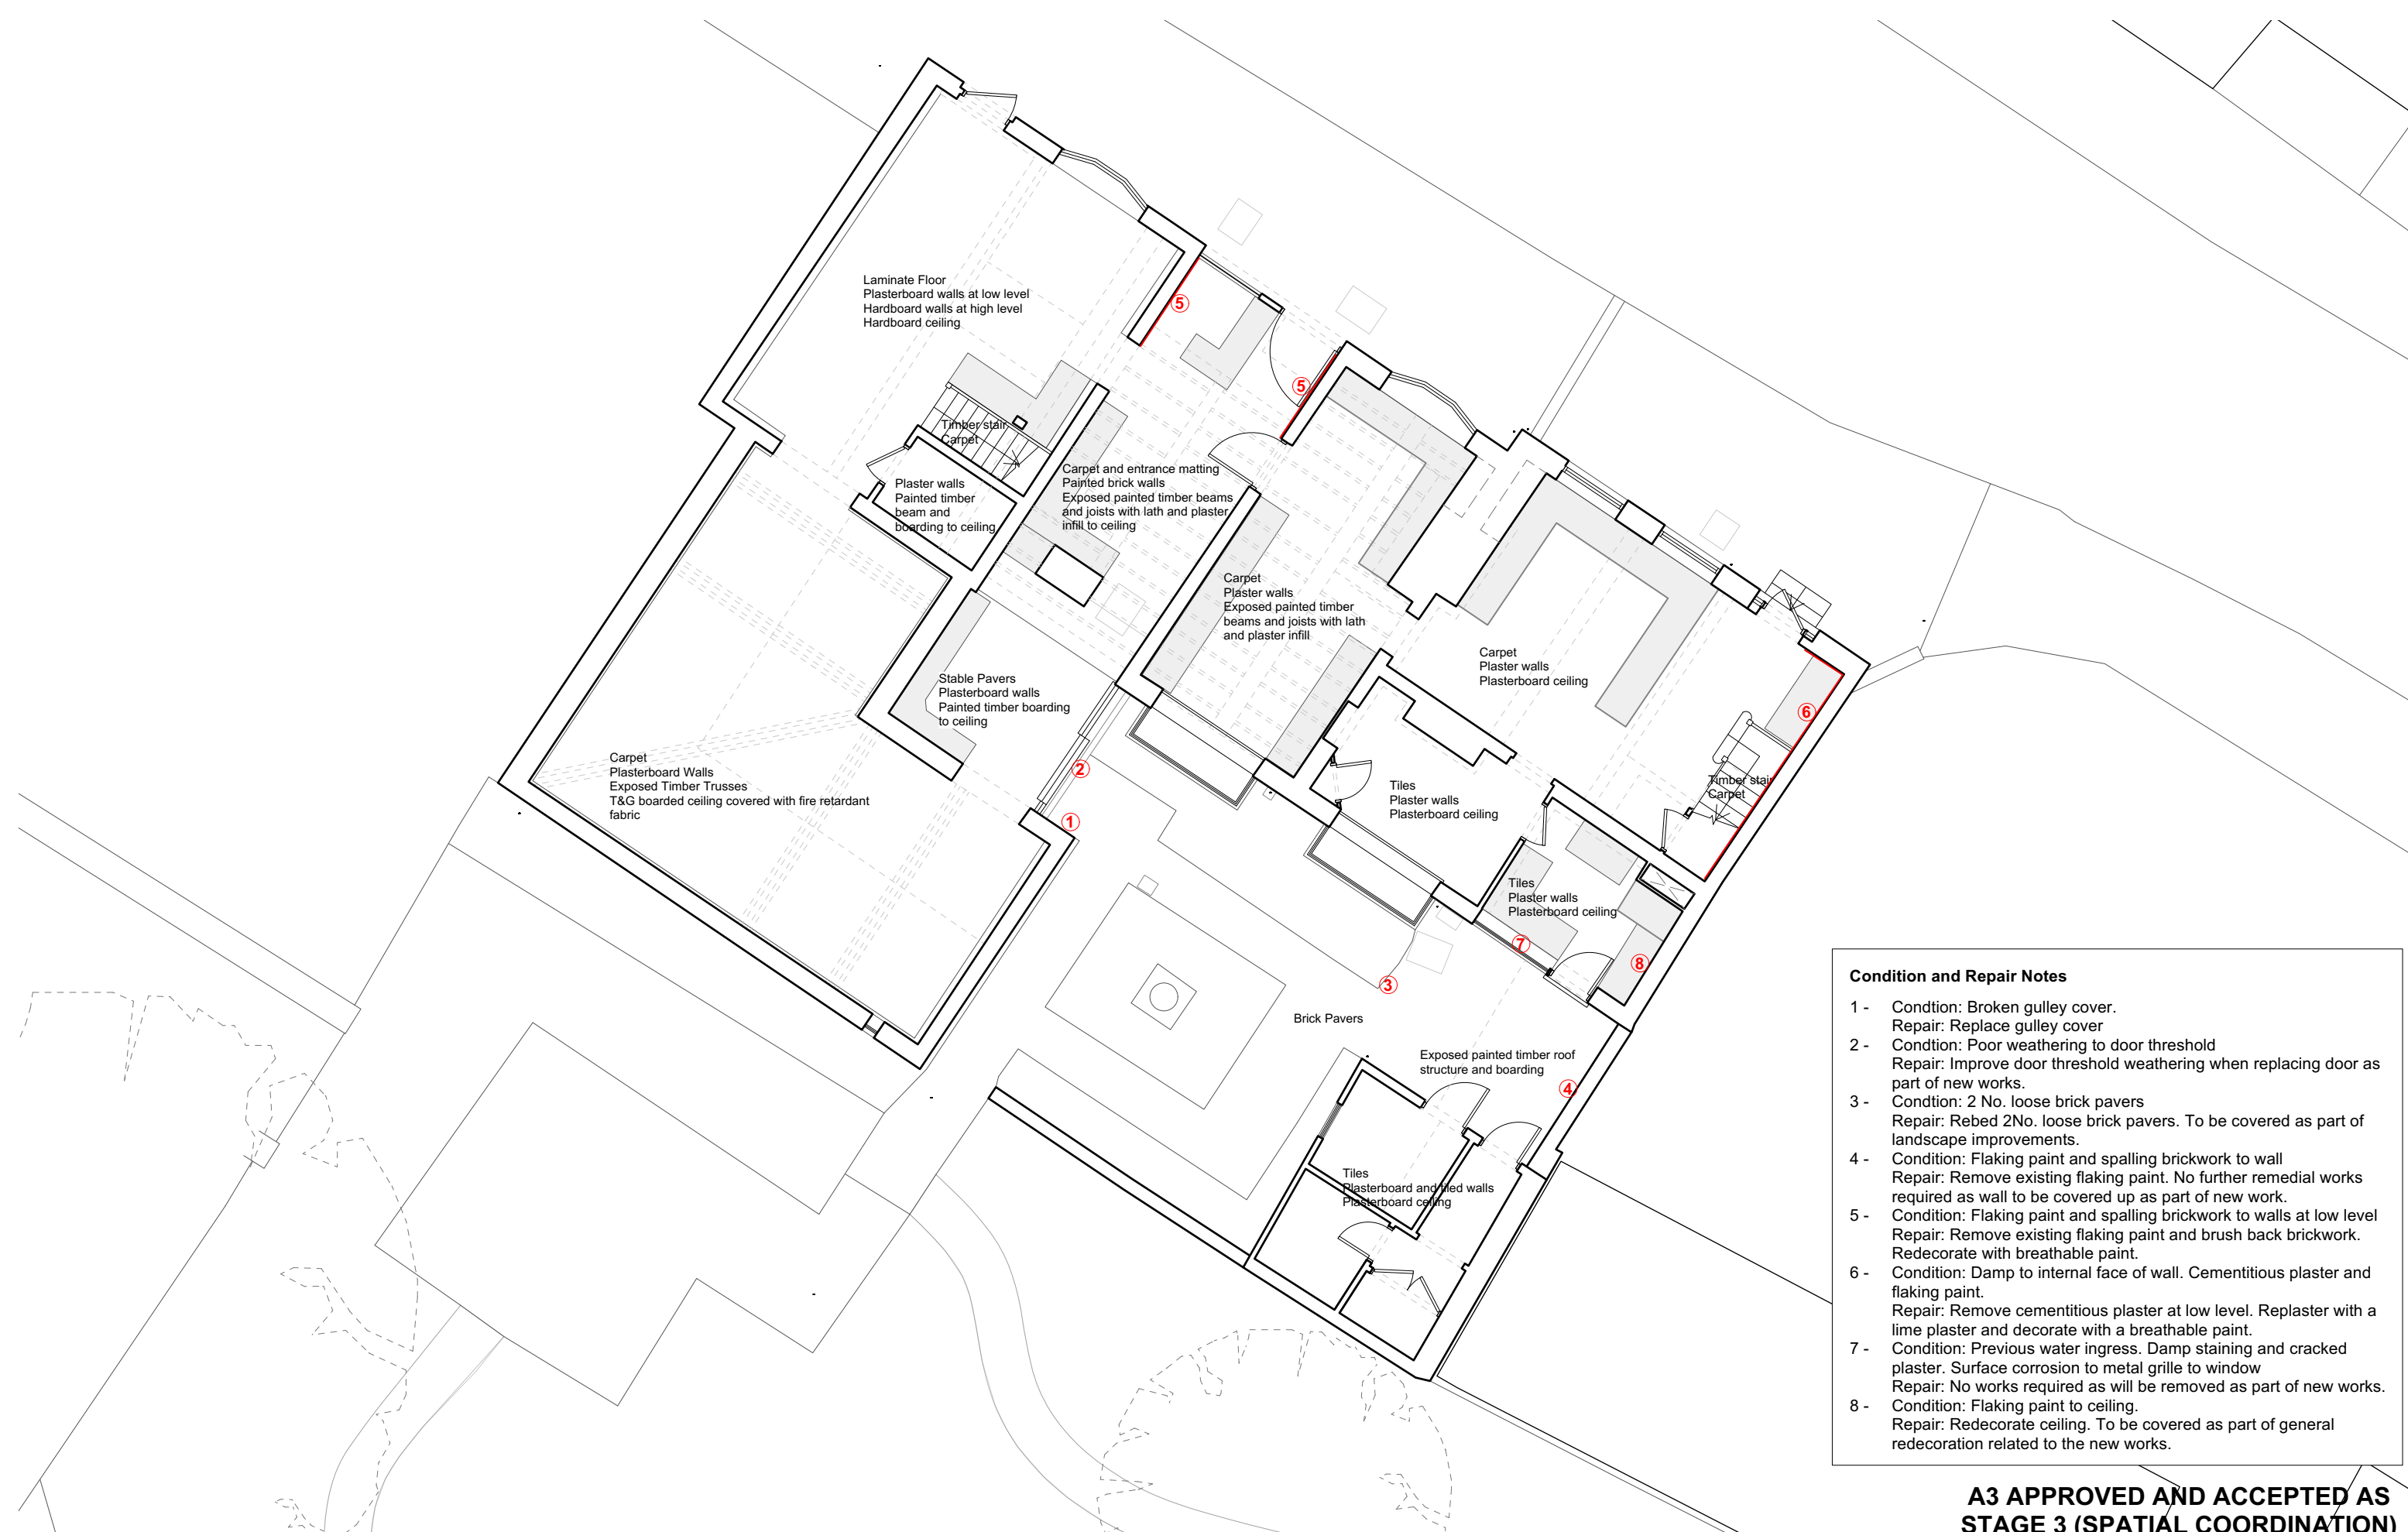
- Condition and Repair Notes**
- 1 - Condition: Broken gully cover.  
Repair: Replace gully cover
  - 2 - Condition: Poor weathering to door threshold  
Repair: Improve door threshold weathering when replacing door as part of new works.

- 3 - Condition: 2 No. loose brick pavers  
Repair: Rebed 2No. loose brick pavers. To be covered as part of landscape improvements.
  - 4 - Condition: Flaking paint and spalling brickwork to wall  
Repair: Remove existing flaking paint. No further remedial works required as wall to be covered up as part of new work.

- 5 - Condition: Flaking paint and spalling brickwork to walls at low level  
Repair: Remove existing flaking paint and brush back brickwork. Redecorate with breathable paint.

- 6 - Condition: Damp to internal face of wall. Cementitious plaster and flaking paint.  
Repair: Remove cementitious plaster at low level. Replaster with a lime plaster and decorate with a breathable paint.

- 7 - Condition: Previous water ingress. Damp staining and cracked plaster. Surface corrosion to metal grille to window  
Repair: No works required as will be removed as part of new works.

- 8 - Condition: Flaking paint to ceiling.  
Repair: Redecorate ceiling. To be covered as part of general redecoration related to the new works.
