**A3 APPROVED AND ACCEPTED AS
STAGE 3 (SPATIAL COORDINATION)
COMPLETE**

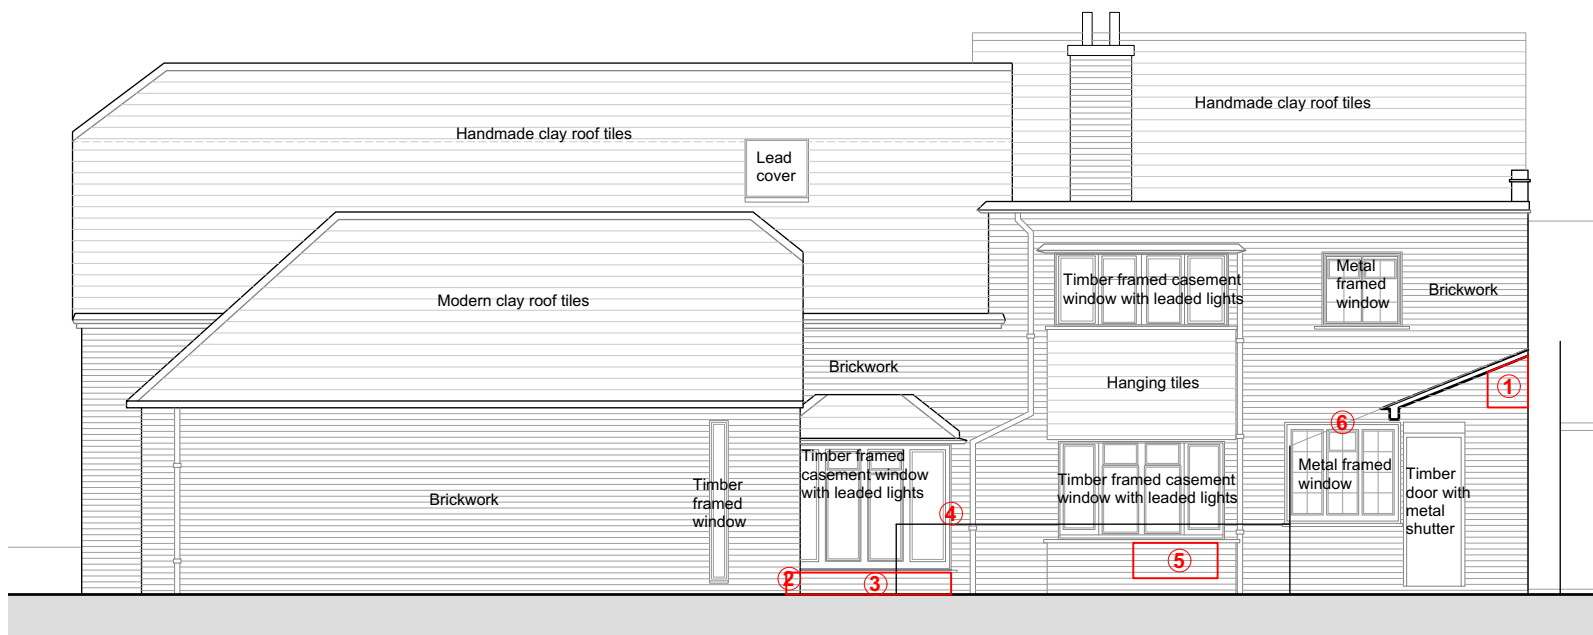
- 1 - Condition: Failed/missing pointing
Repair: Rake out and repoint with lime mortar to match existing
- 2 - Condition: 2 No. damaged bricks to corner
Repair: Piece in 2 No. new bricks to match existing
- 3 - Condition: Failed/missing pointing to bay window brickwork
Repair: Rake out and repoint with lime mortar to match existing
- 4 - Condition: Cracked window pane to reveal
Repair: Replace cracked window pane to match existing
- 5 - Condition: Failed/missing pointing
Repair: Rake out and repoint with lime mortar to match existing
- 6 - Condition: Cracked brick to lintel
Repair: Piece in new brick to lintel to match existing

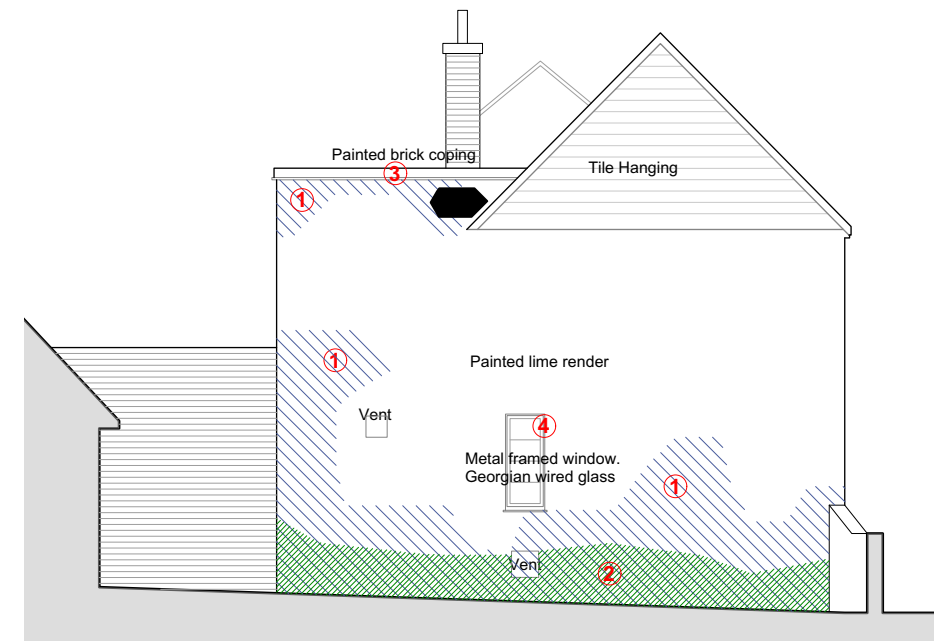
- 1 - Condition: Flaking paint
Repair: Brush back and remove paint. Redecorate with breathable paint (colour to match existing) following repairs to render.
- 2 - Condition: Skim cost of render failing
Repair: Cut back to sound render. Remove failing areas back to brickwork and re-render with lime render.
- 3 - Condition: Flaking paint to brick coping
Repair: Brush back and remove paint. Redecorate with breathable paint (colour to match existing)
- 4 - Condition: Failing decorations to window and cill
Repair: Rub back and redecorate window

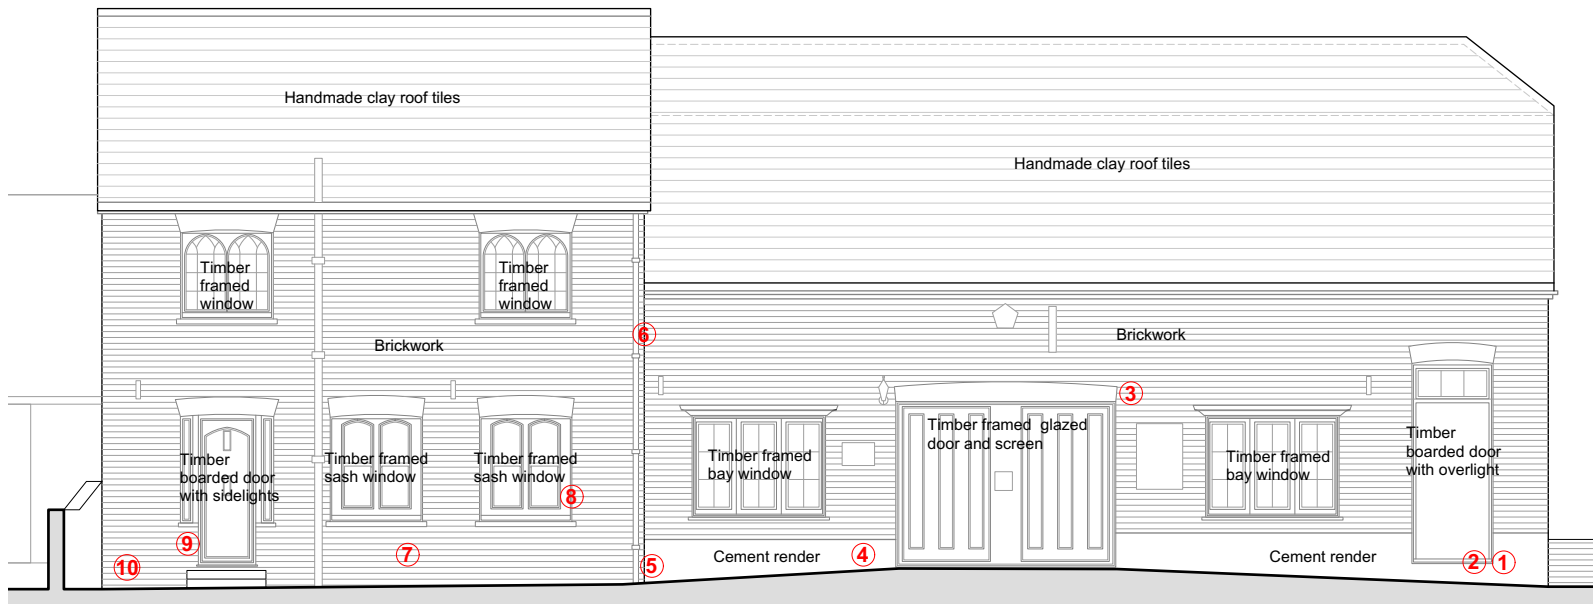
- 1 - Condition: Missing/cracked cement render
Repair: Patch repair cement render to match existing
- 2 - Condition: Crack to corner of concrete door step
Repair: Fill crack to door step with cementitious mortar

- 3 - Condition: Hairline crack to brickwork
Repair: Rake out and repoint crack to brickwork with lime mortar
- 4 - Condition: Damaged cement render
Repair: Patch repair cement render to match existing

- 5 - Condition: Damaged cement render to corner at low level
Repair: Patch repair cement render to match existing
- 6 - Condition: Failed joint between buildings
Repairs: Rake out and repoint joint between buildings with lime mortar to match existing

- 7 - Condition: 7 No. spalled bricks at low level
Repairs: Piece in 7No. new bricks to match existing
- 8 - Condition: Failed joint to side of window
Repairs: Repoint joint between window and brickwork with lime mortar to match existing

- 9 - Condition: Failed/missing pointing
Repair: Rake out and repoint with lime mortar
- 10 - Condition: Triangle vents to brickwork. 1 No. damaged
Repair: Piece in new triangle vent to match existing.

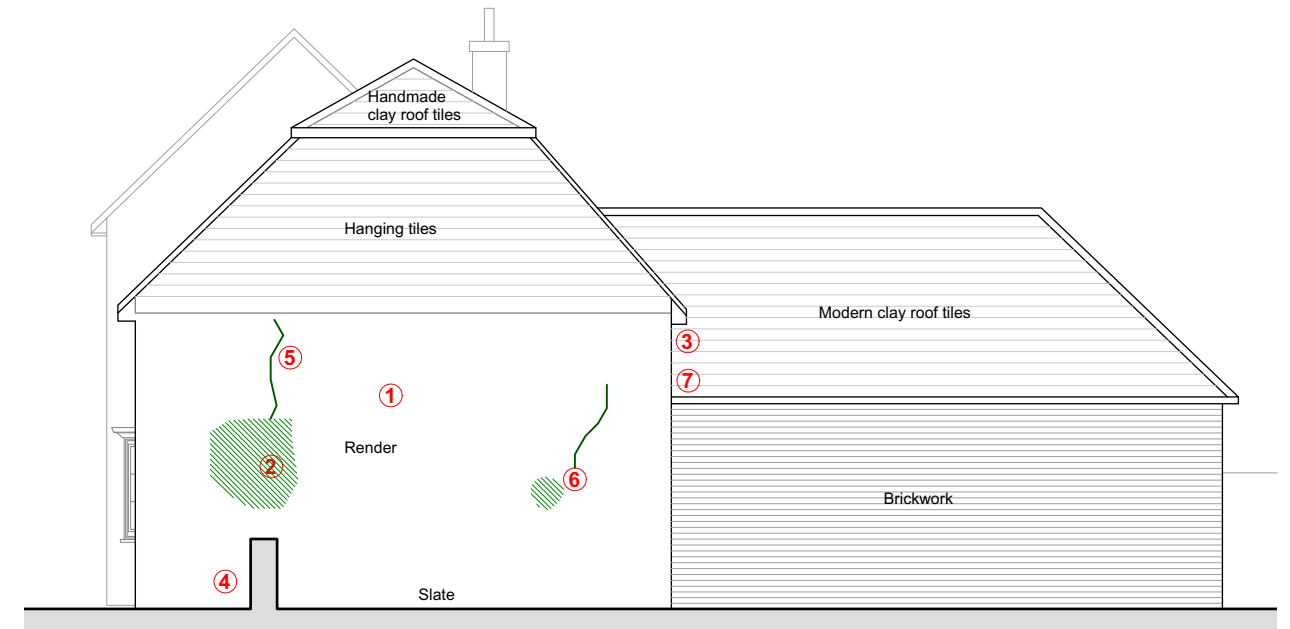
- 1 - Condition: Old Ivy roots on wall
Repair: Carefully remove ivy roots. Redecorate with breathable paint following removal.
- 2 - Condition: Blown render
Repair: Cut back to sound render. Remove failing areas back to brickwork and re-render with lime render. Redecorate with breathable paint following repairs to render.
- 3 - Condition: Upvc gutter and downpipe
Repair: Replace with cast iron gutter and downpipe
- 4 - Condition: 2 No. damaged bricks to plinth
Repair: Piece in 2No. new bricks to match existing
- 5 - Condition: Hairline crack
Repair: Pin back render and fill crack with lime render. Redecorate with breathable paint following repairs to render.
- 6 - Condition: Crack and small area of blown plaster
Repair: Cut back to sound render. Remove failing areas back to brickwork and re-render with lime render. Redecorate with breathable paint following repairs to render.
