DAVID PARTRIDGE LTD

**REPORT ON FORMER STABLE BUILDING,
 COTSWOLD HOUSE,
 CHEDWORTH,
 GLOUCESTERSHIRE**

JOB NUMBER 23 / 196
CLIENT Mr and Mrs M Langley
Date 29th August, 2023

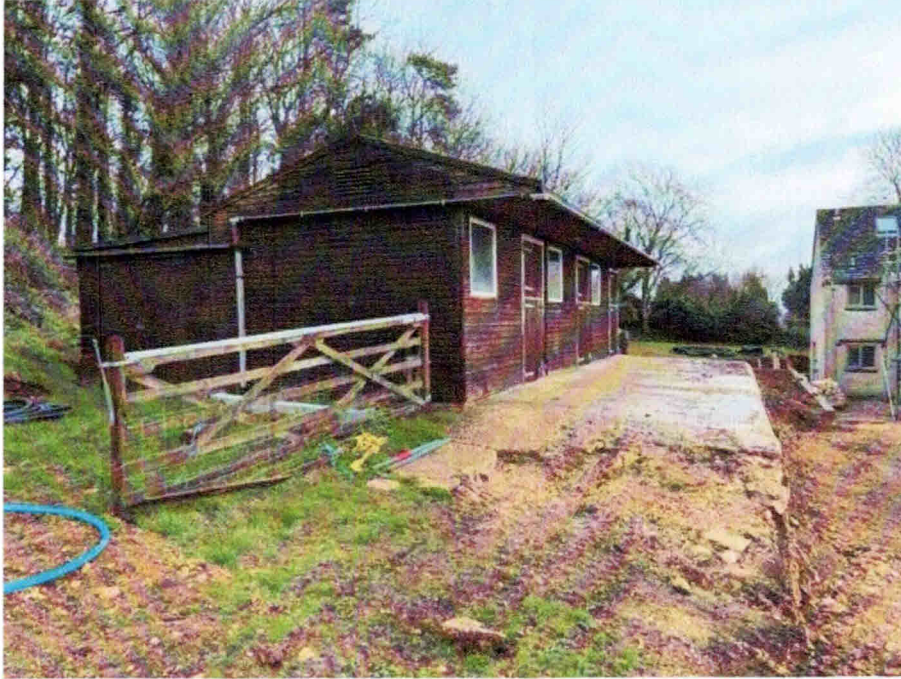
PLATE A -- GENERAL VIEW FROM SOUTH WEST

The 'site' comprises a detached, single storey building which is rectangular on plan with the longer axis orientated east to west. [Plate A].

Plate A [front SW corner of the building] indicates that the timber frame sole plate is supported on a brickwork masonry sub-structure as outlined in the External Wall description. This strongly suggests that the foundations comprise a perimeter trench of concrete taken down to stable subsoil. The alternative and quite typical, but less robust foundation solution in this situation would be a flat slab of concrete off which would be built the walls – however, this alternative is unlikely to exist because brickwork masonry is seen disappearing below floor slab level and therefore most likely down to a concrete trench.

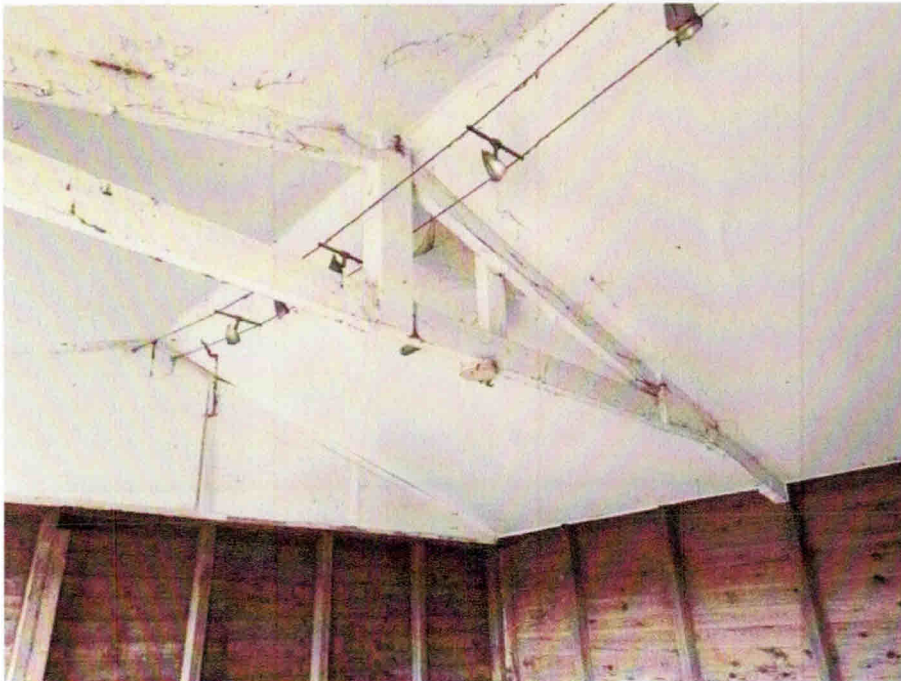
PLATE B -- OVERALL STRUCTURE

The structural form of the felt clad roof is a series of timber boards spanning the length of the building on to the gable walls between which are fabricated timber trusses. [Plate B]. The boards are tightly abutted together. The trusses are supported in the rear wall on steel brackets bolted to both the truss rafter and the top of a timber stud which is aligned exactly below the rafter. [Plate C]. In the front wall the truss is supported on a vertical timber bracket bolted to a timber stud. [Plate D].

- The lining boarding supporting the felt finish is without damage from water penetration especially at the ridge and eaves which are the most vulnerable locations in every building.
- The trusses show no vertical deflection along their length, no timber splitting at any of the joints and no compression on their supporting timbers at each eaves location.

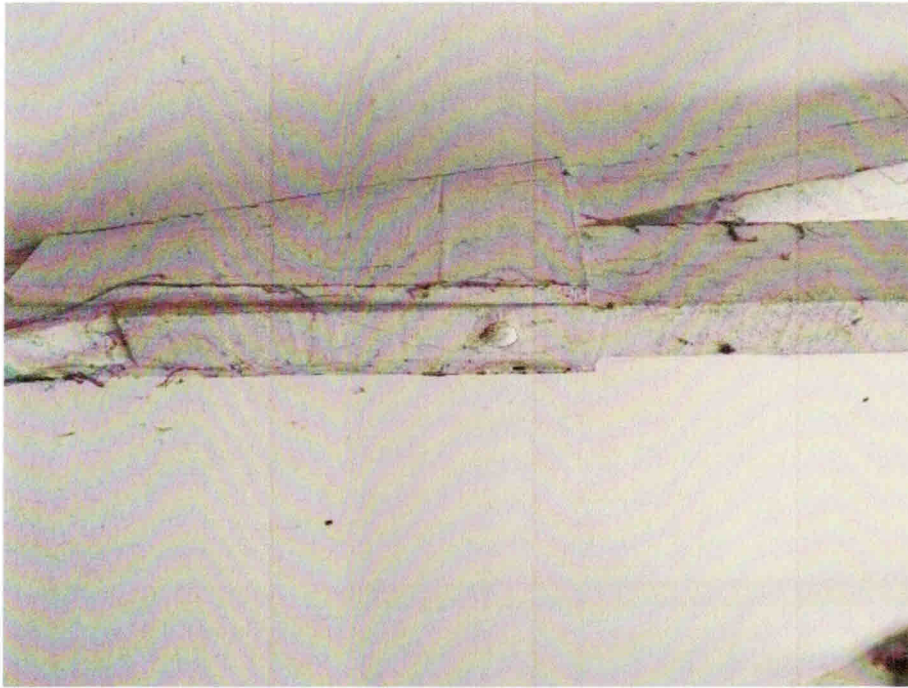
PLATE E -- RAFTER / TIE CONNECTION ON REAR ROOF SLOPE

The ceiling chords of the trusses connect with their rafters at the front wall position but at a distance of about 700mm inside the rear wall – the rafter tie connection is made with a vertical bolt and a timber gusset screwed to each side of the joint. [Plate E].

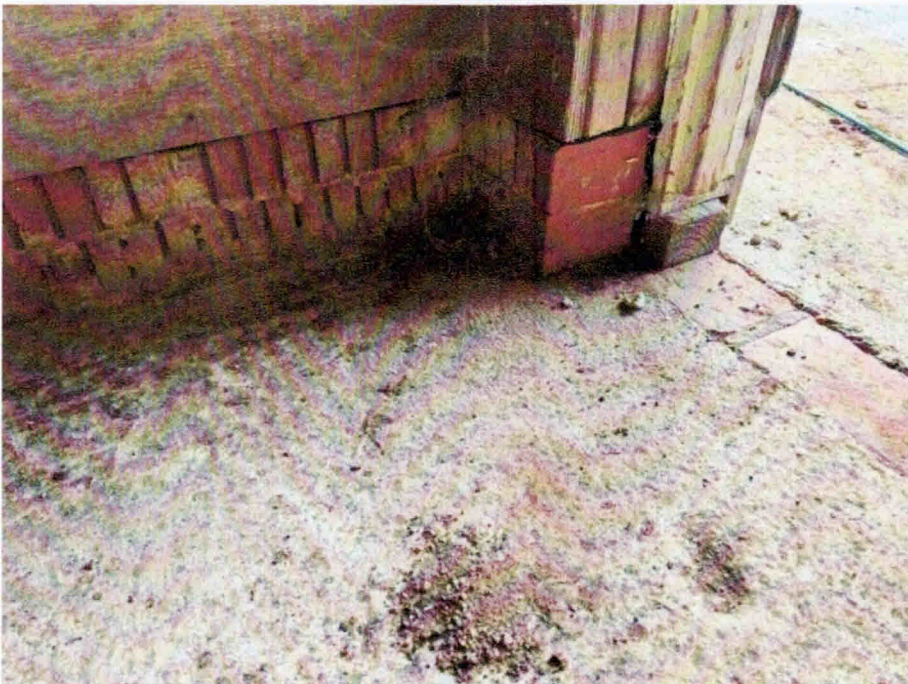
PLATE F -- WALL SOLE PLATE ON SUB-STRUCTURE MASONRY

The walls comprise a series of vertical timber stud spanning from ground floor level to eaves. Horizontal boards span between the studs on all elevations; they are tightly abutted together. [Plate C]. The openings in the front, south elevation are simply formed with studs each side. The studs are supported on a timber 'sole' plate fixed to the top of the brickwork masonry sub-structure. [Plate F].
