Harpers, Green Street, High Easter, Essex. CM3 1HU. Historic building recording and analysis of the House. Recorded 18 09 2023.

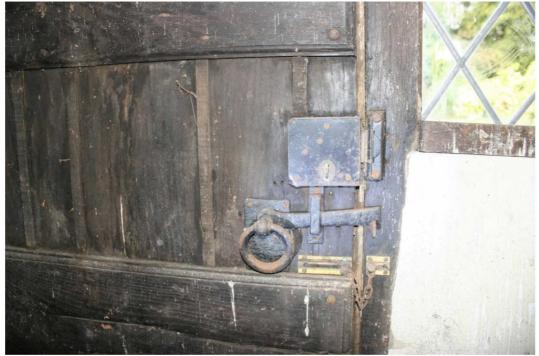
Detail of the inside of the front door.

The central door and leaded light windows all date the 1964 development. The windows have oak frames which have shrunk badly. While the front door has aged quite badly it is obviously a C20th replica of a plank and batten door with vertical fillets added to reduce the draughts. The door furniture is MC20th and all screwed in place. The door jambs are also inserted and the peg holes for the original studs can be seen out of place. The wrought iron strap hinges may be authentic.

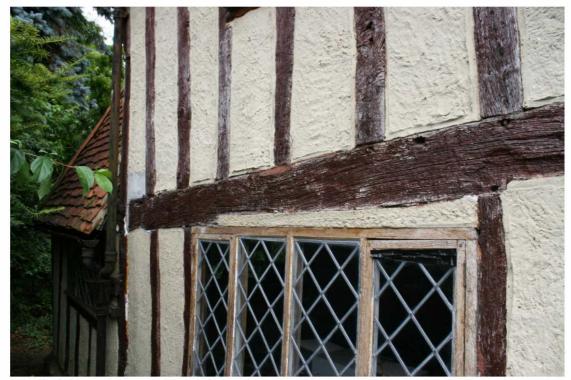
Detail of the midrail and the oak framed windows.

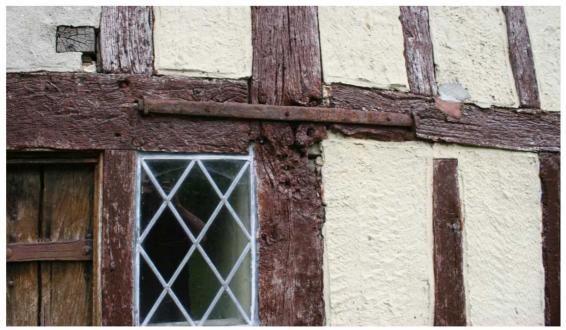
Failing storey post with LC18th or EC19th iron strap repair.

The oak frame has suffered from subsidence at both ends and this has lead to fracturing of the storey posts where the midrails meet them. The movement is historic nad has been addressed with Lc8th or EC19th wrought iron straps. The infill panels all appear MC20th with hard cement render on EML. In places it has been used to cover sections where the window openings have been changed. The oak frame has been painted to resemble red ochre. There is a large number of nails to indicate the building was lath and plastered in the past.

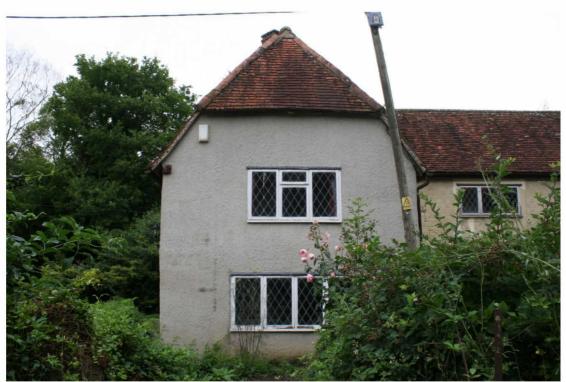
The east elevation of the original cottage.

The east elevation has brush dabbed rough cast render over EML and has 1964 leaded lights. The upper storey has a three light casement with a top hung light. The lower floor has a four light casement. These windows have anodised aluminium stays and catches. The frames are badly rotted and can pulled apart by hand.

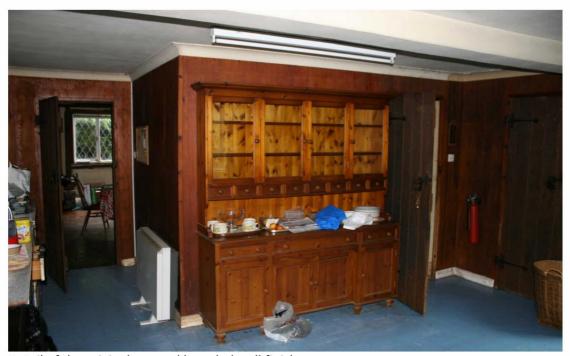
All the fabric dates to the 1964 works with some later intervention to install new plumbing and a water softener. The walls were clad with pressed vertical boards which suffered badly from water ingress. This hardboard product was used extensively in homes and offices in the 1960's and early 1970's.

Detail of the original pressed boarded wall finish.

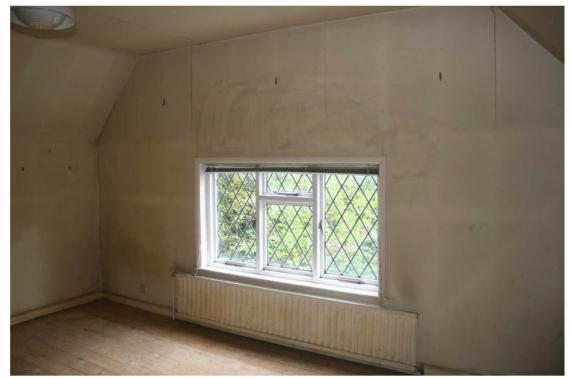
Looking NE in the NE Bedroom. Note the studwork visible in the walls.

Built on a budget, the studwork frames can be seen through the thin plasterboard.

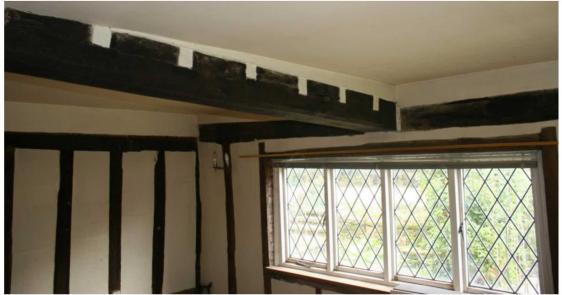
The main joist has sunk and the floor above remade to be level.

The fireplace appears to have been reduced in width and the back canted to take a cast iron insert. The bricks are 50x110x230mm red/orange typical of the C16th and C17th set in thick beds of white lime mortar. Originally, the brickwork was render over but it has been removed (most likely as part of the 1964 works) and reshaped. Two concrete moulded rosettes have been added and painted. The shortened bressummer has no apotropaic marks or taper burns. The main axial joist has lost all of the common rafters which had soffit tenons with refined entry and the floor above has been levelled and raised well above the midrails.

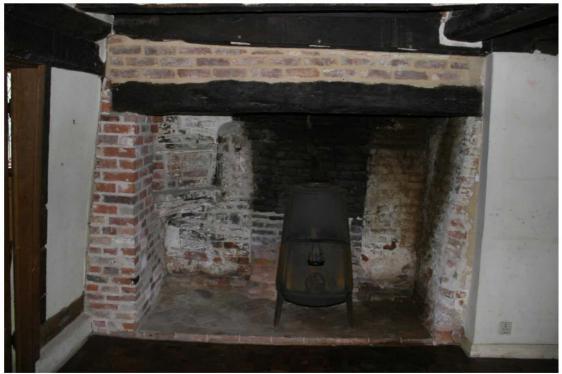
The fireplace in the Drawing Room.

The fireplace has the same 50x110x230mm red bricks as that in the Snug but has less alteration. The bressummer is likely original and in the LHS corner is a blocked off aperture for a bread oven. The lower part of the fireback has recent repairs but the extensive sooting indicates there was a cast iron fireplace that has been removed. The wood burner is MC20th.

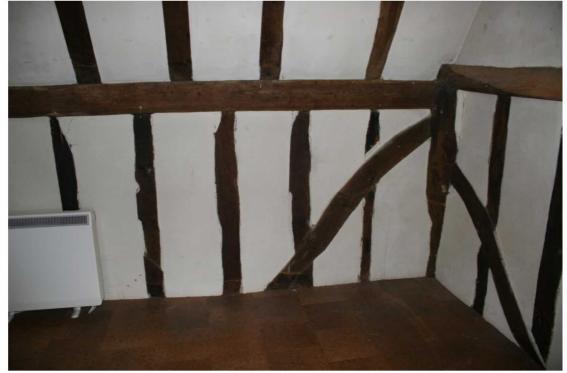
Framing in the NE corner. Note the empty trench for a missing brace.

The frame has definitely been reordered in the eastern wall as the braces do not coincide with the original mortices. The SE corner post has been shaved back due to beetle damage.

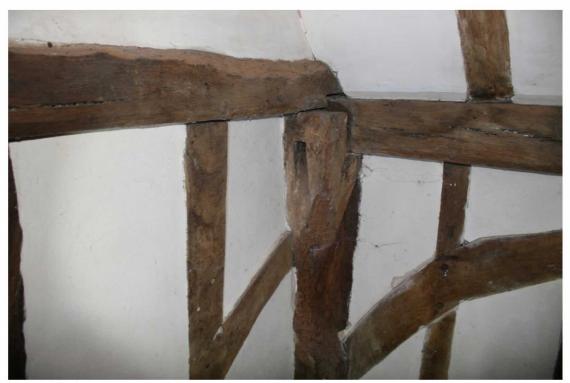
Framing in the SE corner. The corner post has been shaved back.

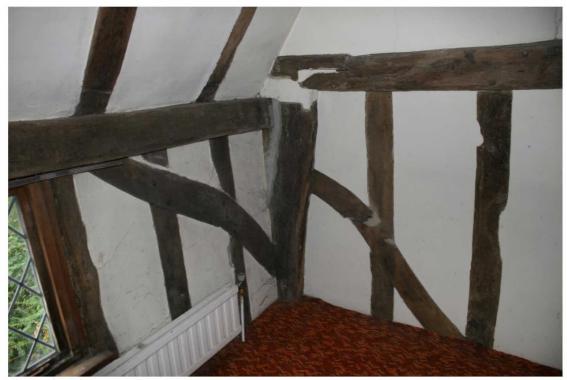
The frame is a reflection of that in the SE Bedroom but retains its original serpentine braces. A further brace has been nailed across the studwork in the west wall to arrest racking.

The racked frame in the SW corner.
