# **Belldown, Copdock, Suffolk**

## **Heritage Asset Assessment**

**Leigh Alston MA (Oxon), Architectural Historian**

**May 2023**

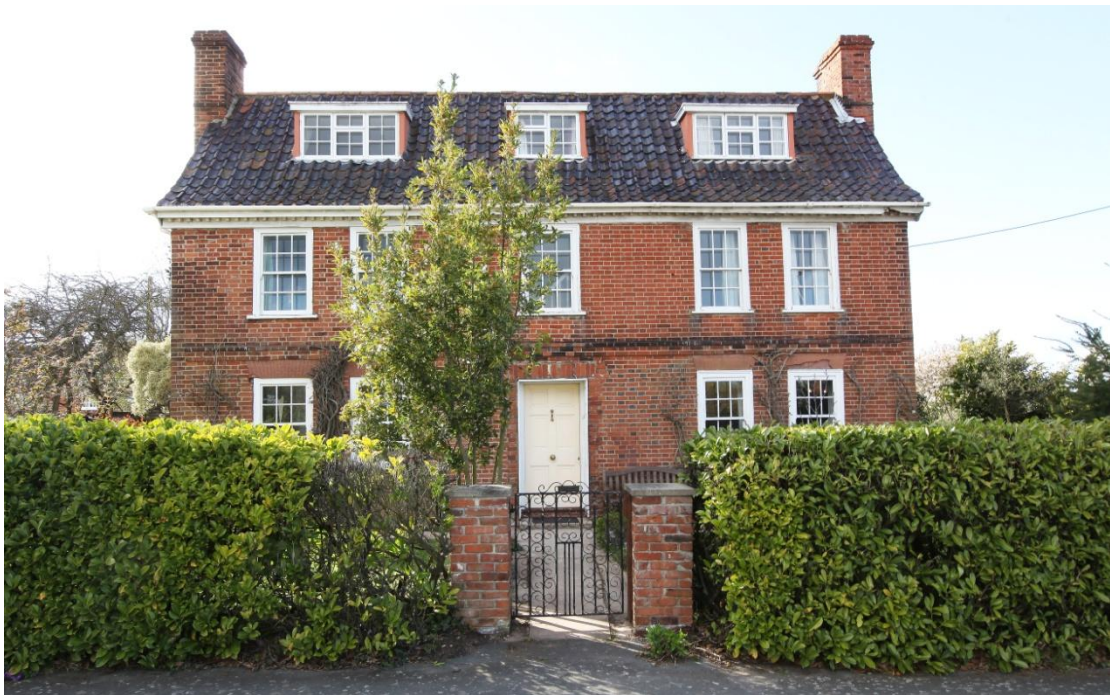
**Illus. 2.** The eastern facade from the remaining section of the original road between London and Ipswich. The current symmetrical appearance dates only from the mid-20<sup>th</sup> century when the adjoining sash windows to the left of the central entrance were separated to match those on the right. In their current form the three dormer windows are also 20<sup>th</sup> century additions that replaced the smaller pair in figures 8-10.

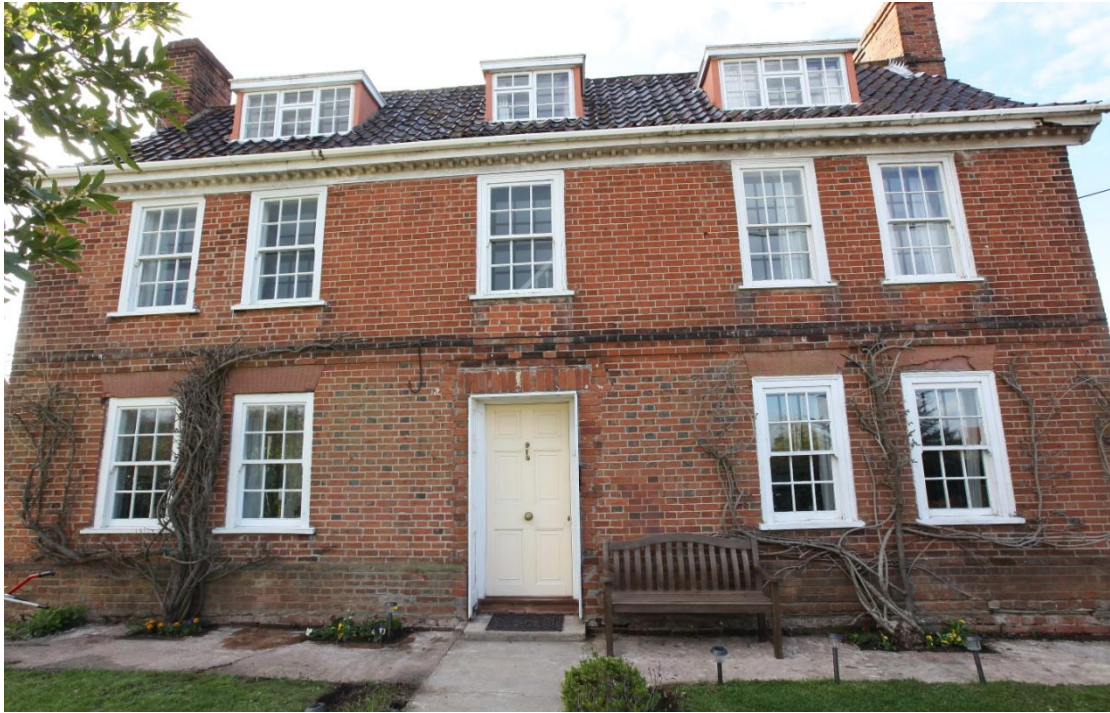
**Illus. 3. The Flemish Bond brickwork of the facade has been heavily repointed, obscuring the evidence of its original arrangement, but in all probability it was identical to that shown in figure 8-10. The area between and around the four left-hand windows was rebuilt when the unusual adjoining sashes were separated. All but the penultimate first-floor window on the right contain horns and cannot pre-date the mid-19<sup>th</sup> century (i.e. the sides of their upper sashes project beneath their lower rails to strengthen the joints in a manner not seen before this date).**

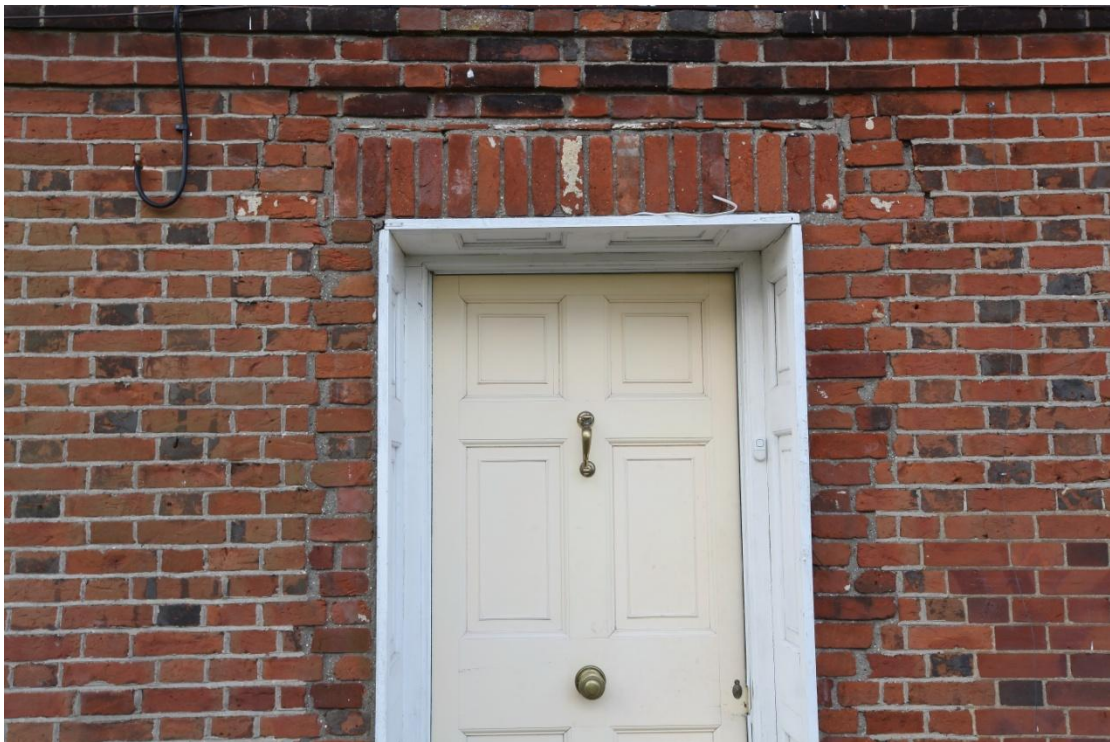
**Illus. 4. A detail of the central entrance which is defined by recent brickwork laid in hard grey cement mortar with a crude modern flat arch above. The Post Office entrance may have been widened at some point, and the flat arch replaced a Georgian flat hood.**

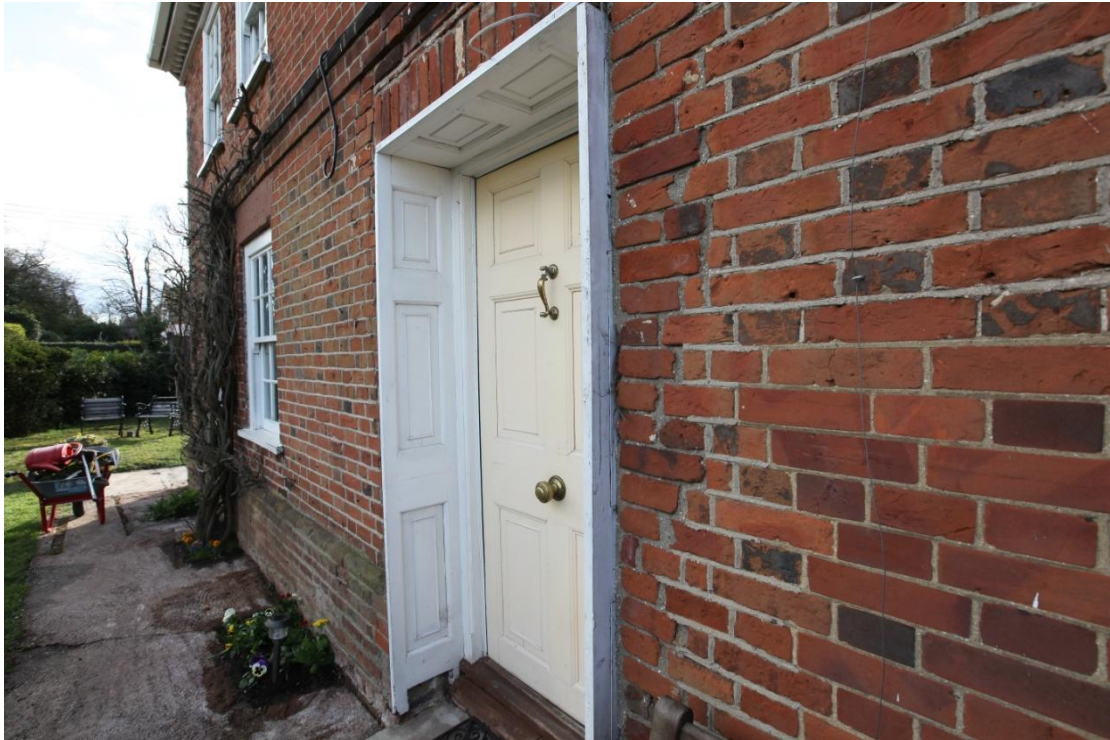
**Illus. 5. A further detail of the main entrance showing the extent to which the panelled door surround projects beyond the wall face. Although dating from the 19<sup>th</sup> century this panelling is not shown in the early-20<sup>th</sup> century images and does not fit the building. It is likely to have been installed by the previous owner who is understood to have been a professional furniture restorer, and given the building's complex history as a Post Office and a pair of low-status cottages any potentially original fixtures and fittings should be treated with similar caution.**

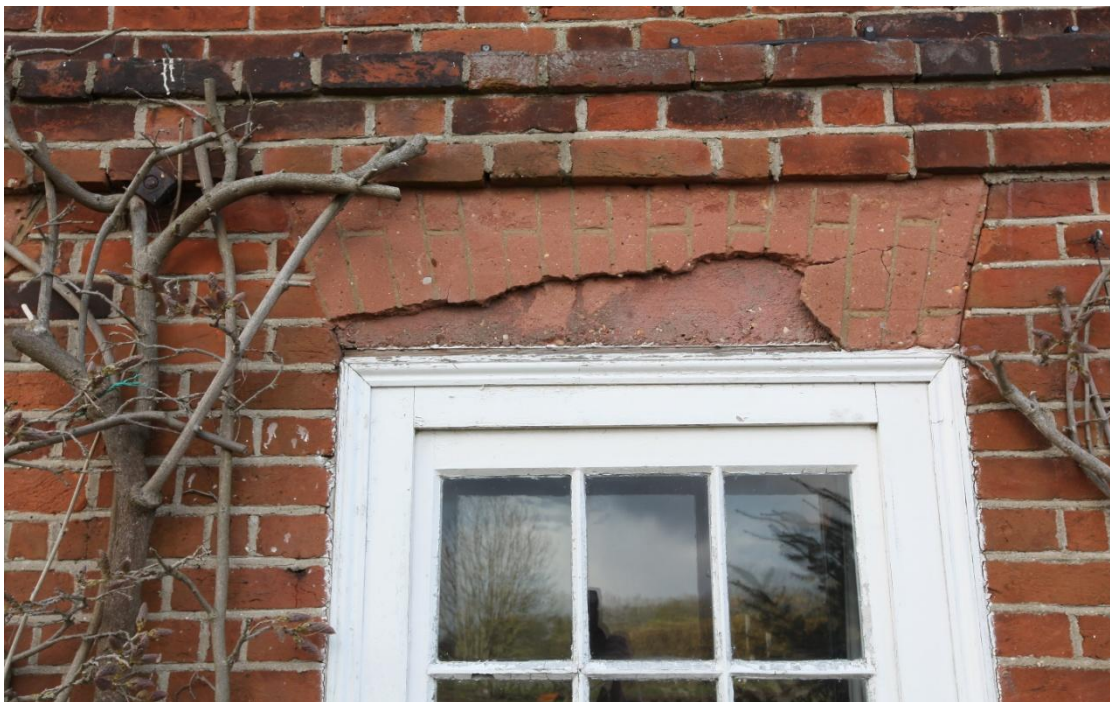
**Illus. 6. A detail of the apparent flat arch over the right-hand ground-floor window which in fact consists of a concrete lintel covered by a recent layer of cement incised and painted to resemble brickwork. The other three arches are identical.**

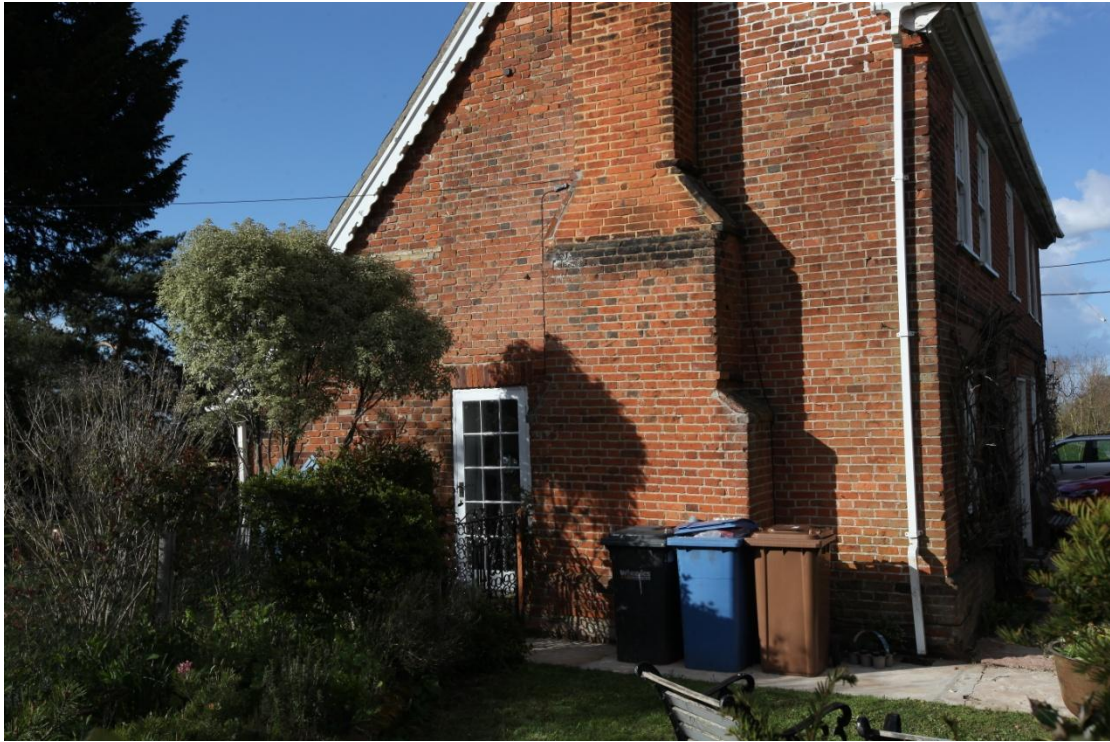
**Illus. 7. The modern glazed door in the southern gable is respected by an ostensibly 19<sup>th</sup> century flat arch and occupies the position of the entrance to the blacksmith's cottage in figures 8-10. The brickwork of the rear lean-to on the left is modern and replaced the render shown in the early photographs.**

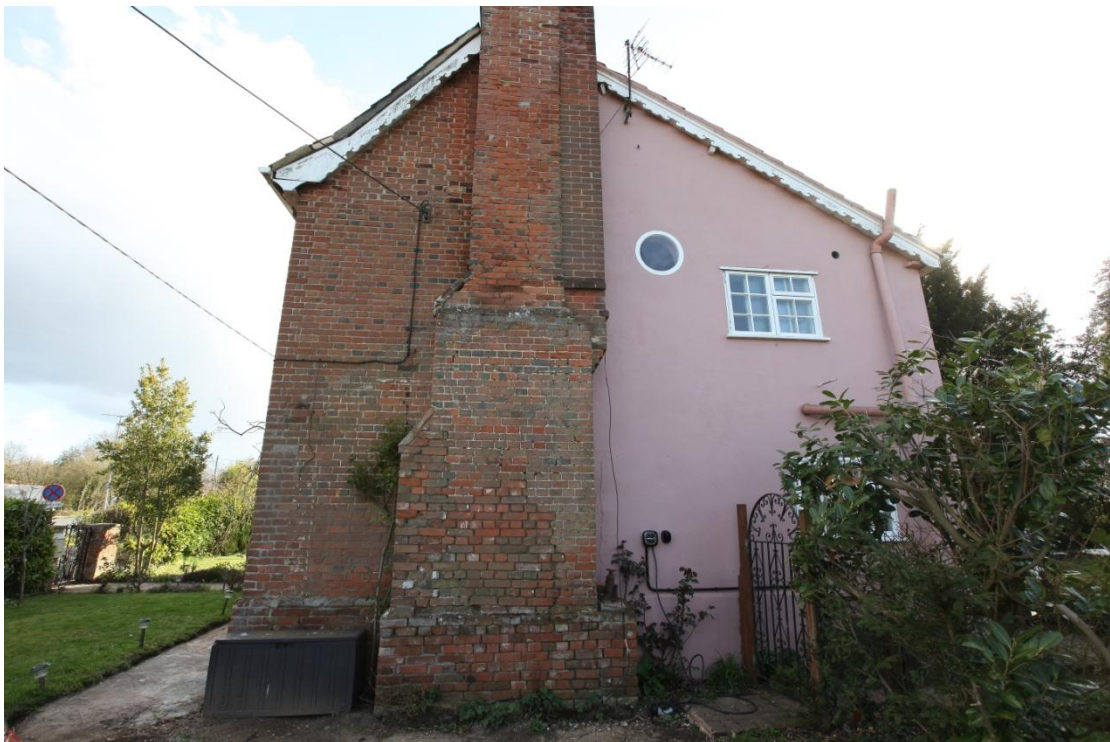
**Illus. 8. The northern gable, partly encased in the cement render of the late-20<sup>th</sup> century two-storied rear extension. The chimney was previously adjoined by a boarded lean-to shed that may have contained a bread oven (figure 10), and the brickwork of the chimney itself has been much altered. The curious double shaft relates either to the missing oven or an inserted first-floor fireplace of which there is no internal evidence.**

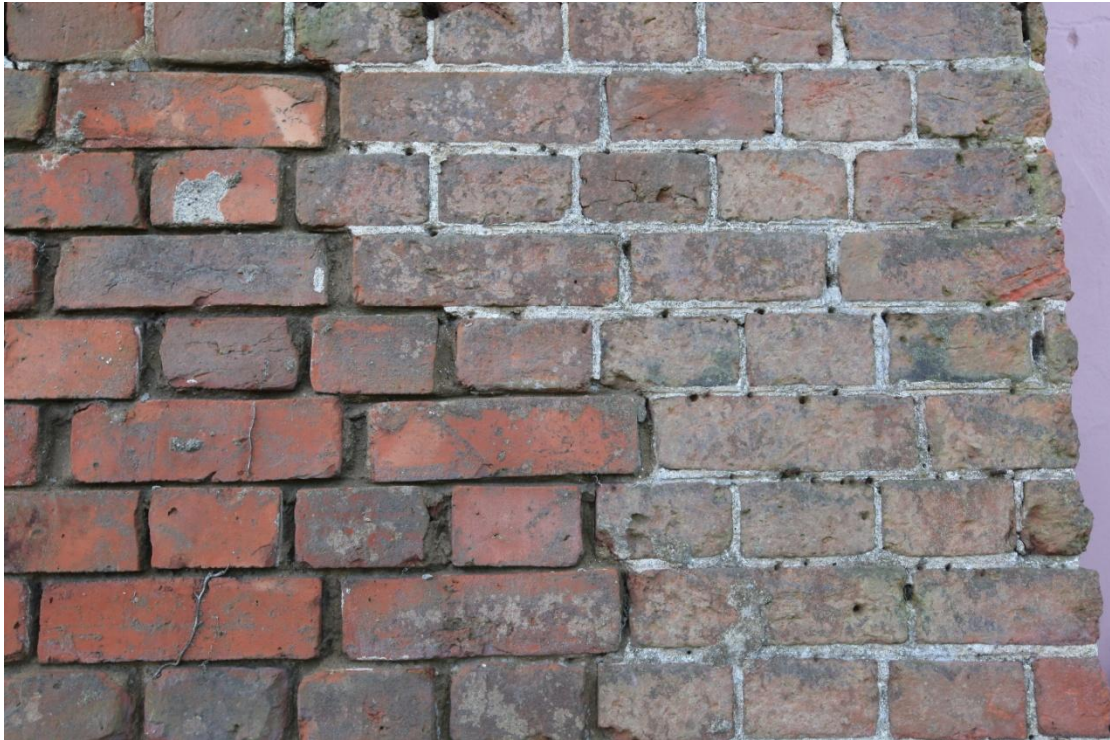
**Illus. 9.** A detail of the external brick chimney in illustration 7 showing a section of modern rebuilding on the left with an area of original brickwork that has escaped repointing on the right. The finely ruled mortar joints are typical of the 18<sup>th</sup> and early-19<sup>th</sup> centuries, and would have extended to the entire building.

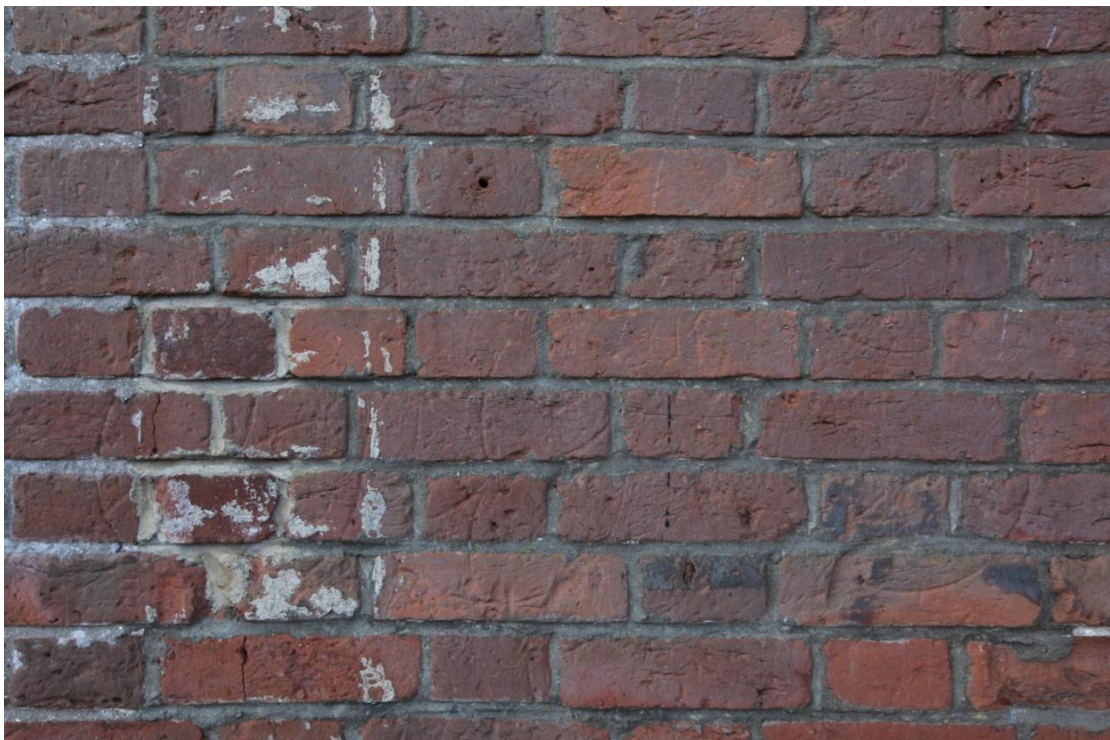
**Illus. 10.** A second detail of the northern gable in illustration 8 showing the repointed area to the left of the chimney which nonetheless preserves three incised apotropaic circles with evidence of internal 'petals'. These 24 cm diameter hexafoils or daisywheels were used to ward off evil spirits and probably lay within a lean-to shed when first executed.

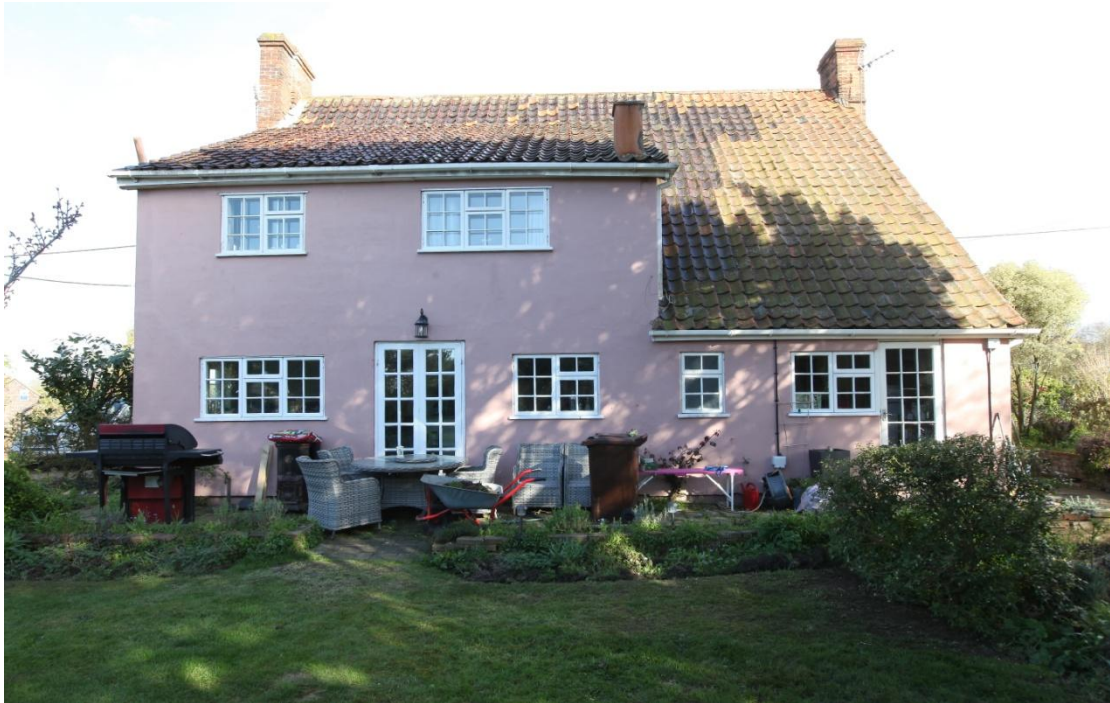
**Illus. 11.** The house from its rear garden with the late-20<sup>th</sup> century two-storied extension on the left. This consists of cement blocks and must date from the 1970s or 80s. The single-storied structure contains matching windows but probably reflects the height of the original rear lean-to on the historic maps. However, it must represent a replacement as both rear corners were indented on the maps (indicating the previous structure shopped short of the gables).

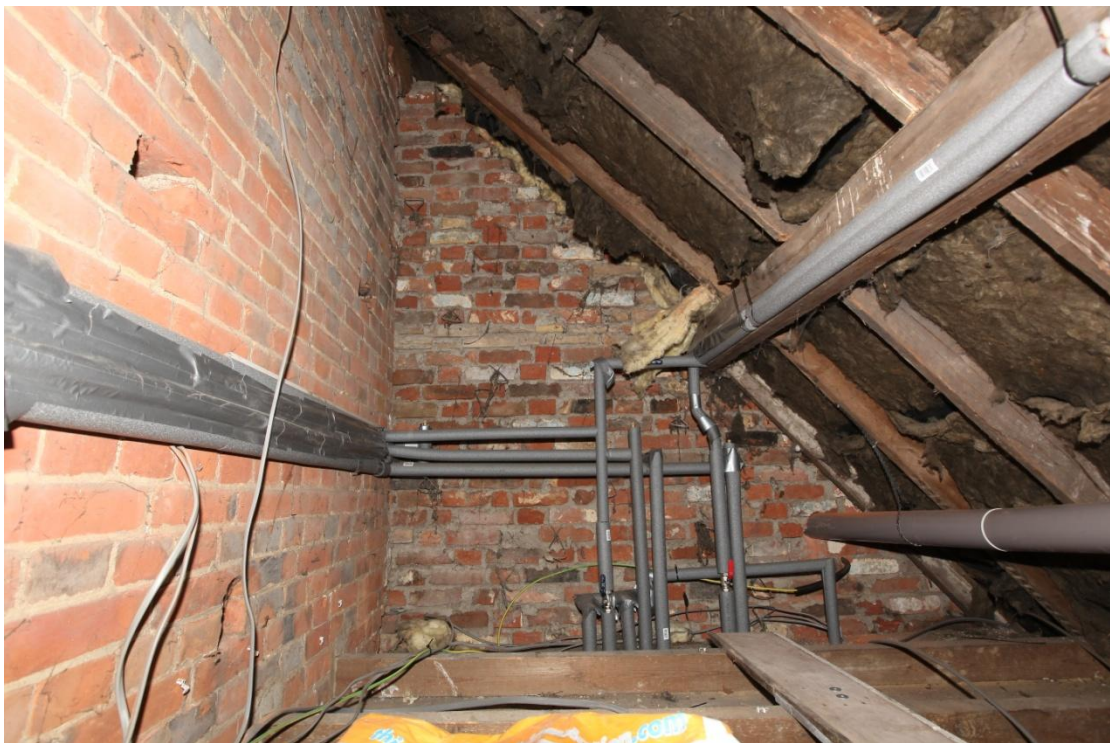
**Illus. 12.** The internal southern roof gable of the single-storied lean-to in illustration 11, with the original rear wall of the house on the left. The gable consists of re-used brick laid in cement mortar and dates only from the 20<sup>th</sup> century. The original rear wall lacks windows and evidently adjoined a similar timber-framed lean-to from the outset.

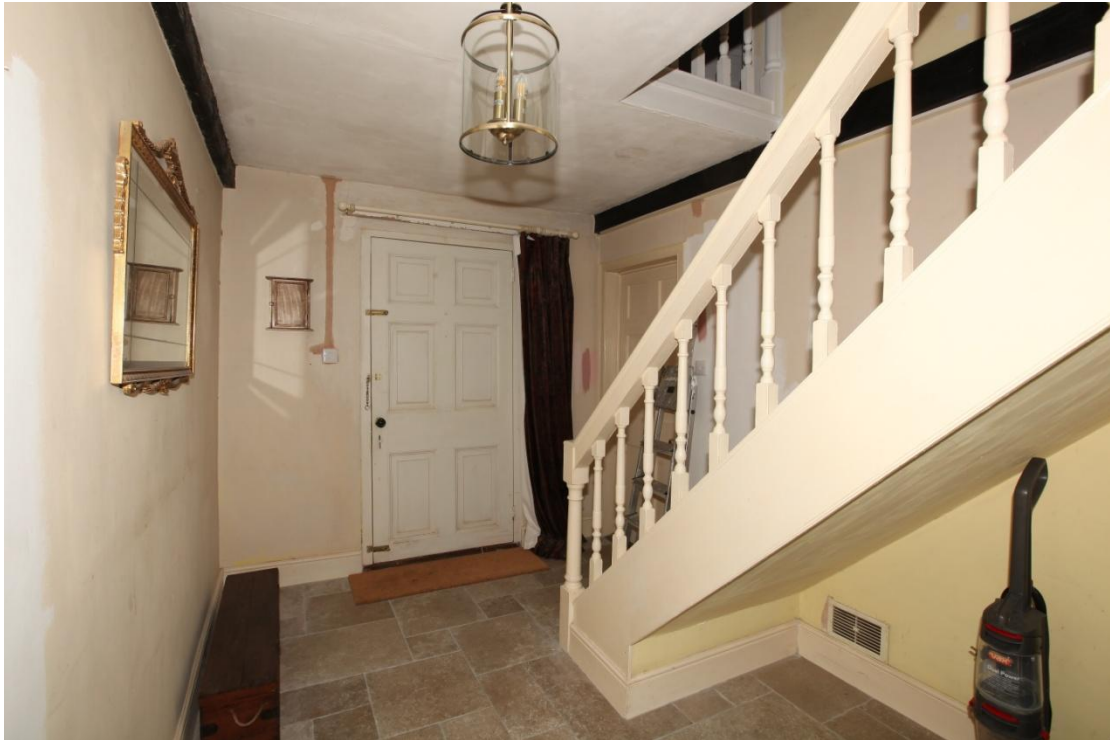
**Illus. 13.** The central entrance passage, which at 2.4 m or 8 ft is unusually wide for a house of otherwise modest proportions. The panelled entrance door is secured by early-19<sup>th</sup> century HL hinges and the staircase with gun-barrel turned newel posts is typical of the mid-19<sup>th</sup> century, but there is evidence of extensive repair and it is unclear whether these features survived the conversion of the house or were installed by the previous owner. No such staircase is mentioned in the 1988 listing entry.

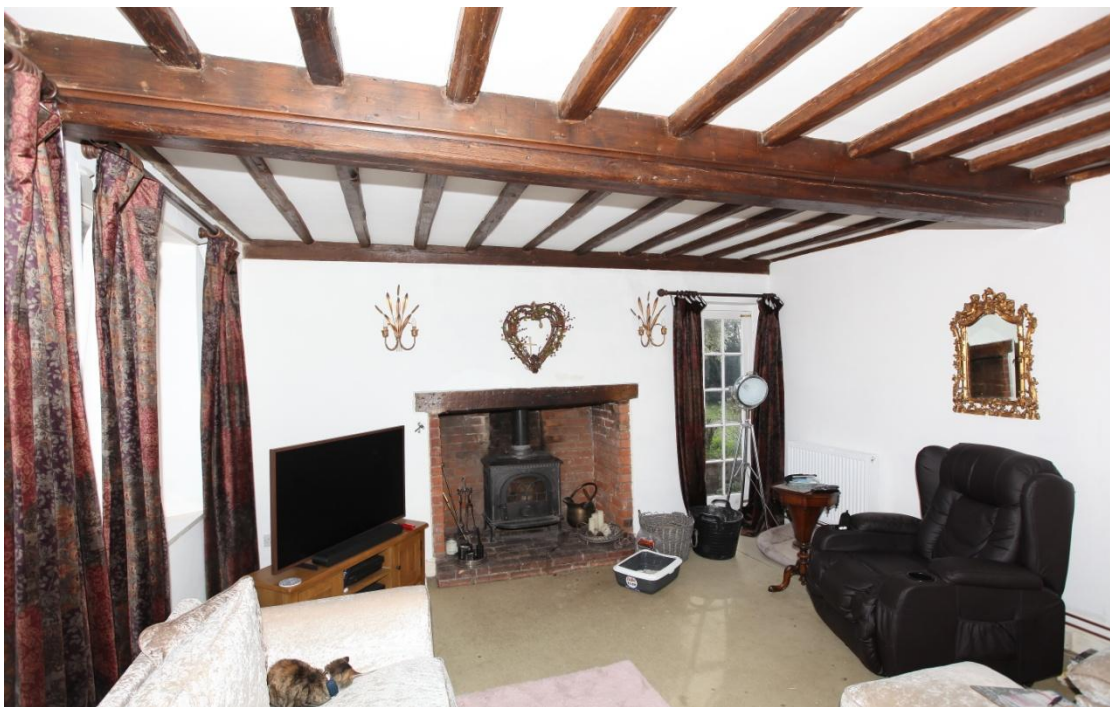
**Illus. 14.** The sitting room's southern gable showing the modern glazed door in the entrance to the blacksmith's cottage. The brickwork of the fireplace is consistent with the early-19<sup>th</sup> century but the lamb's tongue chamfer stops of its lintel are more typical of the 17<sup>th</sup> century and it may have been imported – although it fits the brickwork.

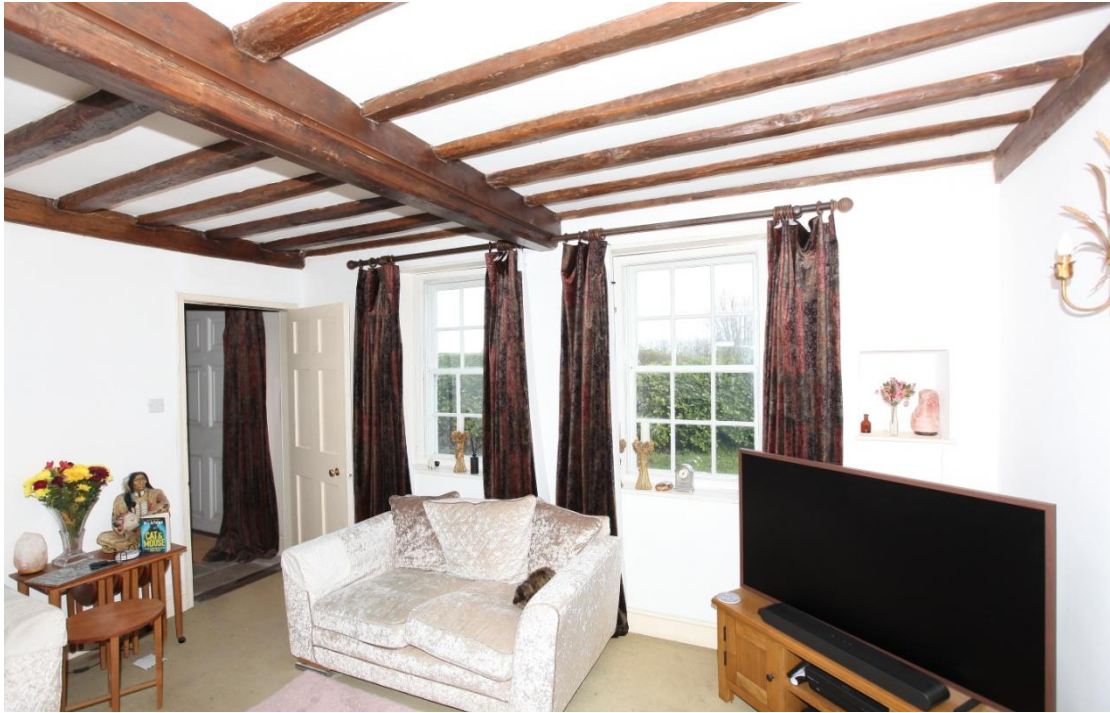
**Illus. 15. The 20<sup>th</sup> century windows in the front wall of the sitting room with an ostensibly late-19<sup>th</sup> or early-20<sup>th</sup> century door in the presumed wall between the two cottages on the left.**

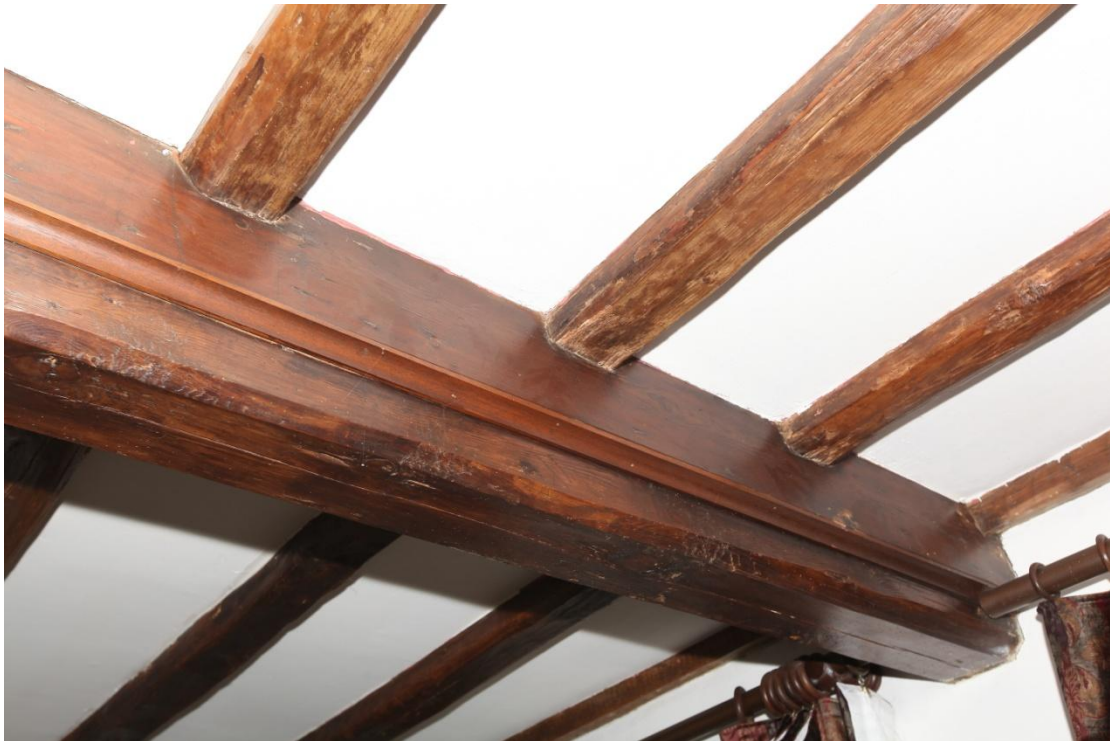
**Illus. 16. A detail of the neatly chamfered binding joist between the windows of the sitting room in illustration 15 with later boards concealing the joints of the common joists above. The pine timber appears authentic and may have been boxed at some point. The roughly hewn pine common joists are also convincing, and match the rafters in illustration 26, but there is no evidence of the plaster that might have been expected in a house of this period and quality.**

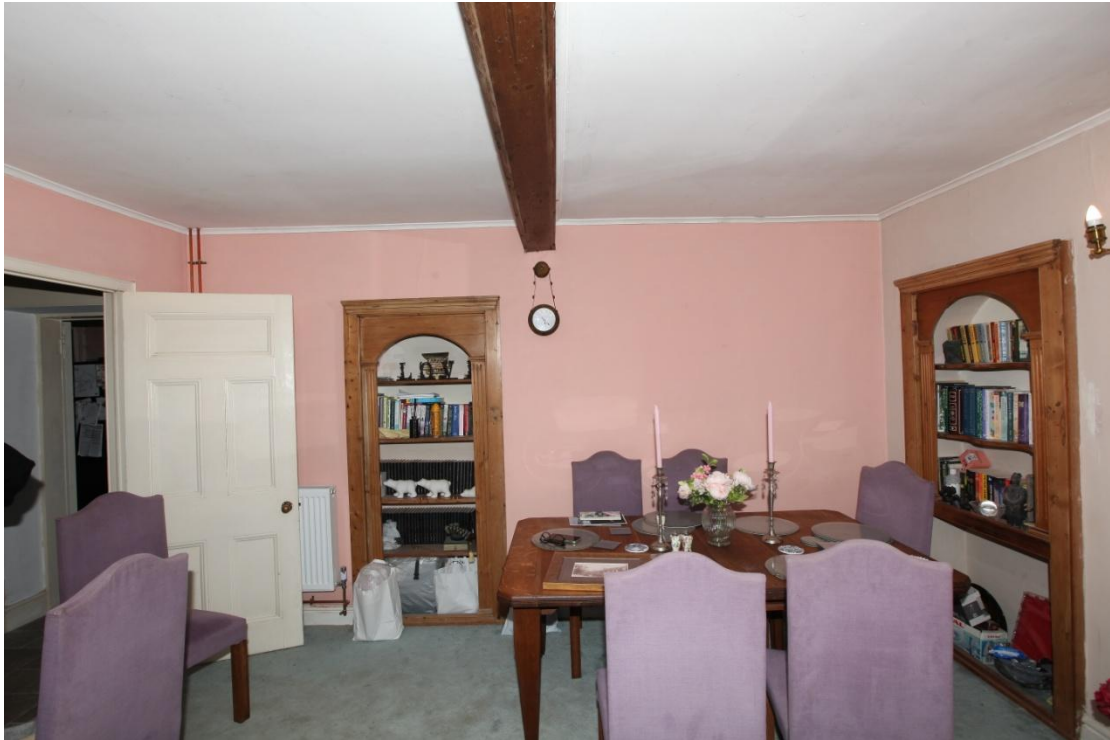
**Illus. 17. The rear wall of the dining room showing the arched shelves of stripped pine that were probably installed by the previous owner. The timber is a mixture of old and new, and contains anomalies such as fittings for door hinges. The left-hand unit penetrates the brick wall and may have formed a doorway previously.**

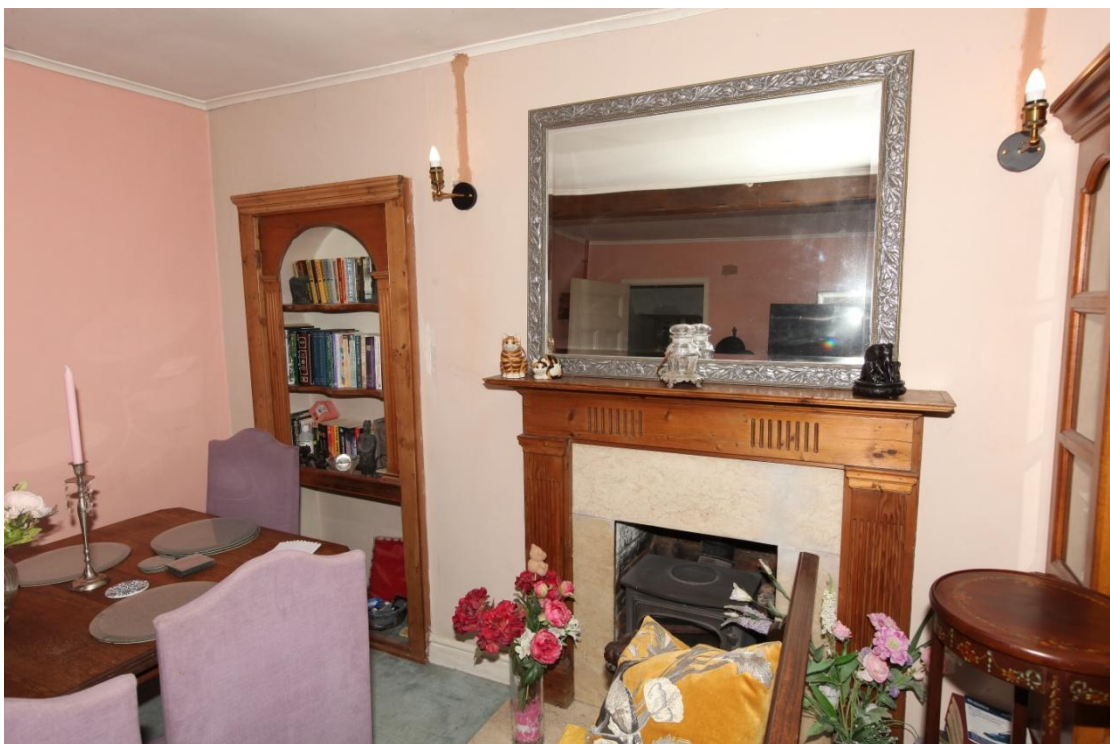
**Illus. 18. The early-19<sup>th</sup> century-style fire surround in the northern gable of the dining room. Like the shelf units this consists of at least two types of timber and is likely to have been installed by the previous owner who worked as a furniture restorer.**

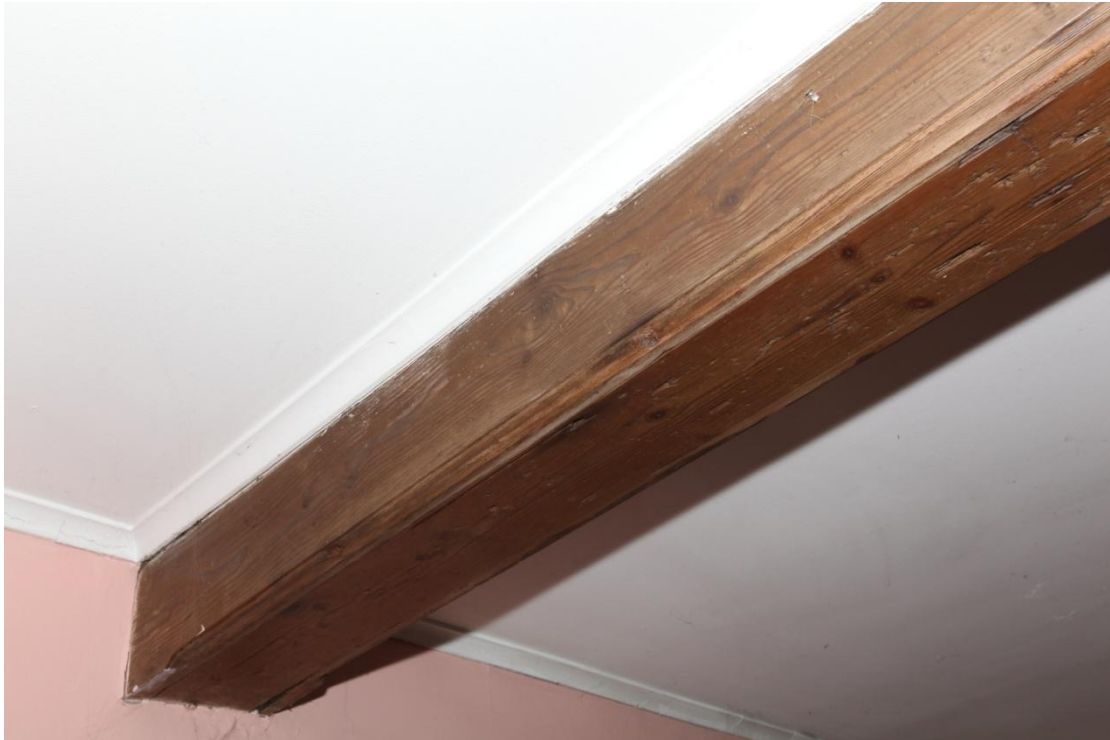
**Illus. 19.** A detail of the binding joist in the dining room (illustration 18), which is hidden by chamfered pine boards. These timbers are of some age, with chamfers that respect the width of the building, and may be original to the structure.

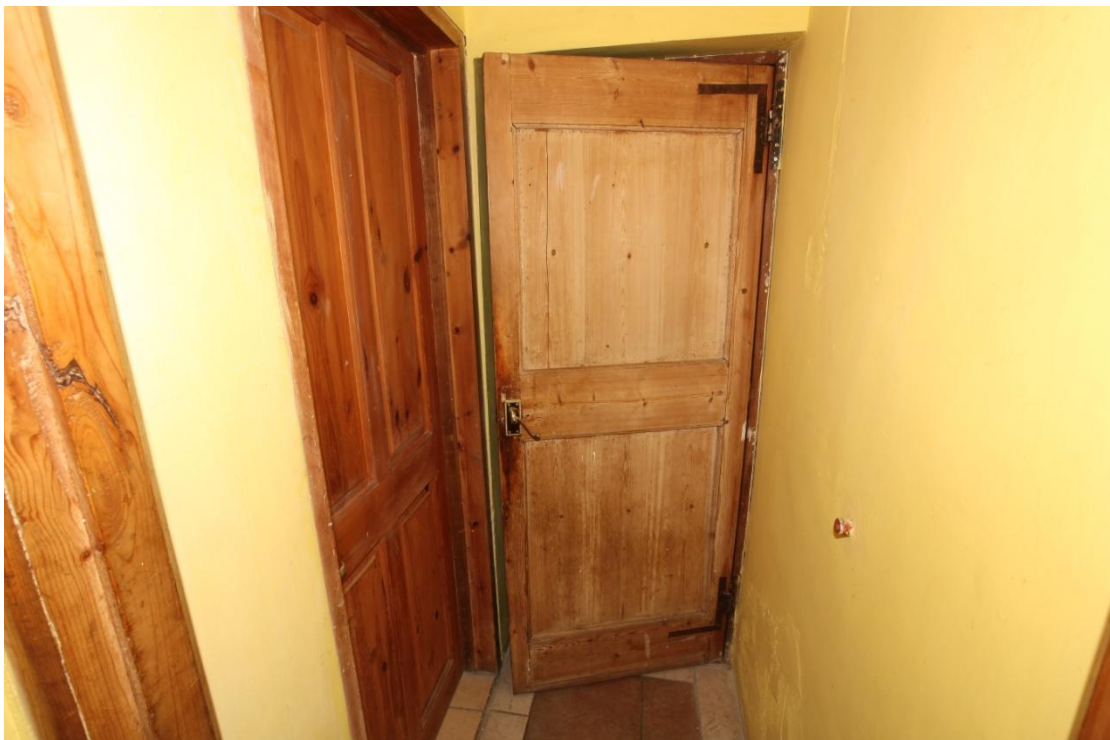
**Illus. 20.** The lean-to behind the sitting room contains a number of ostensibly early-19<sup>th</sup> century pine doors with HL hinges that may be contemporary with the house, although, as elsewhere, some features are clearly later and it is unclear to what extent material has been imported. The kitchen in the two-storied extension is entirely modern.

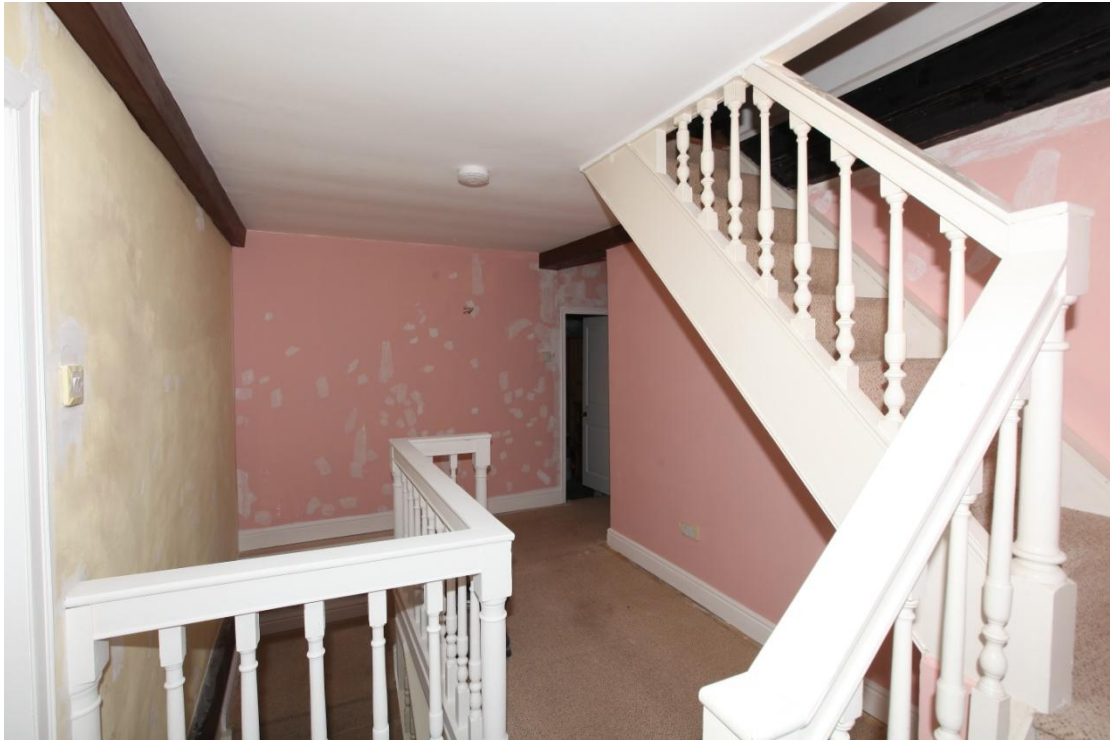
**Illus. 21.** The stair landing from the east, with the attic stair on the right. As elsewhere in the building, the few exposed structural timbers consist of pine in a manner that only became the norm at the end of the 18<sup>th</sup> century. The staircase has been much altered but may retain some old elements and is in keeping with the character of the facade.

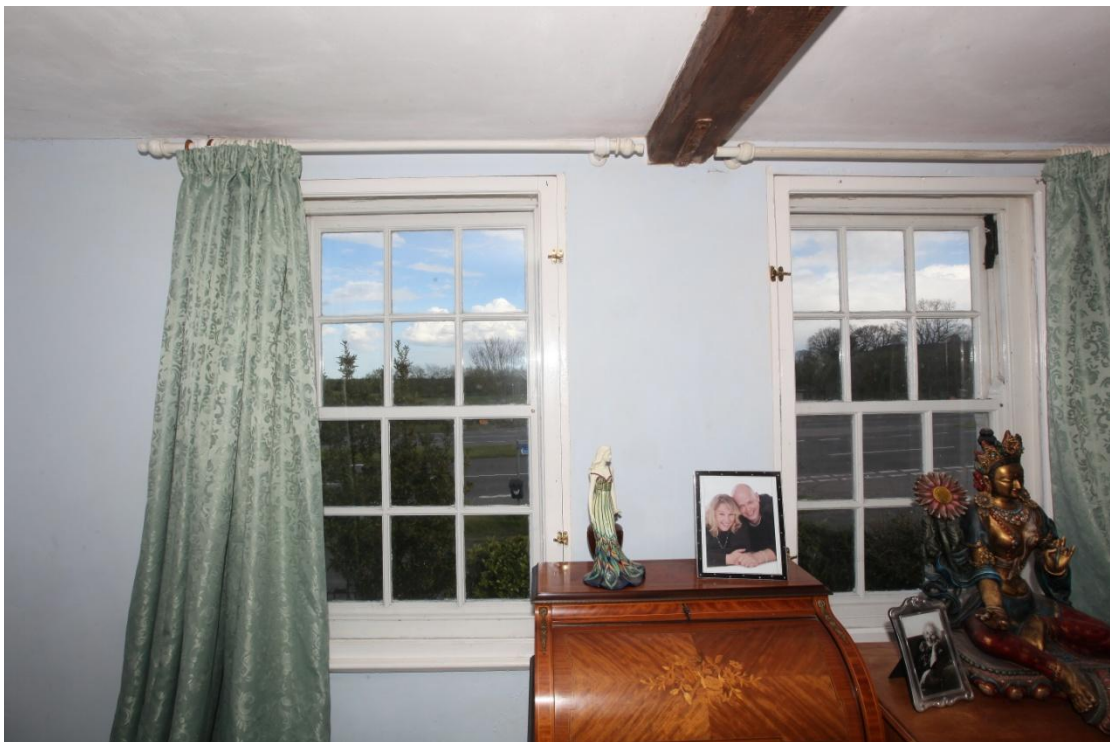
**Illus. 22.** The 20<sup>th</sup> century windows in the front wall of bedroom 1. As in the sitting room beneath, there is no obvious evidence of the partition that might have been expected given the crowded nature of the blacksmith's cottage in the 19<sup>th</sup> century.

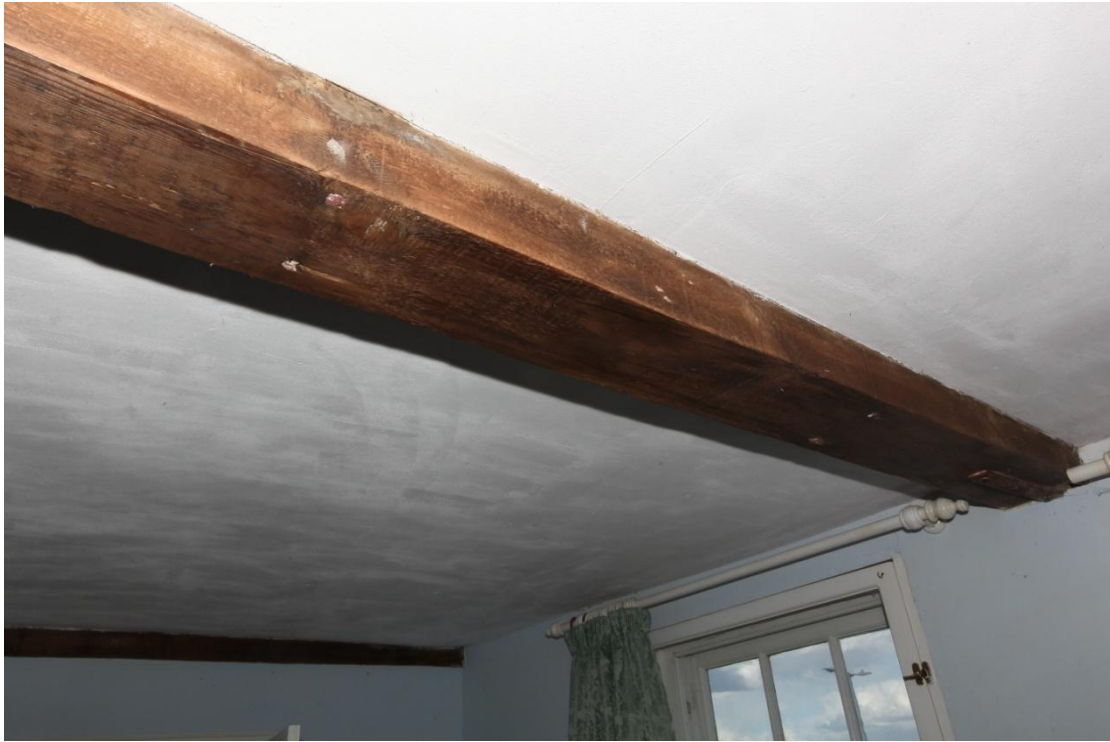
**Illus. 23.** A detail of the pine binding joist of bedroom 1, which contains vertical pegs and scored lines for the concealed common joists above. The unusually plain nature of this timber suggests it was concealed by moulded planks like those which survive elsewhere in the house.

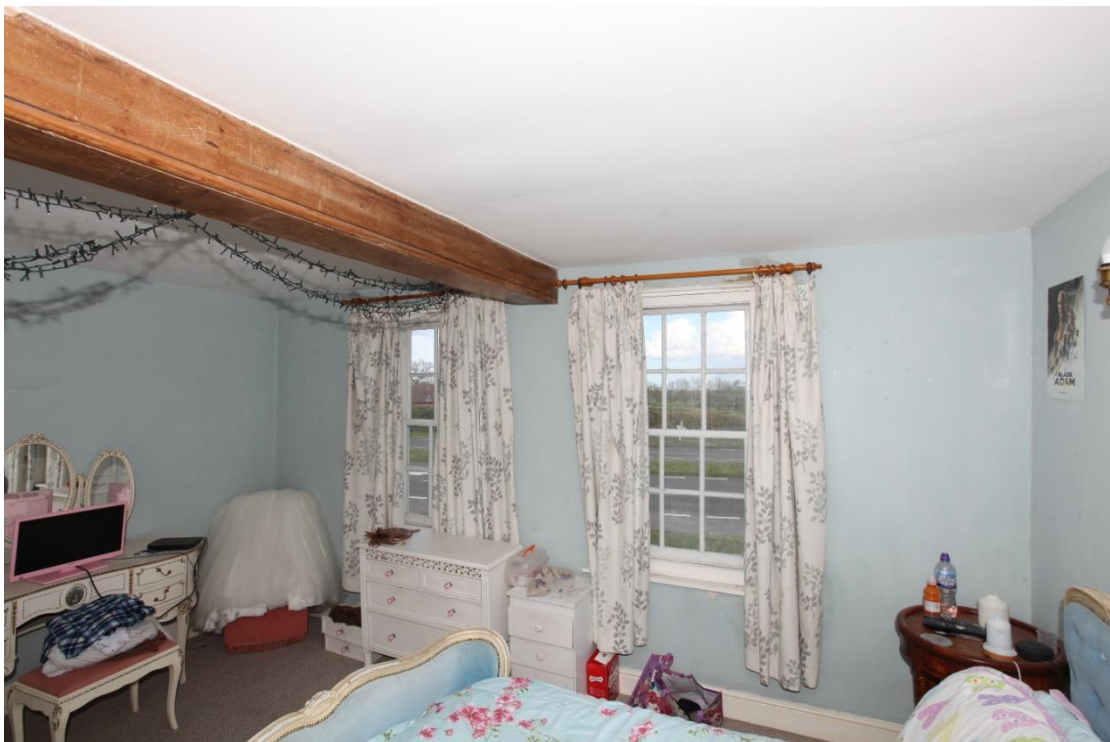
**Illus. 24.** The front wall of bedroom 2, which is divided from the rear corridor by a late-20<sup>th</sup> century partition. The binding joist on the left retains what may be its original moulded pine boards.

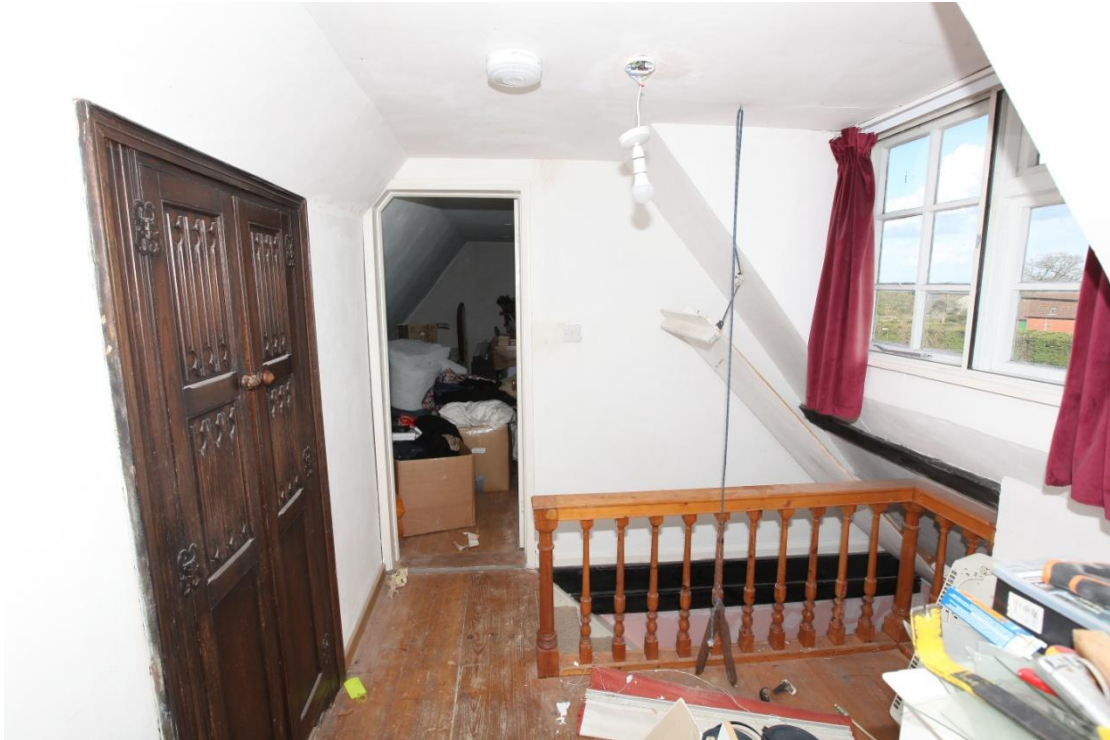
**Illus. 25.** The modern stained pine stair balustrade on the attic landing, with a built-in ‘Old Charm’ mid-20<sup>th</sup> century cupboard door on the left. The structure is largely hidden at this level by the plasterboard of a late-20<sup>th</sup> century refurbishment, but the original rafters are visible above the ceiling (illustration 26). The horizontal timber beneath the window may represent an original butt-purlin.

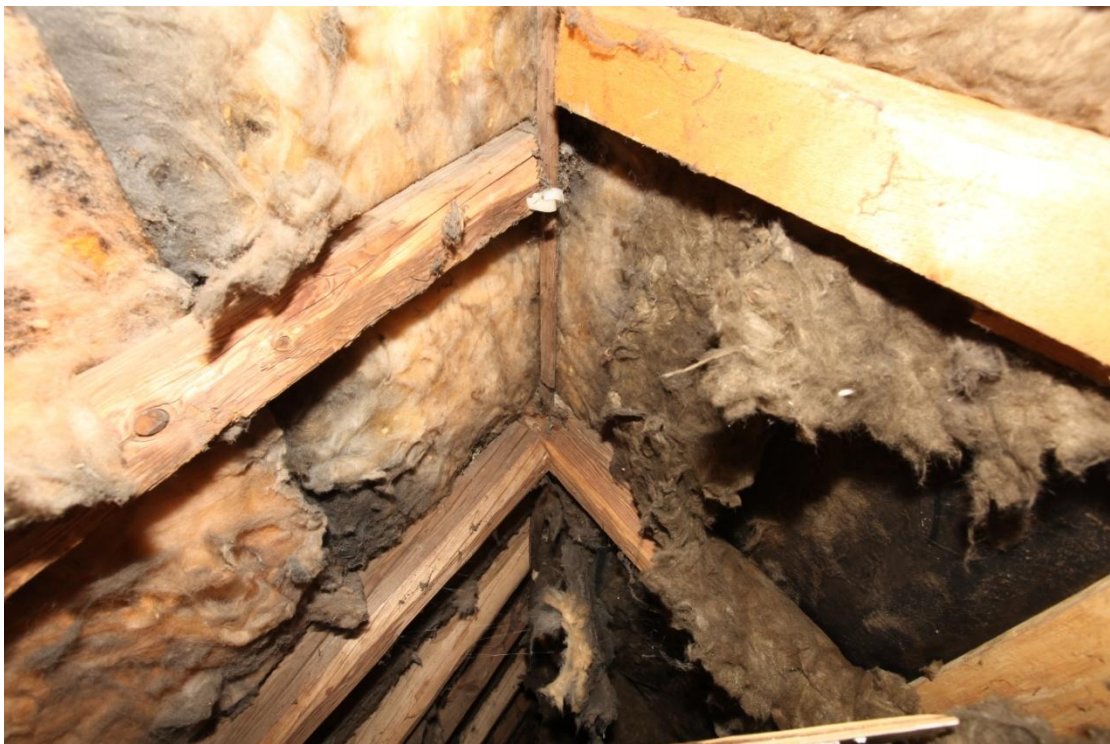
**Illus. 26.** The apex of the roof structure showing its pine rafters nailed to an ostensibly original ridge-board interrupted by a principal truss in the centre. The larger principal rafters are secured by a peg. The use of pine and a ridge board in this way is unlikely to pre-date the end of the 18<sup>th</sup> century and is more typical of the early-19<sup>th</sup> century.
