Bay tree at 3 Lansdowne Avenue, Winchester

Tree Condition Assessment

Report reference number: **TCA-KC/3LANSDOWNE/002**

Report date: **November 2023**

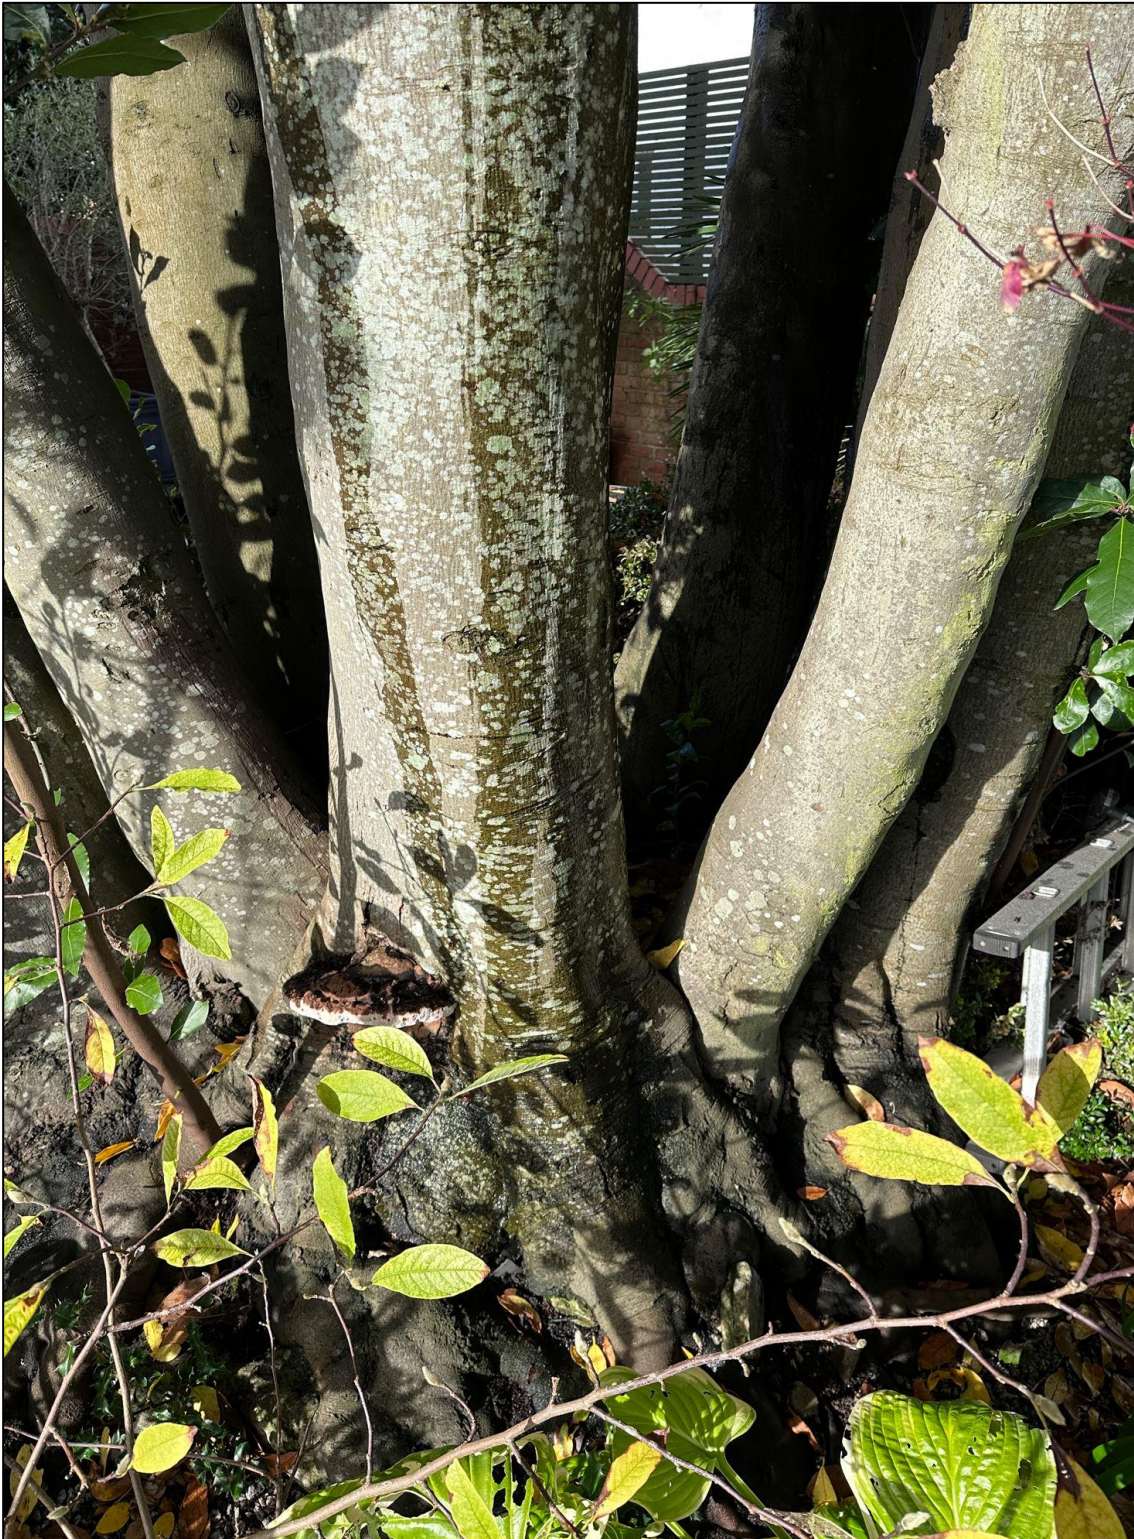
- 27 I detail noteworthy biomechanical and structural defects in full at the tree schedule (appendix one). Most notable is the presence of fungal fruiting bodies of *Ganoderma applanatum/adspersum* at multiple locations around the stem base. The fungus is described as causing root and butt rot in broadleaf trees when in advance stages³. During my survey and report in 2020 I did not observe any fungal fruiting bodies in the locations where they now appear to proliferate.

Photo one - *Ganoderma spp.* to base of tree

- 32 I recommend the tree is felled and replaced with two new trees. The work will require consent from the local planning authority.
- 33 All permitted or approved tree work must be carried out in accordance with *British Standard 3998:2010 Recommendations for tree work*. Work should be carried out by suitably qualified and experienced professional arborists with appropriate levels of public liability insurance.

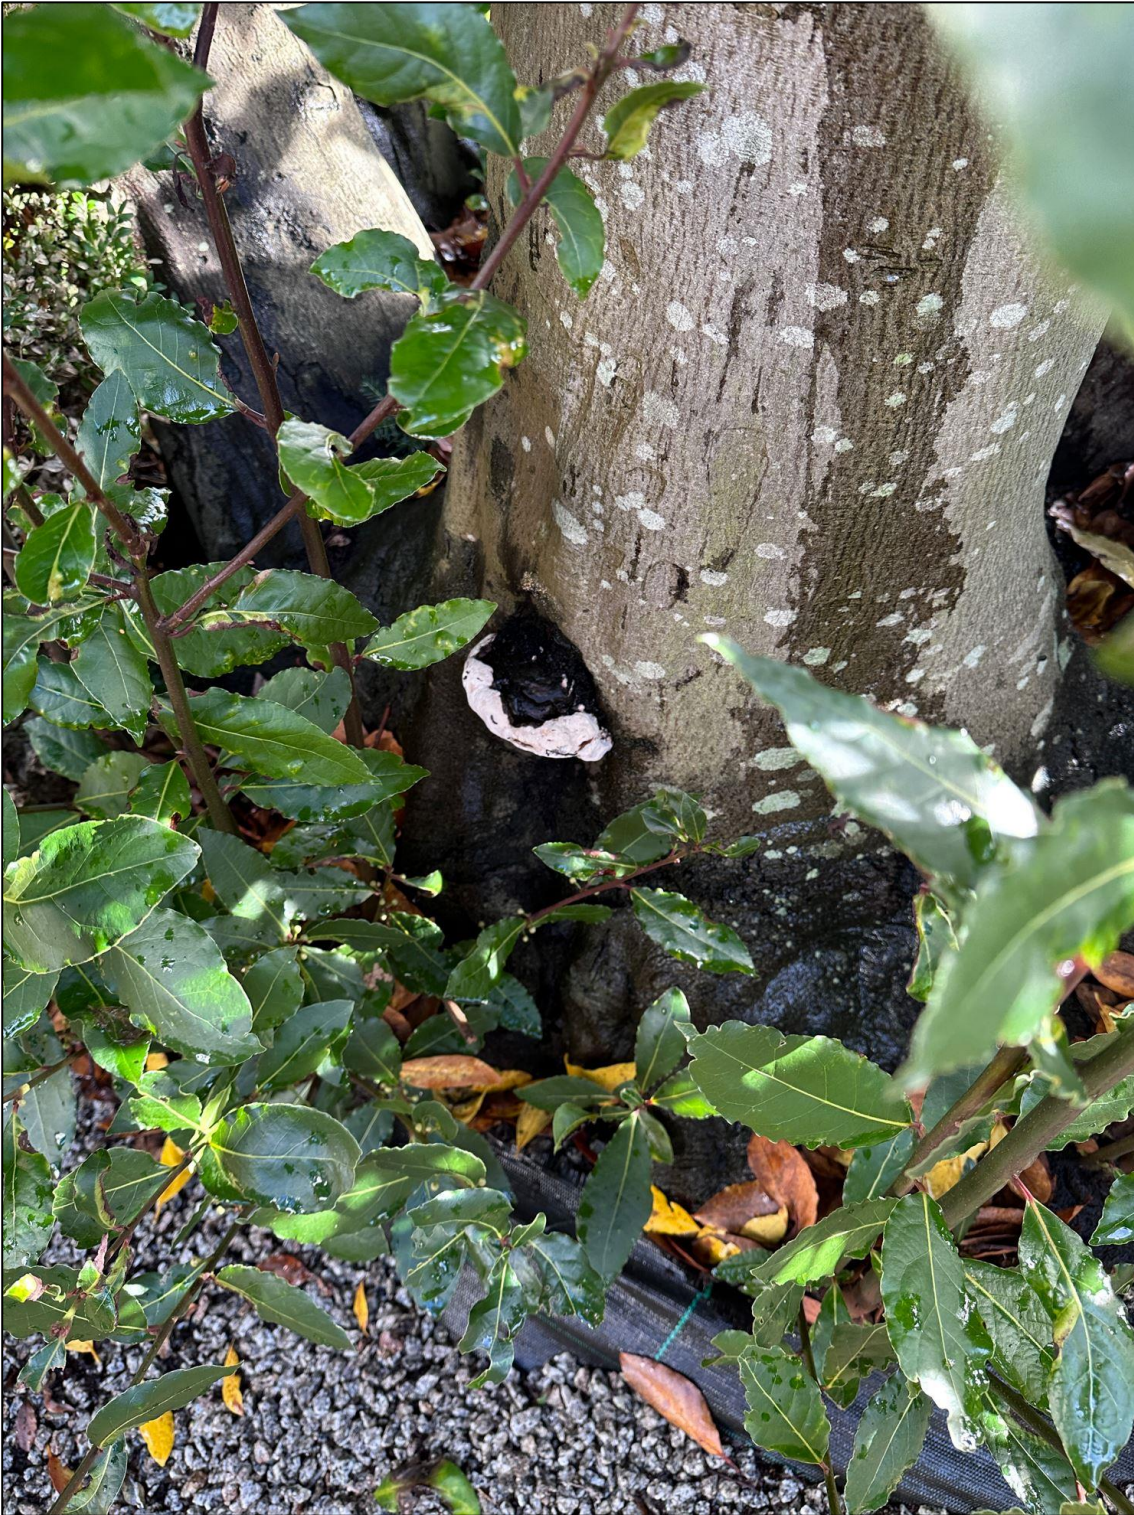
Photo two – *Ganoderma* spp. to base of tree location #2

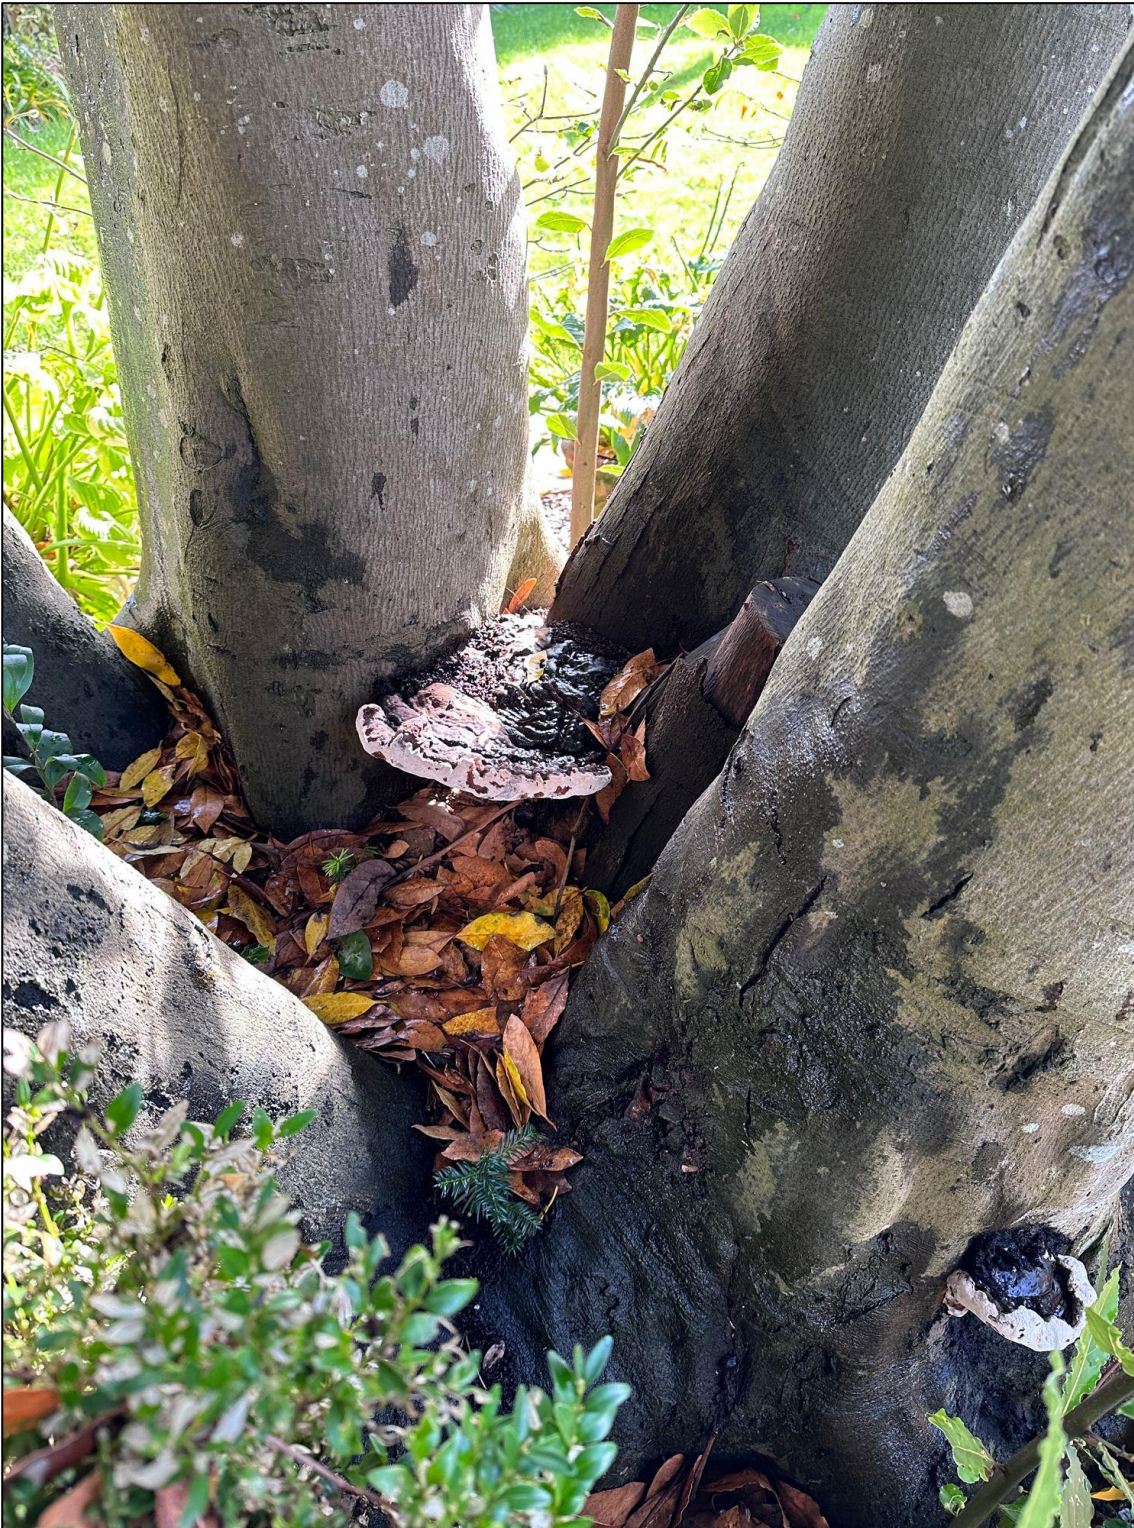
Photo three – *Ganoderma* spp. to internal base of tree.
