## Photographic Schedule of Condition

**Kings Buildings, 16 Smith Square, London, SW1P 3HQ**

October 2023

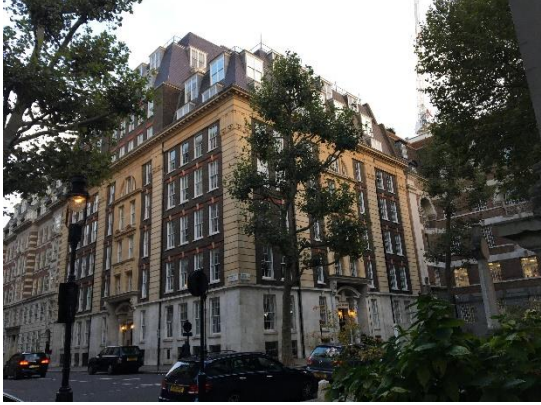
2.	Detail view of Smith Square

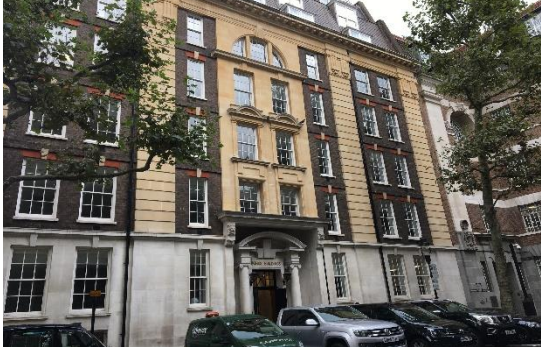
3.	Flank elevation on Dean Stanley Street

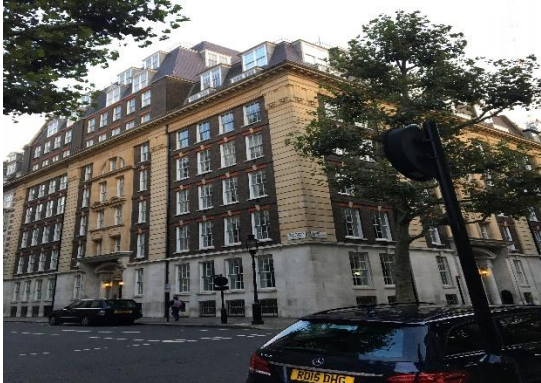
4.	Upper rear elevation as viewed from Noble House enclosed rear alleyway

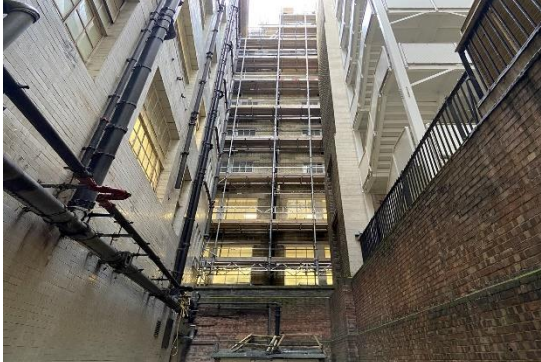
Photo No	Photograph Description	Photograph
5.	Drone view of Kings Buildings; street to the LHS is Dean Stanley Street. Atrium to the centre, and rear basement roof not visible

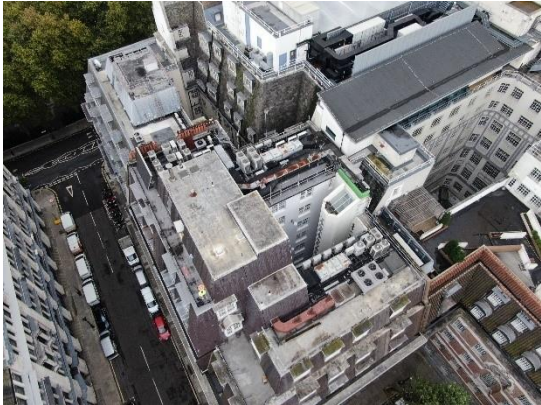
6.	View of the glazed roof over the rear basement, surrounded by the walls of adjacent Noble House. This is the roof to be removed and replaced by a leanto roof with 6 Velux rooflights, all below the rear parapet wall

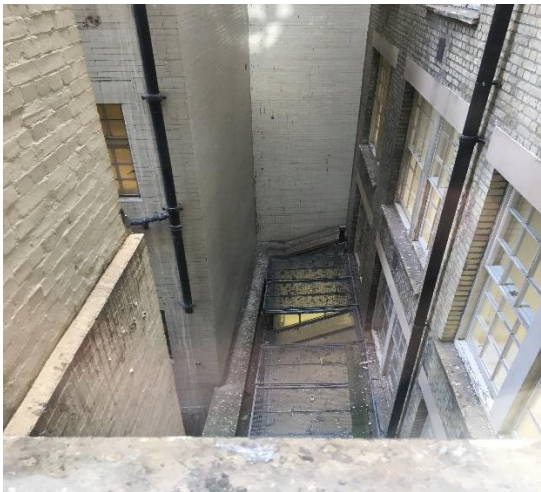
7.	View of the basement roof and the east facing alley way behind Noble House

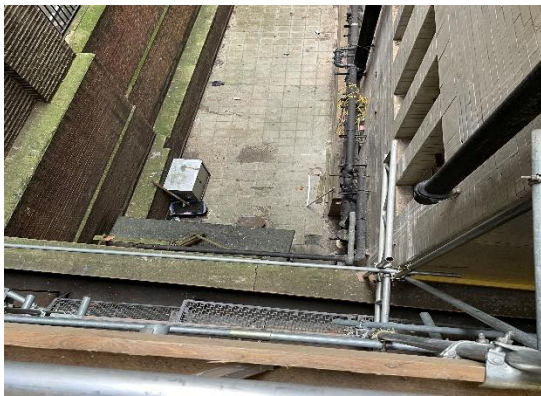
8.	Further view of the alleyway behind Noble House

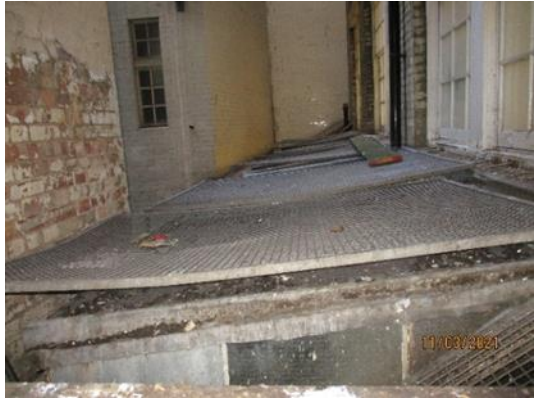
10.	Further view of the existing roof

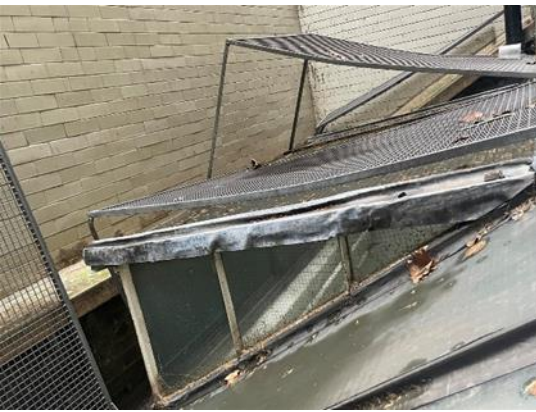
11.		
12.	From the interior, a general view of the single glazed steel framed windows and leaks causing poor decoration and mould internally.

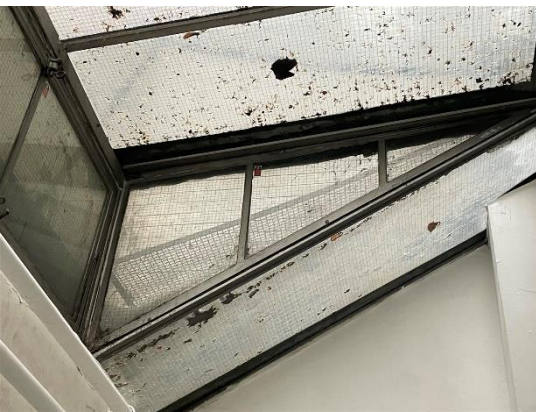
13.	Further internal view of the existing roof

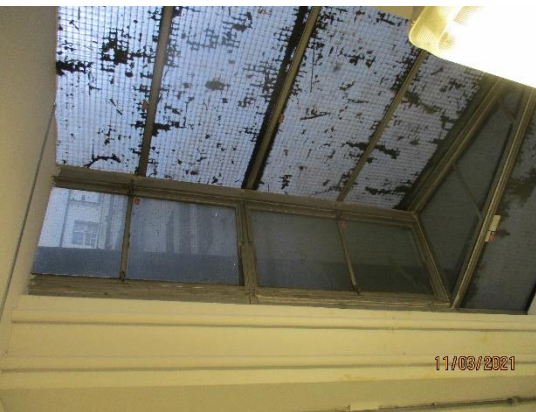
Photo No	Photograph Description	Photograph
14.	Asbestos identified within the basement rooflights.

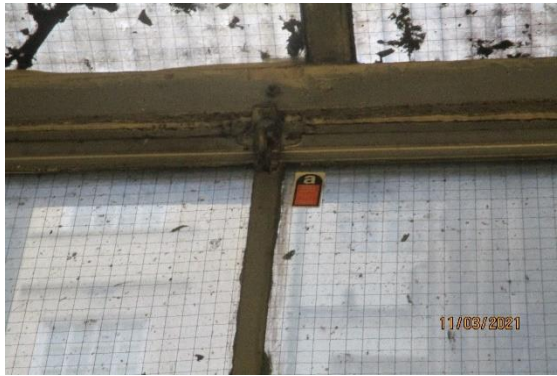
15.	Representative view of cracked glazing to the basement rooflights.

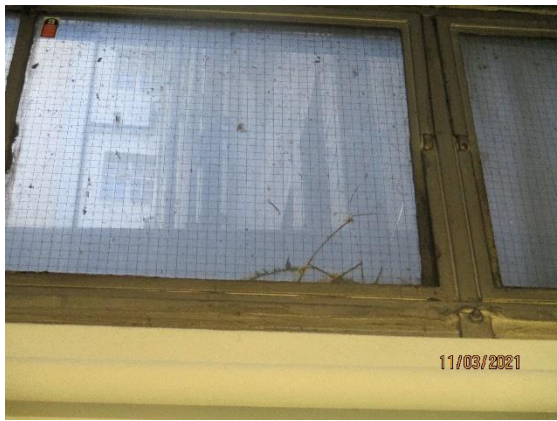
16.	General view of the basement roof

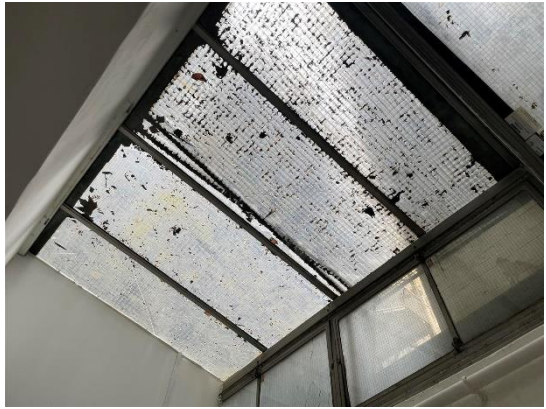
17.	Representative view of cracked glazing to the basement rooflights.

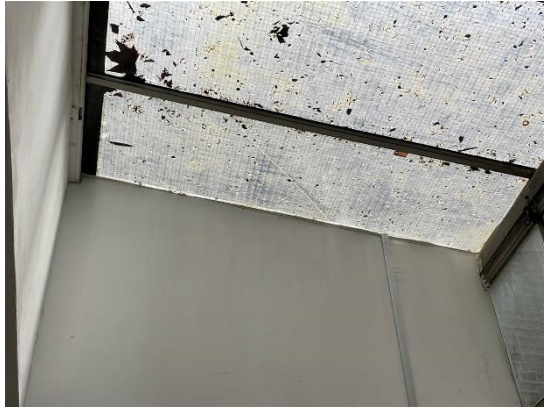
Photo No	Photograph Description	Photograph
18.	Representation of build-up of debris on glazing blocking the gutter behind the parapet wall causing water ingress and subsequent peeling of decoration and mould.

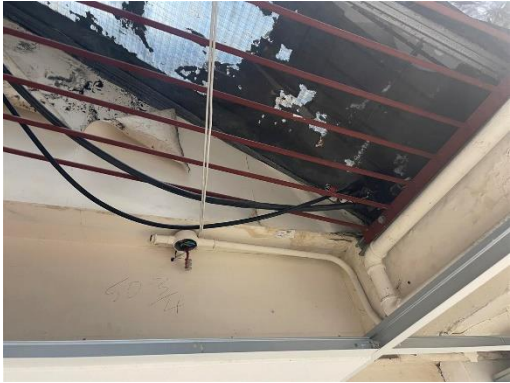
19.	Representation of build-up of debris on glazing blocking the gutter behind the parapet wall causing water ingress and subsequent peeling of decoration and mould.
