14th November 2023

Our Ref: B1408/NF/MNJ/REV A

RE: Structural Survey of Timber Conservatory, Sheepcombe House, Tockington, Bristol, BS32 4NZ

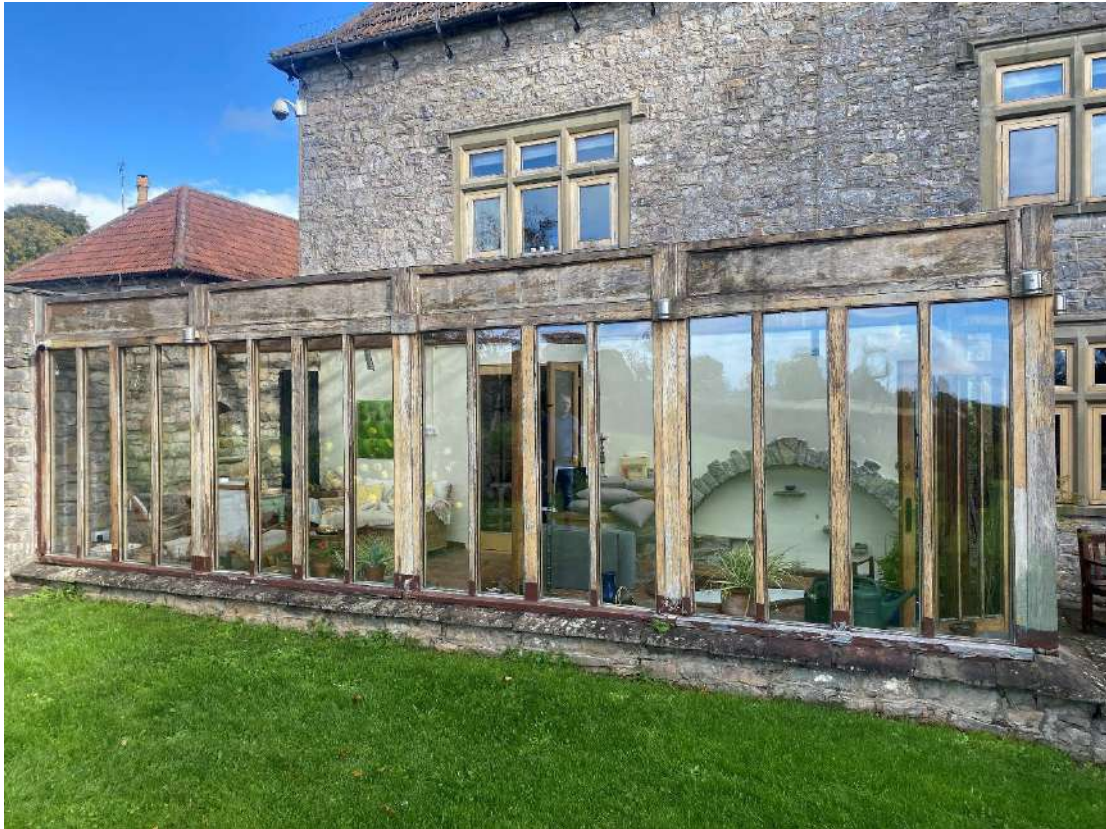
Photograph 1 – Conservatory to be surveyed

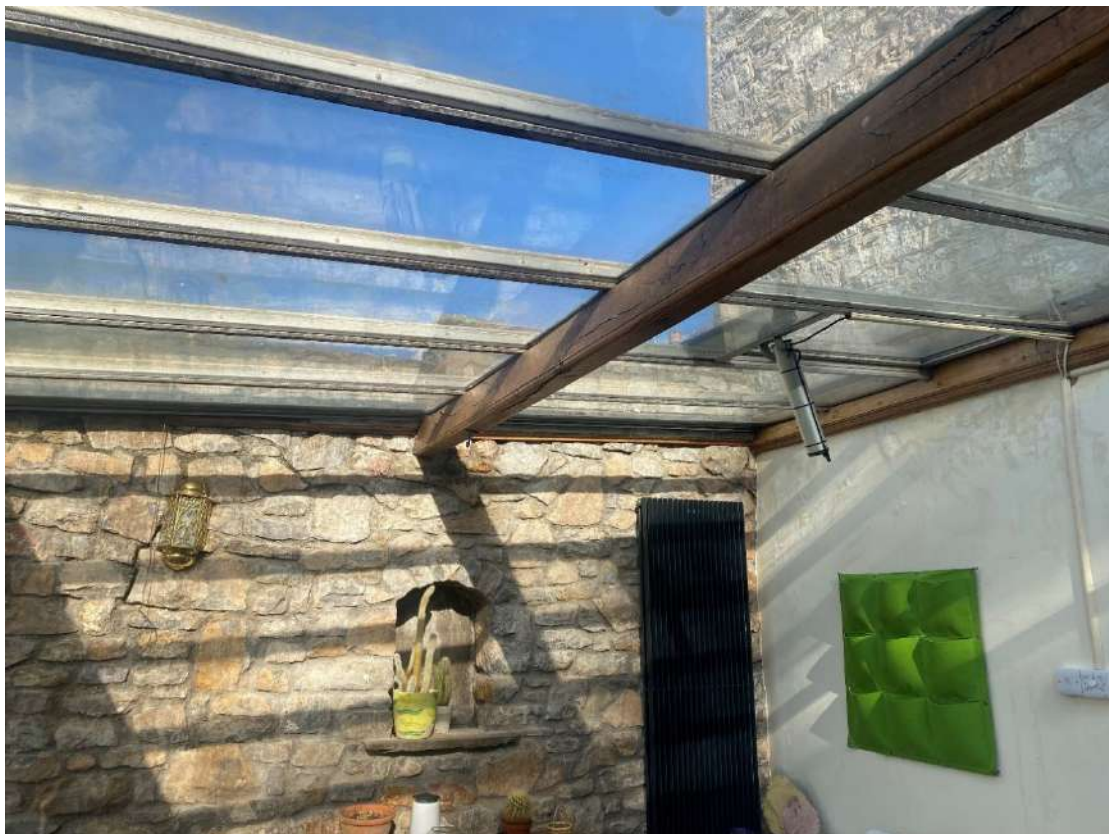
Water staining was present on the timber purlins indicating water ingress was present which will slowly deteriorate the structural integrity of the members over time. Stress cracks were present in each of the purlins however it cannot be confirmed at the time of the survey if these are historic or have formed in more recent years. Other areas of water ingress were present along the wall of the main property where the glass roof

Photograph 2 – Support purlins

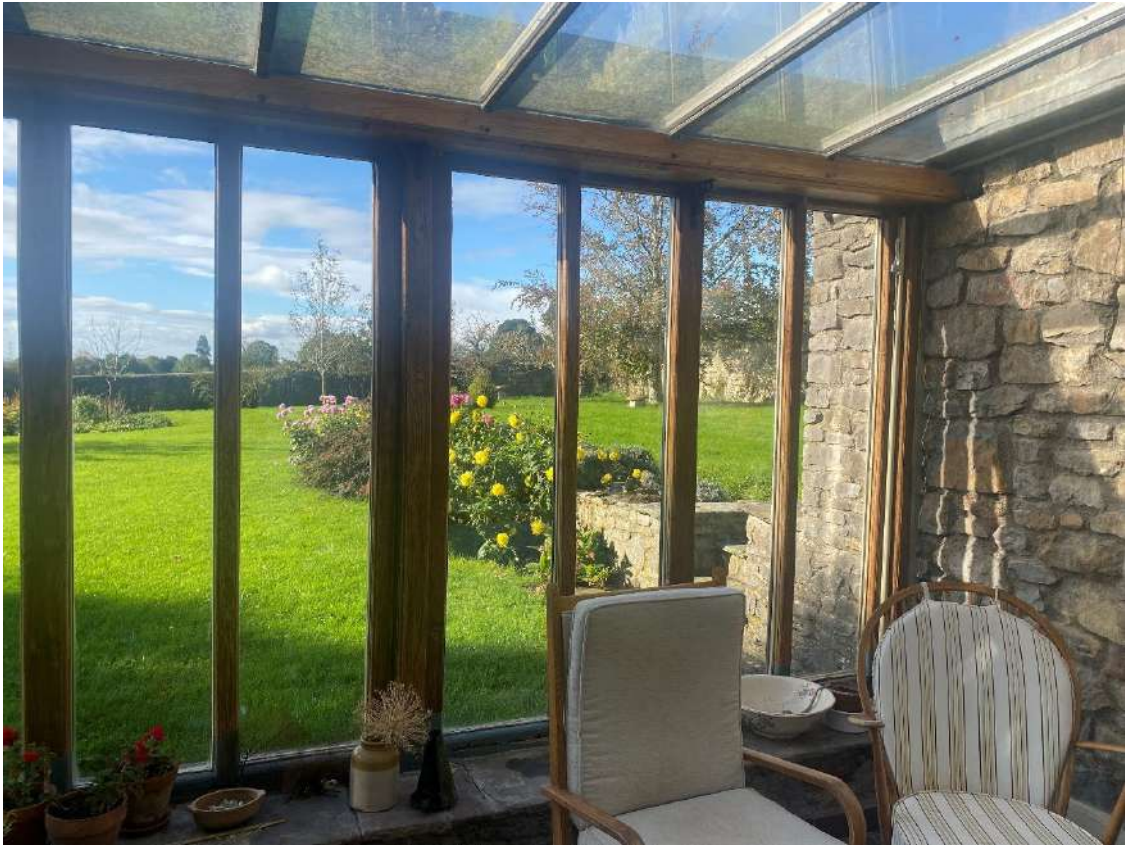
Photograph 3 – Timber posts between frames

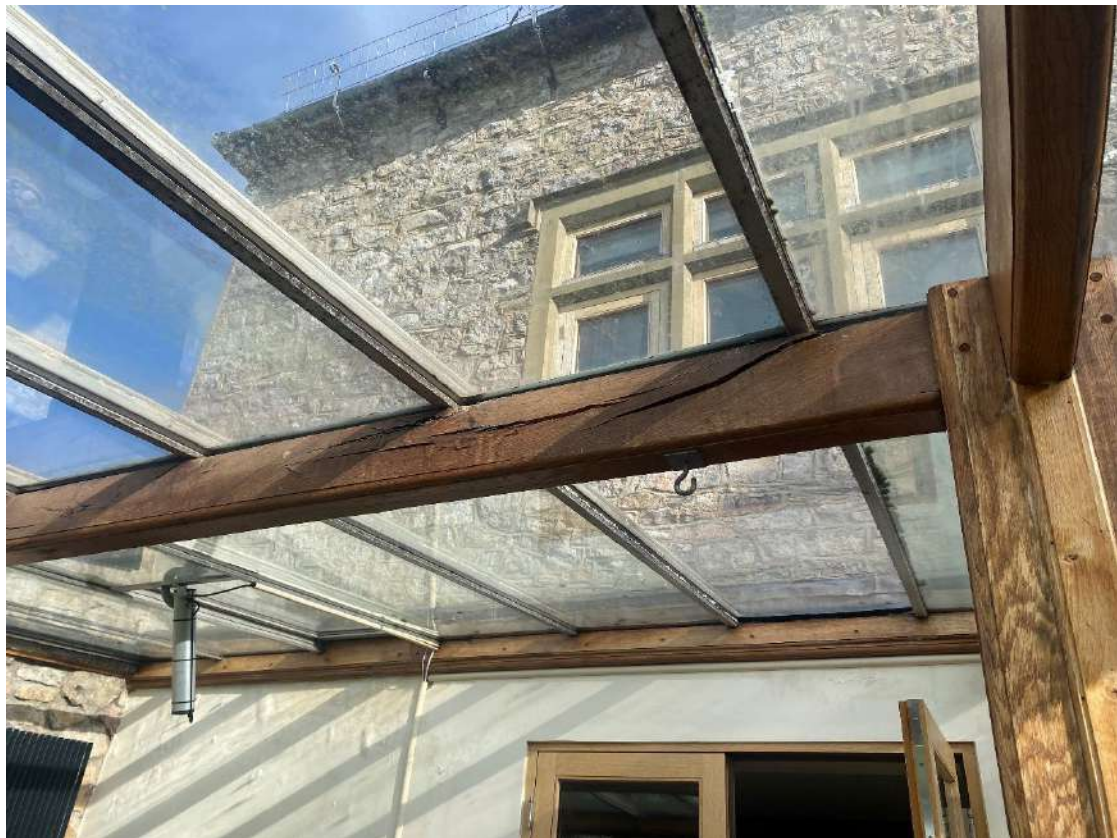
Photograph 4 – Purlins supported on post

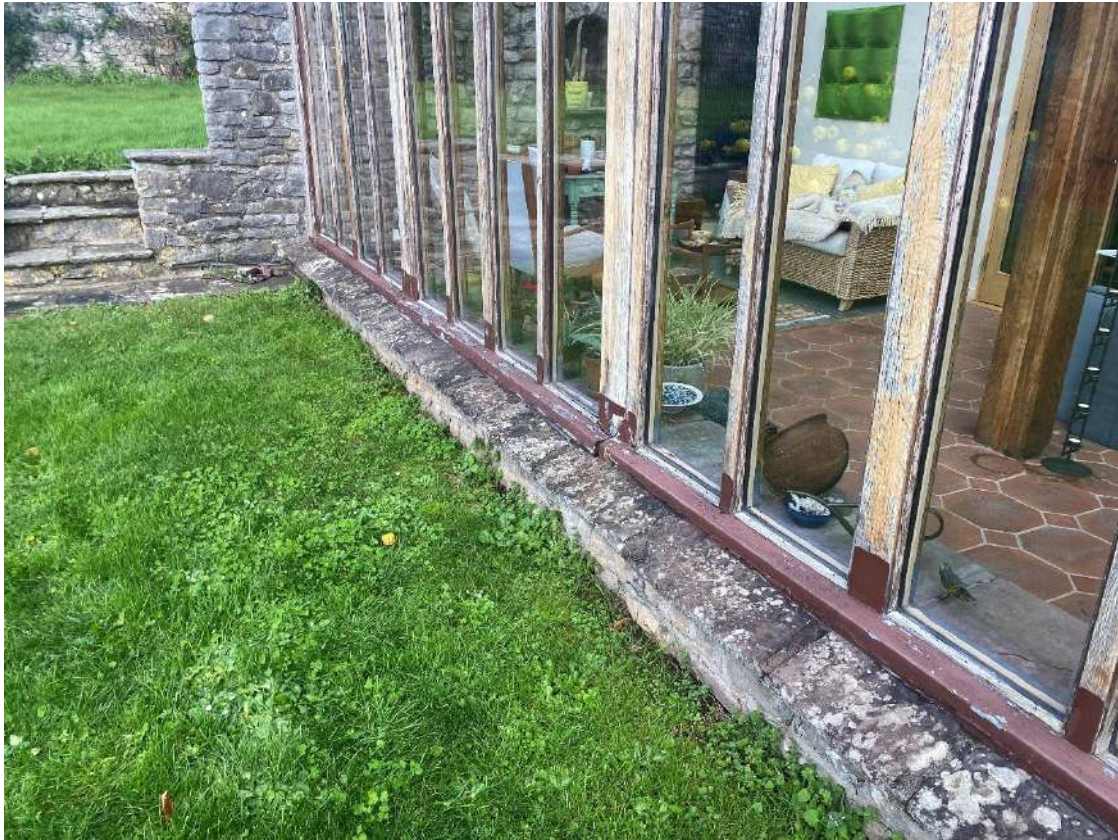
Photograph 5 – Dwarf wall

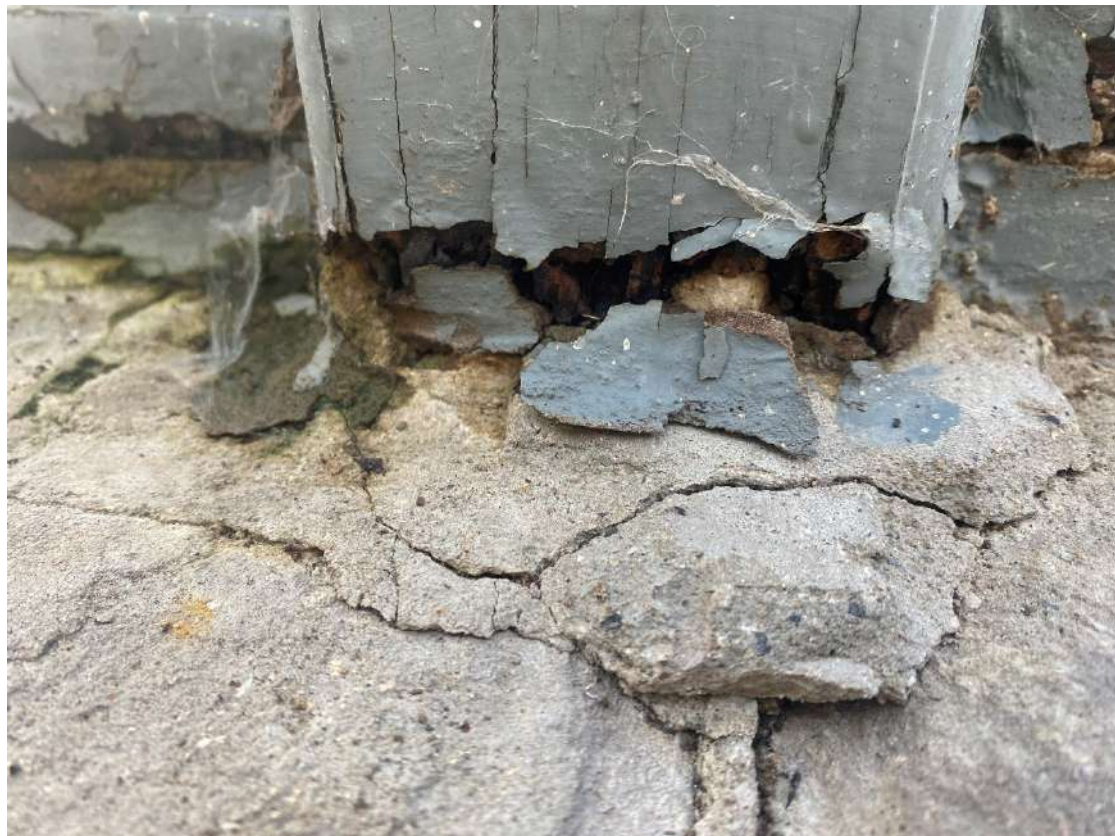
Rotting timber was present throughout the conservatory and was most obvious around the base of the timber frame supporting the glazed elevations. The base of the timber posts which supports the timber header showed signs of serious deterioration on both the internal and external zone which has been caused by damp, water ingress and lack of maintenance over time (see photographs 6-9). The base of the timber frames were rotting with some sections of frame almost completely eroded (see photograph 10 and 11). The timber members are built directly on top of the dwarf stonework wall which has no protective barrier between the wall and the timber causing damp and condensation to accumulate.

Photograph 6 – Rotten timber at bottom of post

It is in our professional opinion that the main structural timber frame forming the conservatory has such deterioration that large areas of timberwork would need to be removed and replaced. Almost all of the timber posts supporting the glazed elevations show substantial erosion at their base causing their structural integrity to be hampered. The bottom sill of the timber window frames would also need to be completely removed and replaced. No major areas of decay could be found towards the top of the windows however water ingress was present in these areas which will eventually cause decay.

It is our professional opinion that due to the amount of rot present in the timbers the existing structure has come to the end of its lifespan. Assessing the amount of timber work which needs to be fully replaced it would be more financially viable to take down the existing timber structure and replace with a new structure formed in a material such as steelwork which will have a longer lifespan and will not be subject to the same forms of deterioration noted. This conclusion has been formed due to the amount of rotten timber present which is mainly located at the base of the frame meaning the removal and reinstating of new timbers would be complex and difficult to undertake without removing the whole glazed panel. The roof is also in need of a full replacement with areas of cracked glass, water leaking and the lead flashing having failed. We would recommend that this is replaced with a more environmentally and economically friendly design such as timber joists with suitable levels of insulation.

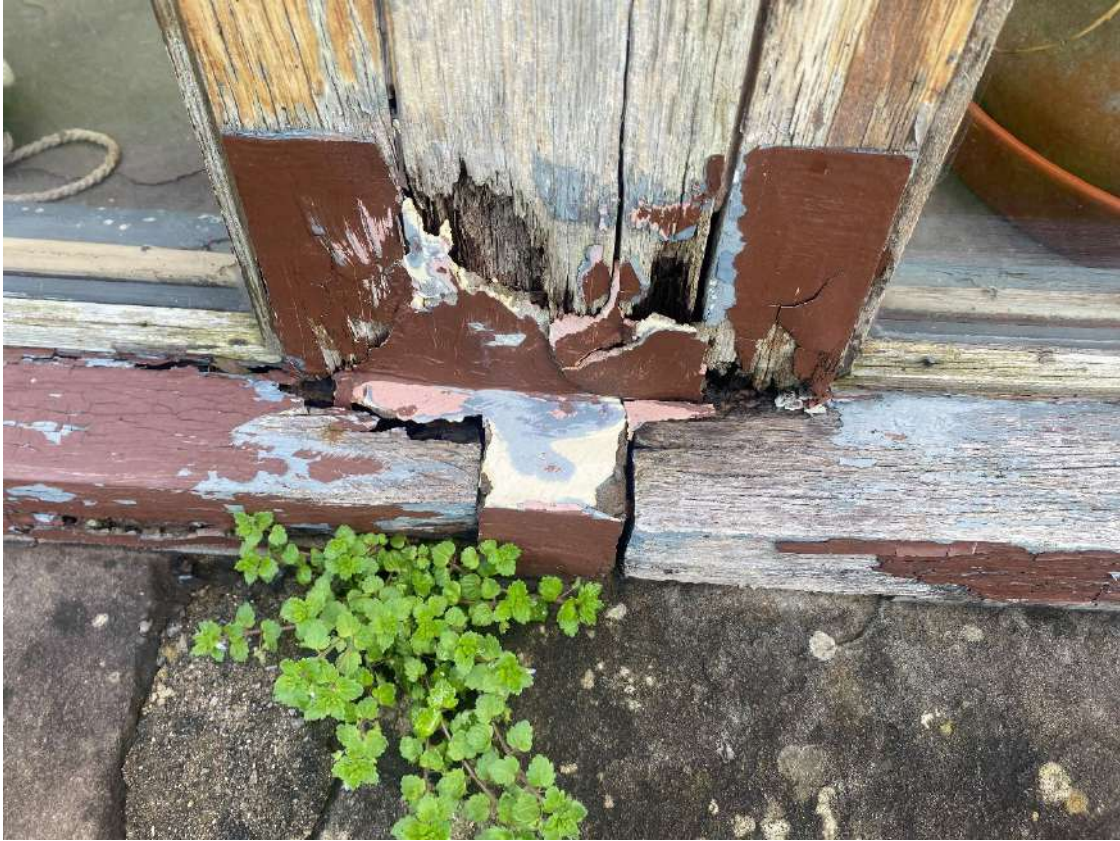
Photograph 7 – Rotten timber at bottom of post

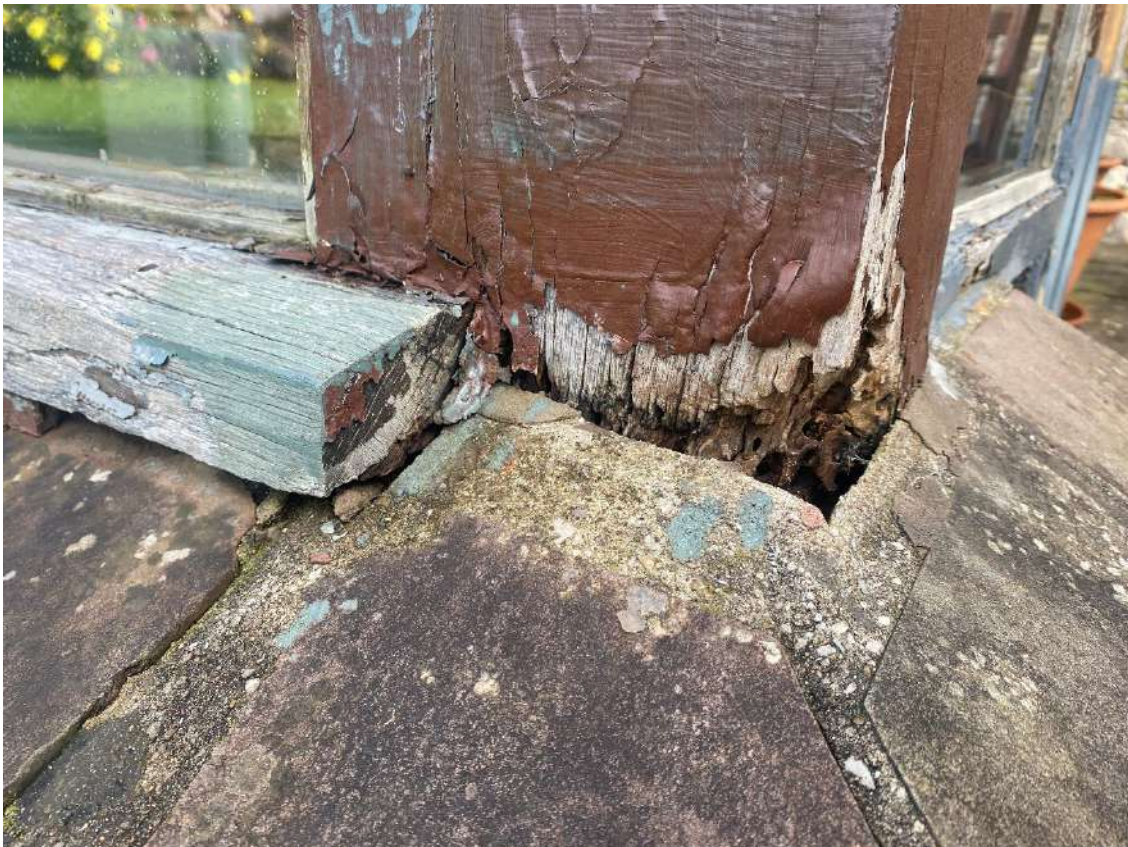
Photograph 8 – Rotten timber at bottom of post

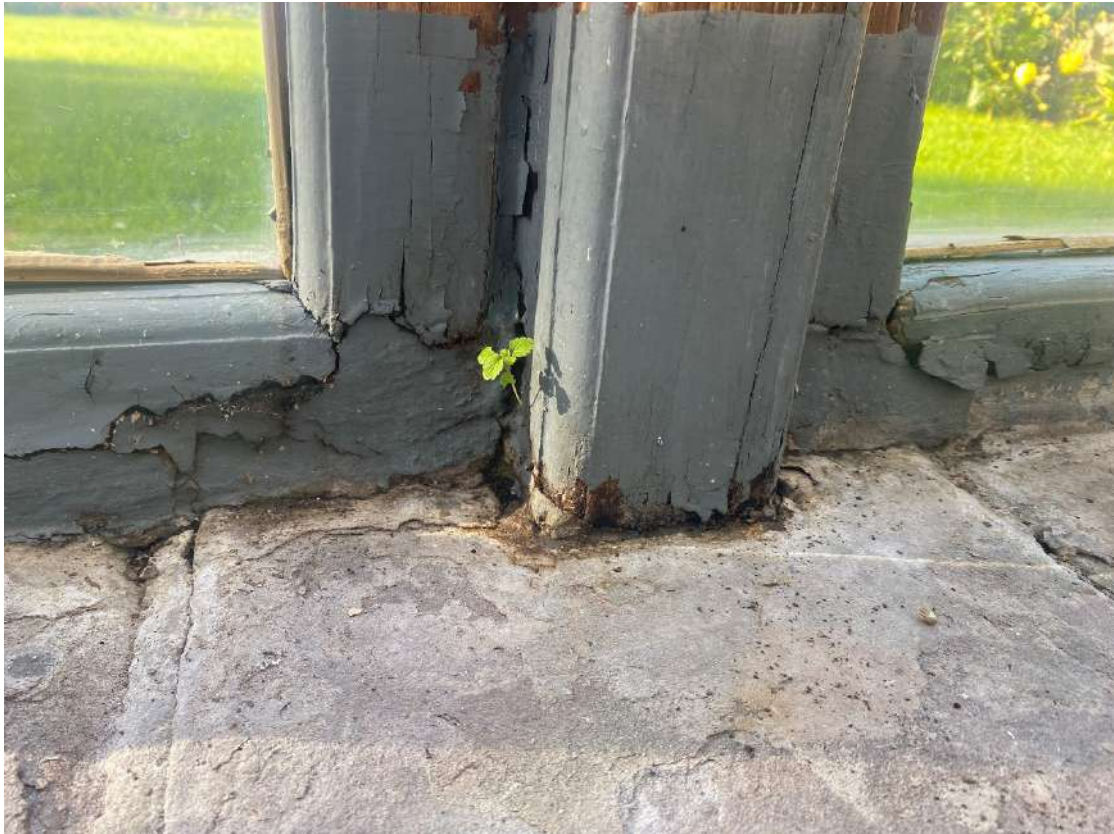
Photograph 9 – Rotten timber at bottom of post

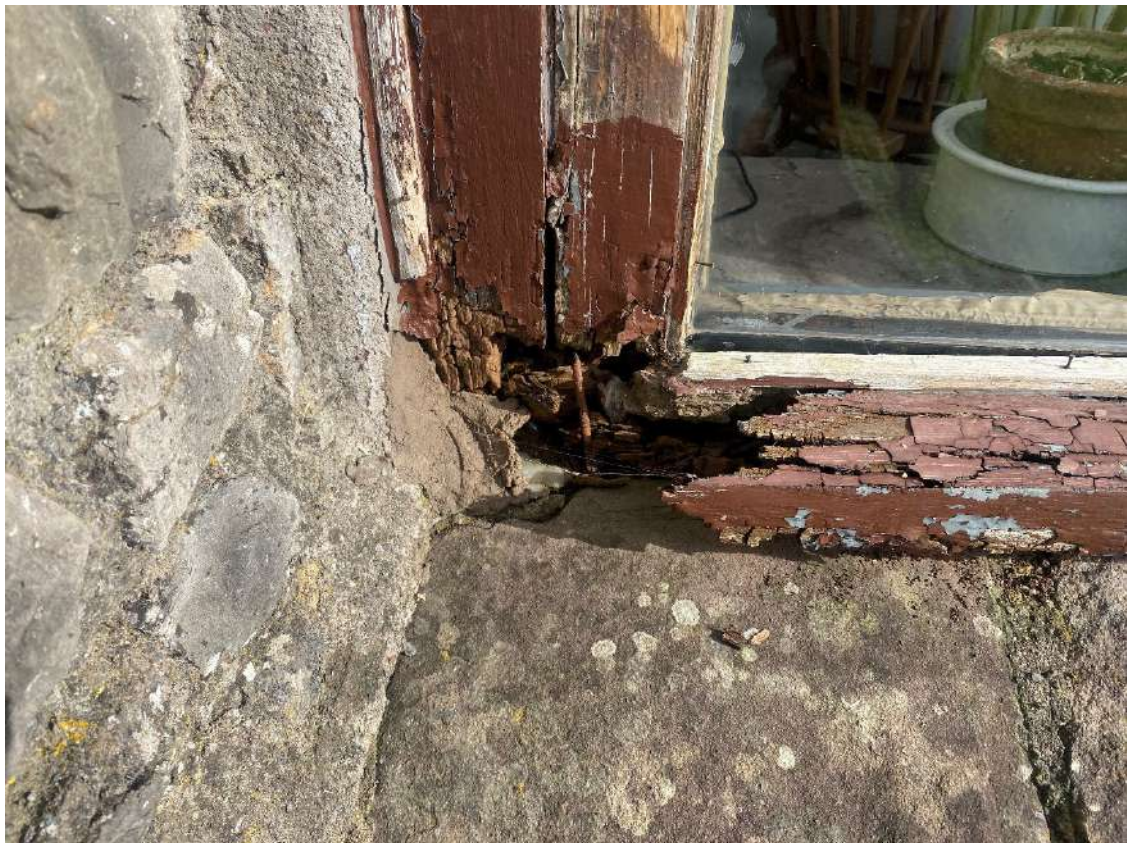
Photograph 10 – Rotten timber at base of frame

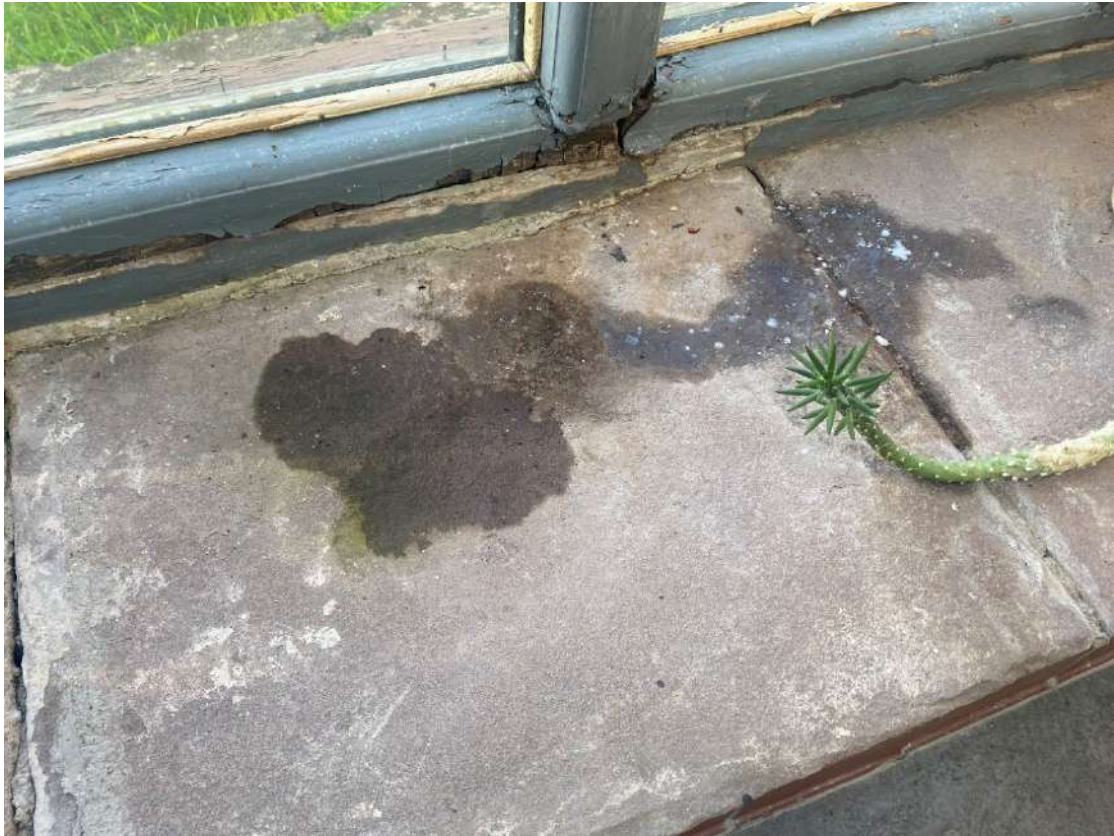
Photograph 11 – Rotten timbers and signs of water ingress

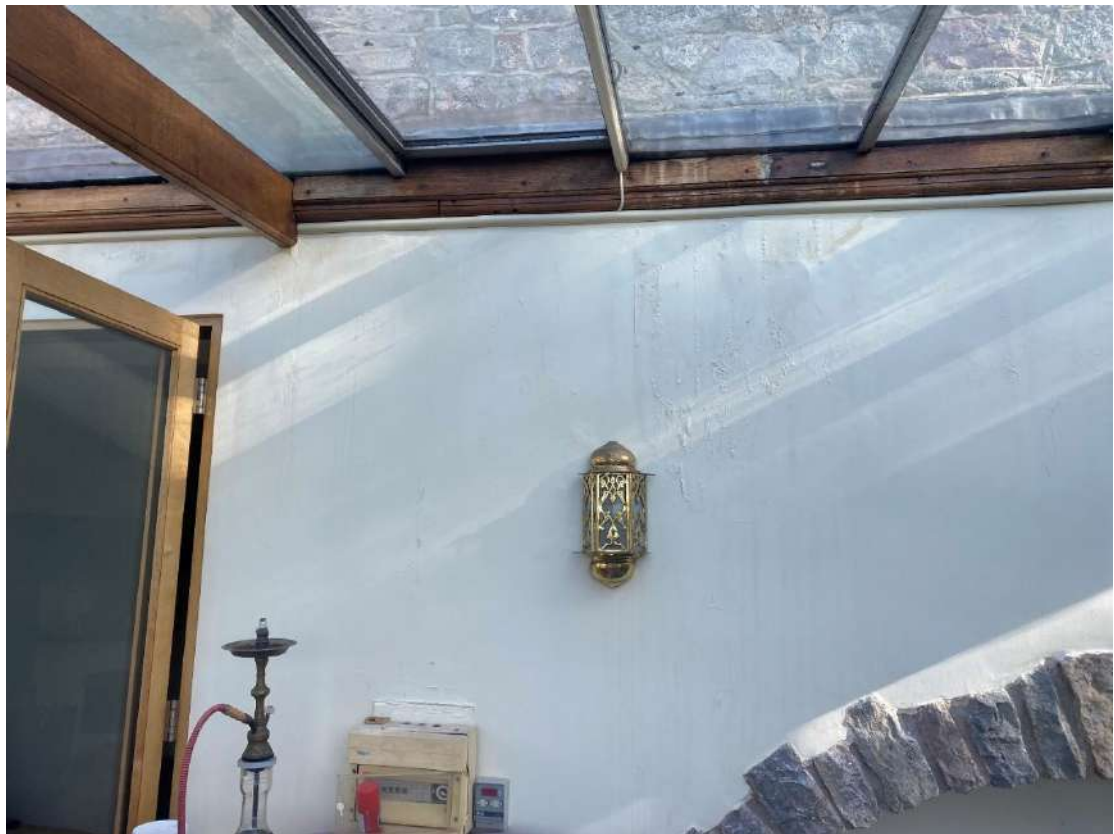
abuts (see photograph 12 and 13). Stained and flaking plaster showed large areas where water ingress and damp has penetrated.

The rear wall of the house which supports one side of the roof showed signs of water ingress across its length indicating the lead flashing has failed. Continuous damp penetration across this wall could cause degradation of the mortar between the stonework eventually leading to the structural integrity of the wall being affected.

Photograph 12 – Signs of damp present

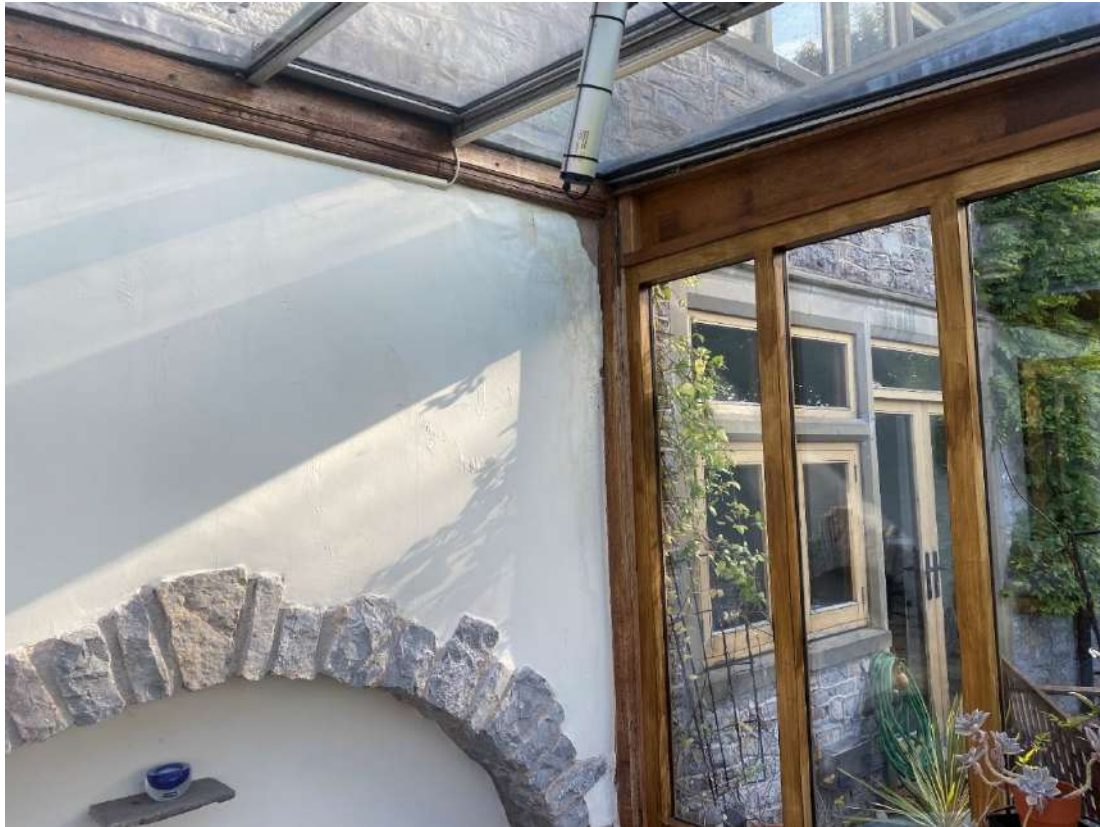
Photograph 13 – Signs of damp present

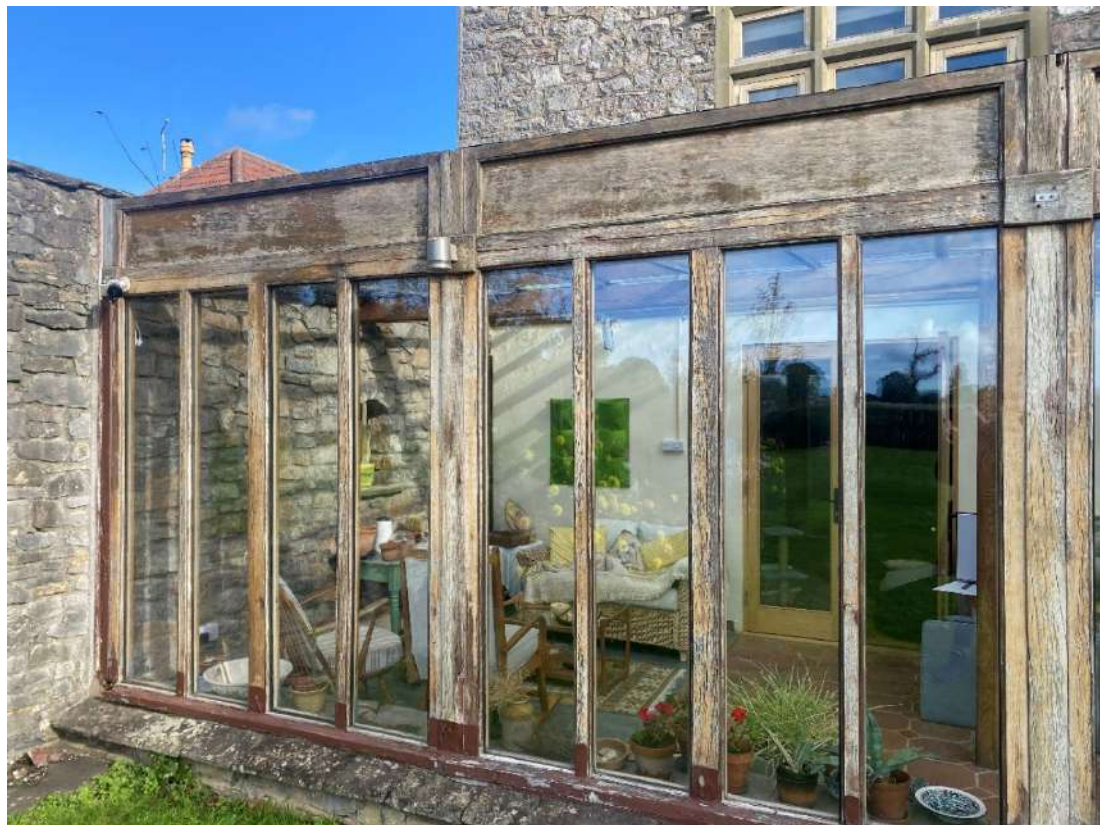
Externally differing stains on the timbers indicated the protective finish to the timber work had almost entirely eroded (see photograph 14) meaning no suitable protective layer is protecting the timbers from weathering.

Photograph 14 – Discoloration in timber shows protective layer diminished
