**Site Survey for Replacement Windows  
at**

**65 Wolsey Road  
Moor Park  
HA6 2ER**

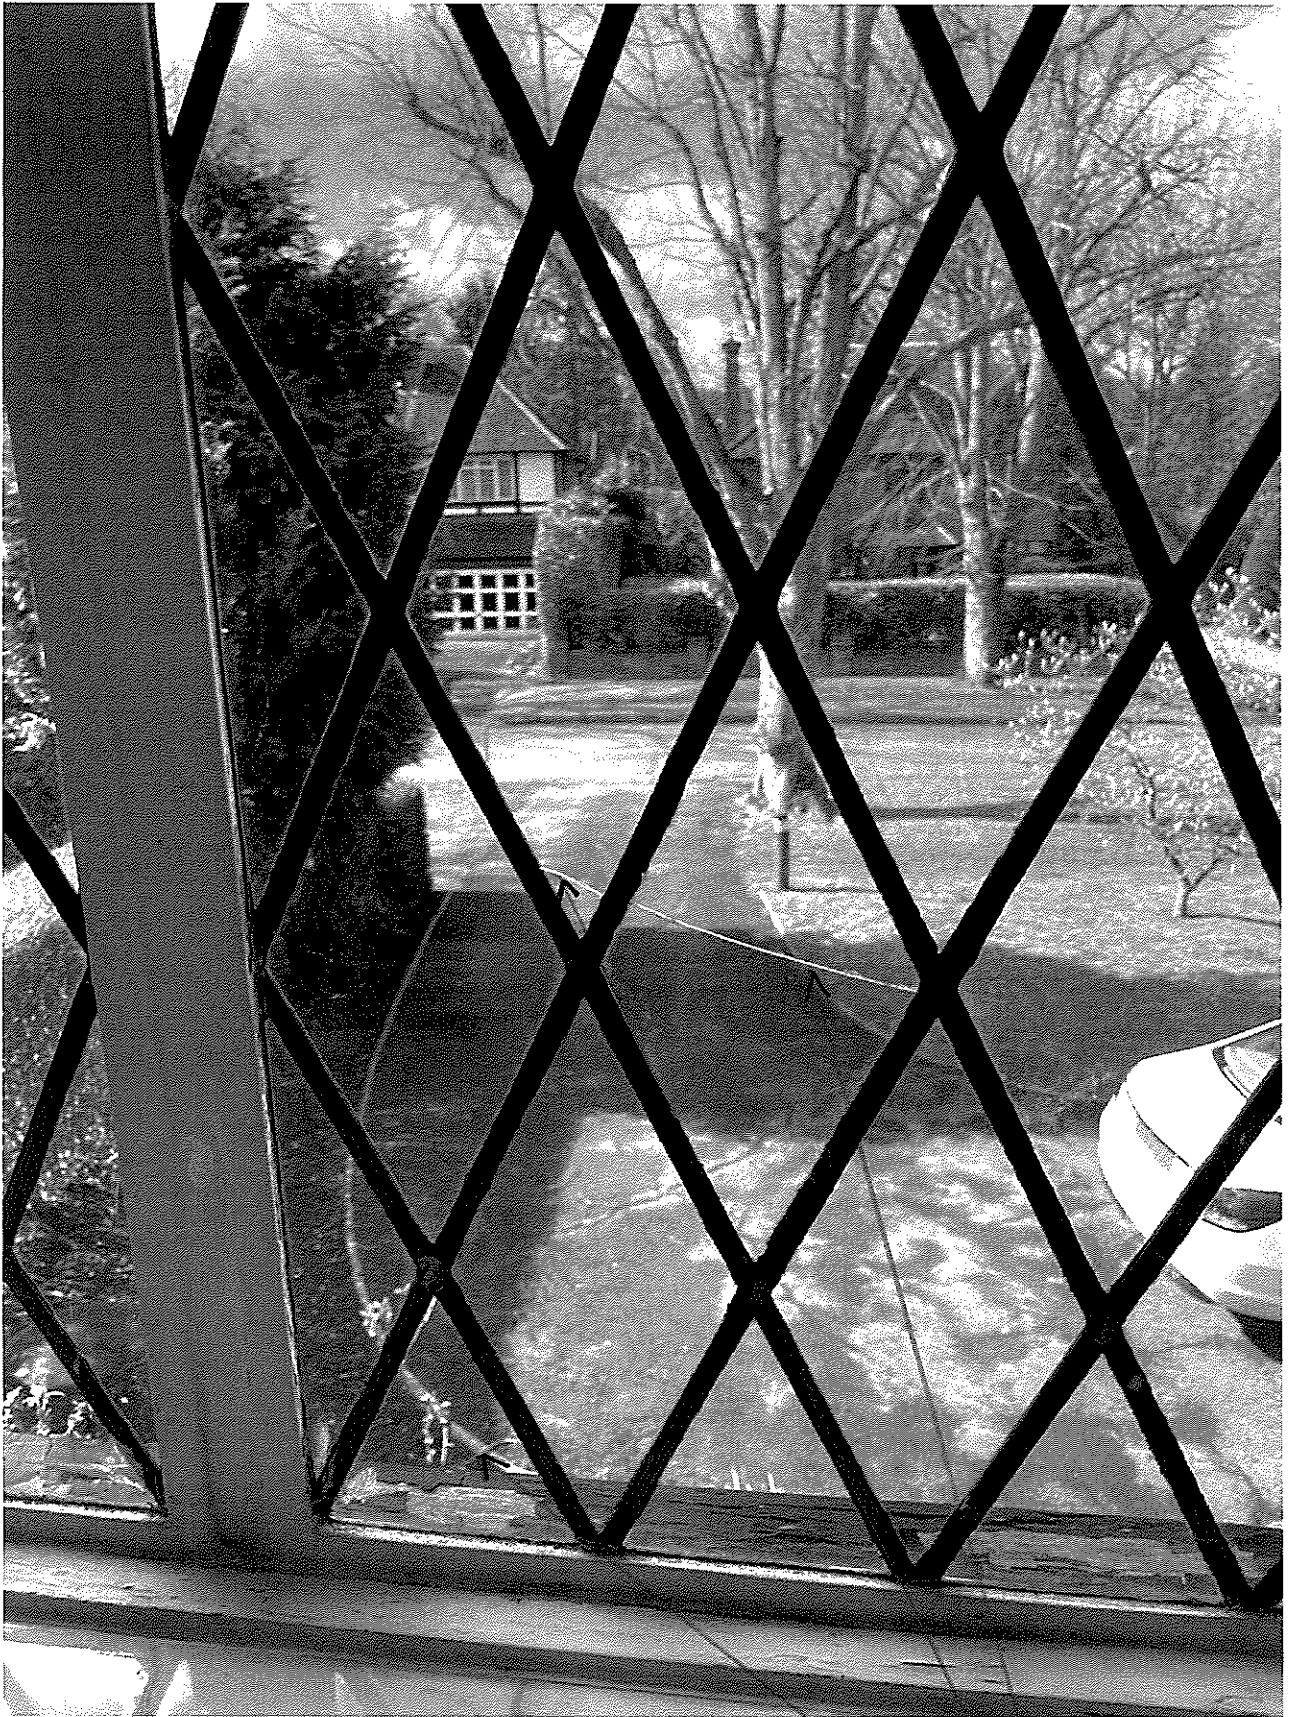
Cracked glass

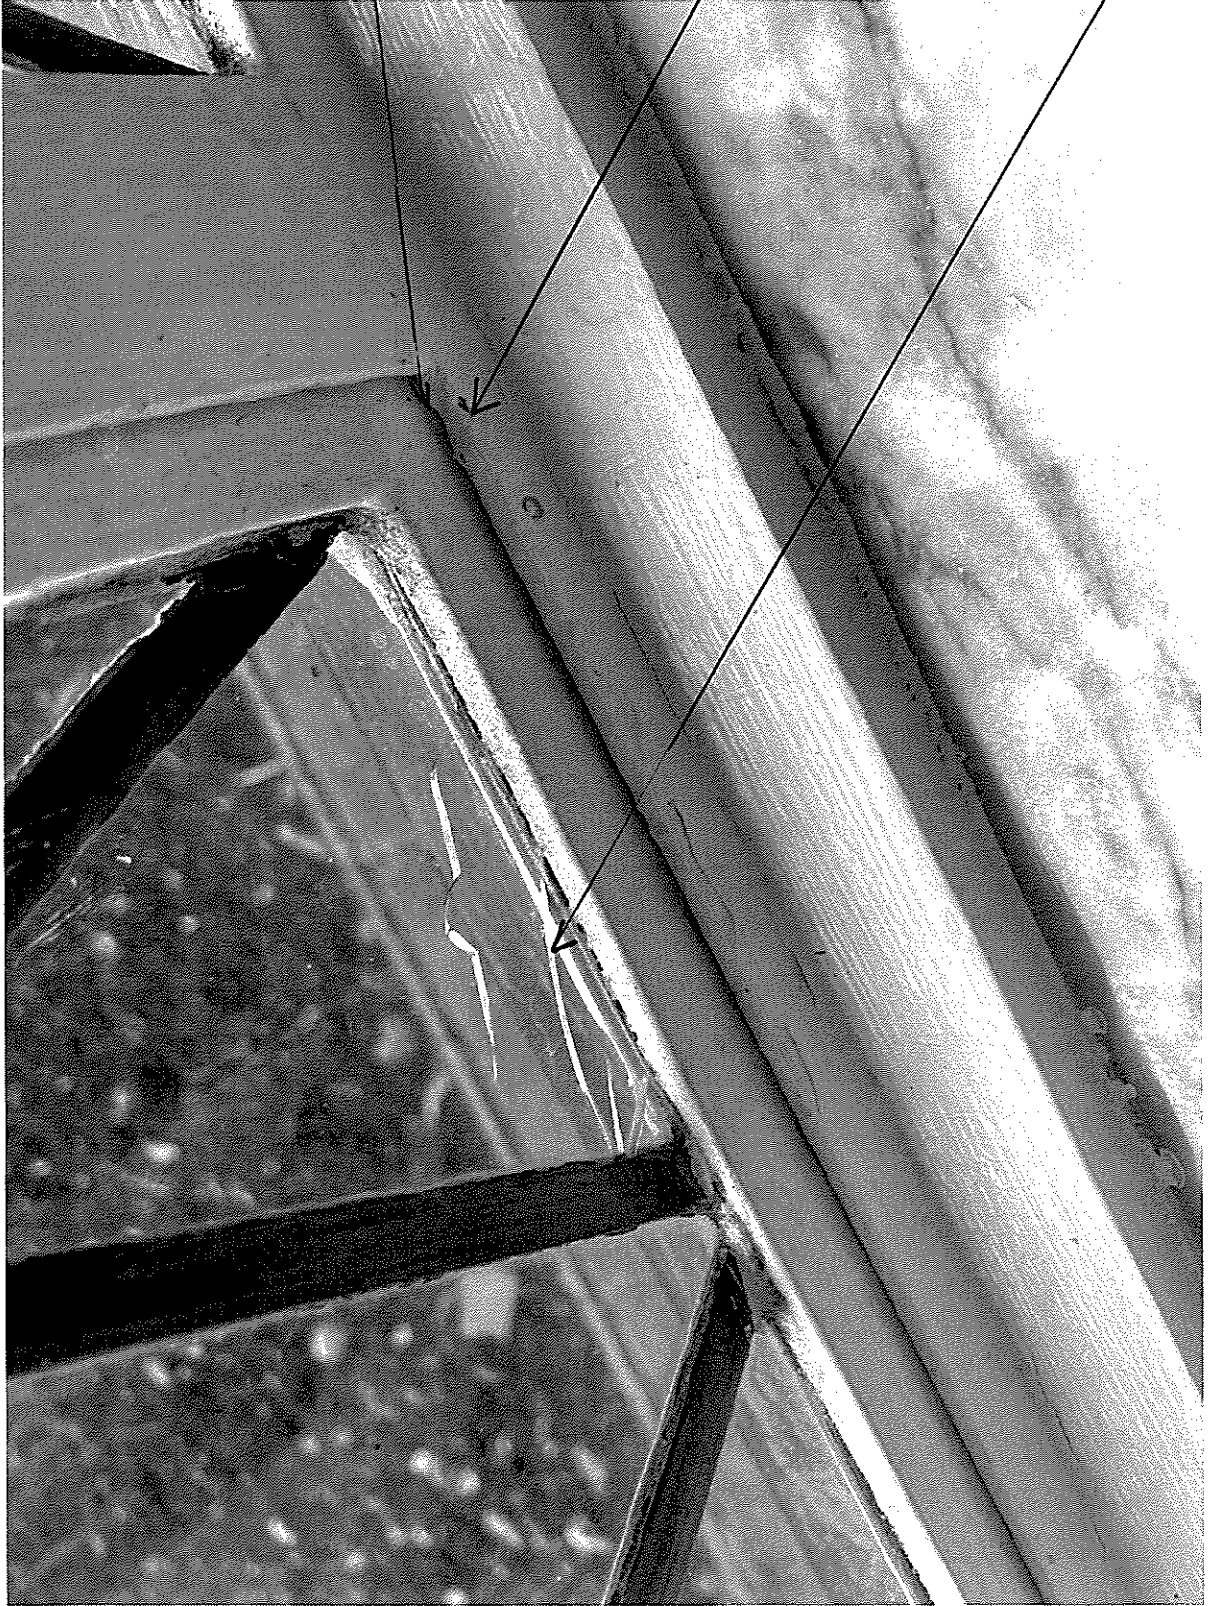
Gap in bent window frame.

Twisted frames

Cracked Glass

Bent frame  
due to  
rust.

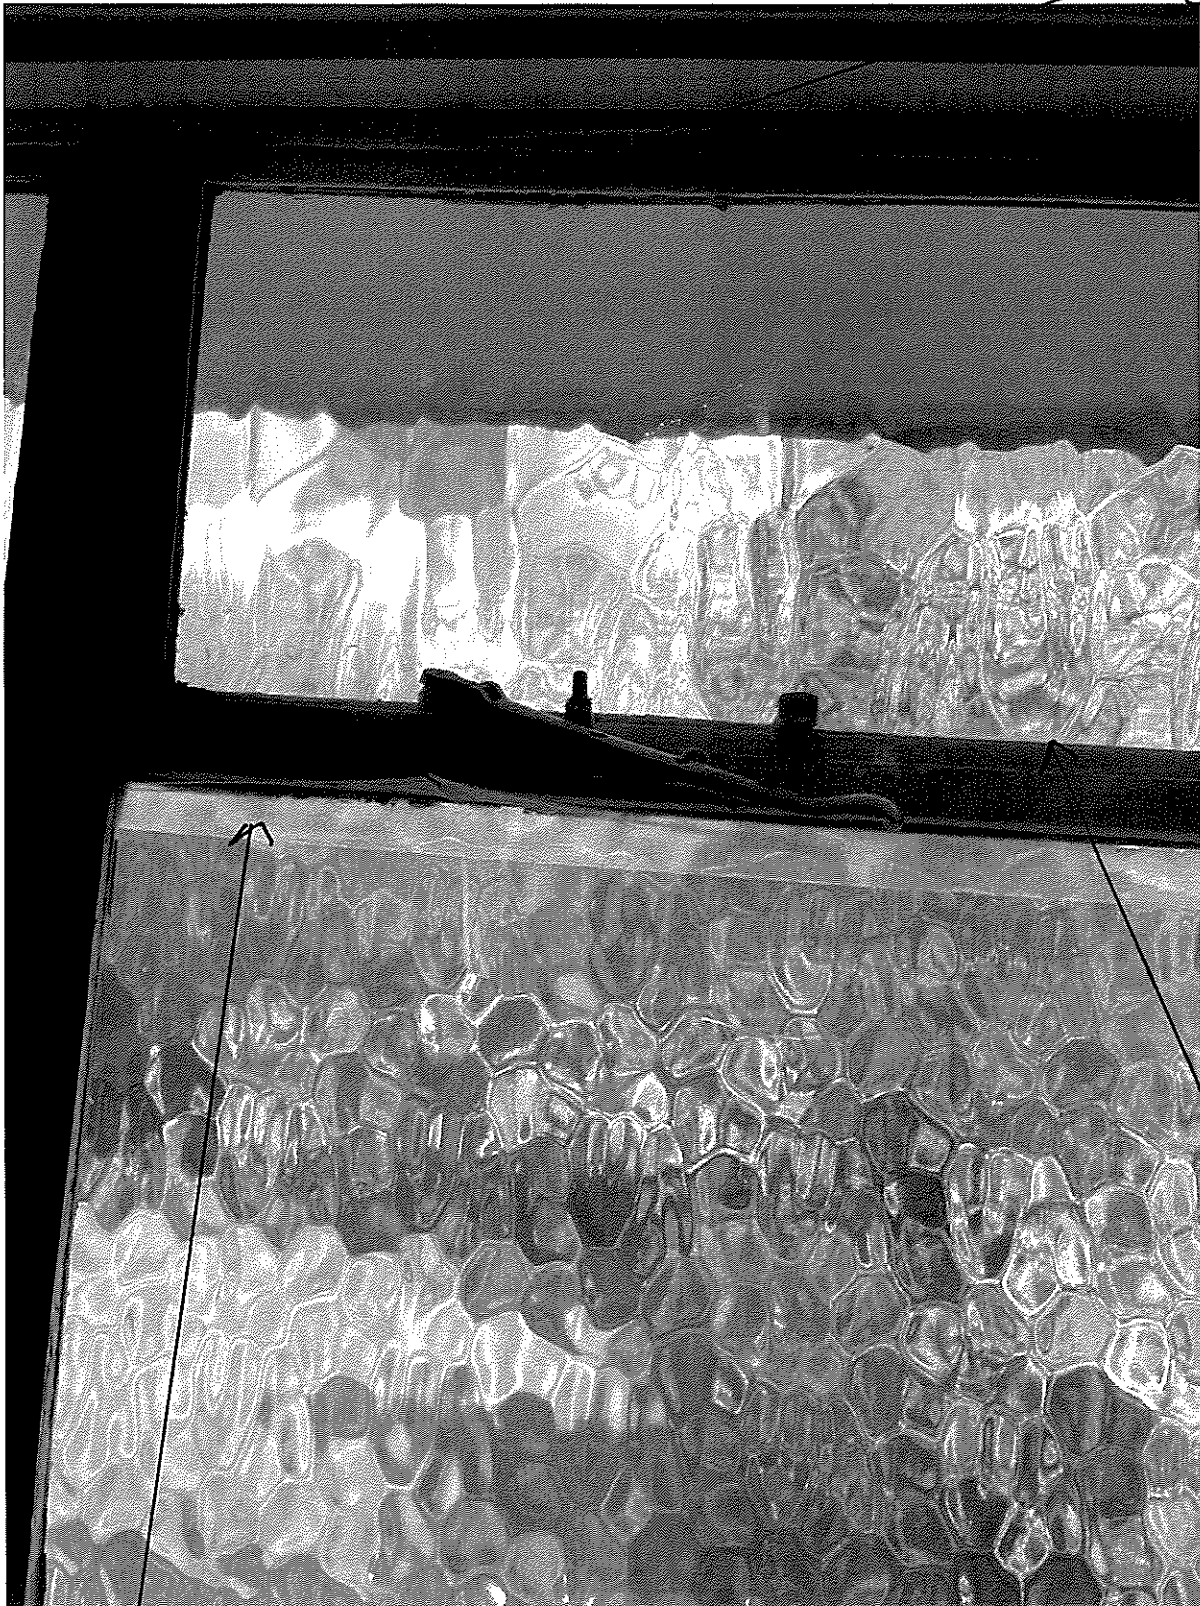
Cannot  
close as  
bent.

Plastic sheeting to  
avoid draft and leeches.

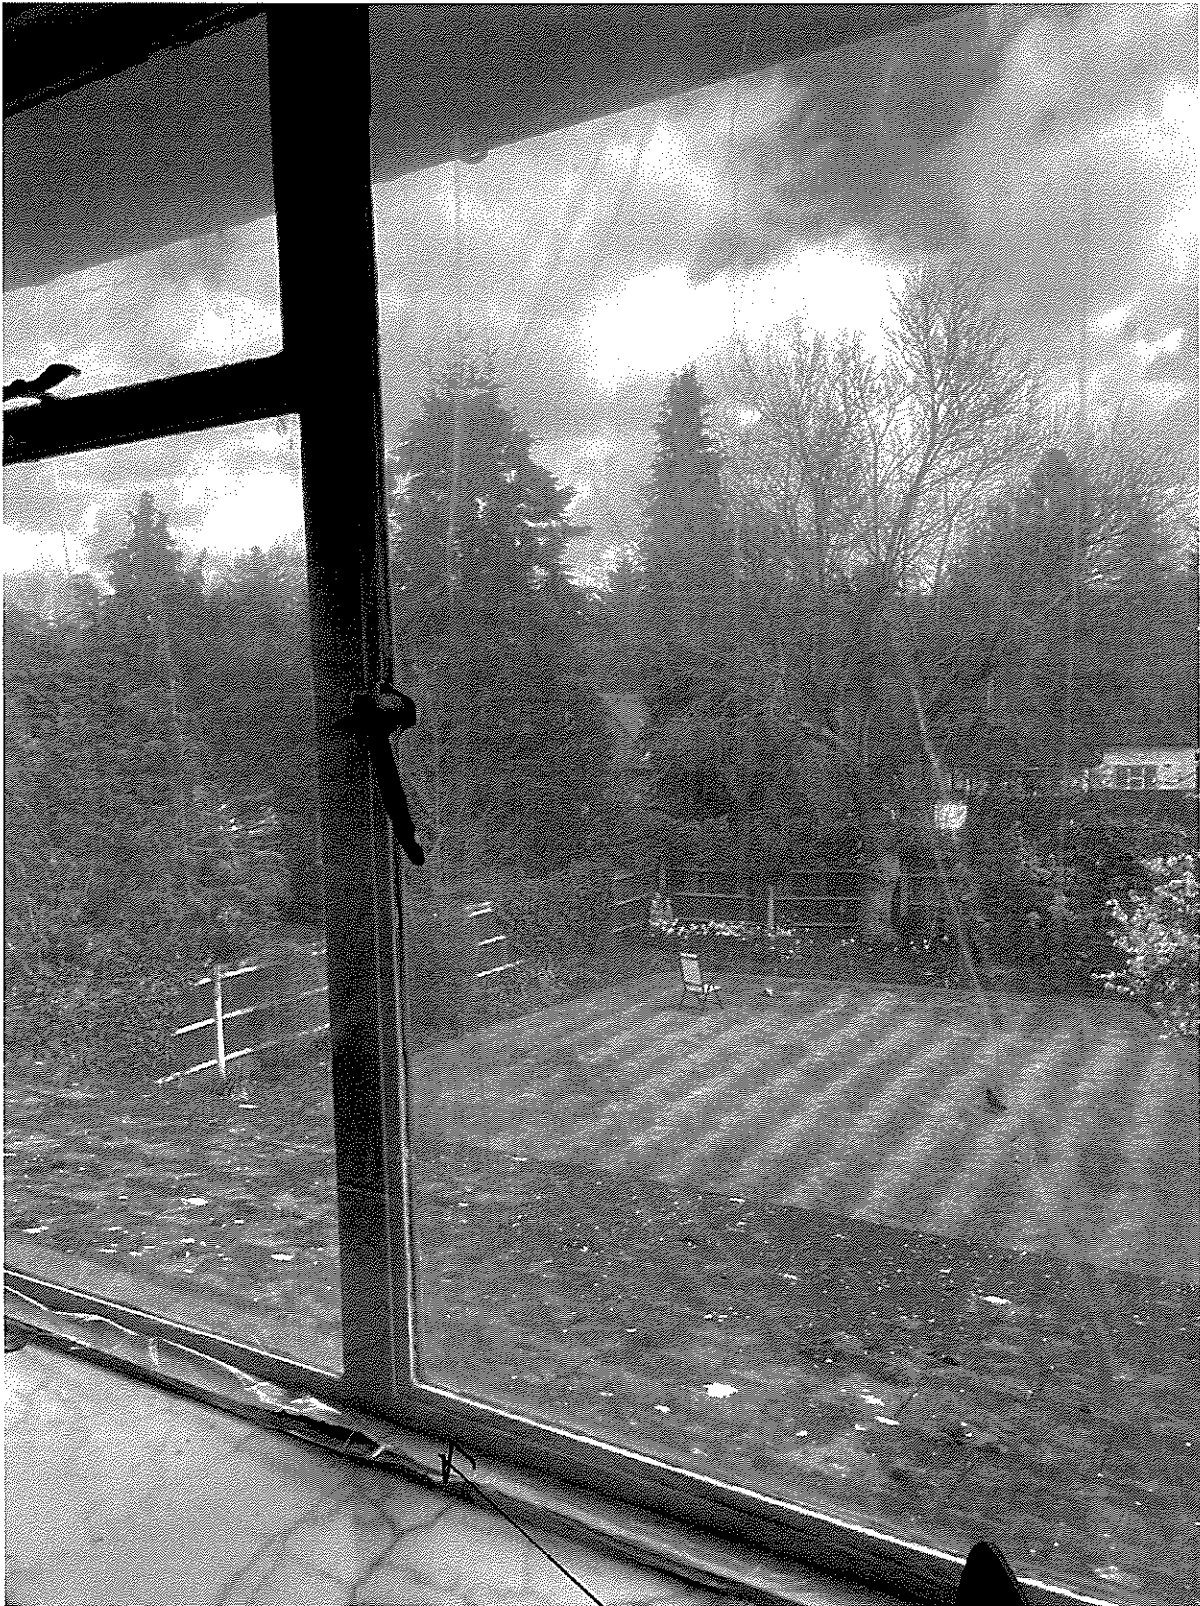
Plastic sheeting to  
avoid draft and leakage.
