**VISUAL TREE INSPECTION OF 2  
TREES AT BEAUFORT PARK, LISVANE ROAD.  
LISVANE.**

FOR  
Edenstone Homes

16<sup>th</sup> November 2023

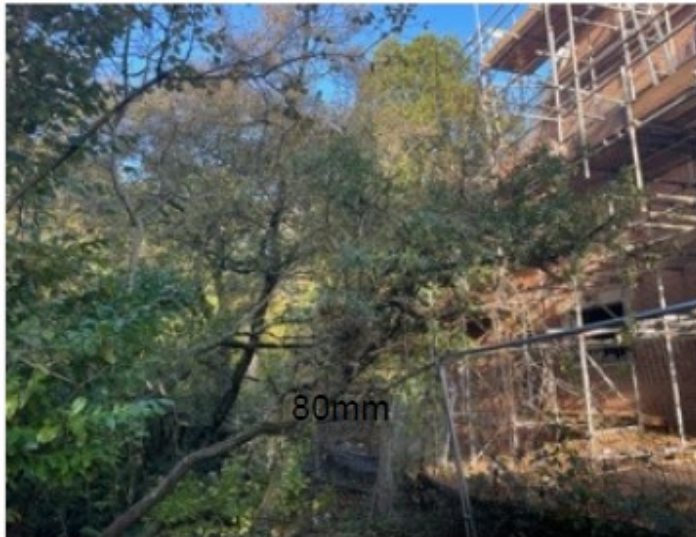
T3 Oak                  Height 4m                  diameter 430mn

A branch of this tree leans across the stream into the site at an angle. T2, a laurel grows up through this branch. This branch overhangs and droops into the garden of the new house.

Reduce branch back to .5m beyond the garden boundary.

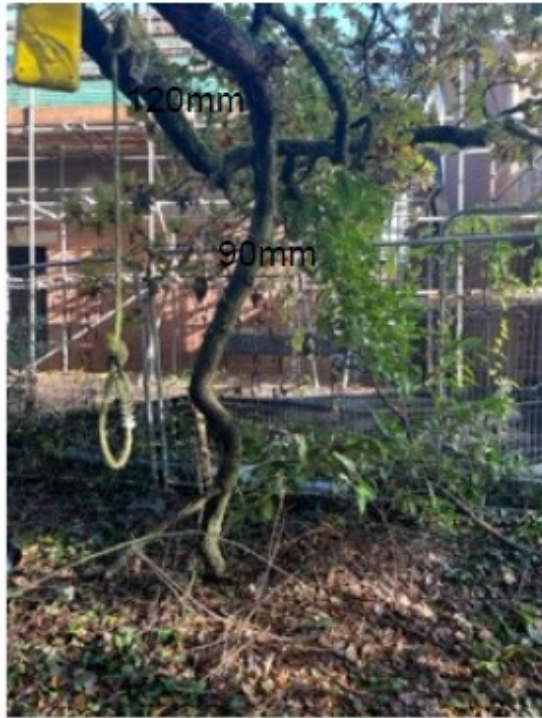
T4 Oak                  Height 12m      Diameter 530mm

This tree has 2 low branches to the east, both touching the ground. The northernmost of the branches has partially snapped off. Both branches are very low and will overhang the garden of the new house. 1 of the branches is 90mm and the other 120mm.

This tree is covered by TPO 11/01301/DCO and is number T14 of the TPO.

Reduce and raise both branches back to .5m beyond the garden boundary and 2m from current ground level.
