Tree Condition Survey Report (VTA)

Site: Norewood Lodge, 72 Nore Road, Portishead, North Somerset, BS20 8DU

Client: Bupa

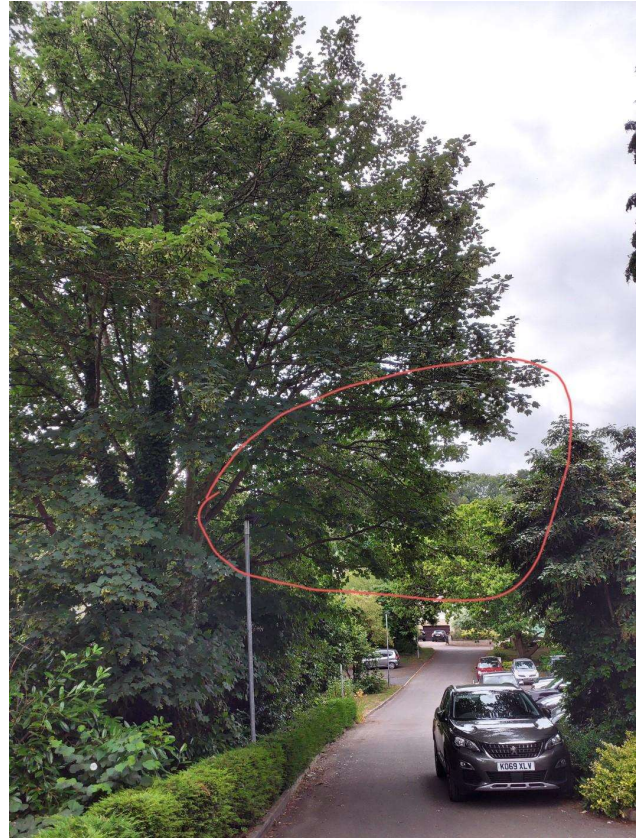
T34

34	N/A	Sycamore	Acer pseudoplatanus	11-15m	400	Mature	Good	Good	Unable to clarify ownership with maintenance. No access due to steep embankment and dense vegetation. Gardener requested lower limbs over car park be removed to improve visibility. Multi stemmed from base without included bark.	None Significant	Multi-Stem	Minor Dead Wood Under 50mm Diameter, Previously Reduced, Pruning Wound	None Observed	Building, Car park, Garden	High	No access to base/stem	Client

Inspection ID:	6212
Inspected By:	MattP
Inspection Date:	06/07/2023
Inspection Notes:	
Stem Diameter [mm]:	400
Common Name:	Sycamore
Scientific Name:	<i>Acer pseudoplatanus</i>
Physiological Condition:	Good

Tree / Group ID	Common Name	Work Task	Work Priority	Description	Tag No
9	Common walnut	Remove Dead Wood Over 50mm Diameter	Within 3 - 6 Months	Remove significant deadwood over 50mm	949
21	Scots pine	Client Action/Client to inform owner	Within 1 - 3 Months	Inform owner of proximity of crown to roof and significant lean and end weighting to stem.	N/A
34	Sycamore	Remove Specific Branch/Limb	Within 12 - 18 Months	Gardener has requested that the lower limbs identified on picture be removed to stem to improve visibility to main road/entrance.	N/A

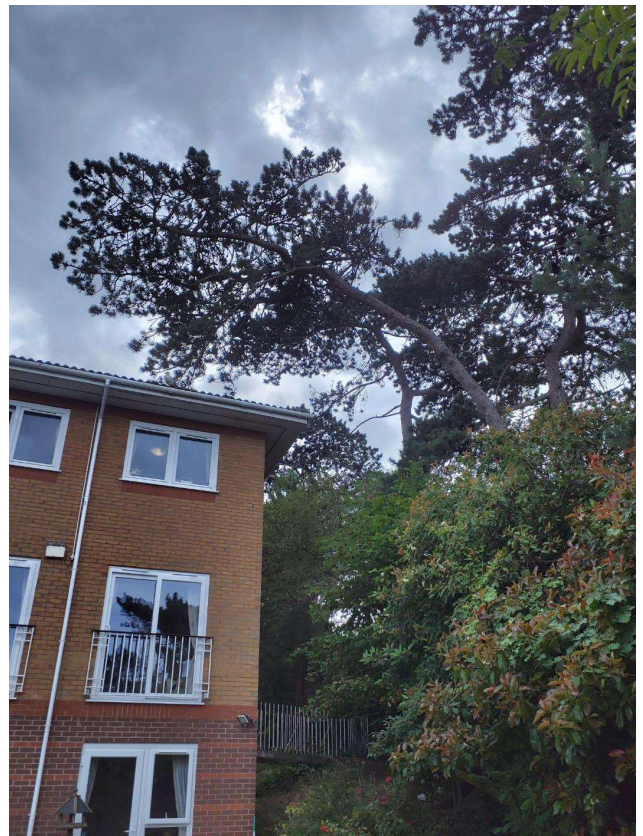
T21

Inspection ID:	6175
Inspected By:	MattP
Inspection Date:	06/07/2023
Inspection Notes:	
Stem Diameter [mm]:	400
Common Name:	Scots pine
Scientific Name:	<i>Pinus sylvestris</i>
Physiological Condition:	Good

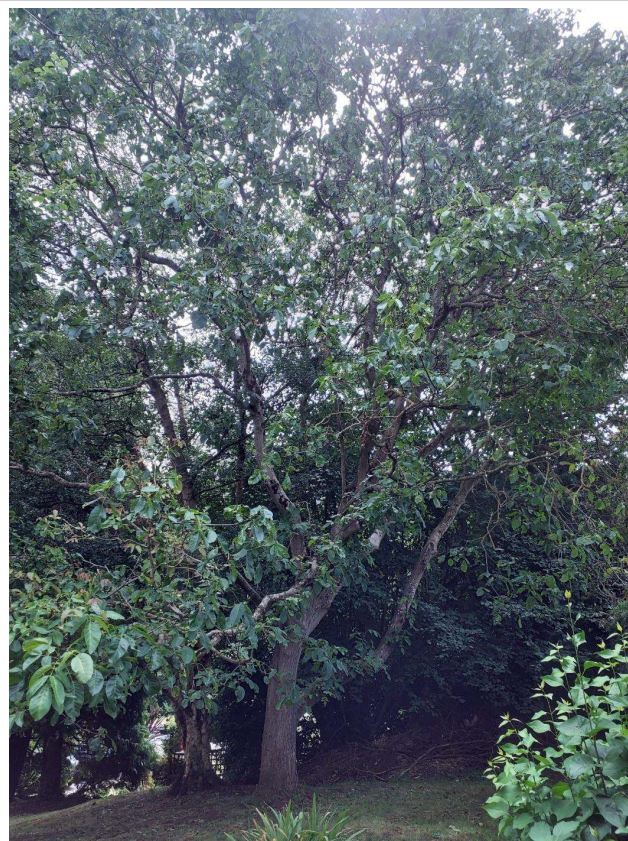
T9

8	948	Silver birch	Betula pendula	11-15m	500	Mature	Good	Fair	Included co-dominating stems from base.	Exposed Roots	Co-dominant Stem, Significant Buttressing	Branch Rip Wound, Minor Dead Wood Under 50mm Diameter, Pruning Wound	None Observed	Car park	High	Good	Client
9	949	Common walnut	Juglans regia	11-15m	500	Mature	Fair	Good		Exposed Roots	Forked	Low Branches, End Weighting of Branches/Stems, Major Dead Wood Over 50mm Diameter, Pruning Wound	None Observed	Car park	High	Good	Client
10	948	Apple	Malus domestica	5-10m	250	Mature	Fair	Good		None Significant	Leaning Stem - Minor	Minor Dead Wood Under 50mm Diameter, Pruning Wound	None Observed	Building, Car park, Garden	High	Good	Client
11	N/A	Holm oak	Quercus ilex	5-10m	100	Semi-mature	Good	Good		Exposed Roots	Leaning Stem - Minor	Suppressed Growth, Minor Dead Wood Under 50mm Diameter, Pruning Wound	None Observed	Open space	High	Good	Client
12	941	Pedunculate oak	Quercus robur	16-20m	670	Mature	Good	Good		Exposed Roots	Pruning Wounds - Occluded	Minor Dead Wood Under 50mm Diameter, Pruning Wound	None Observed	Building, Car park	High	Good	Client

Inspection ID:	6135
Inspected By:	MattP
Inspection Date:	06/07/2023
Inspection Notes:	
Stem Diameter [mm]:	500
Common Name:	Common walnut
Scientific Name:	Juglans regia
Physiological Condition:	Fair

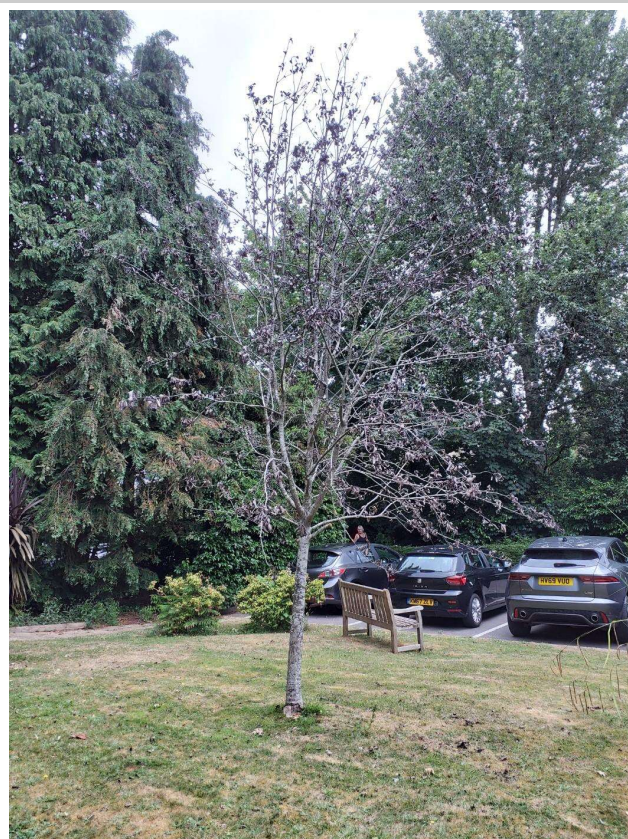
T7

Inspection ID:	6126
Inspected By:	MattP
Inspection Date:	06/07/2023
Inspection Notes:	
Stem Diameter [mm]:	90
Common Name:	Whitebeam
Scientific Name:	Sorbus aria
Physiological Condition:	Poor
