Tree condition survey of various trees

Birdworld, Holt Pound, Farnham, GU10 4LD

Report date
15th November 2023

Report reference
J612.08

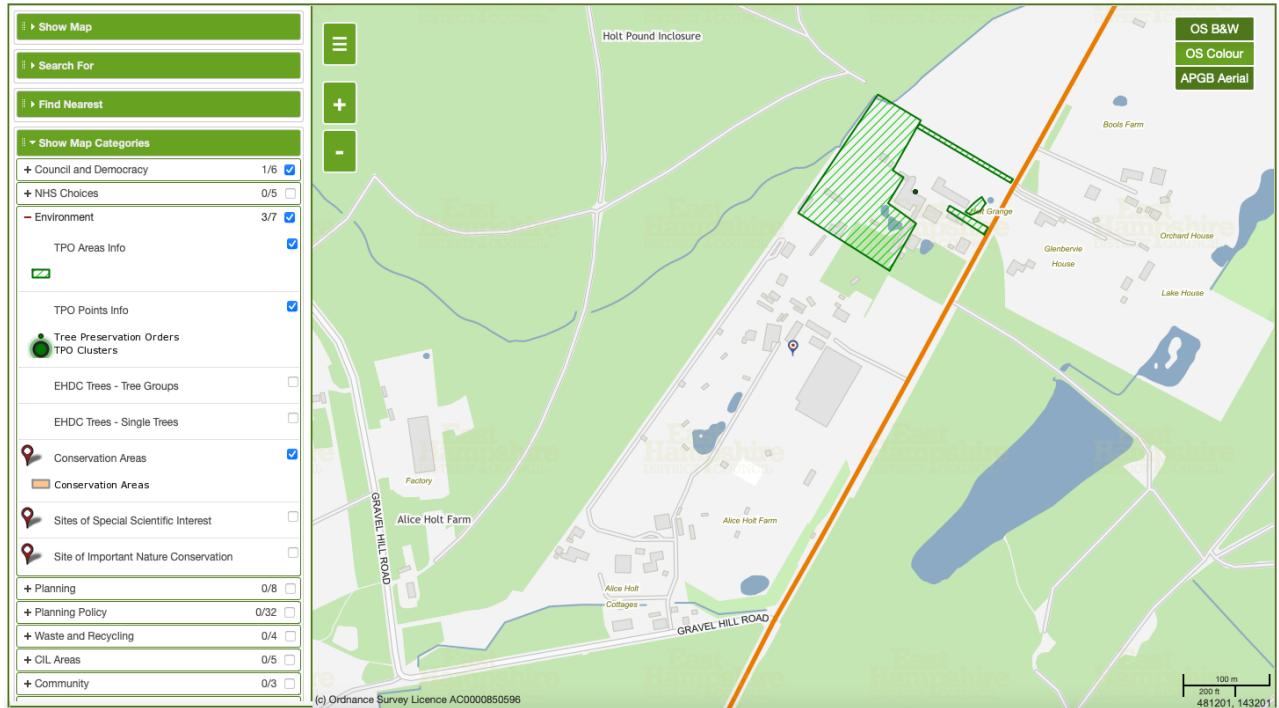
SAL1 Image provided by council website².

- 3.1 The online mapping tool provided by East Hampshire District Council, accessed on 15th November 2023 identifies that the site is not subject to Conservation Area controls. However, Tree Preservation Order (472)70 does relate to the northern parts of the site (section 1 main entrance, section 2 seashore, section 8 car parking and section 9 additional car parking). See image SAL1:
