Barn at Montrose, Henton nr Wells, Somerset

Report on the Structural Condition

Project Number:8386

Date: May 2016

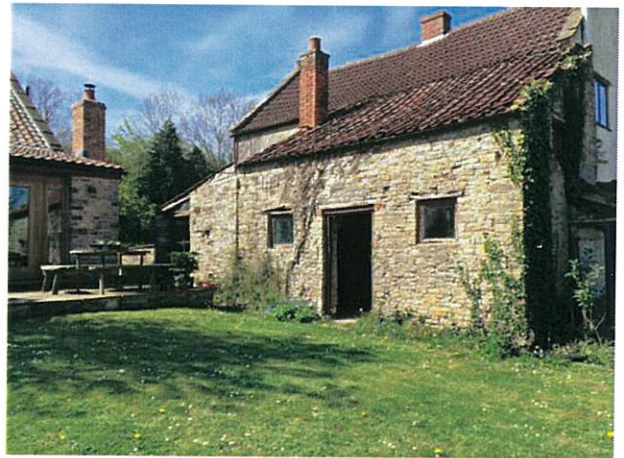
2.2 The central section has a single door, flanked by two small windows. These apertures all have oak lintels exposed externally, which are rotten and should be renewed. The internal lintels, of oak, are in reasonable condition and could remain.

The walls are of solid masonry construction, with lias stone in a lime mortar matrix. The walls to this part are plumb and true. Apart from some localised repointing, no significant repairs are required.

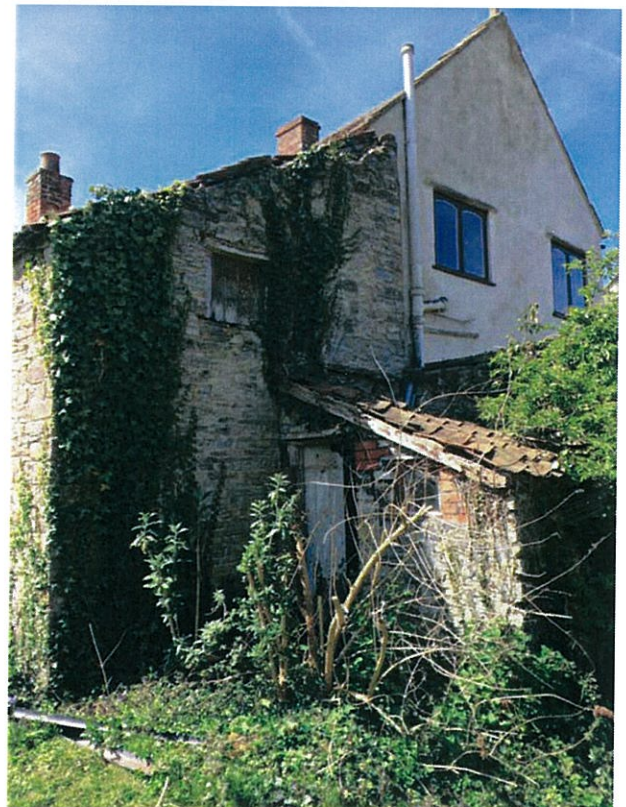
2.3 The exception to this is the verge along the top of the north gable, where ivy growth is heavy and may have loosened the masonry. Some local stonework consolidation may be required here,

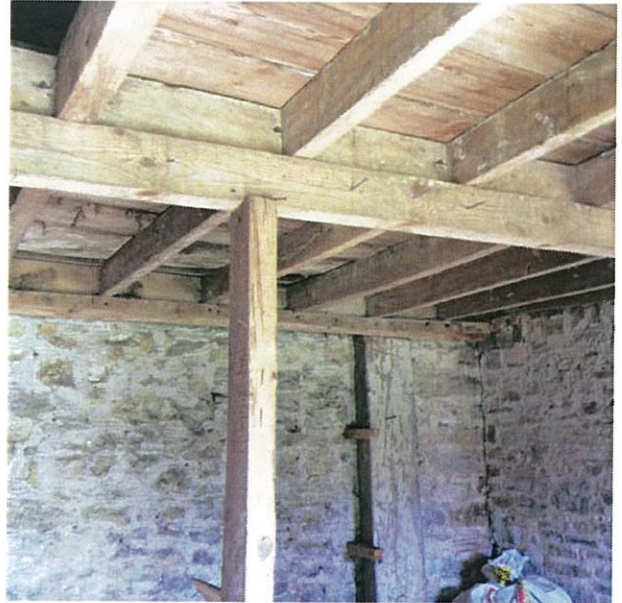
- 2.4 The upper hay loft floor comprises softwood boarding on small, 110mm deep by 35mm wide elm joists. The elm joists are generally in sound condition but are undersized for domestic use for the clear span involved. A central spine beam, with a single prop have been introduced to prevent deflection of the floor.

It would be better during the conversion to install deeper softwood joist to clear span front to back without need for any intermediate propping. The original elm beams could be retained and "partnered" by the new joists.

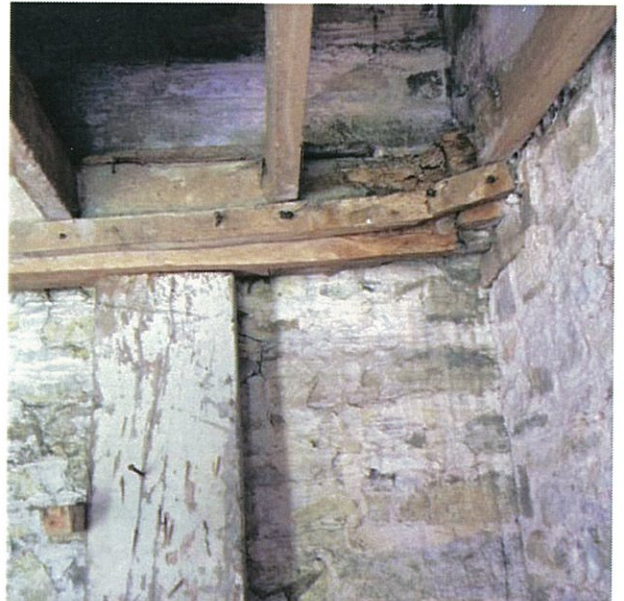
- 2.5 The 225mm x 225mm elm beam running parallel to the rear wall has failed due to rot near its north bearing. A rudimentary timber prop has been used to carry the fractured end.

The beam could be retained if required and a stainless steel repair undertaken at the fractured end.

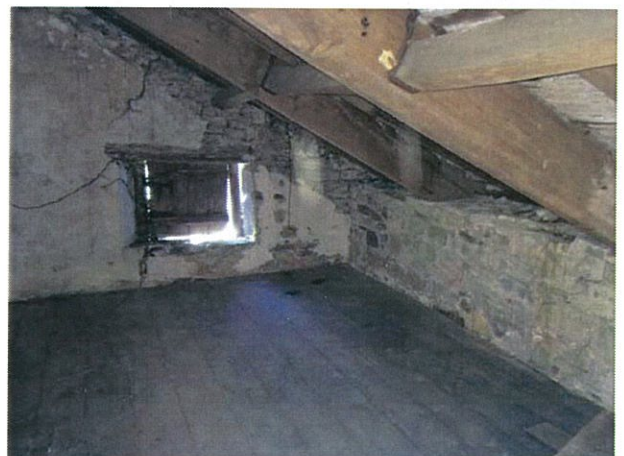
- 2.6 The roof is covered in clay pantiles on a lath and plaster layer, supported by small common rafters (75mm x 50mm). The rafters span onto two lines of purlins which are deflecting. One has become detached from the iron hangers used to carry them on the principal rafters.

The 3 principal rafters are slightly bent, but this distortion probably occurred when they were still green. All the roof is of elm.

Certainly the section size of the principals at 250mm x 75mm should be ample to carry this modest roof.

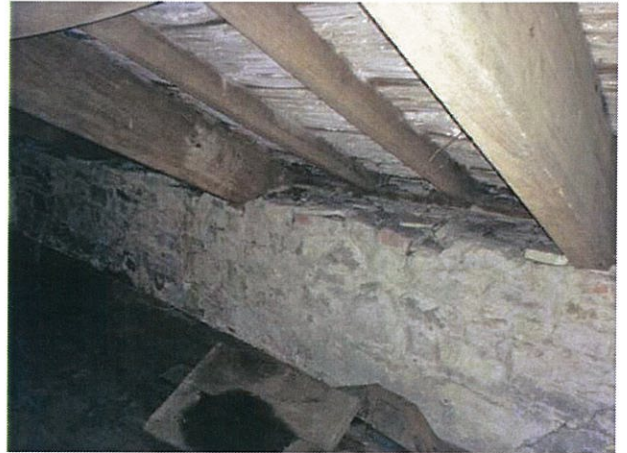
- 2.7 At the eaves, the rafters are bearing on a small wall plate at the outer edge of the wall. The principal rafters simply bear on top of the masonry.

Given the need to provide insulation, and therefore deeper rafters, it may be sensible to dismantle the roof, using new members generally, but keeping the principal rafters for re-use and to be exposed in the upper storey.

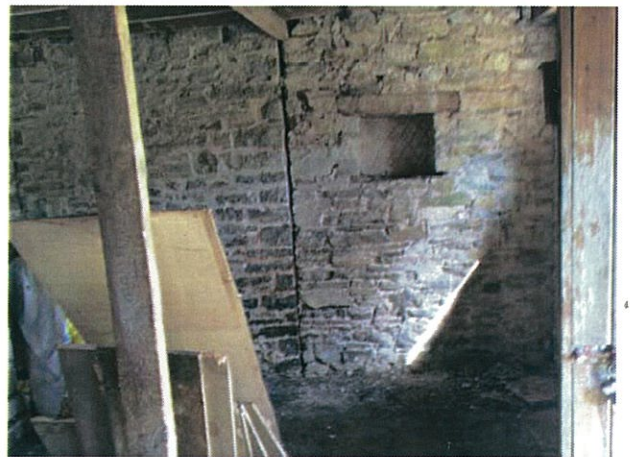
- 2.8 The rear, party wall, is in good condition. The north wall has a straight joint which no doubt marks the extent of an earlier construction.

This joint could be incorporated into the new doorway giving access to the new hall and kitchen.

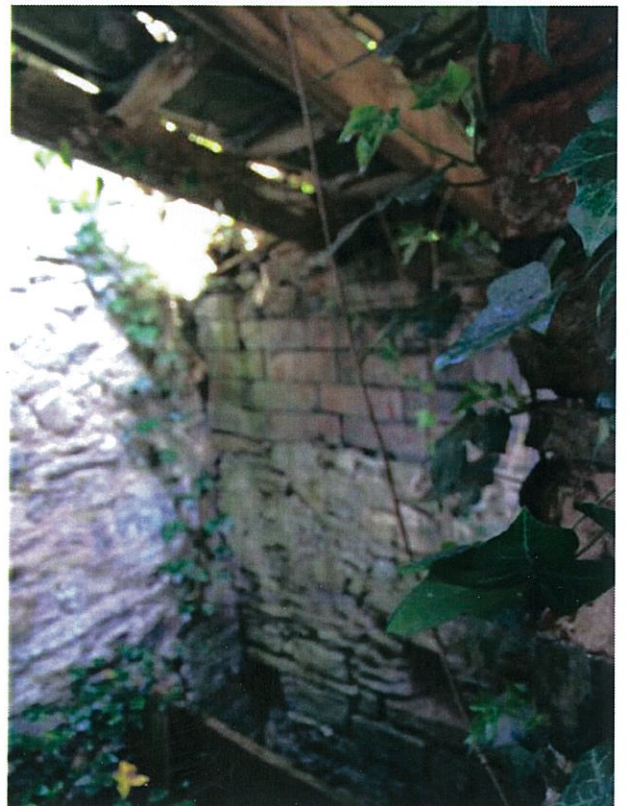
- 2.9 The small lean to the north has a collapsing roof, and a fractured, insubstantial end wall. It would be best to dismantle the building entirely and construct new build off new foundations.

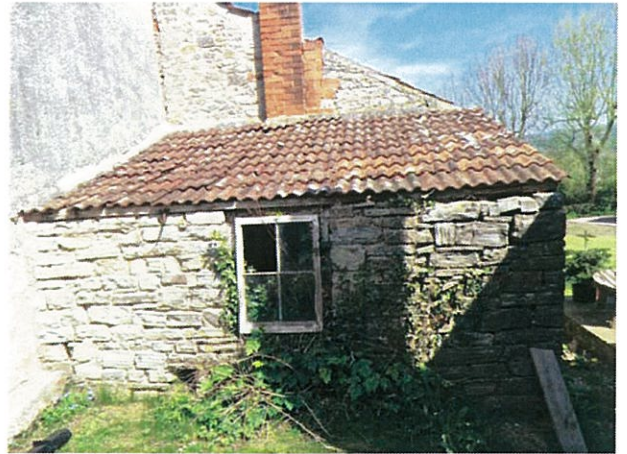
- 2.10 The southern lean to has a roof covered in triple roman clay tiles, and has solid masonry walls of lias.

It contains a small fireplace with a brick chimney abutting the south gable of the central building.

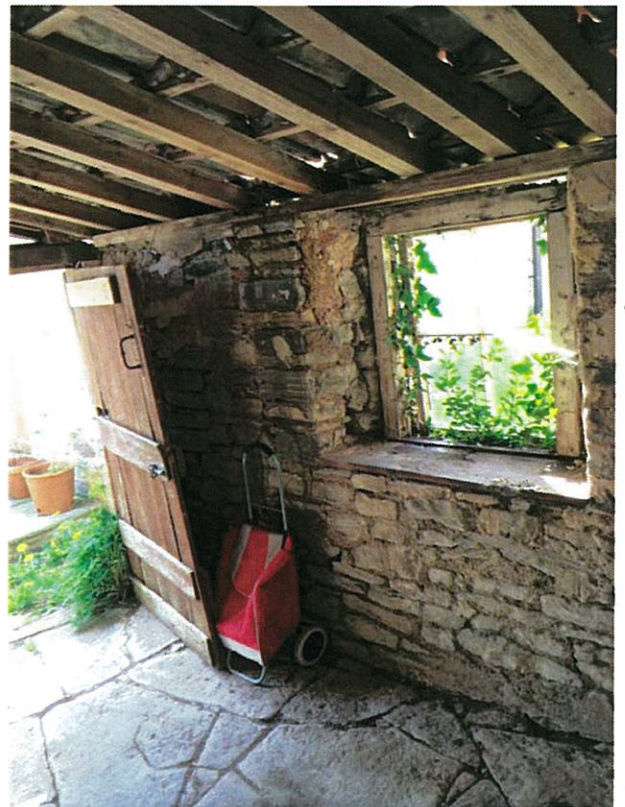
- 2.11 The roof structure comprises a series of 75mm x 75 simple clear spanning rafters. They are in a reasonable condition but the wall plate on the south wall has partly disintegrated due to wet rot, has have the plates which support the top of the rafters each side of the chimney breast.

Given the need for insulation in the roof it would be better to provide a new roof structure.

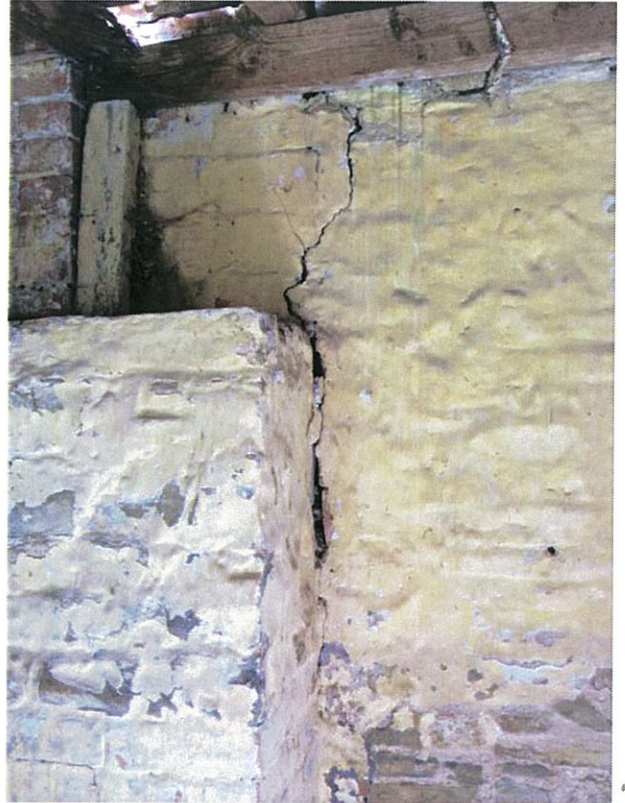
- 2.12 The walls to this lean to are generally plumb and stable. There is a crack in the south wall of the central building which is more visible inside the lean to. This crack should be held together by stainless steel bars glued into the bed joint either side of the movement crack.

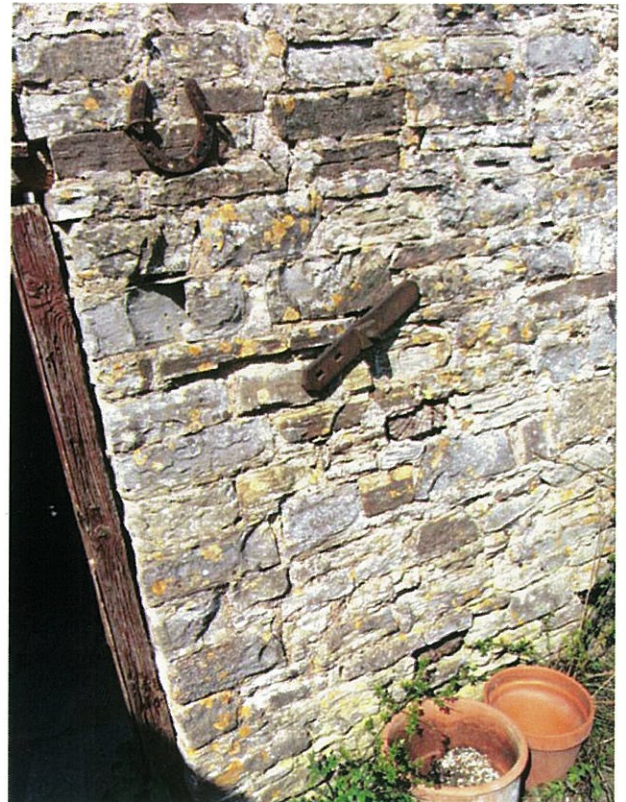
- 2.13 There is an iron tie bar visible on the east wall facing the garden. This is related to the old pump inside this wall and is not a structural component.
