FAIRFIELD ROAD, DROYLSDEN

SITE COMPLETION REPORT

Job: Number: LKC 20 1761
Date: 1st December 2023
Client: J Greenwood (Builders) Ltd

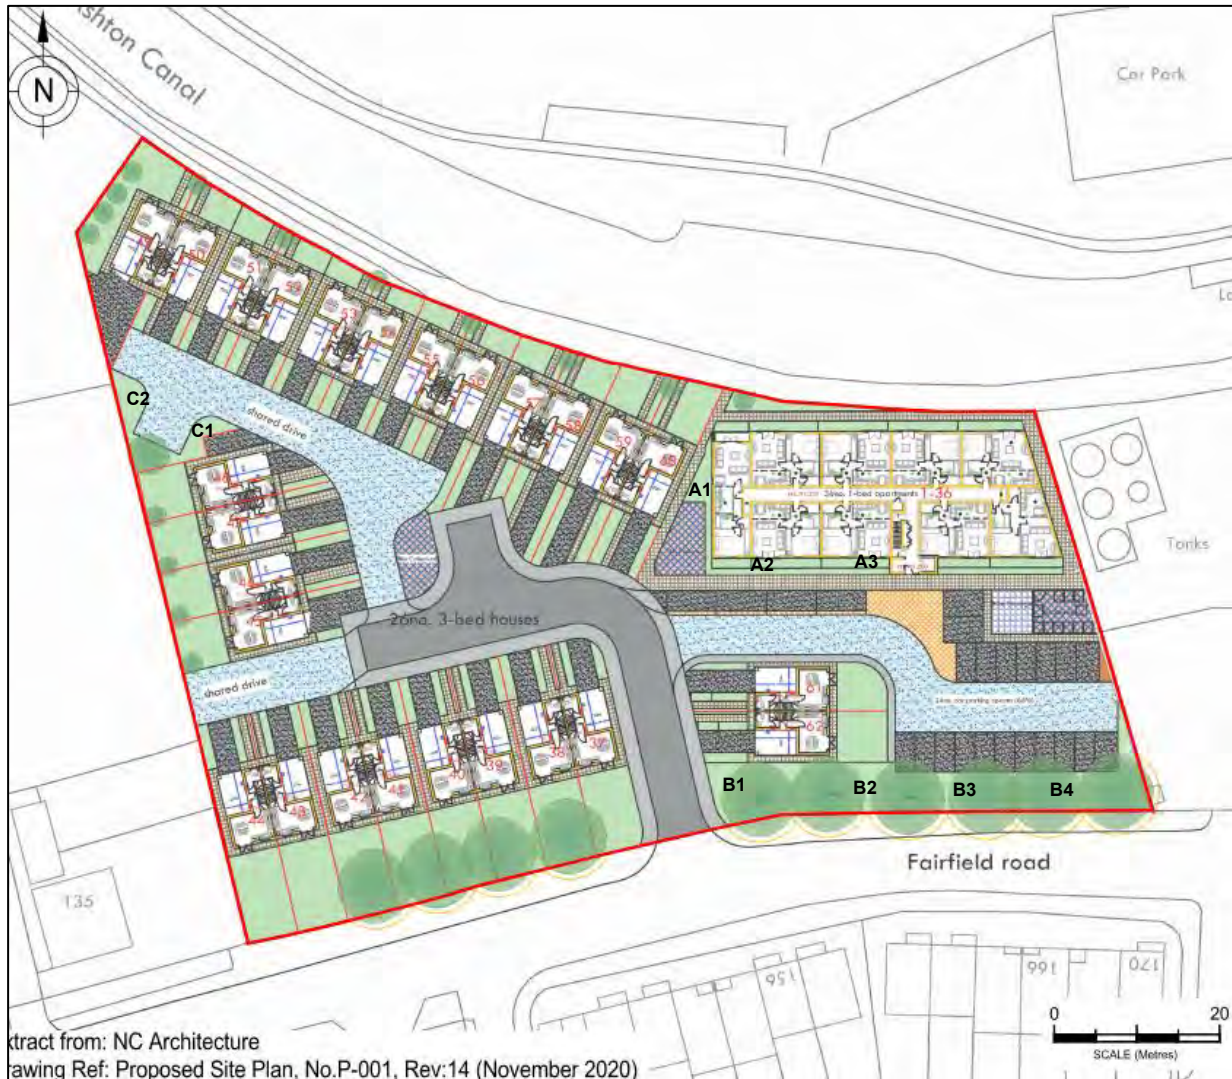
APPENDIX A
SHARED SOFT LANDSCAPING DEPTH
VALIDATION LOCATIONS

Note: A1-A3, B1-B4 and C1-C2 denote the locations of depth validations.

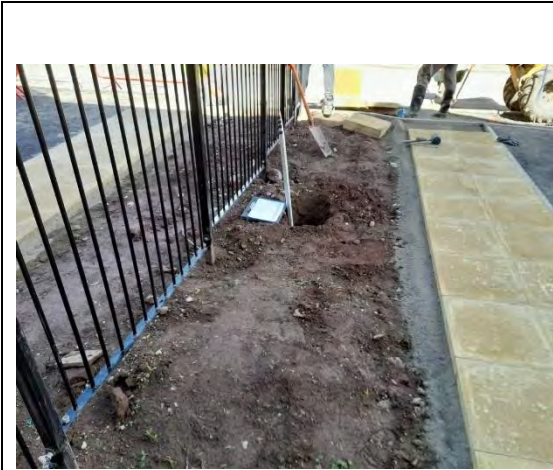
Photograph 1: View of front garden in Plot 37.

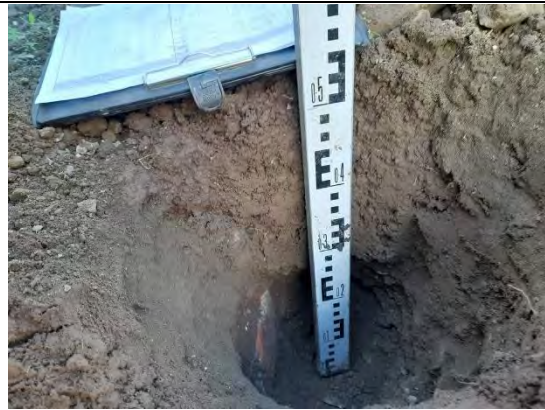
Photograph 2: View of depth of soil within the front garden of Plot 37.

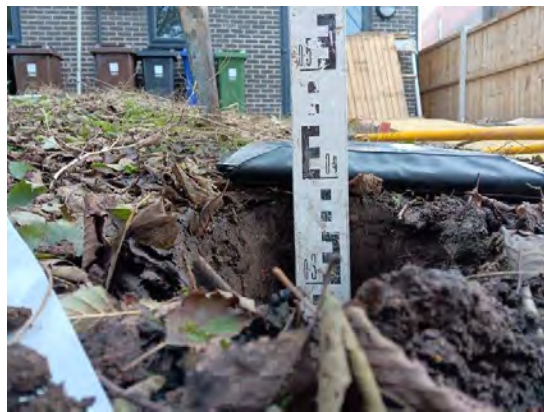
Photograph 8: View of depth of soil within the rear (S) garden of Plot 37.

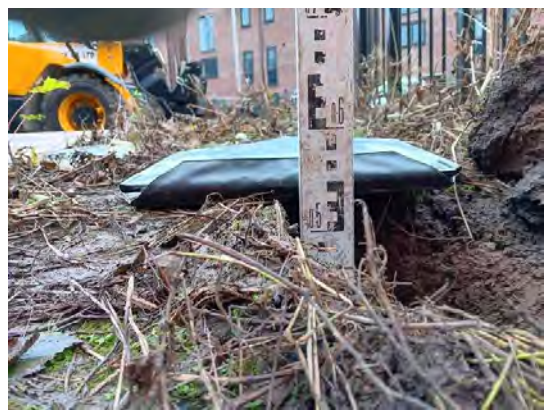
Photograph 11: View of depth of soil within the front garden of Plot 38.

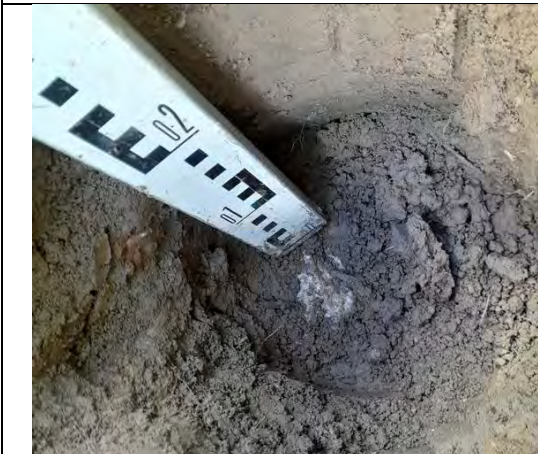
Photograph 15: View of soil within cover system and geotextile at base in rear (N) of Plot 38.

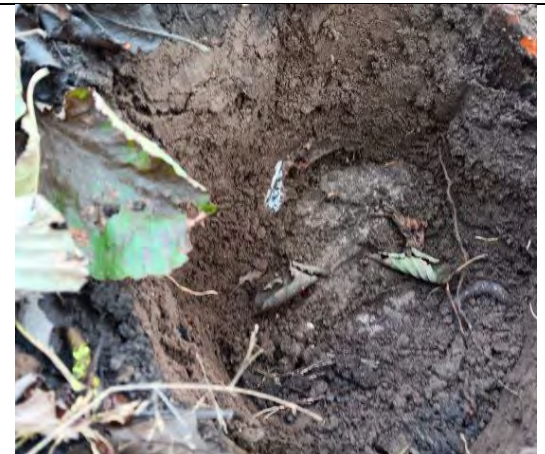
Photograph 18: View of soil within cover system and geotextile at base in rear (S) of Plot 38.
