Site: Fairfield Road, Droylsden
Plots: Ground Floor of Apartment Block (Plots 1-9) & Plots 37-62
Date: 23rd November 2023
LKC Ref.: CL-602-LKC 20 1791-02 Plots 1-9 & 37-62 R1

GAS MEMBRANE VALIDATION REPORT

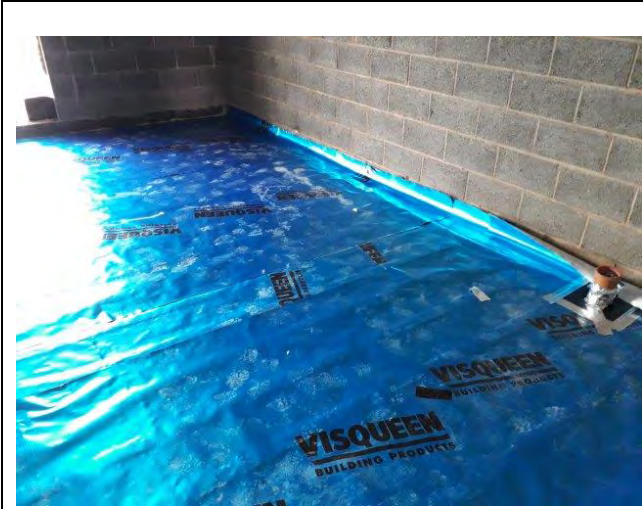
Plot 2

Photograph 1:
Evidence of gas membrane coverage across Plot 2.

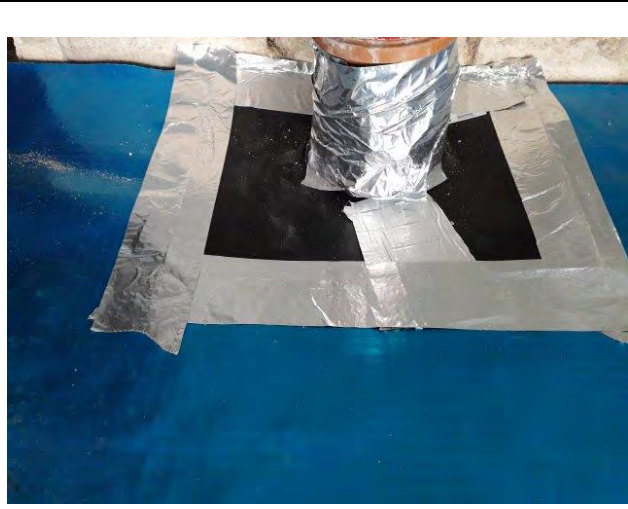
Photograph 2:
Evidence of appropriate sealing around services for Plot 2.

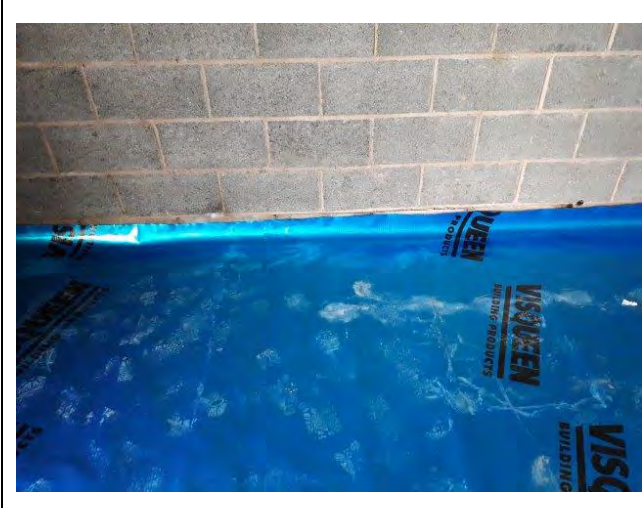
Photograph 3:
Evidence of appropriate sealing of membrane to DPC with appropriate overlap for Plot 2.

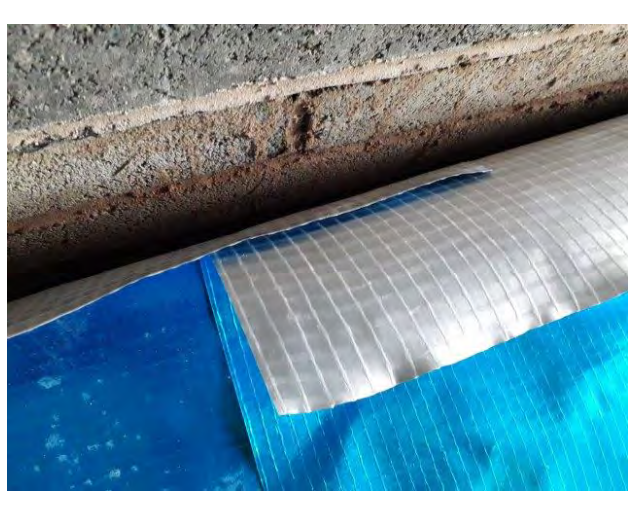
Photograph 4:
Evidence of appropriate overlap of the membrane for Plot 2.

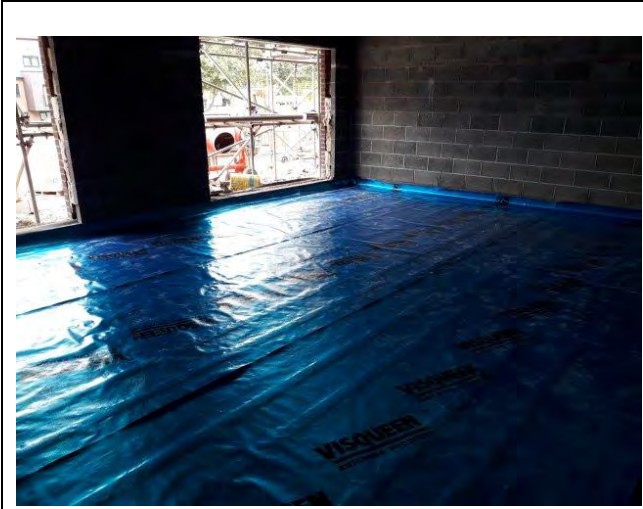
Plot 3

Photograph 1:
Evidence of gas membrane coverage across Plot 3.

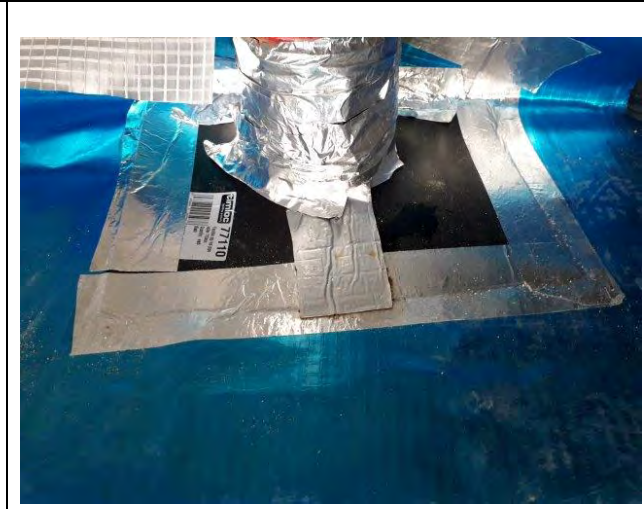
Photograph 2:
Evidence of appropriate sealing around services for Plot 3.

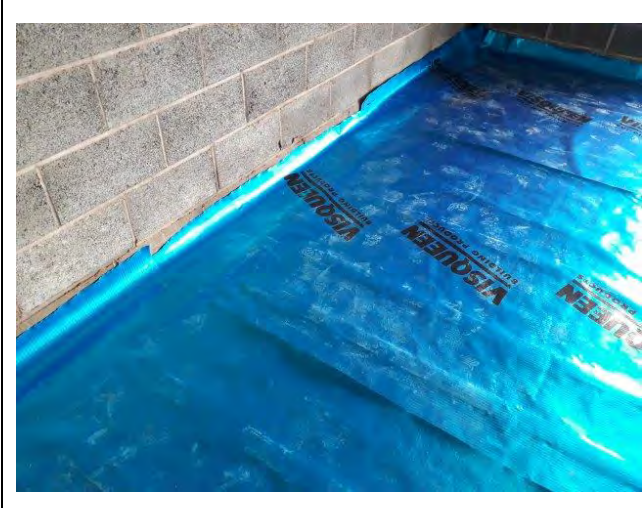
Photograph 3:
Evidence of appropriate sealing of membrane to DPC with appropriate overlap for Plot 3.

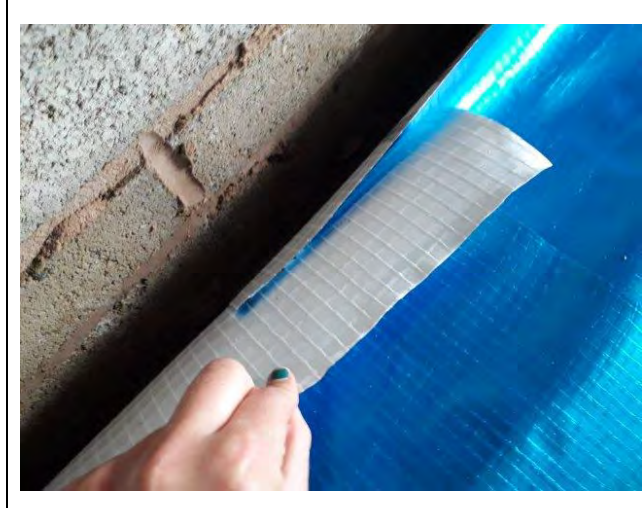
Photograph 4:
Evidence of appropriate overlap of the membrane for Plot 3.

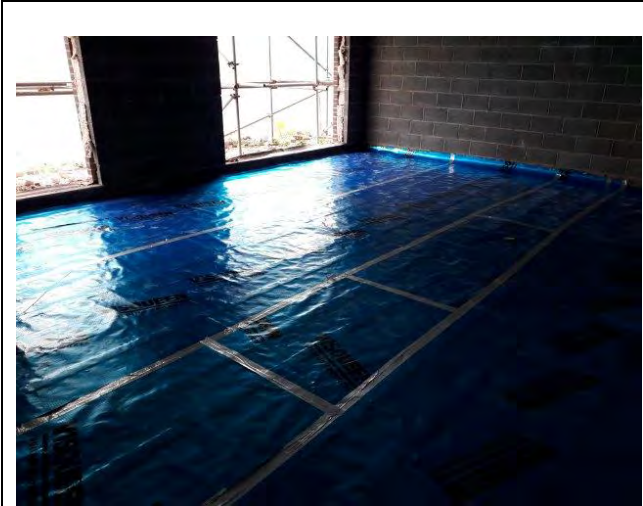
Plot 4

Photograph 1:
Evidence of gas membrane coverage across Plot 4.

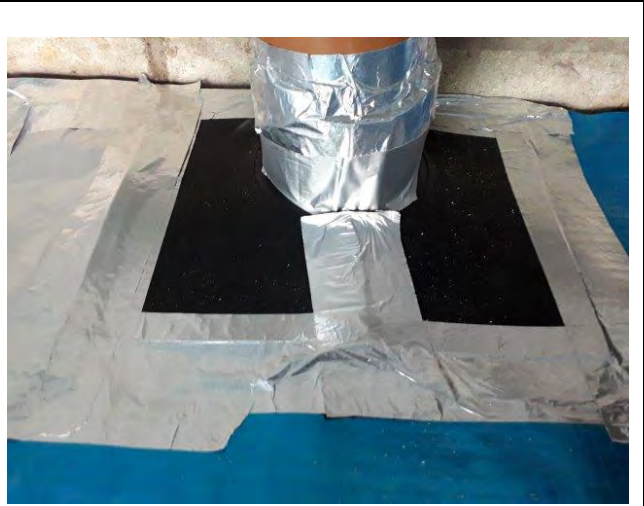
Photograph 2:
Evidence of appropriate sealing around services for Plot 4.

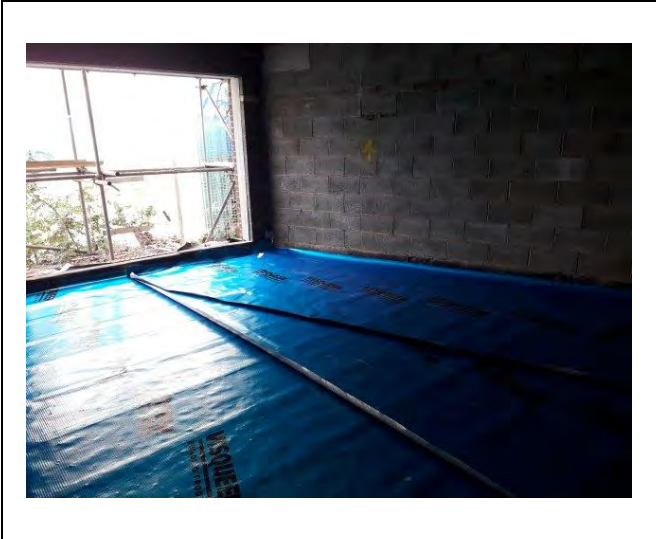
Plot 8

Photograph 1:
Evidence of gas membrane coverage across Plot 8.

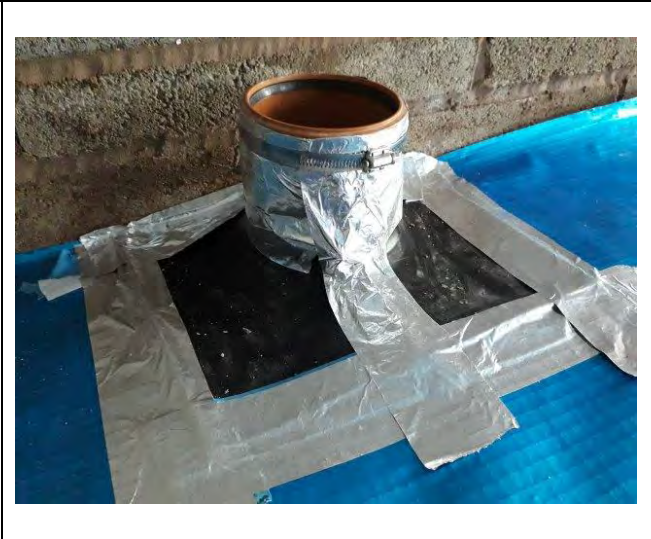
Photograph 2:
Evidence of appropriate sealing around services for Plot 8.

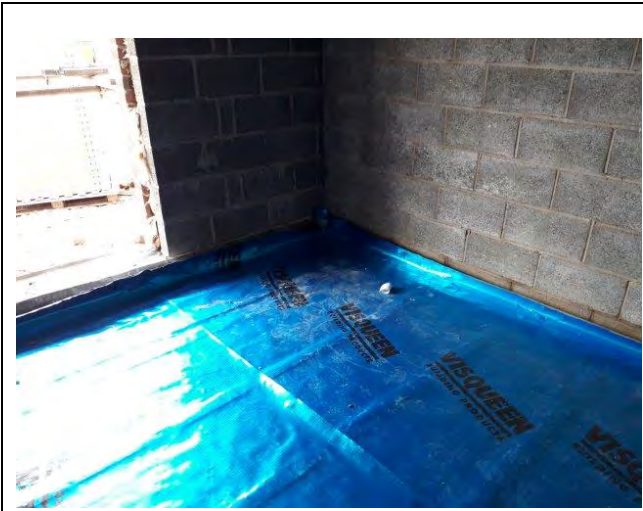
Plot 9

Photograph 1:
Evidence of gas membrane coverage across Plot 9.

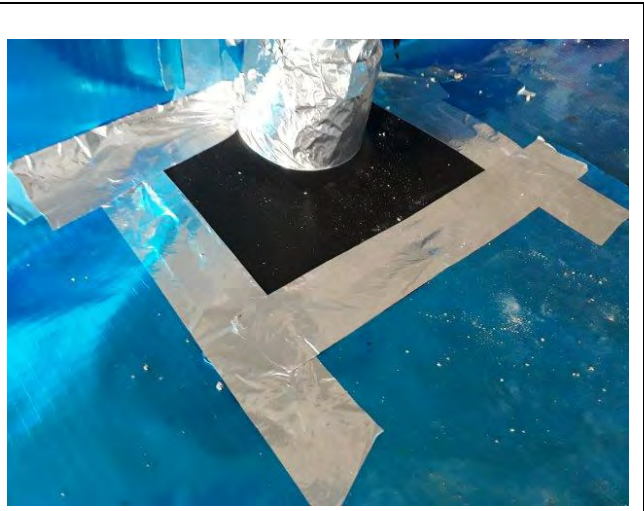
Photograph 2:
Evidence of appropriate sealing around services for Plot 9.

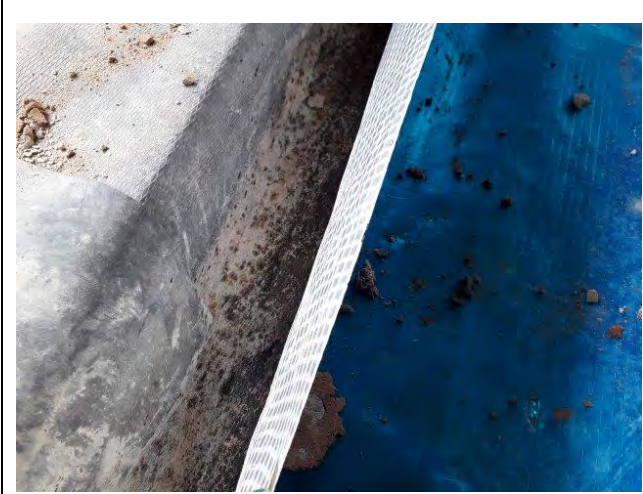
Photograph 3:
Evidence of appropriate sealing of membrane to DPC with appropriate overlap for Plot 9.

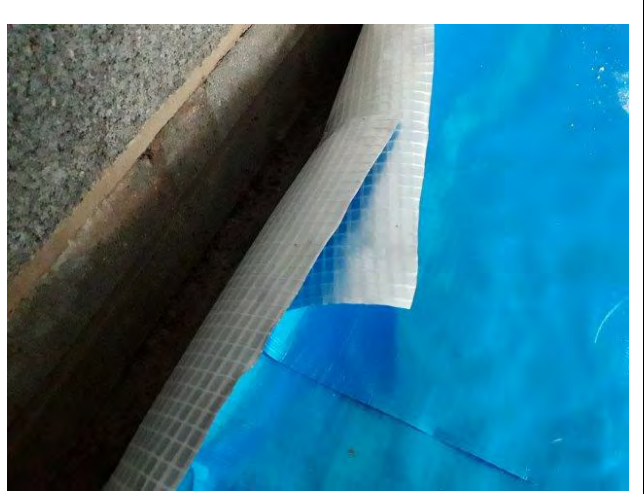
Photograph 4:
Evidence of appropriate overlap of the membrane for Plot 9.

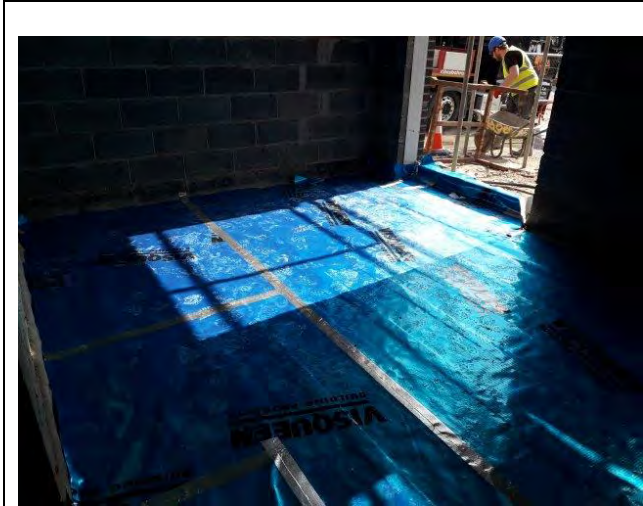
Plot 37

Photograph 1:
Evidence of gas membrane coverage across Plot 37.

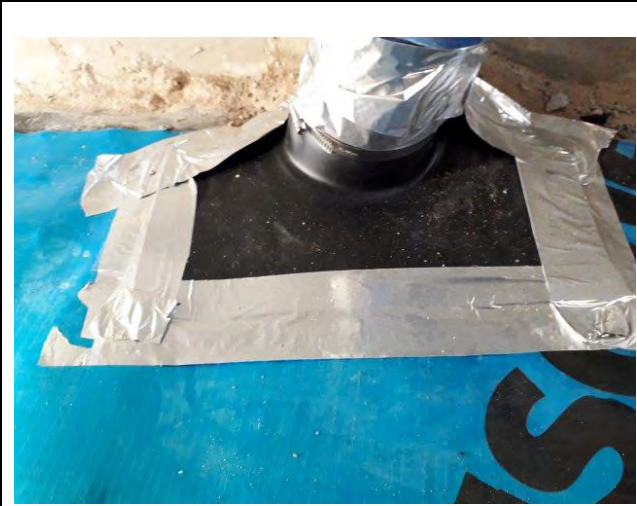
Photograph 2:
Evidence of appropriate sealing around services for Plot 37.

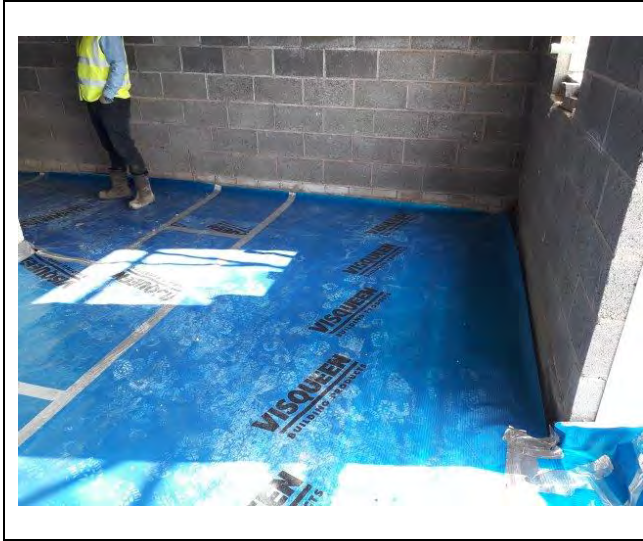
Plot 42

Photograph 1:
Evidence of gas membrane coverage across Plot 42.

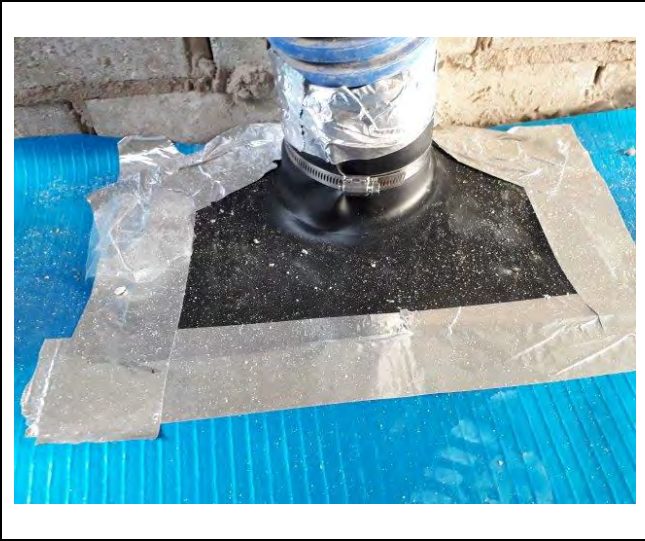
Photograph 2:
Evidence of appropriate sealing around services for Plot 42.

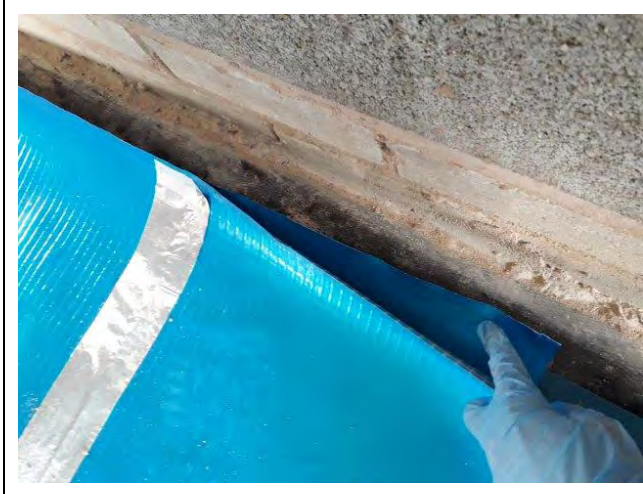
Photograph 3:
Evidence of appropriate sealing of membrane to DPC with appropriate overlap for Plot 42.

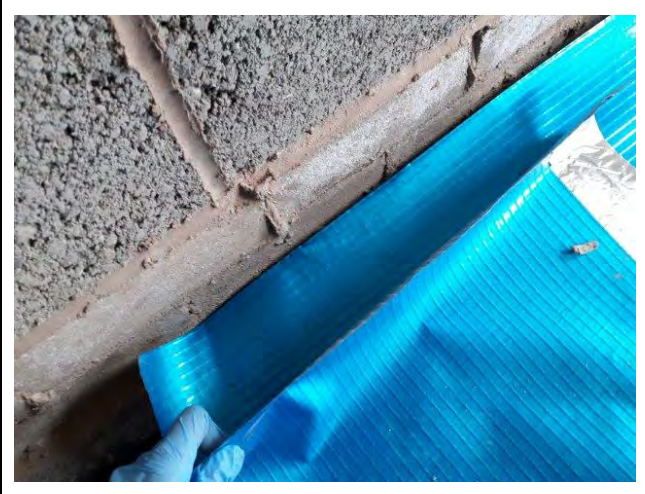
Photograph 4:
Evidence of appropriate overlap of the membrane for Plot 42.

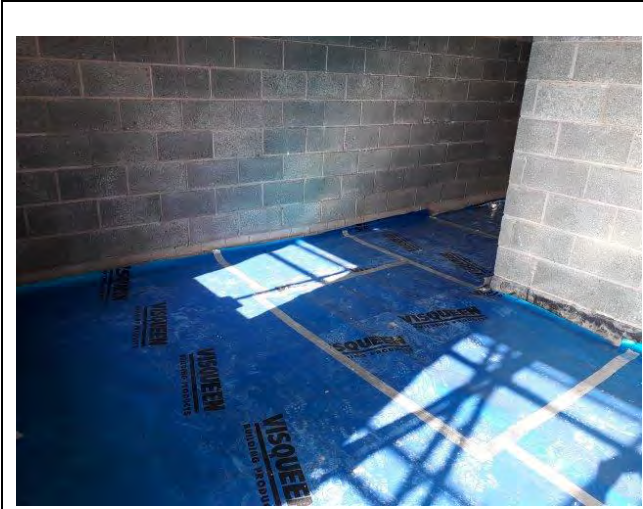
Plot 43

Photograph 1:
Evidence of gas membrane coverage across Plot 43.

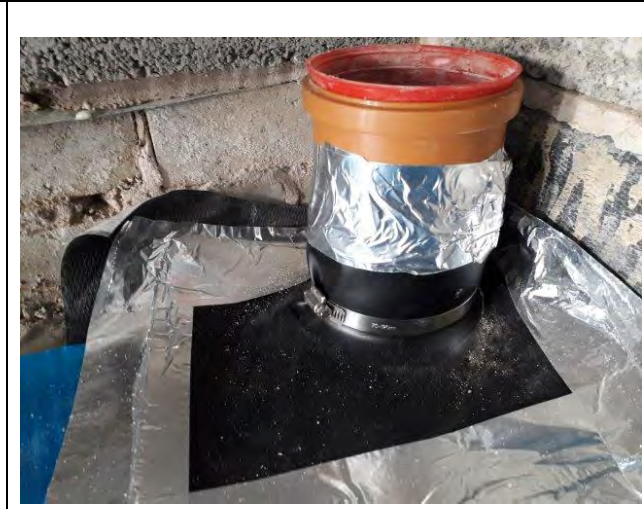
Photograph 2:
Evidence of appropriate sealing around services for Plot 43.

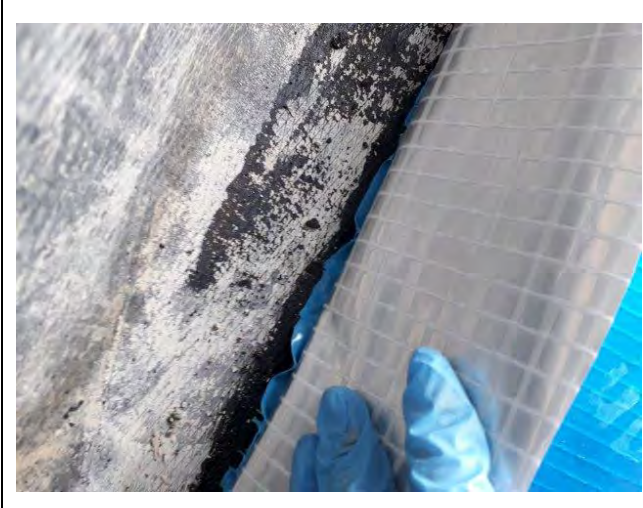
Photograph 3:
Evidence of appropriate sealing of membrane to DPC with appropriate overlap for Plot 43.

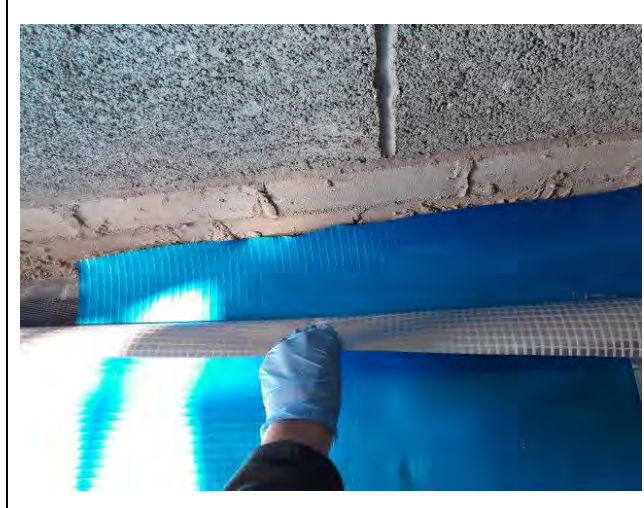
Photograph 4:
Evidence of appropriate overlap of the membrane for Plot 43.

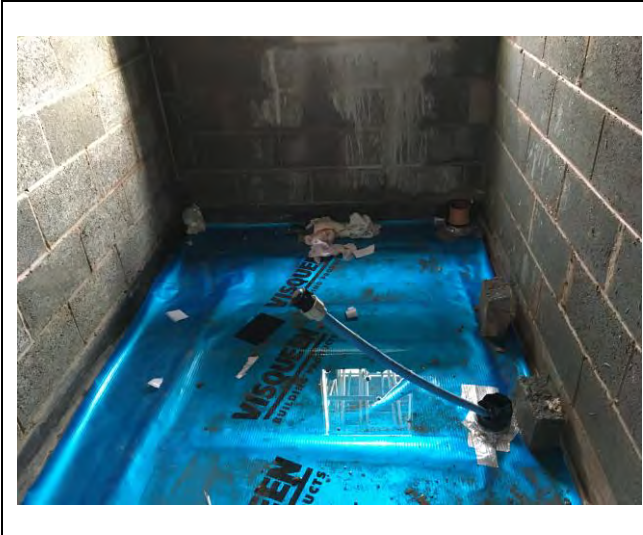
Plot 45

Photograph 1:
Evidence of gas membrane coverage across Plot 45.

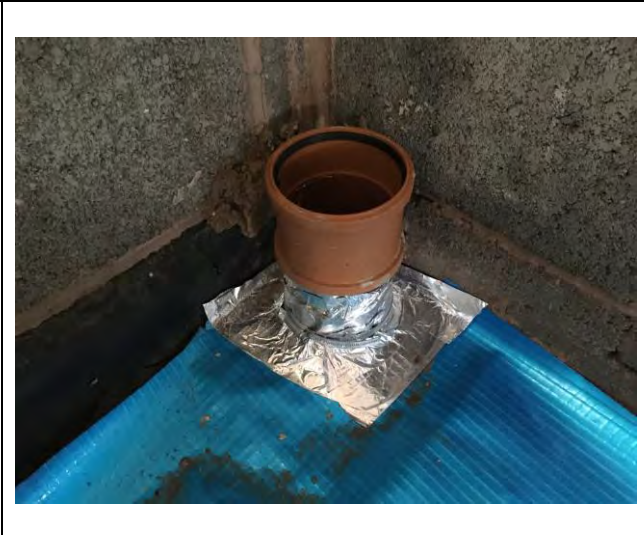
Photograph 2:
Evidence of appropriate sealing around services for Plot 45.

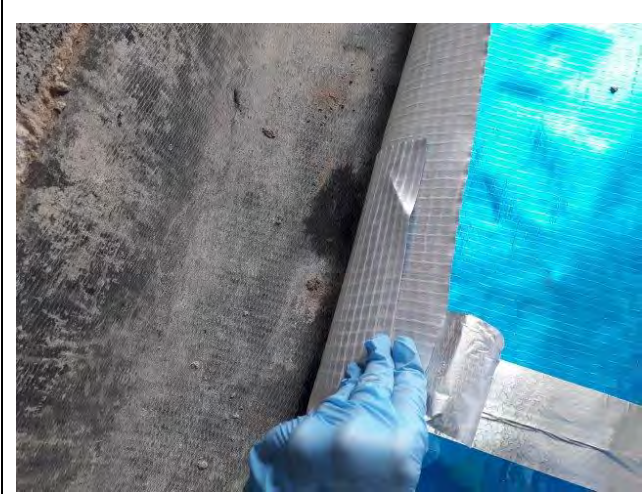
Photograph 3:
Evidence of appropriate sealing of membrane to DPC with appropriate overlap for Plot 45.

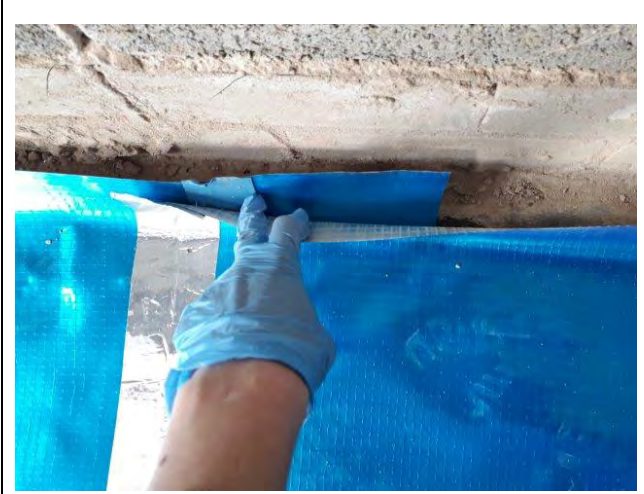
Photograph 4:
Evidence of appropriate overlap of the membrane for Plot 45.

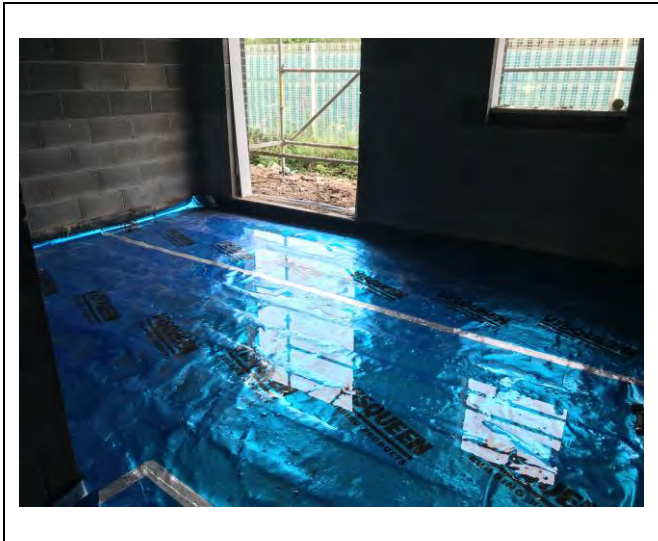
Plot 49

Photograph 1:
Evidence of gas membrane coverage across Plot 49.

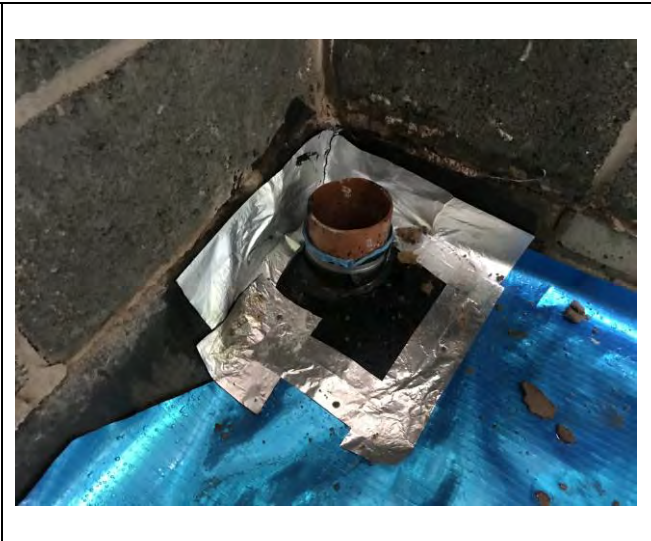
Photograph 2:
Evidence of appropriate sealing around services for Plot 49.

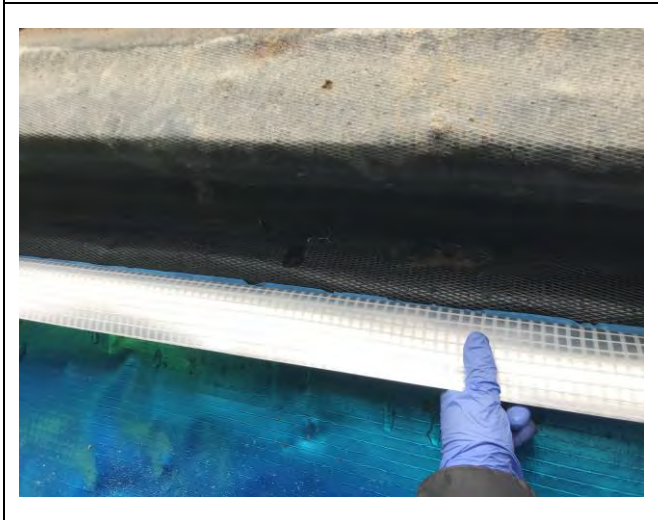
Photograph 3:
Evidence of appropriate sealing of membrane to DPC with appropriate overlap for Plot 49.

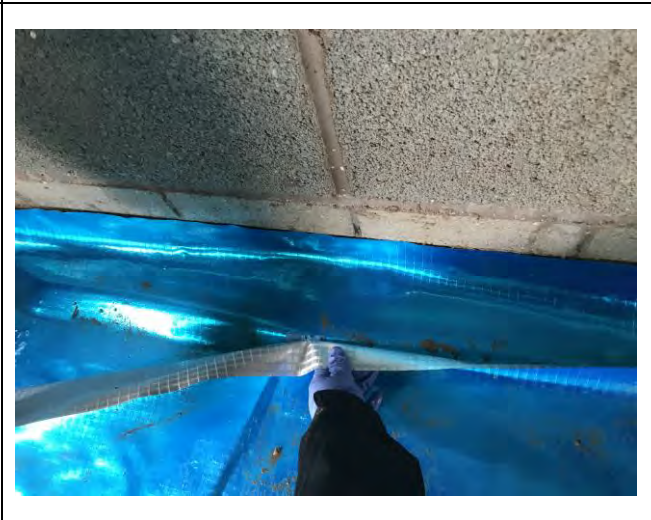
Photograph 4:
Evidence of appropriate overlap of the membrane for Plot 49.

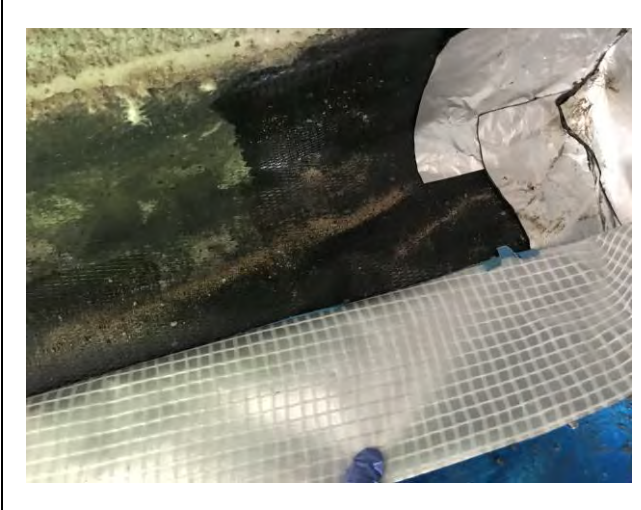
Photograph 3:
Evidence of appropriate sealing of membrane to DPC with appropriate overlap for Plot 50.

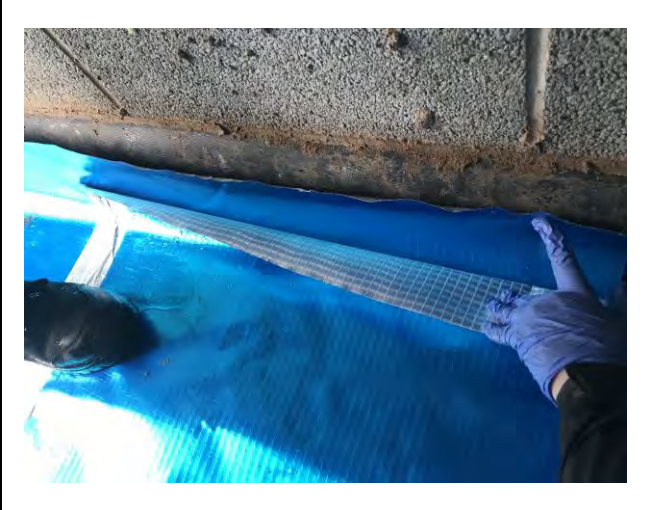
Photograph 4:
Evidence of appropriate overlap of the membrane for Plot 50.

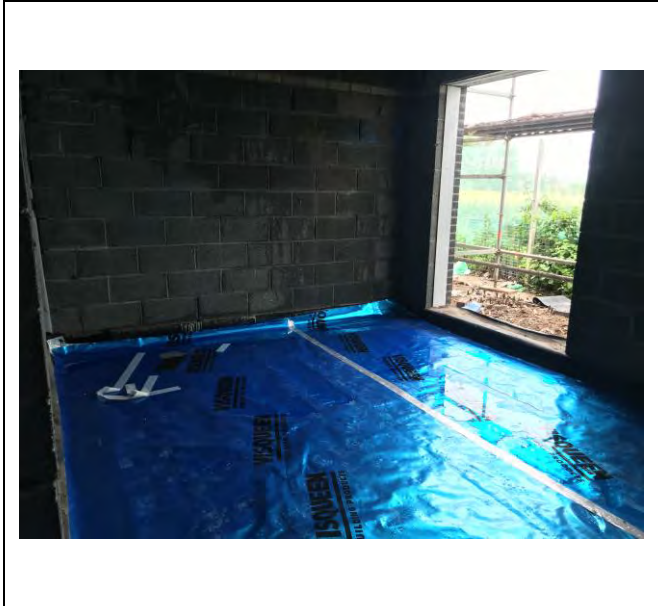
Plot 52

Photograph 1:
Evidence of gas membrane coverage across Plot 52.

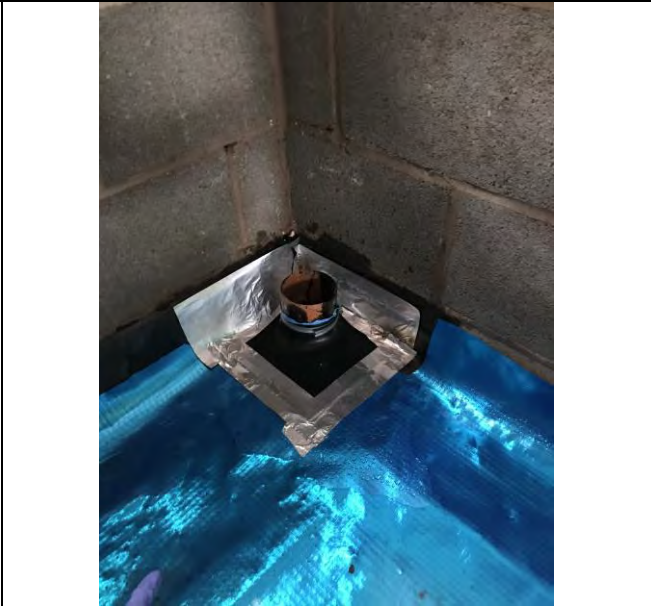
Photograph 2:
Evidence of appropriate sealing around services for Plot 52.

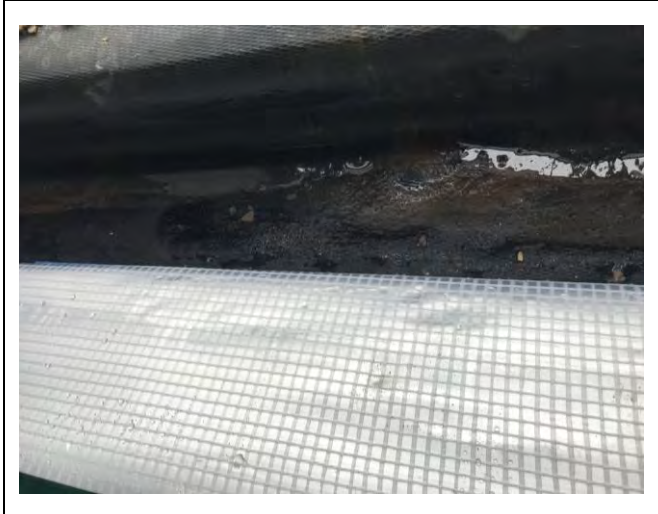
Photograph 3:
Evidence of appropriate sealing of membrane to DPC with appropriate overlap for Plot 52.

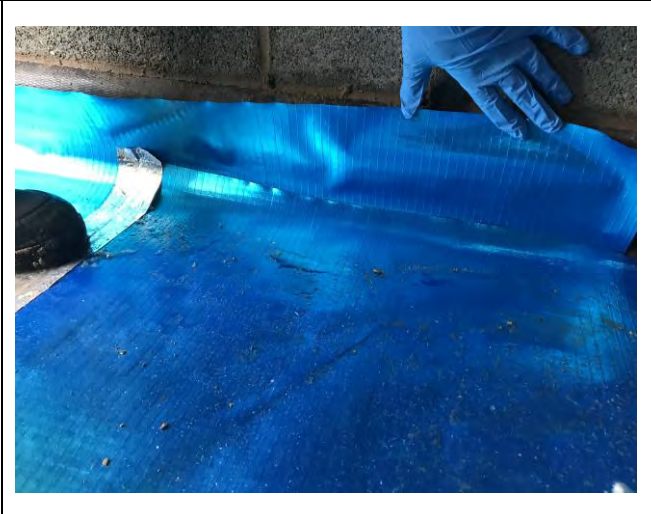
Photograph 4:
Evidence of appropriate overlap of the membrane for Plot 52.

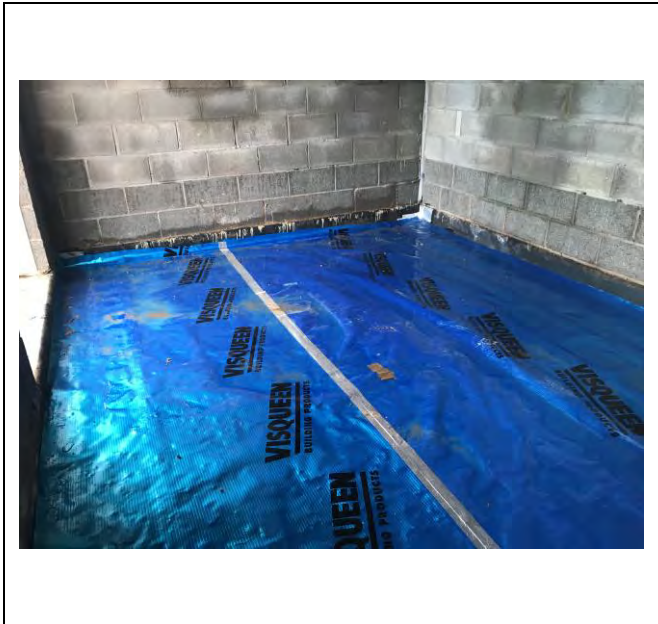
Plot 53

Photograph 1:
Evidence of gas membrane coverage across Plot 53.

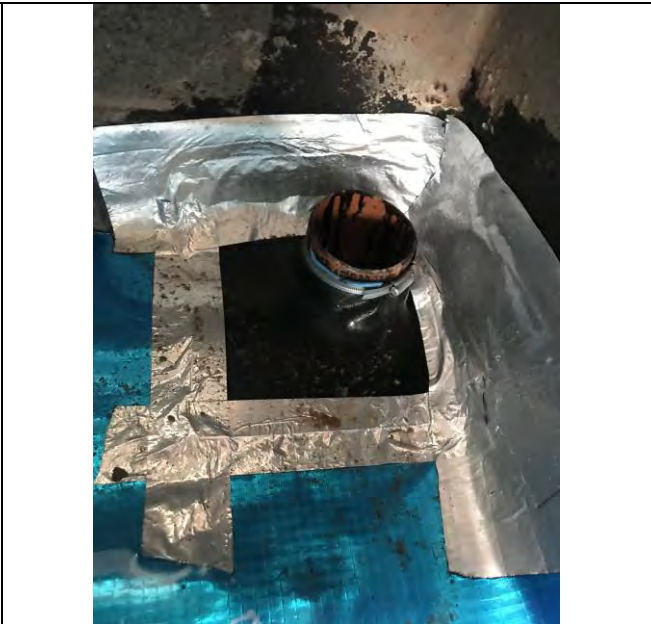
Photograph 2:
Evidence of appropriate sealing around services for Plot 53.

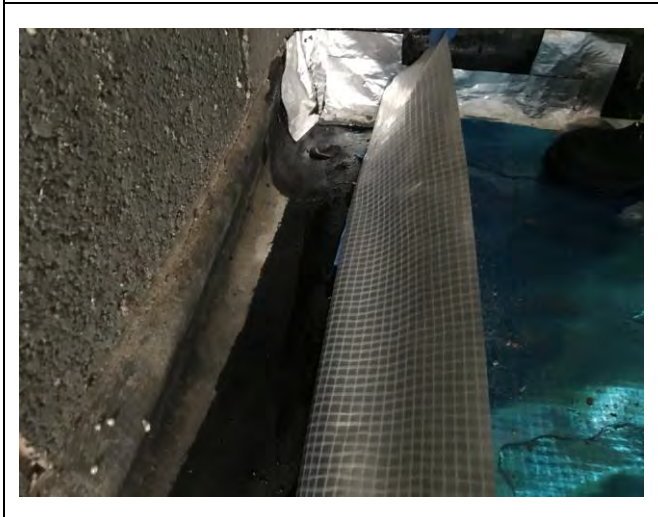
Photograph 3:
Evidence of appropriate sealing of membrane to DPC with appropriate overlap for Plot 53.

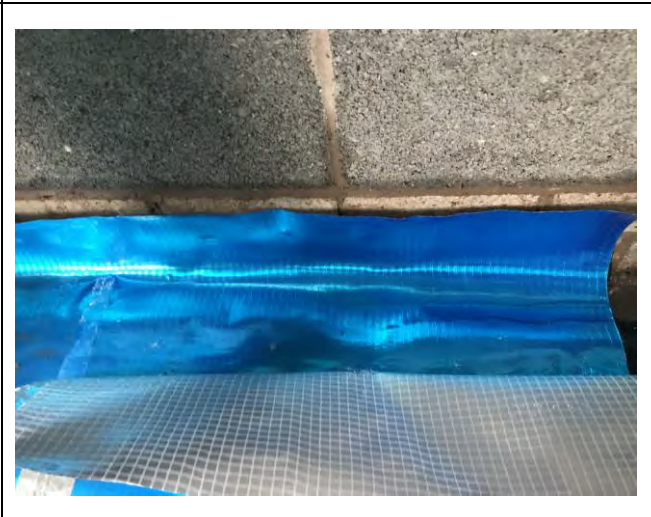
Photograph 4:
Evidence of appropriate overlap of the membrane for Plot 53.

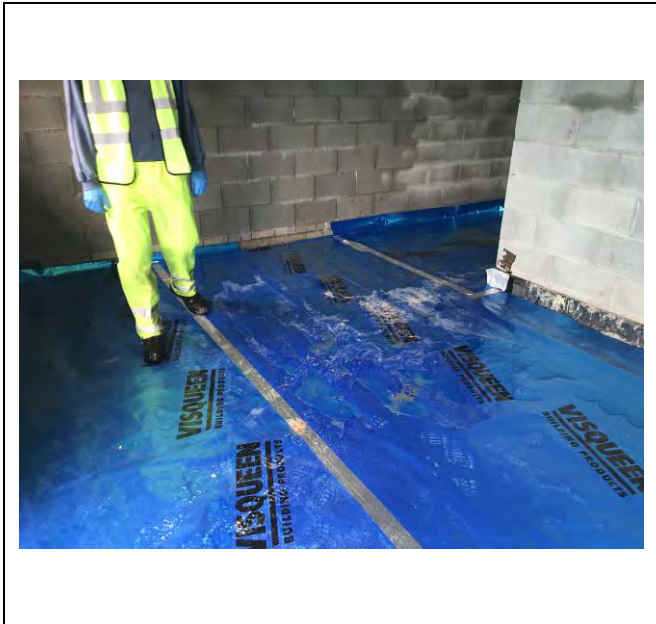
Plot 55

Photograph 1:
Evidence of gas membrane coverage across Plot 55.

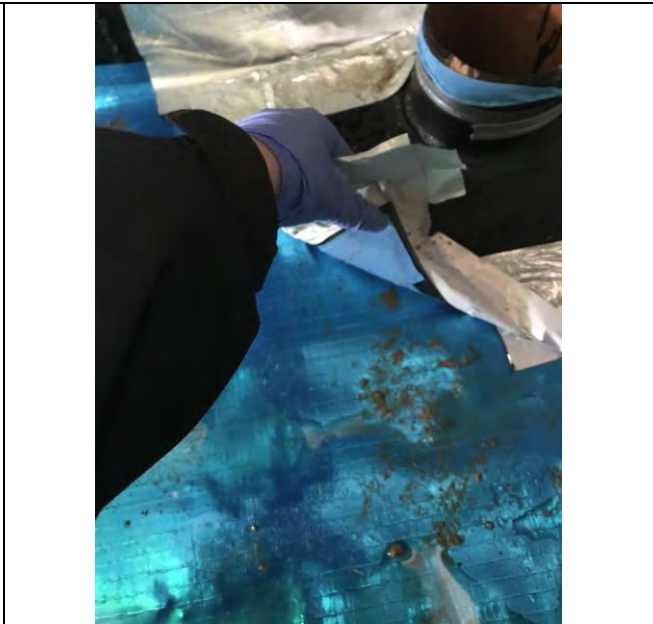
Photograph 2:
Evidence of appropriate sealing around services for Plot 55.

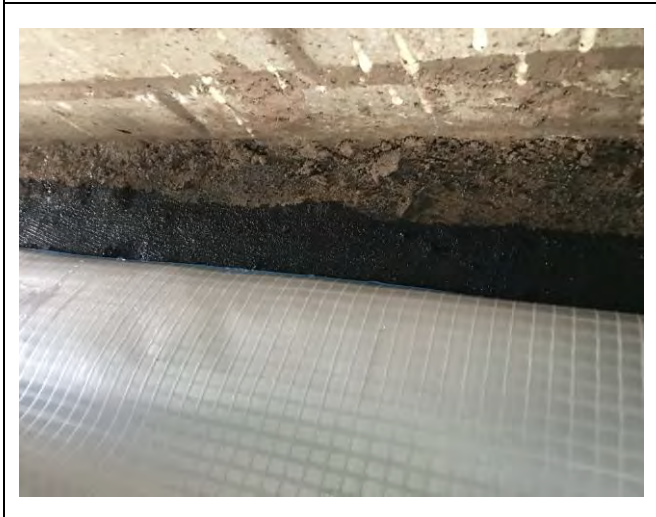
Photograph 3:
Evidence of appropriate sealing of membrane to DPC with appropriate overlap for Plot 55.

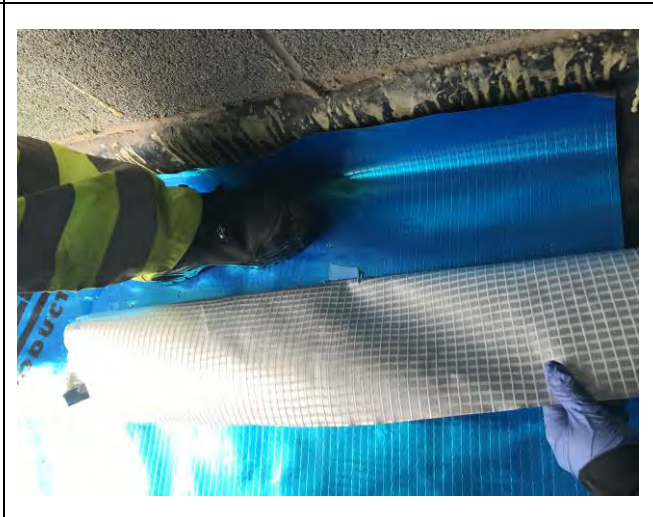
Photograph 4:
Evidence of appropriate overlap of the membrane for Plot 55.

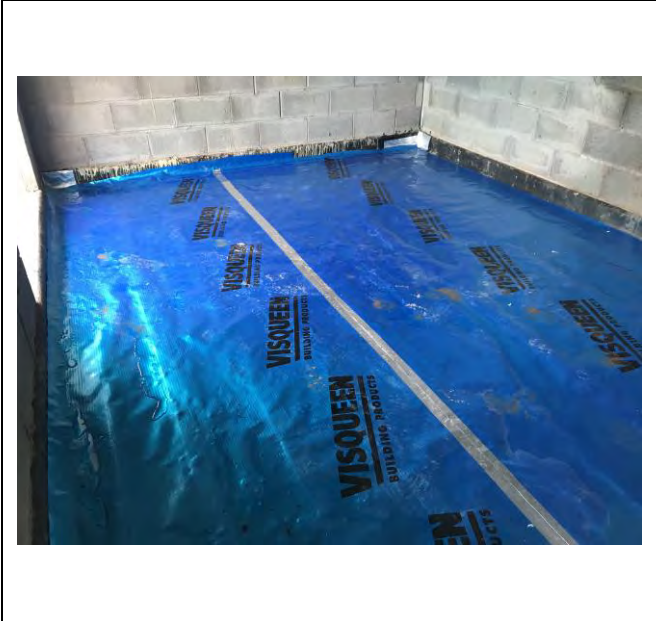
Plot 56

Photograph 1:
Evidence of gas membrane coverage across Plot 56.

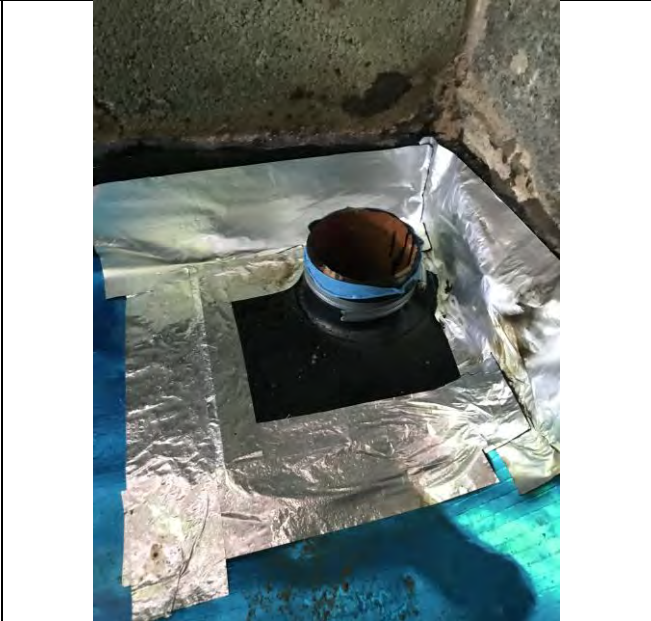
Photograph 2:
Evidence of appropriate sealing around services for Plot 56.

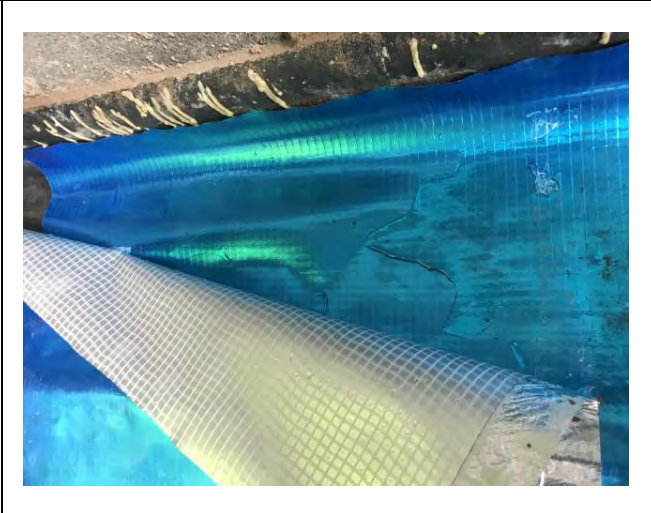
Photograph 4:
Evidence of appropriate overlap of the membrane for Plot 56.

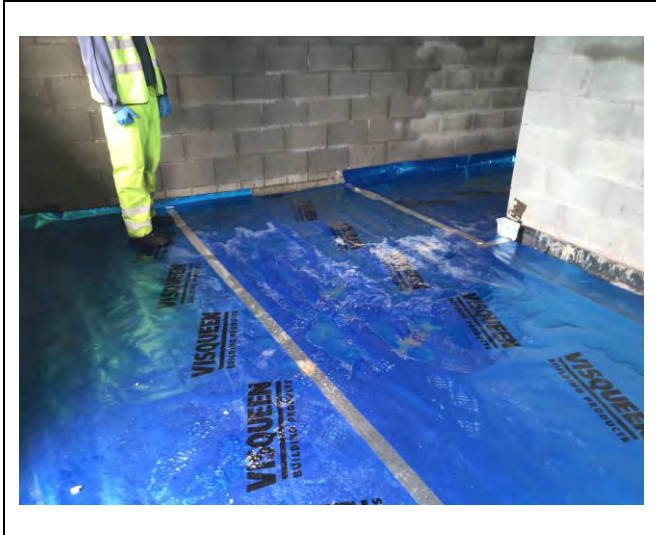
Plot 57

Photograph 1:
Evidence of gas membrane coverage across Plot 57.

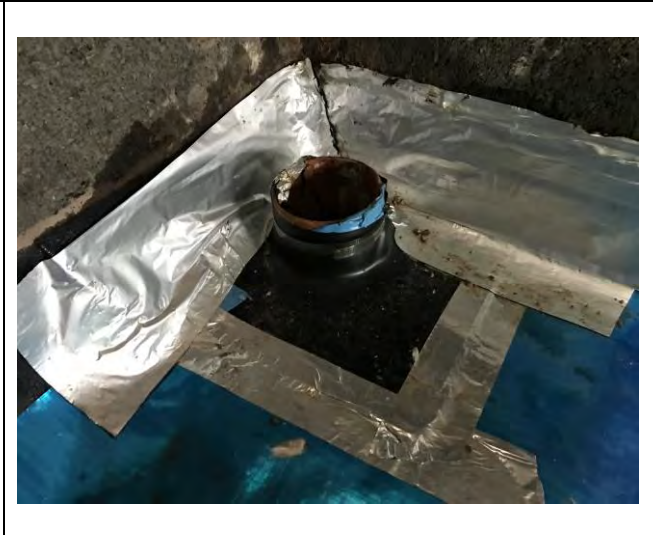
Photograph 2:
Evidence of appropriate sealing around services for Plot 57.

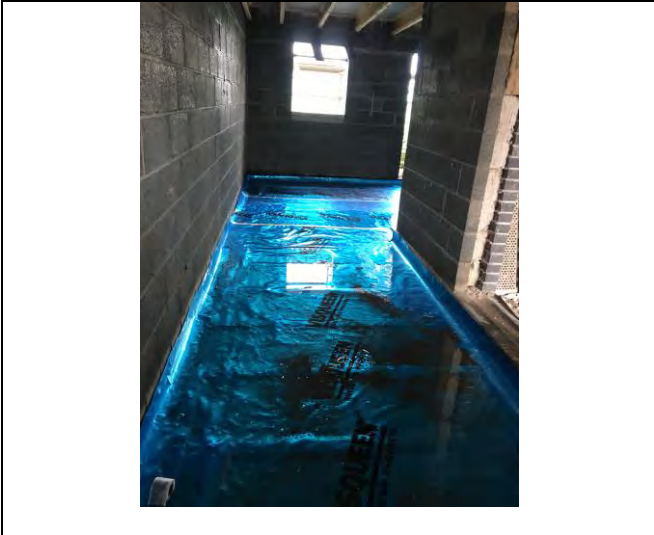
Plot 58

Photograph 1:
Evidence of gas membrane coverage across Plot 58.

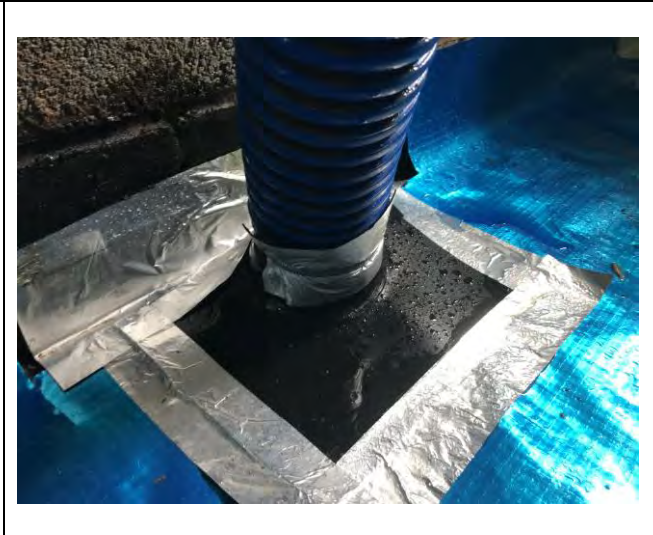
Photograph 2:
Evidence of appropriate sealing around services for Plot 58.

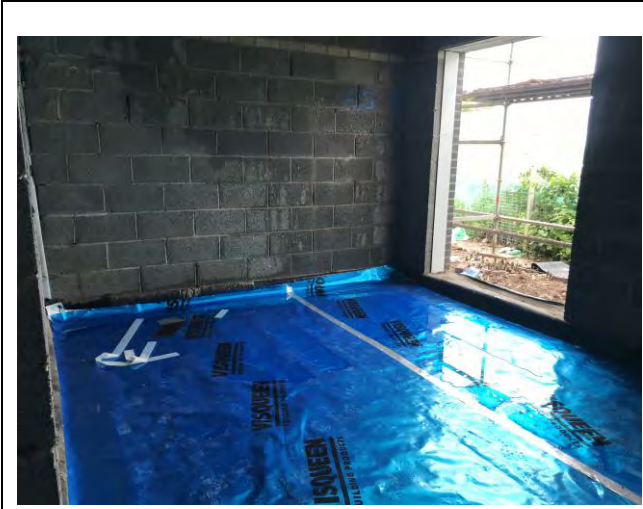
Plot 59

Photograph 1:
Evidence of gas membrane coverage across Plot 59.

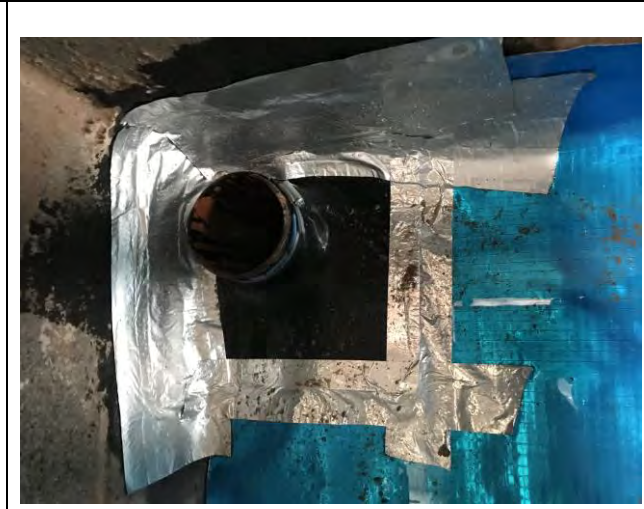
Photograph 2:
Evidence of appropriate sealing around services for Plot 59.

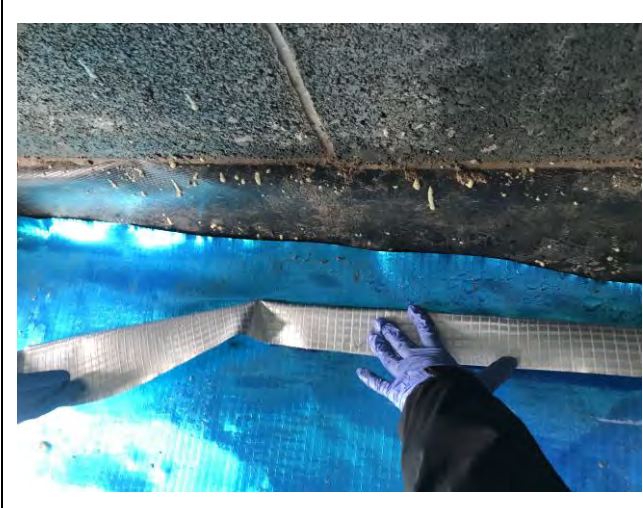
Photograph 3:
Evidence of appropriate sealing of membrane to DPC with appropriate overlap for Plot 59.

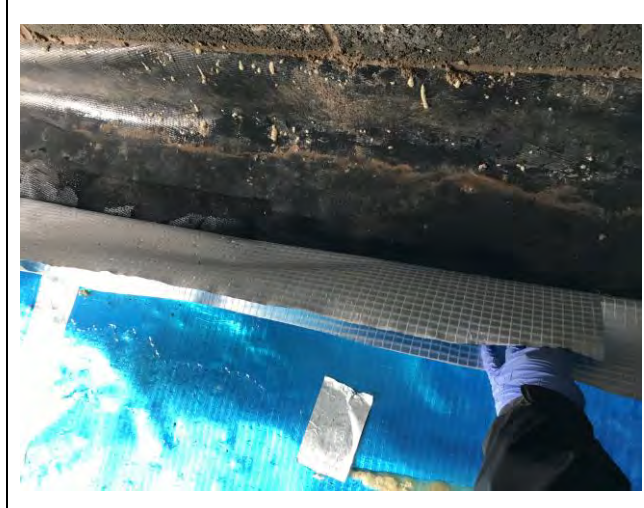
Photograph 4:
Evidence of appropriate overlap of the membrane for Plot 59.

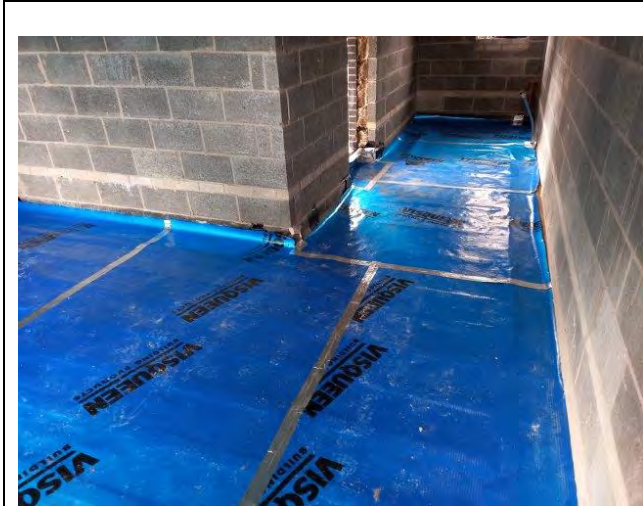
Plot 62

Photograph 1:
Evidence of gas membrane coverage across Plot 62.

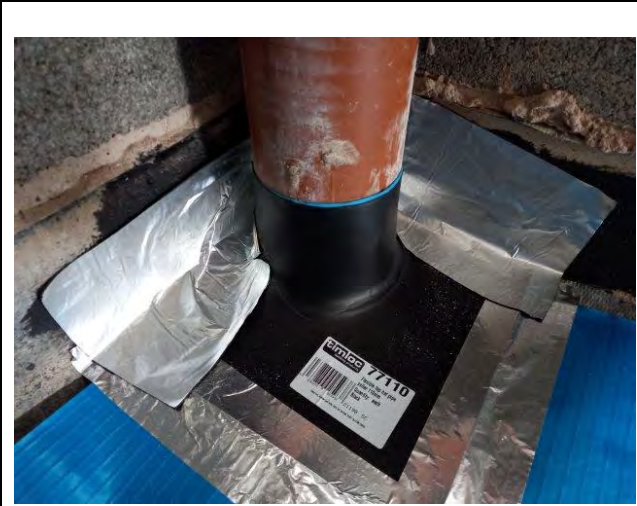
Photograph 2:
Evidence of appropriate sealing around services for Plot 62.

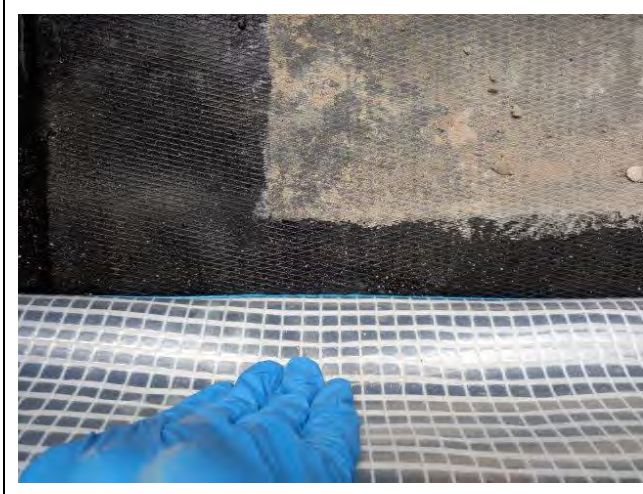
Photograph 3:
Evidence of appropriate sealing of membrane to DPC with appropriate overlap for Plot 62.
