Arboricultural Consultancy for Lloyds Bank

1. Case Details

Insured	Mr Mark Buckley	Address	11 Butts Lane, Egglecliffe, Stockton-on-Tees, TS16 9BT		
Client	Subsidence Management Services	Contact	Stephen Rutherford	Claim No.	IFS-LBG-SUB-22-0102249
ES Ref	SA-250976	Consultant	Giles Mercer	Contact No.	0330 380 1036
Report Date	18/11/2022

11 Butts Lane, Egglecliffe, Stockton-on-Tees, TS16 9BT

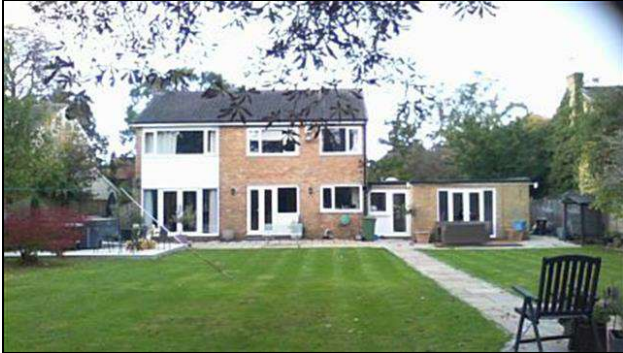
Rear

We understand that the current damage relates to the rear left-hand corner of the insured dwelling, where cracking indicates downwards movement.

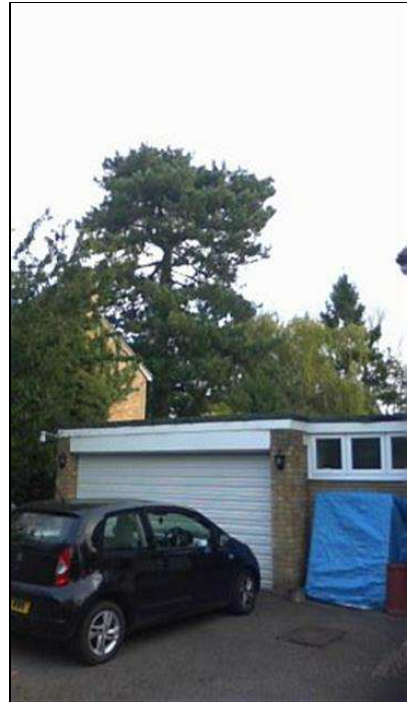
T1 - Pine

With due regards to species profile, size and proximity, the Pine (T1) and Weeping Willow (T2) are considered the dominant features proximate to the focal area(s) of movement and accordingly, where vegetation is confirmed as being causal, we have identified them as the primary cause of the current subsidence damage.

Consequently, we have advocated the complete removal of T1 & T2 as it will offer the most certain arboricultural solution likely to restore long-term stability.

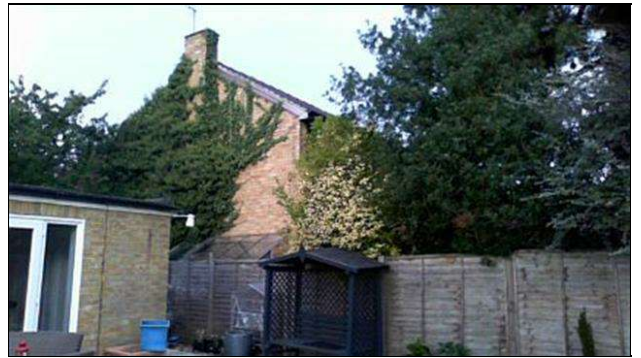
S1 - Privet

Please note that the footing of the insured property fall within the anticipated rooting distance of additional vegetation which we believe presents a foreseeable risk of future damage and accordingly we have made recommendations in respect of this.

Tree No.	Species	Age Cat	Approx. Height (m)	Distance to Building (m) *	Ownership	Action	Requirement
S1	Privet	1	3.9	2.7	A - Third Party	Action to avoid future risk	Maintain at broadly current dimensions by way of regular pruning.
S2	Cotoneaster	1	4.6	8	A - Third Party	No action	No works.
S3	Cotoneaster	1	7	1.5	C - Insured	Action to avoid future risk	Do not allow to exceed current dimensions by way of regular pruning.
T3	Holly	1	6.3	4.75	A - Third Party	Action to avoid future risk	Maintain at broadly current dimensions by way of regular pruning.
T4	Horse Chestnut	1	10.2	23	C - Insured	No action	No works.
T5	Plum (Purple leafed)	1	7	3.8	C - Insured	Action to avoid future risk	Do not allow to exceed current dimensions by way of regular pruning.

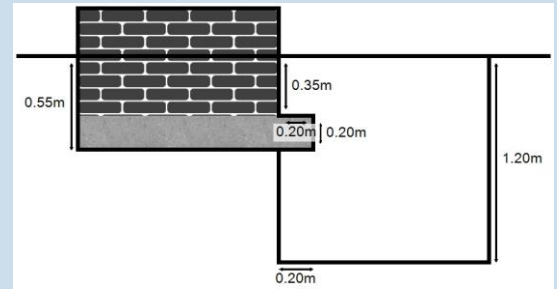
TP/BH1 Foundation Detail and Borehole Log

Extension foundation comprised of brick wall to 350mm bgl, bearing on concrete to 550mm bgl, with a total projection of 200mm from the elevation. Underside of foundation (USF) was exposed to 200mm back from the face of the foundation and probed 200mm back from the face of the foundation.

At 0.55m bgl UNDERSIDE OF EXTENSION FOUNDATION in TP/BH1.

At 0.00m to 0.55m bgl numerous roots of live appearance encountered in TP/BH1.

At 0.55m to 1.60m bgl numerous roots of live appearance encountered and sampled in TP/BH1.
