PROPOSED REPAIRS TO TIMBER FRAME, REPLACEMENT OF FOUR
WINDOWS & PROVISION OF FRENCH DRAIN

MILL HOOK FARMHOUSE, GRANBOROUGH MK18 3NJ

HERITAGE STATEMENT

December 2023

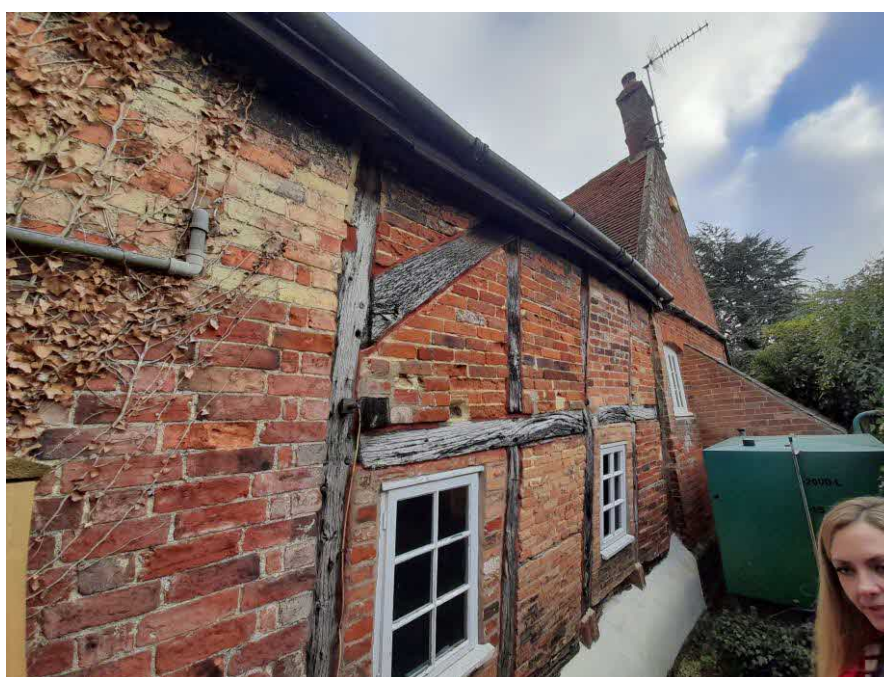
Photograph 2 below shows the problematic South West facing elevation of Mill Hook Farmhouse - the exposed timbers are in a deteriorating and unstable structural condition and require urgent remedial works. The Conservation Accredited Structural Engineer's report in Appendix E explains the need and urgency for the repairs.

Photograph 2
North facing timber frame to original part of building requires extensive repairs

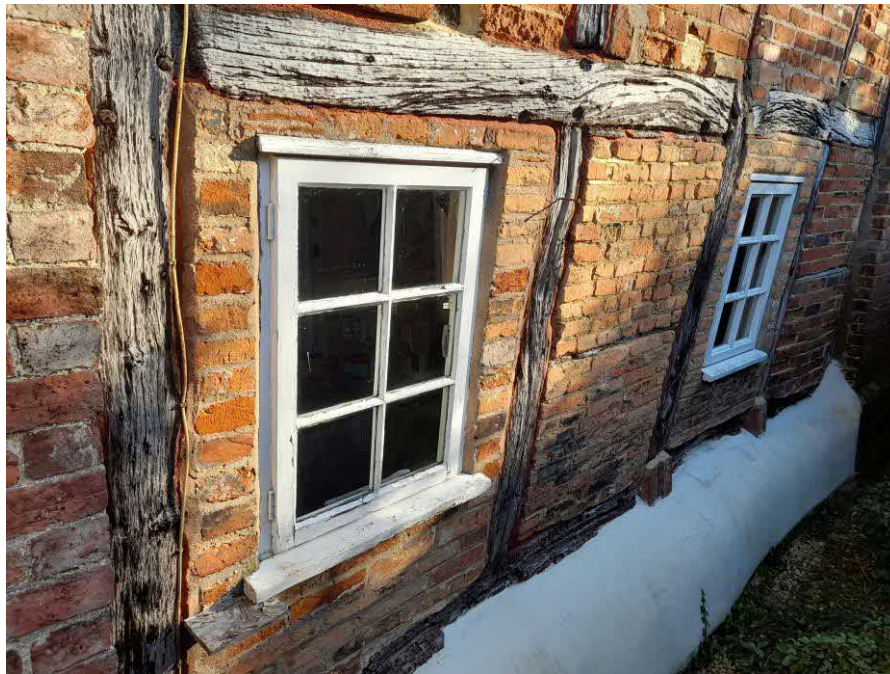
Photograph 3 below shows a closer view of the brick infill panels, with extensive repointing in damaging cement mortar in the joints and around the edges. The bricks themselves are a mixture of sizes and colours within the different panels, which highlights the many changes that this area has experienced historically and in more recent years.

Photograph 3
Close up view showing poor condition of timber frame

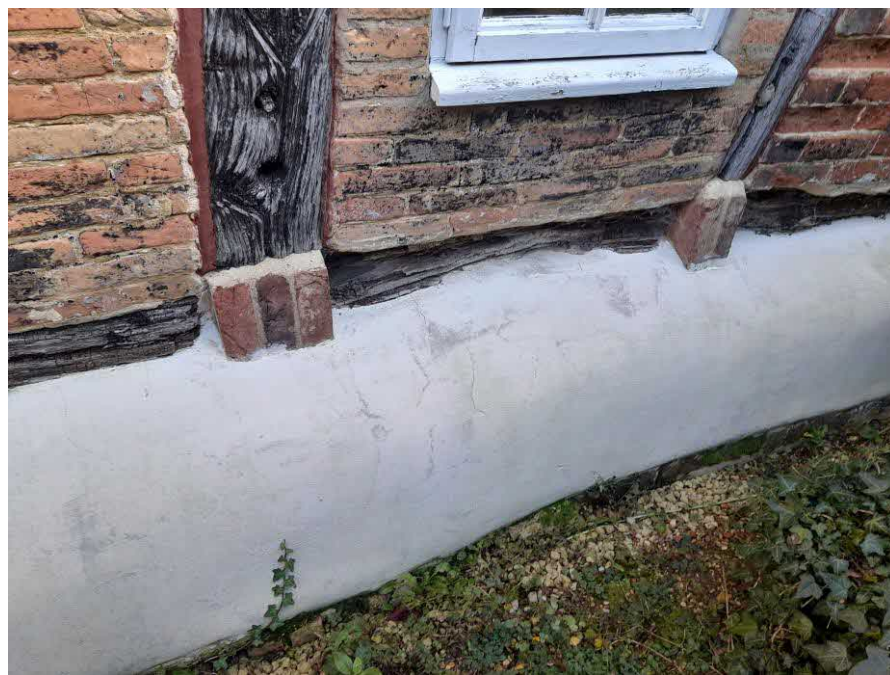
Photograph 4 below shows the temporary repairs undertaken in 2021, with bricks now supporting the bases of the vertical timbers, with the all but non-existent sole plate between them.

Photograph 4
Temporary repairs to shore up wall undertaken in 2021

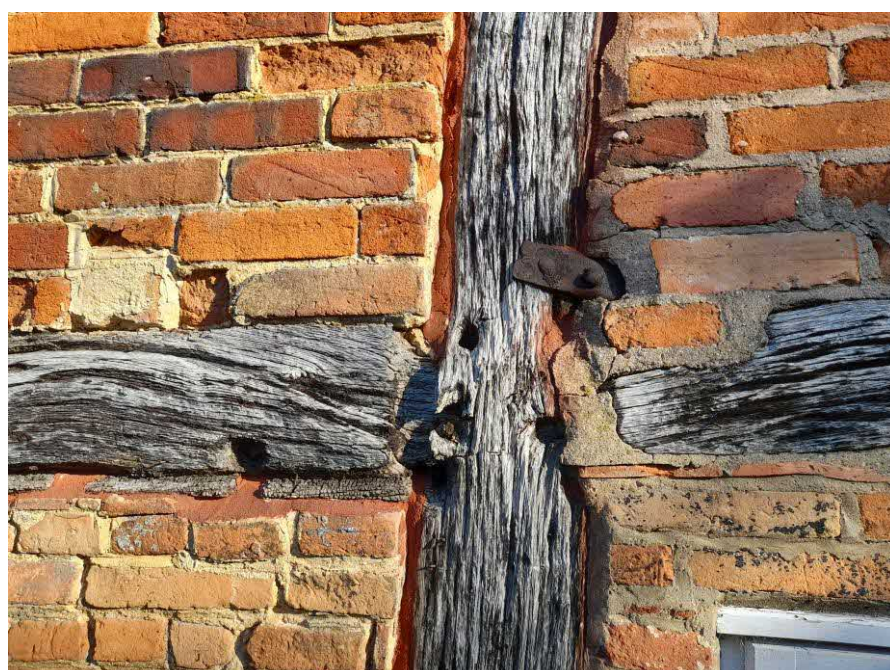
Previous poor repairs and the use of cement has inevitably caused water penetration within the timber connections through extensive open joints, as typically shown in photograph 5 below. This has caused irreversible damage to nearly of the frame, with the full extent to be assessed once the brick panels have been removed. This photograph and photograph 6 below it also show both historic and modern structural interventions through the frame, which is now providing any support.

Photograph 5
Extensive decay to joints with cement infill; historic structural repairs also evident

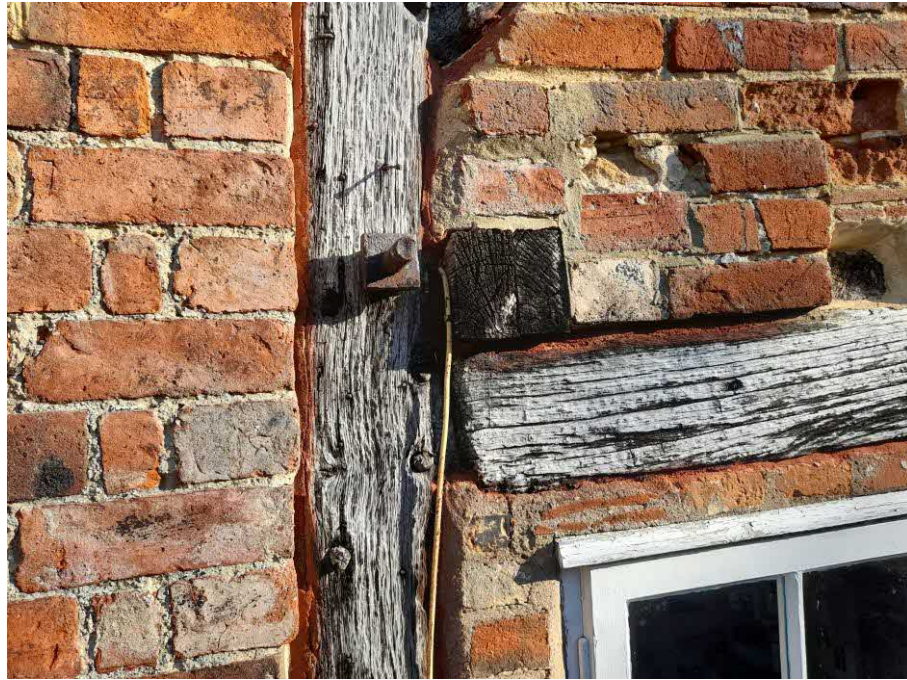
Photograph 6
Met al rod inserted through timber frame in 2021 to stabilize structure

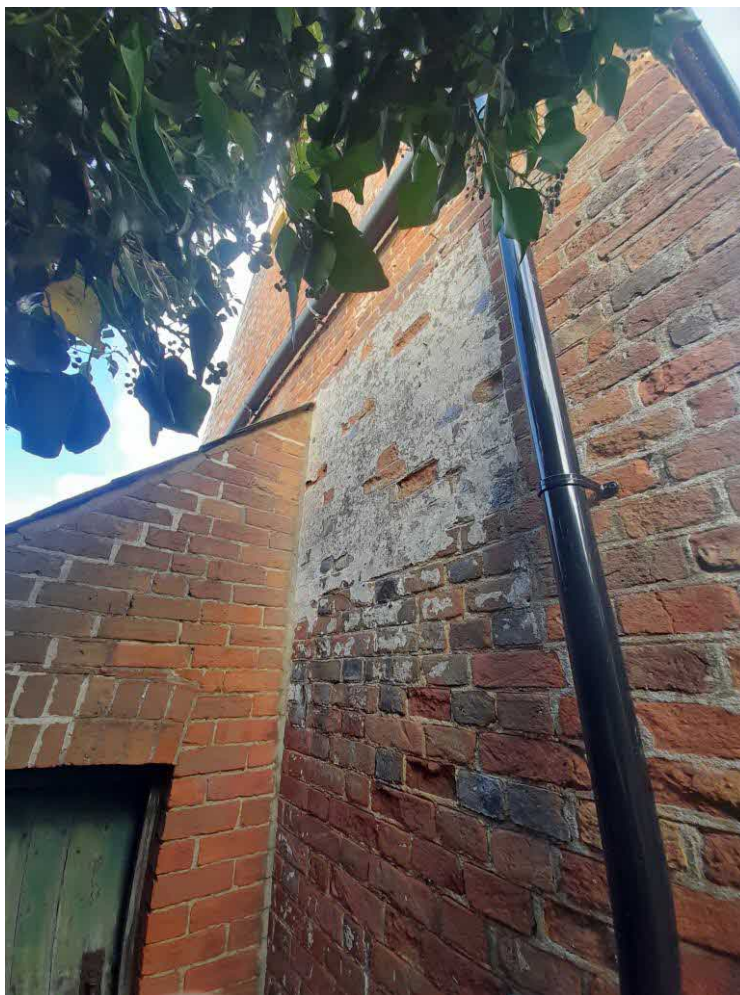
Photograph 7 below shows the adjoining wall, and provides evidence that the brick infill panels would at one time have been rendered or at the very least been covered with liberal coats of limewash. The proposals therefore include rendering in a 'Thermalime' finish, the specification for which is attached as Appendix G, followed by a minimum of four coats of traditional white limewash.

Photograph 7
Evidence of lime render/ limewash to adjoining wall

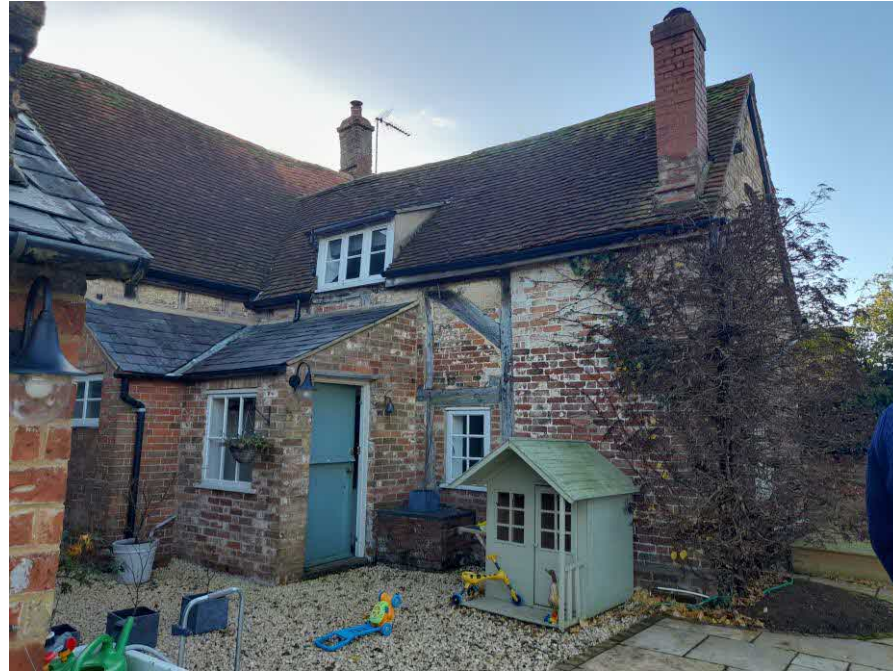
Photograph 8
Window to right of porch to be replaced

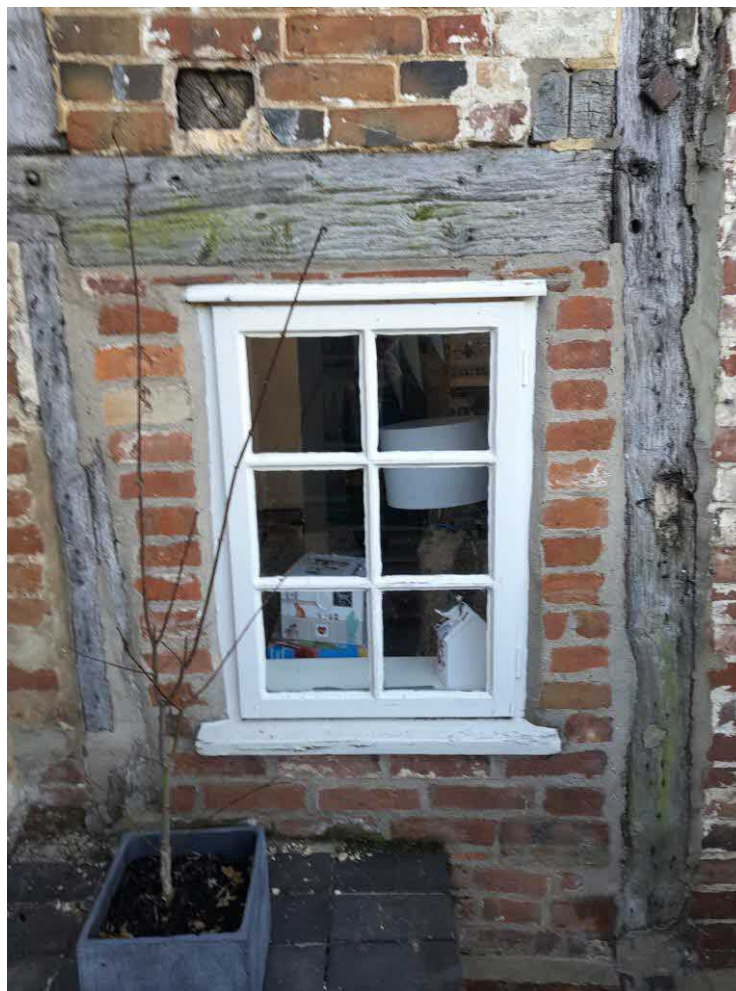
The detail in photograph 9 below shows that this window is a modern off the shelf unit of no historic significance, and it will therefore be replaced with a heritage slim line double glazed unit. This will have thinner glazing bars which will therefore be more traditional. It will also benefit from increased thermal performance , thus meeting the sustainability aims encouraged within Section 5.3 of BS 7913. To ensure airflow, the unit will also incorporate a trickle vent.

Photograph 9
Close up of modern window to be replaced, to right of porch

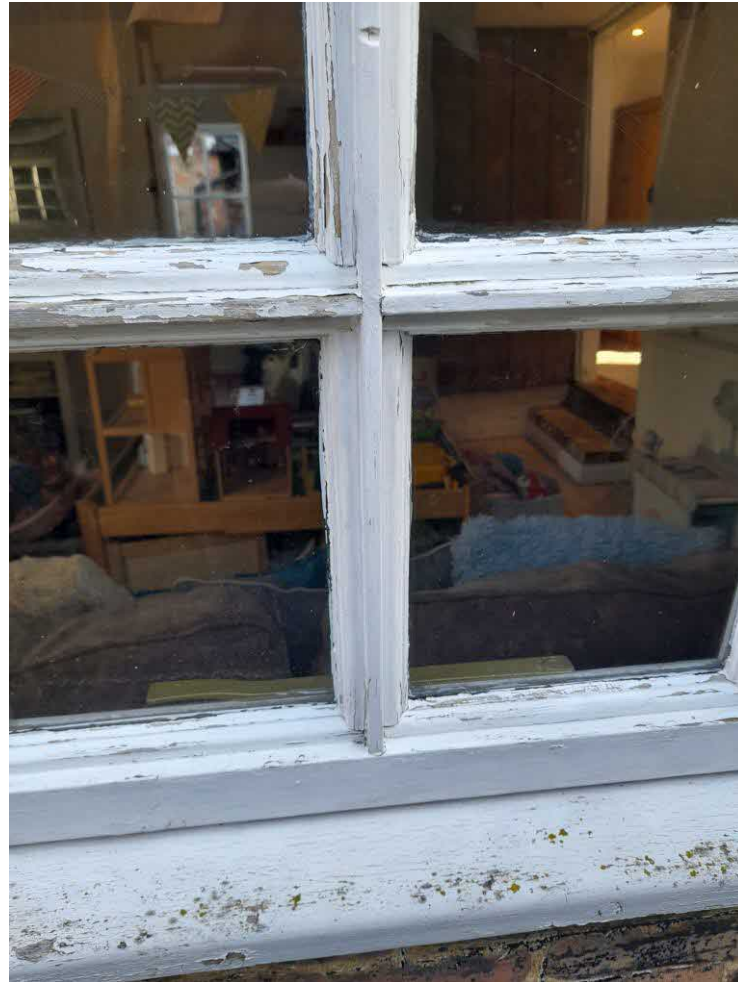
The two windows to the opposite side will need to be removed as part of the timber frame repair work. The windows are of different design, as can be seen from the profiles of the glazing bars in photographs 10 and 11 below , and again they are modern ready-made casements of no historic significance.

Photograph 10
Thick non-traditional glazing bars to right side window within South West facing timber frame panel

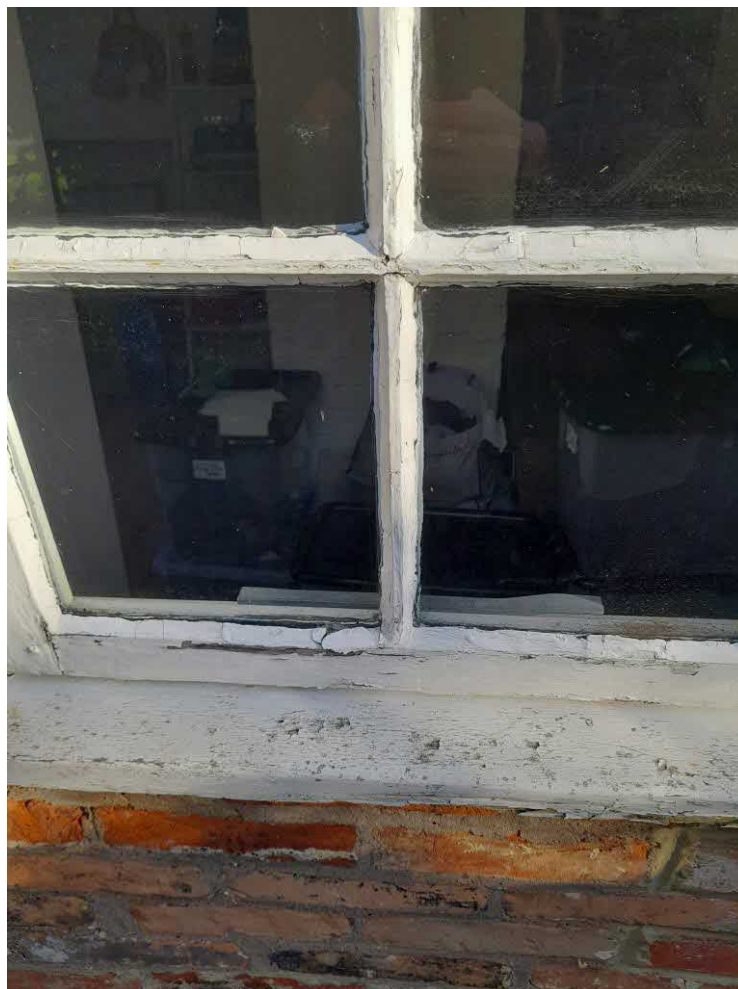
Photograph 11
Close up of modern glazing bars to left side window within South West facing timber frame panel

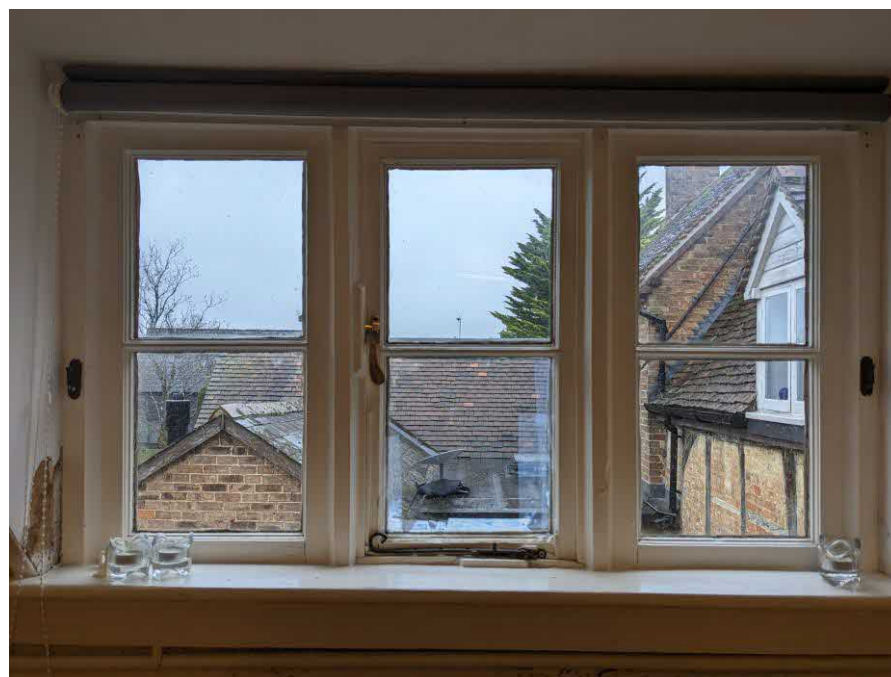
The fourth window proposed for replacement is to the Bedroom to the rear elevation, and can also be seen from photograph 8 above. This window is likely to date from the 1920's so has limited significance, but it is in very poor condition. Internal and external images of this window can be seen from photographs 13 and 14 below, which also highlight its poor condition.

Photograph 13
Internal view of Bedroom window proposed for replacement

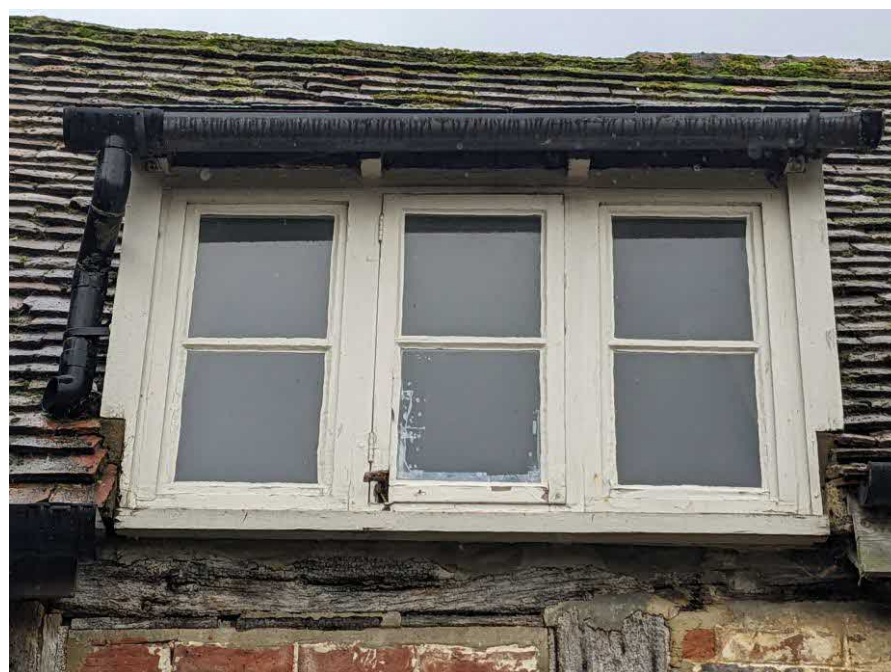
Photograph 14
External view of Bedroom window, showing poor condition of frame

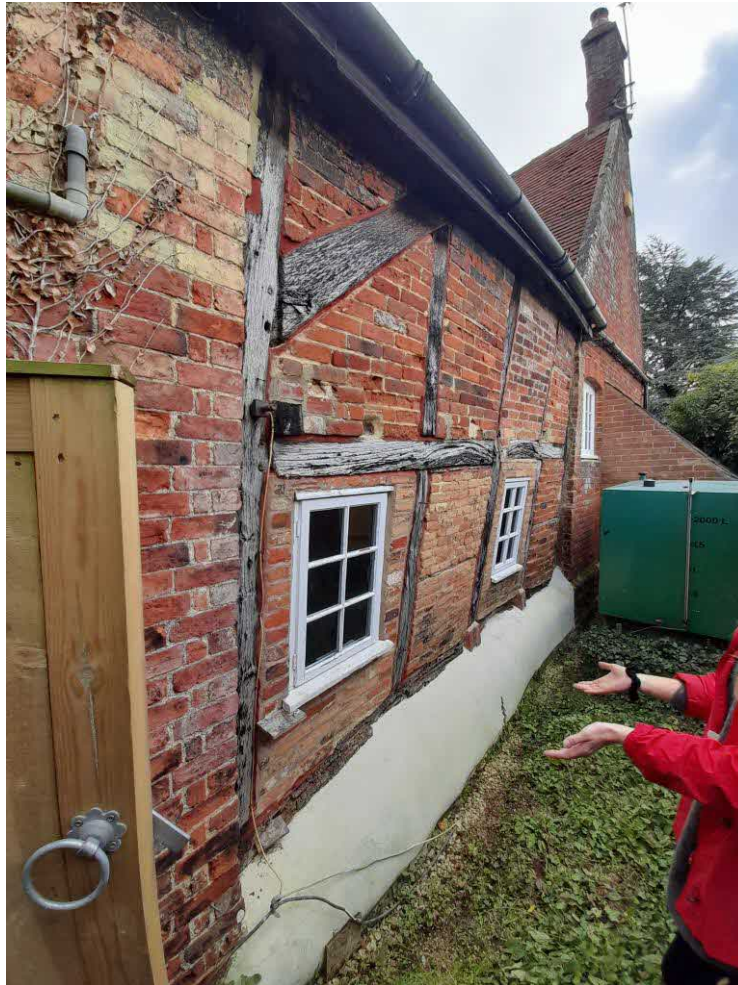
The timber frame to the South West facing elevation of Mill Hook Farmhouse forms part of the earliest structure of the building. It faces directly into the prevailing weather and has deteriorated to the extent that the frame itself offers no structural support. This can be seen from photograph 15 below, which clearly shows how the wall is significantly bowing out.

Photograph 15
Side angle of timber frame highlighting extensive bowing of wall

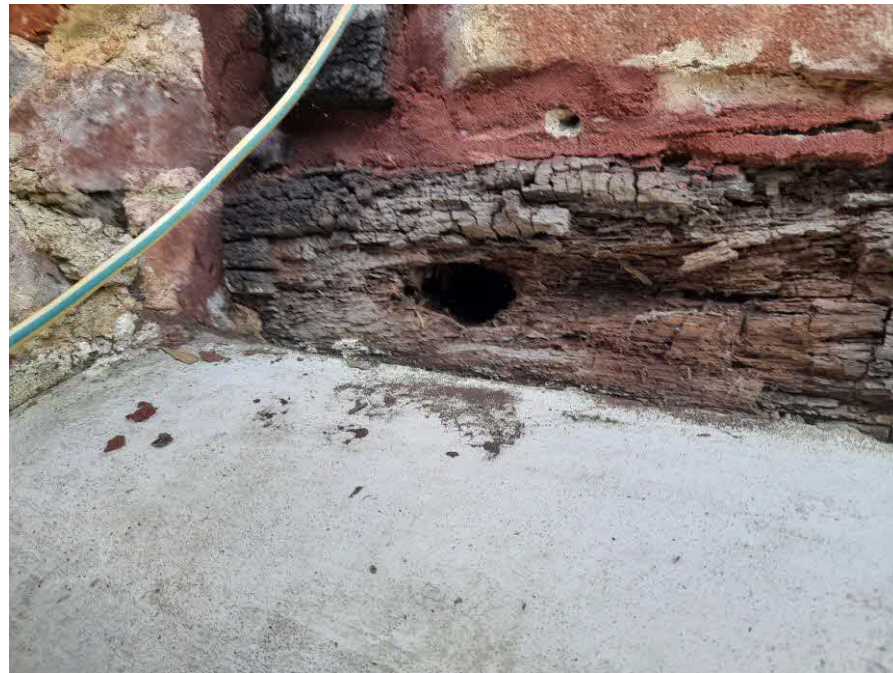
The wall is now braced by a number of metal straps and rods, some historic and the most recent fixed in place in 2021 as a temporary holding measure – the rods can be seen in photographs 5 - 6 above. Typically, the decay has been accelerated by inappropriate modern intervention in the form of cement mortar around the edges and within the joints of the brick panels. This has enabled moisture ingress to disintegrate the tenon joints and sole plate as shown in photograph 16 below, and has made the wall unstable, .

Photograph 16
Extensive decay & rat hole through sole plate to Playroom

The Conservation Accredited Structural Engineer's report attached as Appendix E confirms the problem, with extensive repairs/ potential replacement of the whole of the timber frame now required. This will necessitate removal of the brick infill panels, following which a detailed assessment can be undertaken to see which (if any) of the timbers are salvageable in accordance with best conservation practice and in line with the Conservation Principles set out within this Heritage Statement.

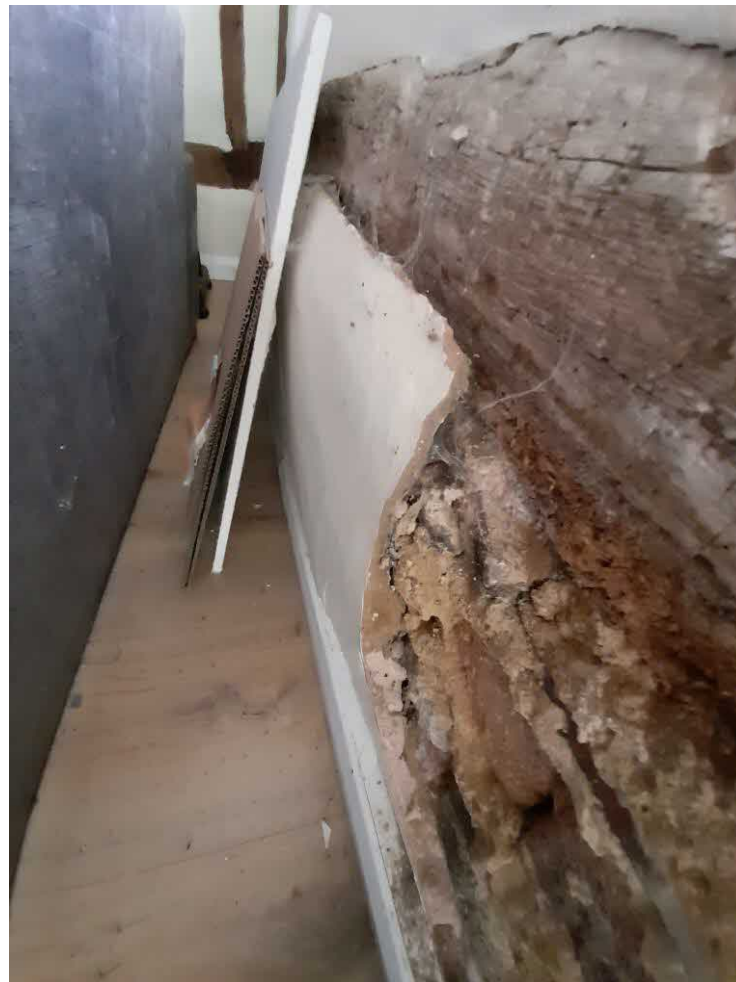
This simple preventative maintenance technique will effectively reduce the external ground levels by enabling water to permeate through shingle at the side of the wall. The stone plinth in photograph 17 below shows how moisture has become trapped at the base of the sole plate on top, causing significant decay.

Photograph 17
Cement render to inside of stone plinth will be replaced in lime

The installation of a French Drain will alleviate the water ingress issue, slow down the deterioration of the timber sole plate, and thereby increase the lifespan of the structure.

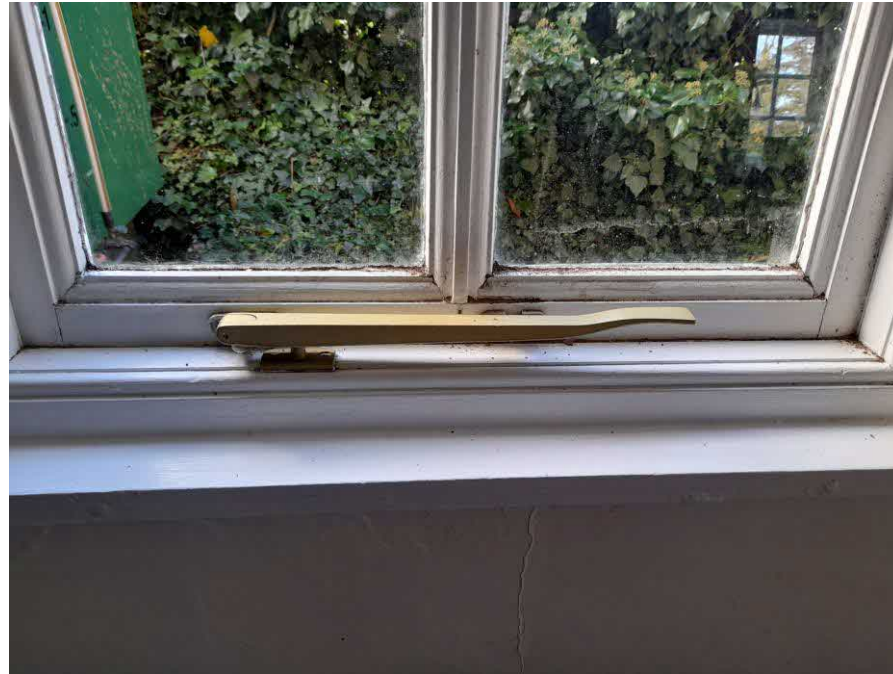
The three windows to be replaced in the Playroom are all modern off the shelf units, and although they are single glazed they have thick glazing bars as shown in photographs 10 and 11 above, and modern ironmongery as shown in photograph 18 below.

Photograph 18
Interior close up of window to be replaced showing thick glazing bars & modern inappropriate ironmongery

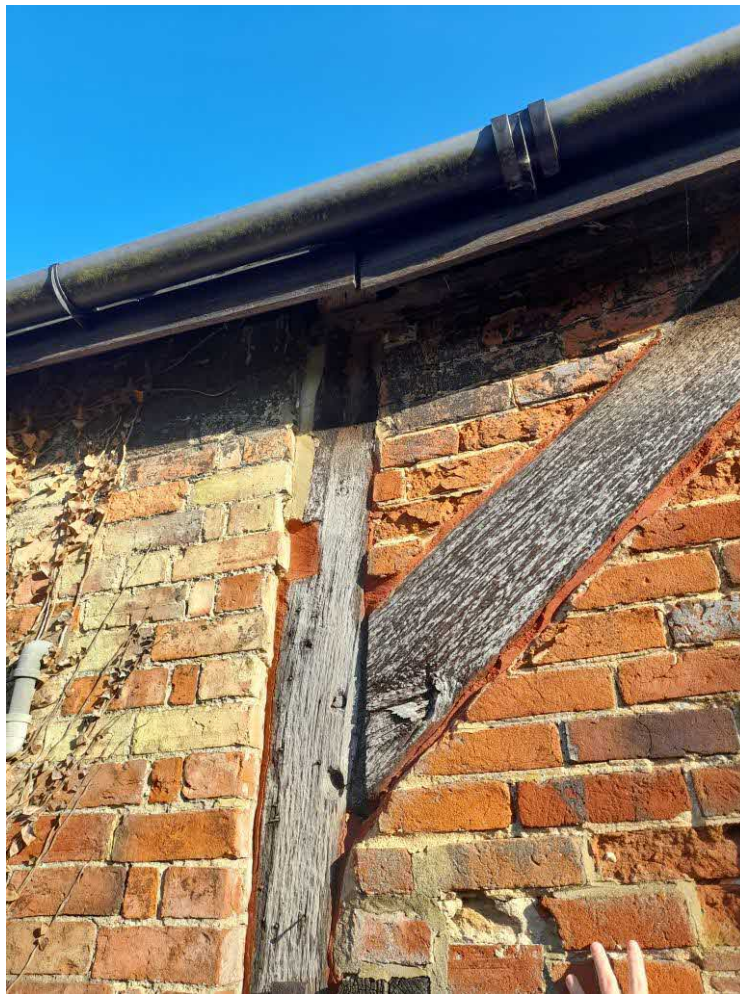
Photograph 21

Detailed assessment of timbers will take place to try to save as much historic material as possible once bricks within panels have been removed

This will include sustainably sourced Oak, salvaged bricks as far as possible supplemented by locally made hand made others which match in terms of size, colour and texture, with the insulated limerender improving thermal efficiency to further enhance the sustainable credentials of the proposals. The panels will also be limewashed on completion in the traditional manner.
