Structural Appraisal

**Mill Hook Farm
17 Winslow Road
Granborough
Buckinghamshire
MK18 3NJ**

Ref: 8759

Date: 28th October 2020

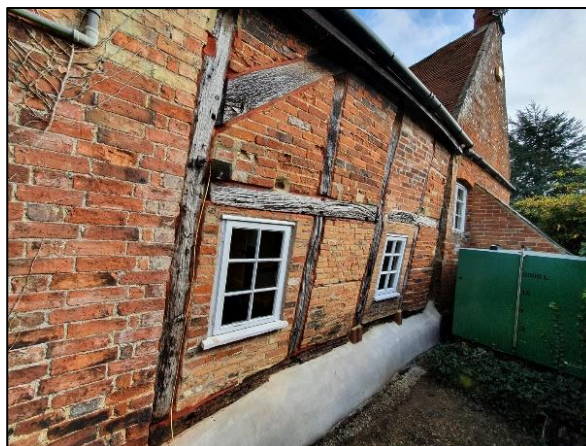
203. The part of the building which formed the focus of our brief is to the rear left and comprises a two storey structure with a timber frame and brick infill [Right, 1].

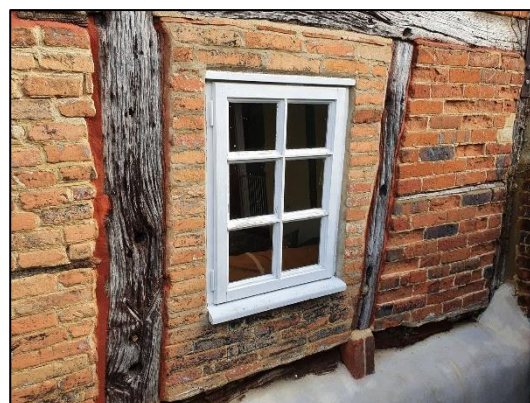
301. The left elevation of the part of the building surveyed has a visible timber frame with a number of phases of brick infill [Right, 1].

302. The wall was leaning outwards by perhaps 300mm over its height.

304. Cementitious mortar had been used in the past to repoint the masonry, leading to blowing of the brickwork faces, particularly to the upper panels and the front lower panel.

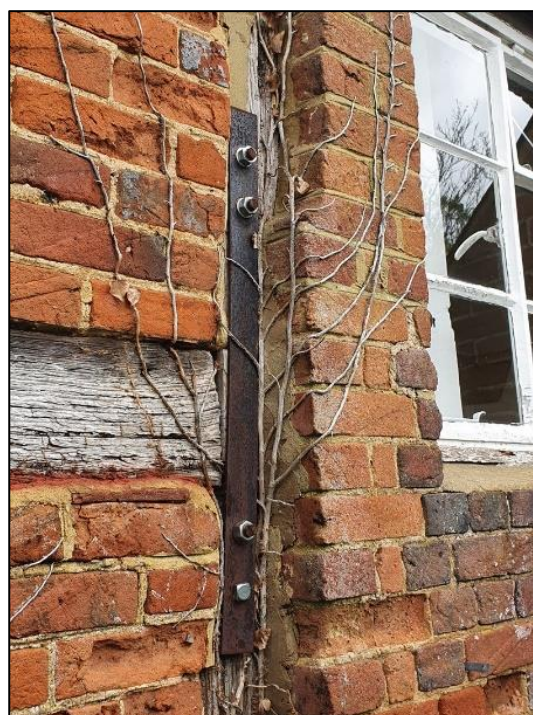
305. In a number of locations, iron or steel straps have been installed. The most recent of these [Right, 2] appears to have been installed in the last 20 years and is located at the interface with the front part of the building.

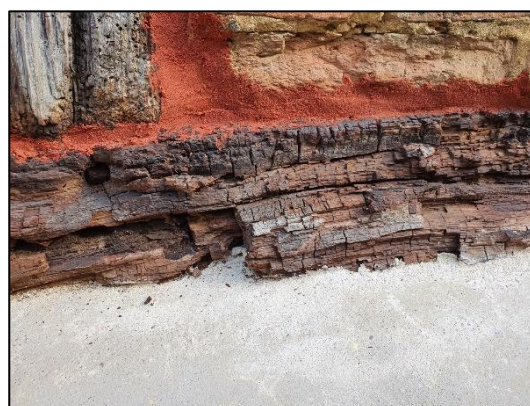
d. The removal of tiles which covered the wall plate at the base of the wall, to expose a rotted sole plate [Right, 3]

307. At the time of our inspection the sole plate had lost approximately half of its cross-section.

605. The rotting of the outer face of the sole plate may be exacerbating the outward lean, and hardwood packers could be introduced to reduce the risks of further rotation.

606. Keeping the sole plate dry will be critical to maintaining its life, and periodic inspections should be made during wet weather to determine whether water is being effectively shed away from the wall.

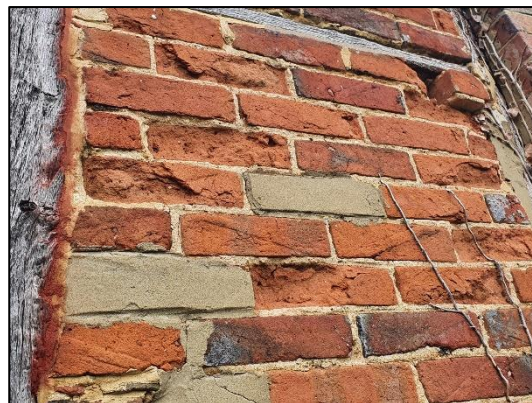
309. Delaminating brickwork [Right, 1].

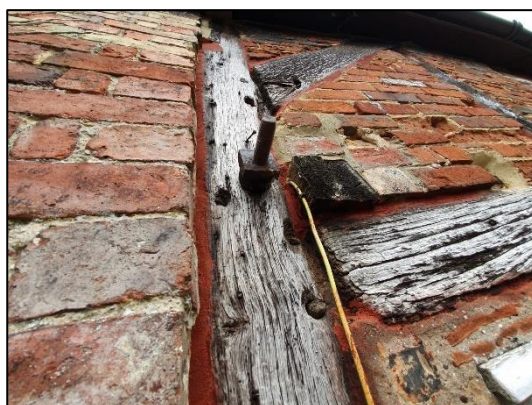
310. Historic repairs [Right, 2]:

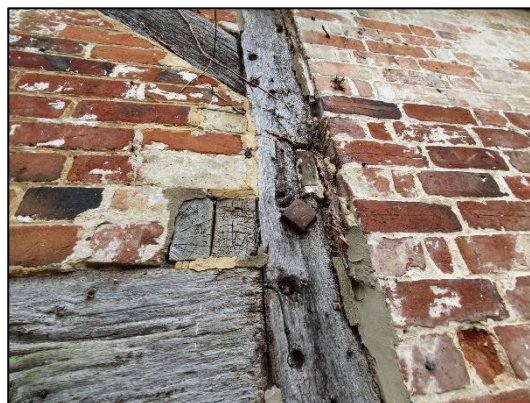
313. The lower parts of the wall had been repointed with what appeared to be a cementitious mortar and the head of a large coach bolt was present at the interface with the extension [Right, 3] but there were no indications of significant structural defect.

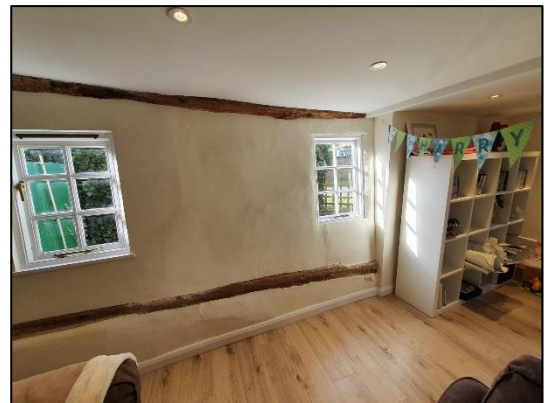
401. The timber at the base of the left elevation [Right, 1] appeared dry to the touch although the timber pegs could be easily removed indicating the ends to have rotted.

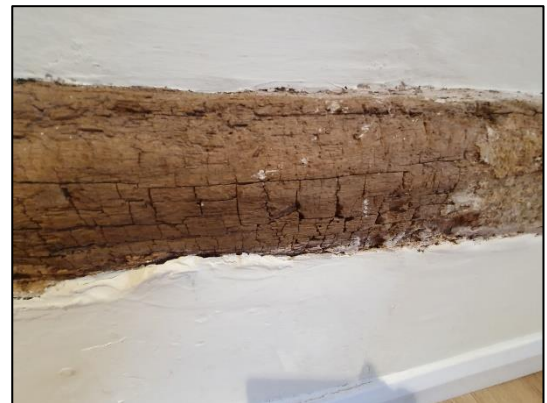
402. There was cuboidal cracking [Right, 2] along the length of the bearing timber and the internal plaster appeared to have blown in the middle section.

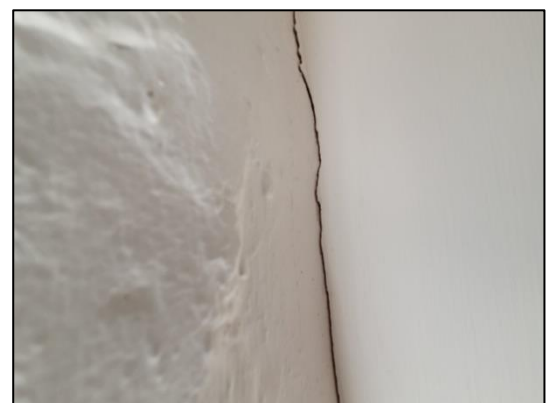
406. There was a vertical crack indicating outward lateral movement of 1mm [Right, 3].
407. There was a horizontal crack along the interface of the ceiling timber and wall indicating slight outward horizontal movement of perhaps 0.5mm.

602. Given the possibility of ongoing movement the area should be monitored in the short-term by repairing the visible internal cracks at the front and rear of the left elevation and monitoring for ongoing cracking. The use of a brittle, breathable filler material is recommended in order that movement is clearly visible.

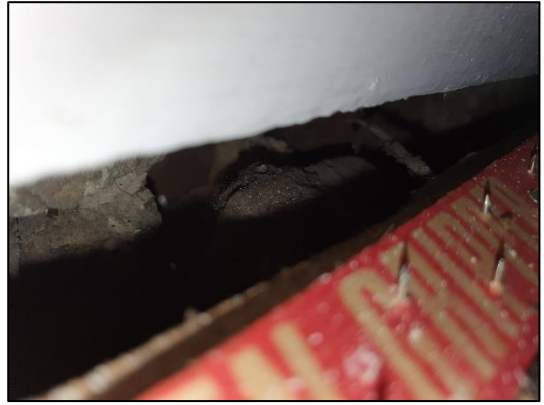
-
411. The left elevation had hairline cracking in a number of locations consistent with the distortion visible on the outside of the wall but this did not appear to have progressed significantly in the last 12 months although hairline cracking did appear to have reopened at the top of the stairs.
412. The leftward lean of the left wall had opened up a gap between the floor and wall, through which some apparent displacement of joists was visible [Right, 1].

603. The floorboards in the first floor above the leaning wall should be lifted to allow an inspection of the joist bearings, and any significant displacement advised to GCA.
