Templar Consultants

Report

**Flat 8
46 Lancaster Gate
London
W2 3NA
(‘the property’)**

13 February 2021

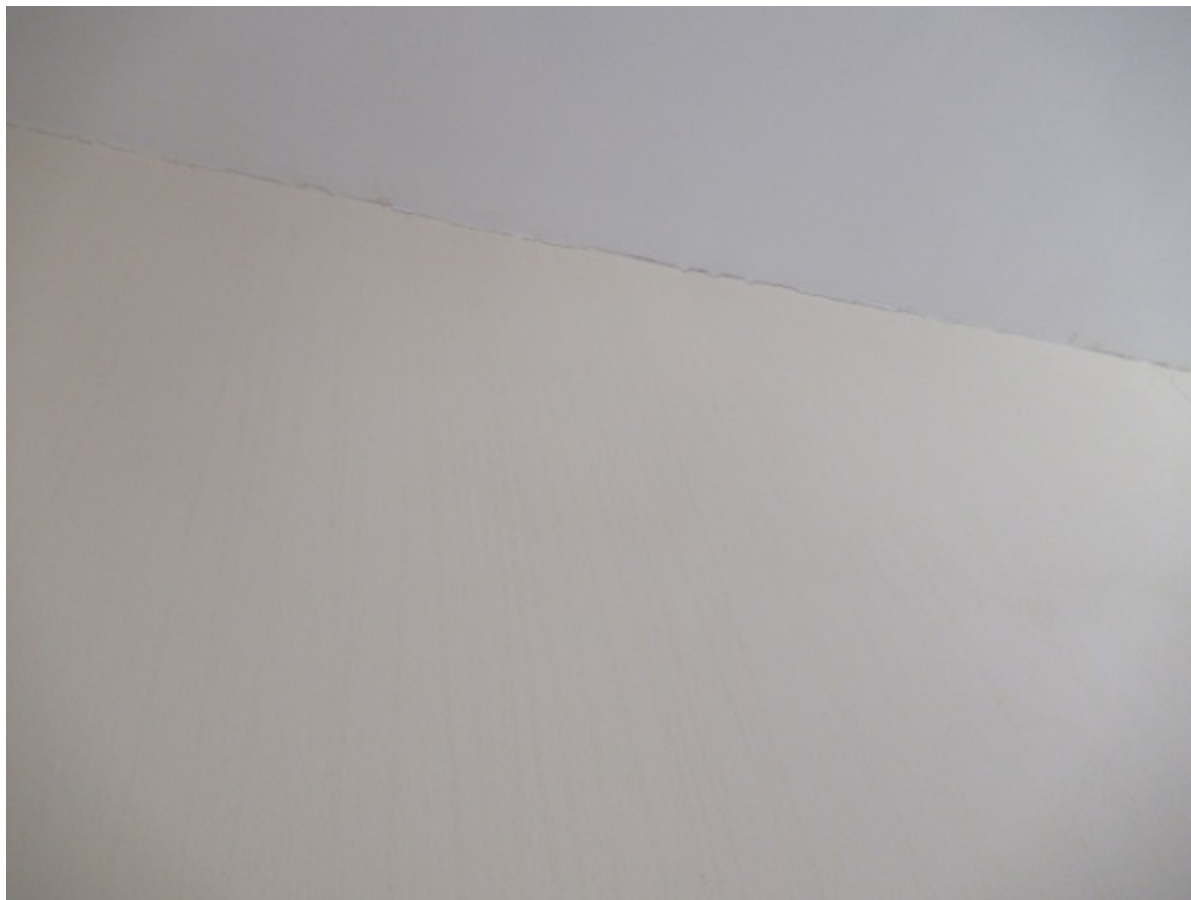
Water staining to walls and ceilings
