Tree Condition Survey Report (VTA)

Site: Wykebeck Court Care Home, 543 York Road, Leeds,
LS9 6NH

Client: Bupa

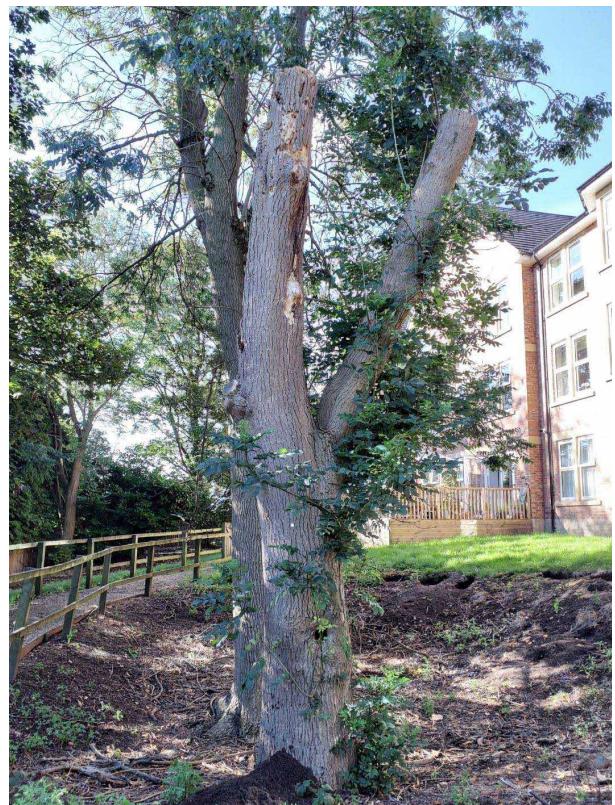
Common ash Tree ID #15

Common Name:	Common ash
Scientific Name:	Fraxinus excelsior
Genus:	Fraxinus
Tree Height [m]:	
Number of Stems:	
Stem Diameter [mm]:	640
(N) Branch Spread [m]:	
(E) Branch Spread [m]:	
(S) Branch Spread [m]:	
(W) Branch Spread [m]:	
Height of First Significant Branch [m]:	
Height of Canopy Above Ground Level [m]:	
Physiological Condition:	Poor
Structural Condition:	Fair
Quality Category:	
Quality Sub-Category:	
Status:	Alive
Comments:	Tree has been reduced to a standing stem, 6m above ground level.
Recommendations:
