# Tree Condition Survey Report (VTA)

**Site:** Wykebeck Court Care Home, 543 York Road, Leeds,  
LS9 6NH

**Client:** Bupa

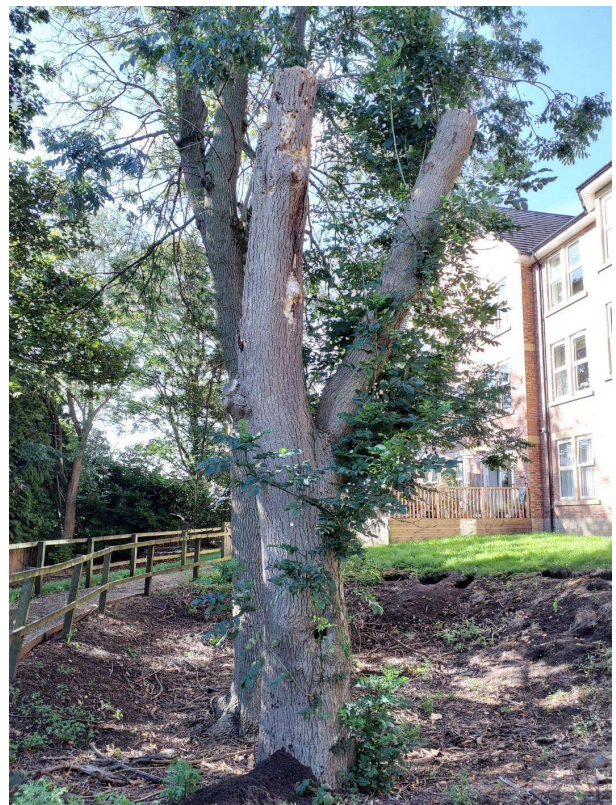
## Common ash Tree ID #15

Common Name:	Common ash
Scientific Name:	Fraxinus excelsior
Genus:	Fraxinus
Tree Height [m]:	
Number of Stems:	
Stem Diameter [mm]:	640
(N) Branch Spread [m]:	
(E) Branch Spread [m]:	
(S) Branch Spread [m]:	
(W) Branch Spread [m]:	
Height of First Significant Branch [m]:	
Height of Canopy Above Ground Level [m]:	
Physiological Condition:	Poor
Structural Condition:	Fair
Quality Category:	
Quality Sub-Category:	
Status:	Alive
Comments:	Tree has been reduced to a standing stem, 6m above ground level.
Recommendations:
