Date: 22.10.2019
Ref: 19 079

Barn and Stables at Shepherds Fold

I refer to my site visit on 18.10.2019, made to carry out a Visual Structural Survey. This Survey and report are required to accompany a planning application to be made on your behalf made by architect Richard Crook, for conversion to living accommodation. This report will comment on the structural condition of the two buildings, and the structural works likely to be necessary for conversion to living accommodation.

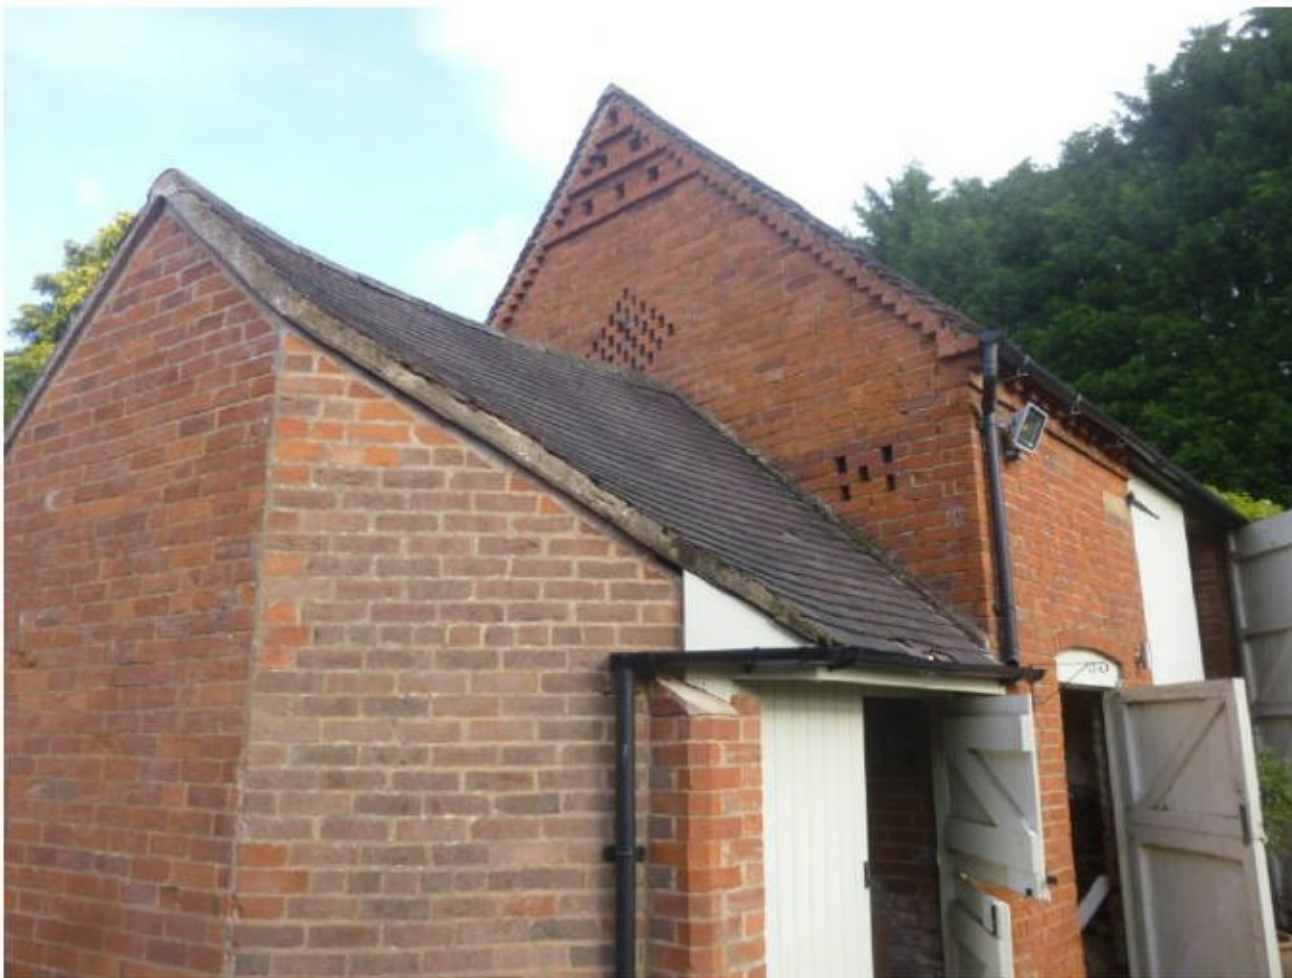
Barn Building

The Barn building is the northern and larger of the two. It is of traditional construction with plain tiled duopitch roof on timber rafters, purlins and trusses. External walls are of solid brick construction with timber lintels generally over openings, and with a brick arch externally over one door opening. Timber first floors are present in the east and west ends, with a full-height open cartway through in the central section. A small single-storey extension is present on the western end, being of similar age and construction. The Barn may be 100 to 200 years old. However, the roof and first floor construction is all of regular sawn timber, and with black bitumen felt lining to the underside of the tiles, so may be more recent than the brick walls. The building may well have been re-roofed in the last 50 years.

The barn building is generally in good structural condition for its age, with the main two-storey roof being to a good line, and with the external walls also being to a good line. The roof to the single-storey extension has sagged significantly on the southern pitch. Areas of weathered pointing generally, and small localised areas of perished brickwork are present at lower level on all external elevations. Minor brickwork cracks are present locally at high level on north and south elevations.

The external tarmac surfacing extended up to the brickwork on the western end, and two rainwater pipes were noted as being unconnected to underground drainage. These factors will have contributed to perished brickwork and weathered mortar in those areas.

Since the building does not seem to have suffered major differential foundation movement, with consequent cracking of the brick walls, and bearing in mind the age of the building, this suggests that the existing foundations have performed adequately, and may not need to be underpinned. However, a final decision on this aspect can only be made after existing foundation depths have been investigated.

- 1 – strengthening of timber purlins for increased roof load
- 2 – strengthening of first floor joists for increased load from living accommodation
- 3 – generalised repointing, and localised replacement of perished bricks

- 4 – replacement of timber lintels internally with modern concrete alternatives
- 5 – removal of large oil tank, removal of external ramp, and lowering of external ground level at the eastern end to below the proposed internal ground floor level. A low path and retaining wall beyond will then need to be created.

- 6 – removal of the large conifer trees at the eastern end within 10m of the building to ensure a stable ground moisture foundation for the existing foundations

- 7 – cutting back of tarmac and other surfacing abutting the external brick walls, to limit further damp problems, and provision of a gravel filled french drain around the full perimeter of the building

- 8 – provision of a new underground drainage system to ensure that rainwater is collected and discharged at least 5m from the building

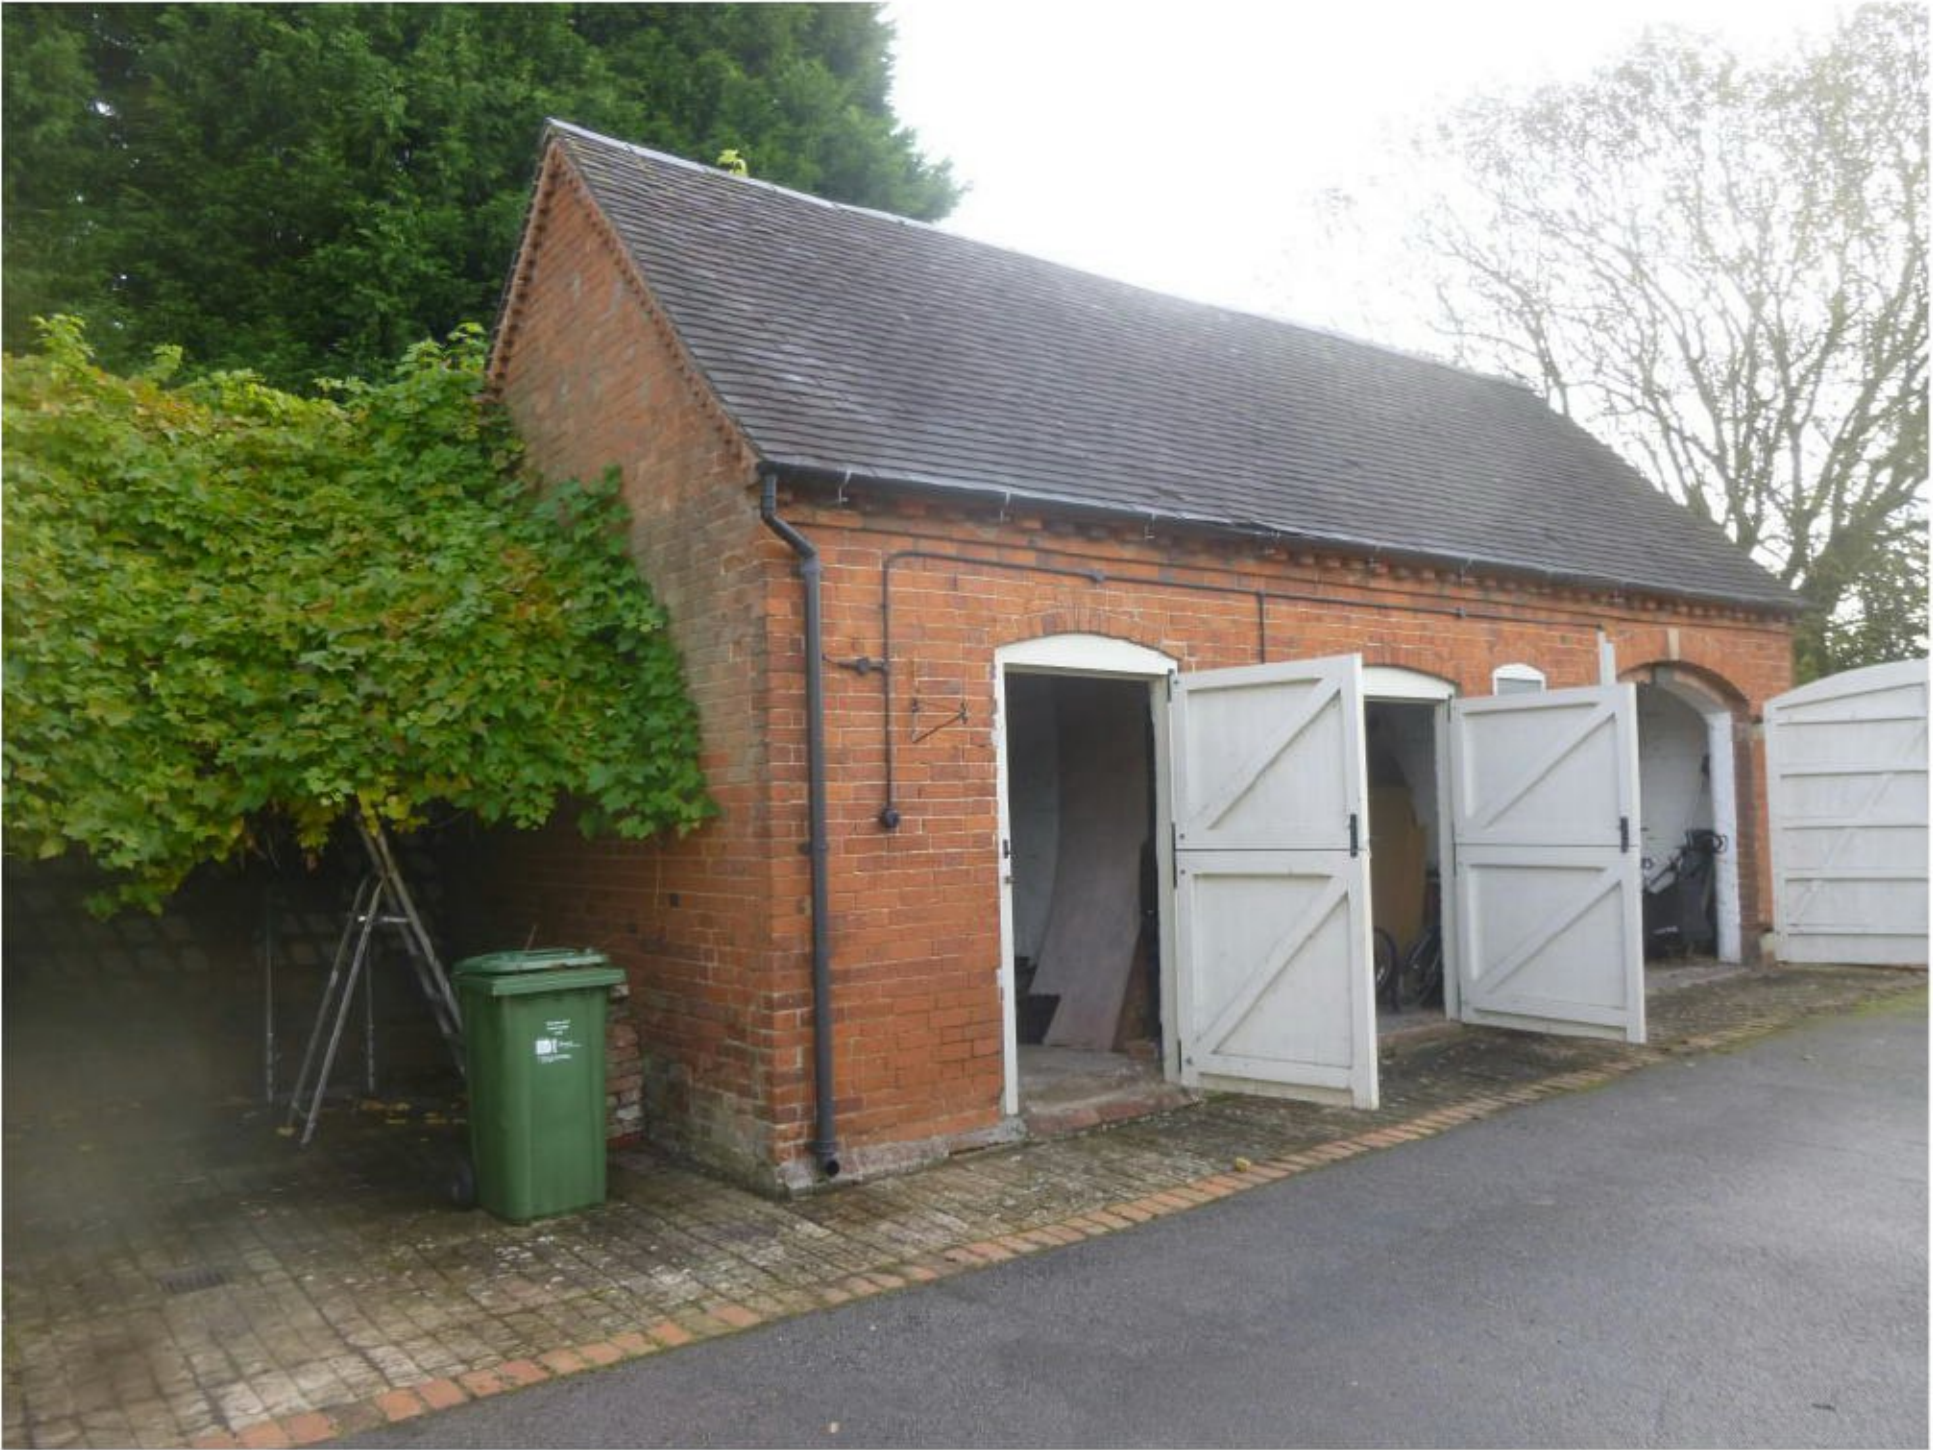
Stables Building

The Stables building is the southern and smaller of the two buildings. It is of traditional construction with plain tiled duopitch roof on timber rafters, and purlins. The internal brick crosswalls provide intermediate support to the purlins. External walls are of solid brick construction with timber lintels internally over openings, and with brick arches externally over the door openings. A small single-storey extension is present on the southern end, being of similar age and construction, but with a shallow-pitched monopitch roof covered with corrugated asbestos-cement sheeting. The Stables may be 100 to 200 years old, with original roof timbering. Black bitumen felt lining is present on the underside of the tiles, suggesting that the building may have been re-tiled within the last 50 years.

The Stables building is generally in good structural condition for its age, with the main roof being to a good line, and with the external walls also being to a good line. Areas of weathered pointing generally, and also small localised areas of perished brickwork, are present at lower level on all external elevations. Minor brickwork cracks are present over door openings on the western elevation.

The external surfacing extended up to the brickwork on the western side, and one rainwater pipe was noted as being unconnected to underground drainage. These factors will have contributed to perished brickwork and weathered mortar in those areas.

Since the Stables building does not seem to have suffered major differential foundation movement, with consequent cracking of the brick walls, and bearing in mind the age of the building, this suggests that the existing foundations are performing adequately, and may not need to be underpinned. However, a final decision on this aspect can only be made after existing foundation depths have been investigated.

- 1 – strengthening of timber purlins for increased roof load
- 2 – generalised repointing, and localised replacement of perished bricks
- 3 – replacement of timber lintels internally with modern concrete alternatives

- 4 – lowering of higher external ground level along the eastern side to below the proposed internal ground floor level. A low path and retaining wall beyond will then need to be created.

- 5 – removal of the large conifer trees along the eastern end within 10m of the building to ensure a stable ground moisture foundation for the existing foundations

- 6 – cutting back of tarmac and other surfacing abutting the external brick walls, to limit further damp problems, and provision of a gravel filled french drain around the full perimeter of the building

- 7 – provision of a new underground drainage system to ensure that rainwater is collected and discharged at least 5m from the building

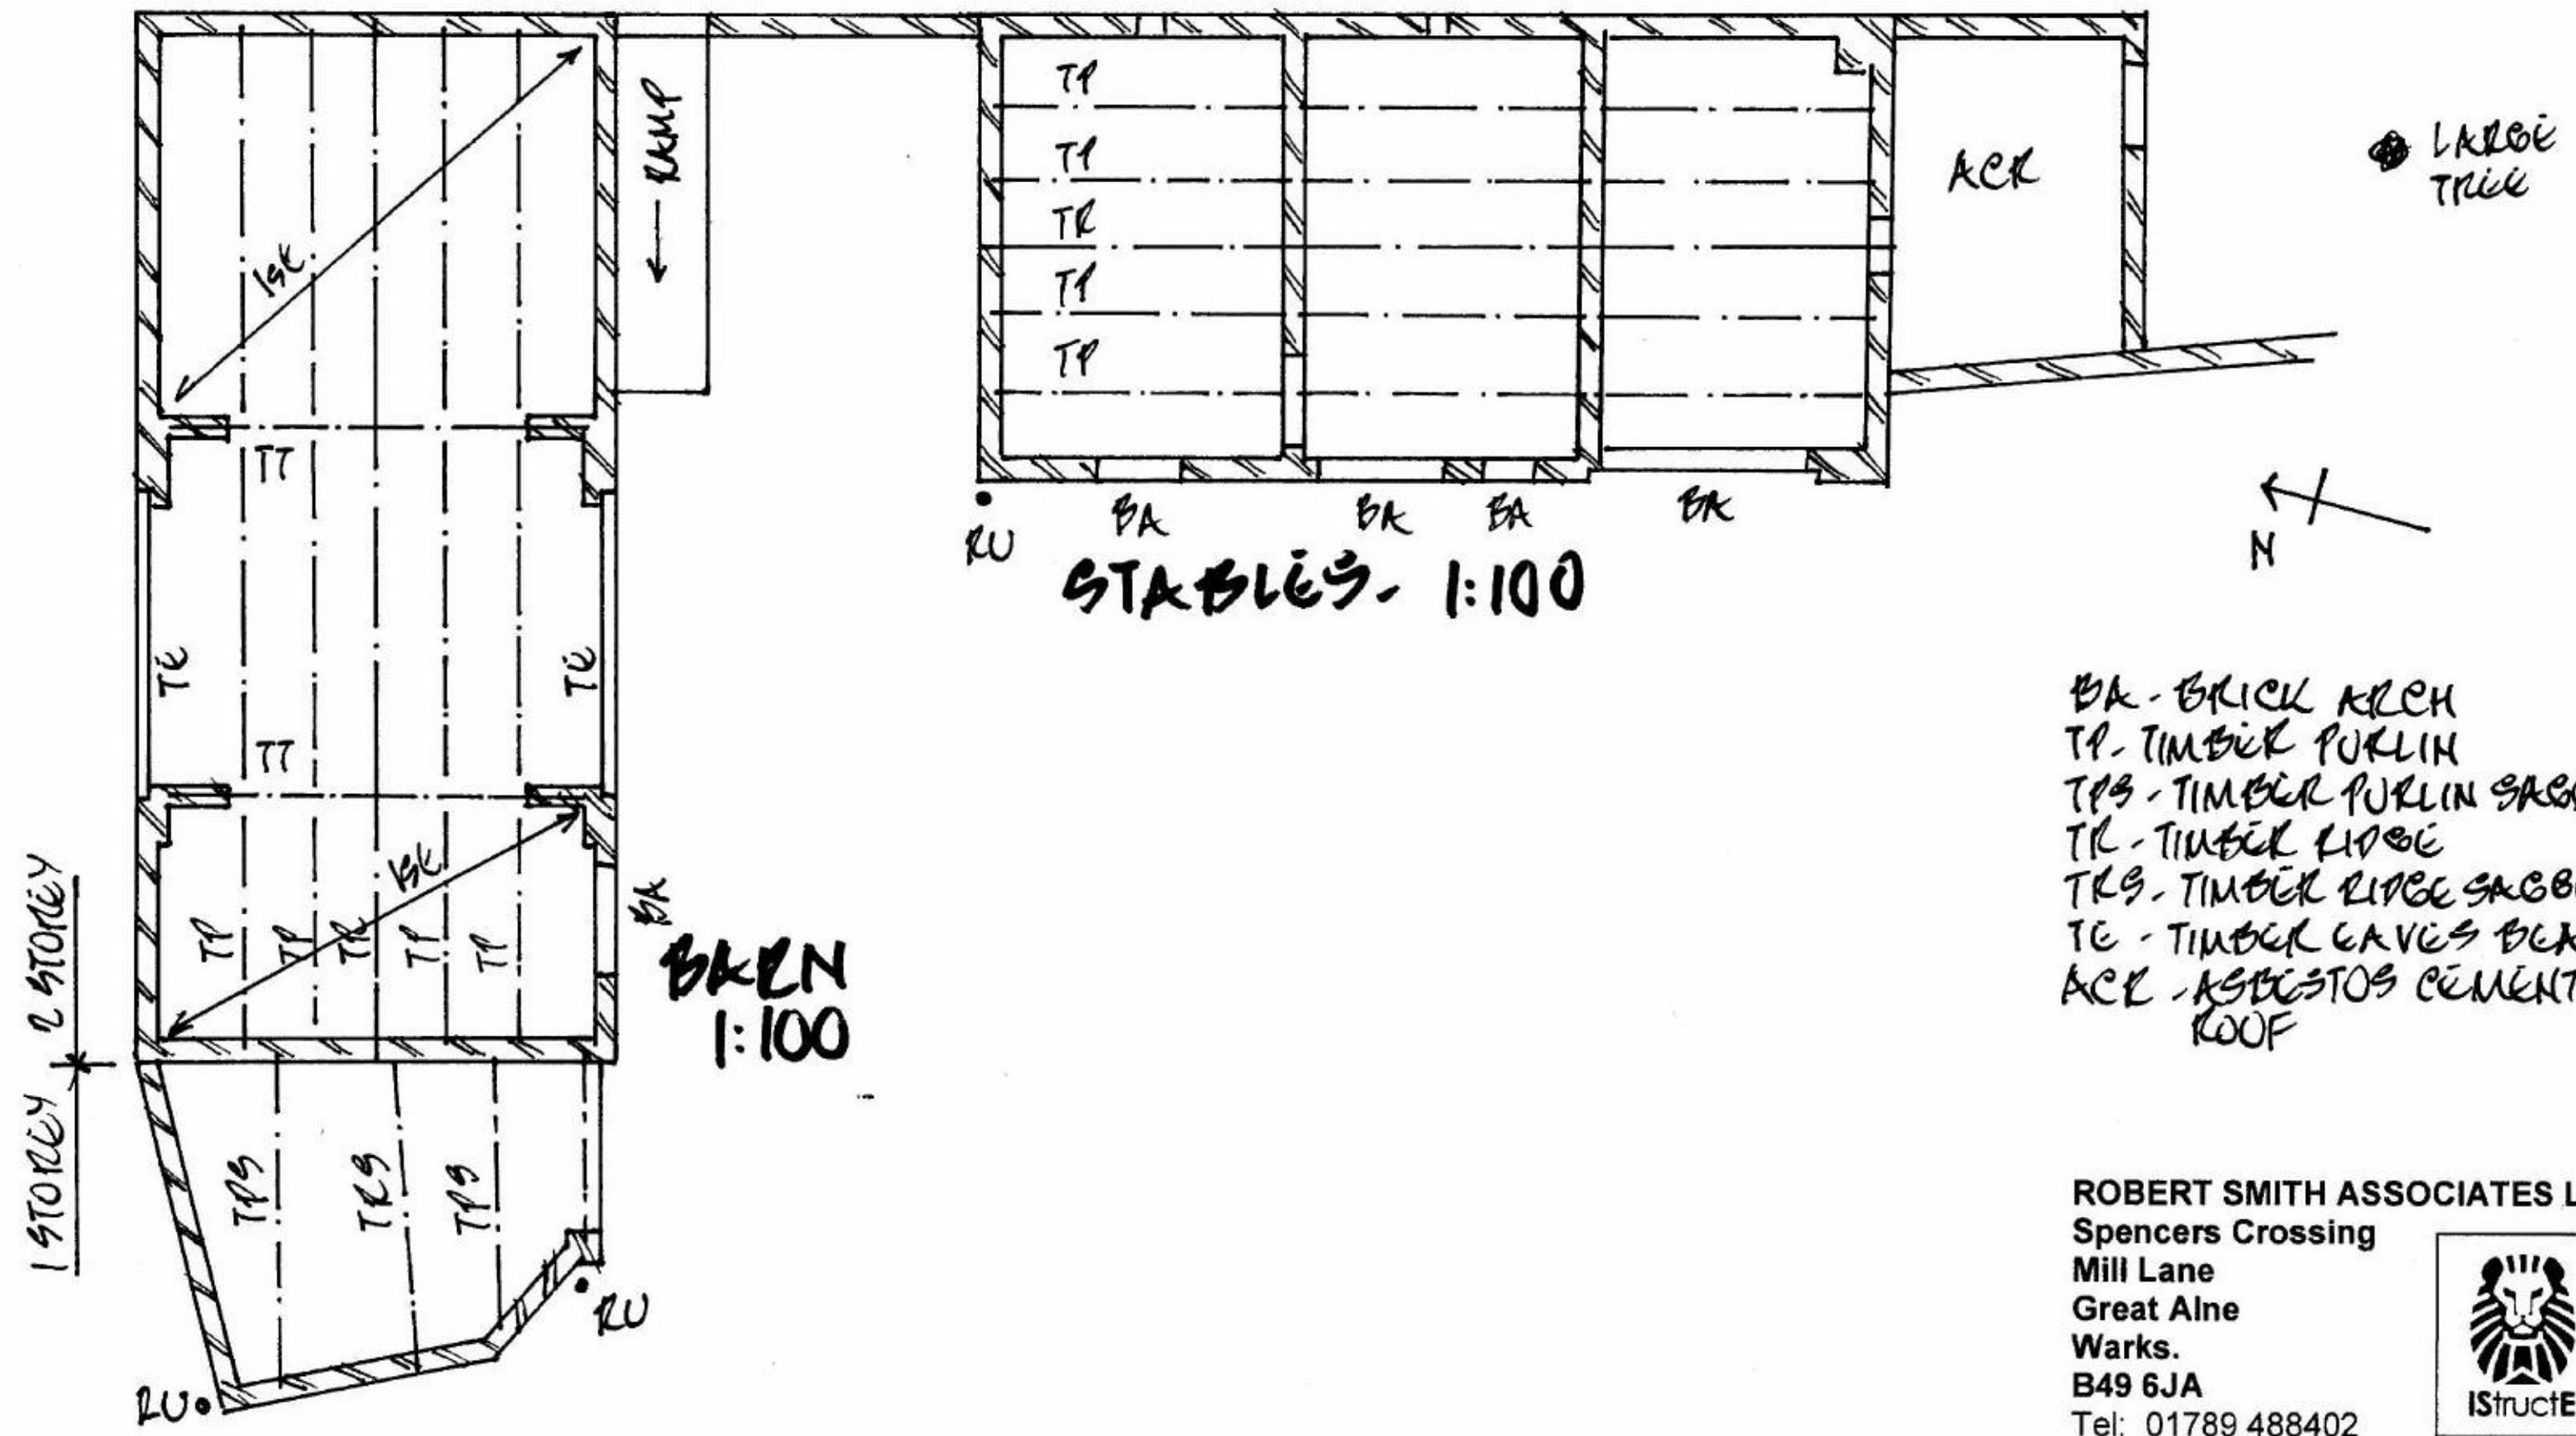
19079/SKL
18.10.2019

LINE OF LARGE DEYLANDIA TREES

OIL TANK

GROUND HIGHER ALONG THIS SIDE
