**THE SCHOOL HOUSE
CRENDON ROAD
SHABBINGTON
AYLESBURY
BUCKINGHAMSHIRE
HP18 9HE**

PE/WK 23/452
27 July 2023

**Building Survey –
The School House, Crendon Road, Shabbington, Bucks HP18 9HE**

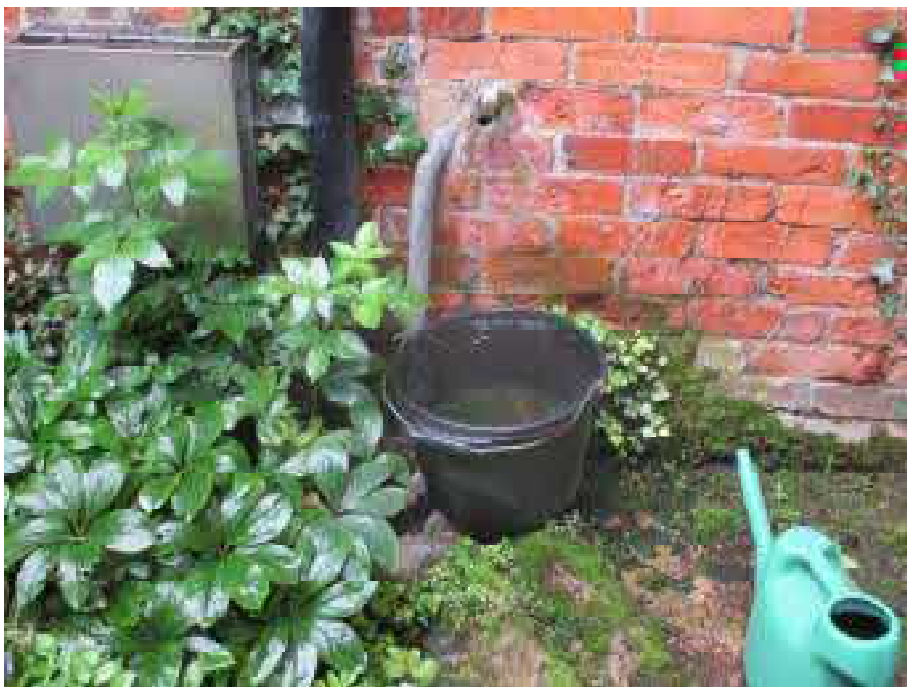
The dampness to the front left hand side is likely to be caused by the constantly dripping overflow from above, causing saturation to the wall and also the render panel trapping moisture behind it externally.

Leaking overflow from toilet

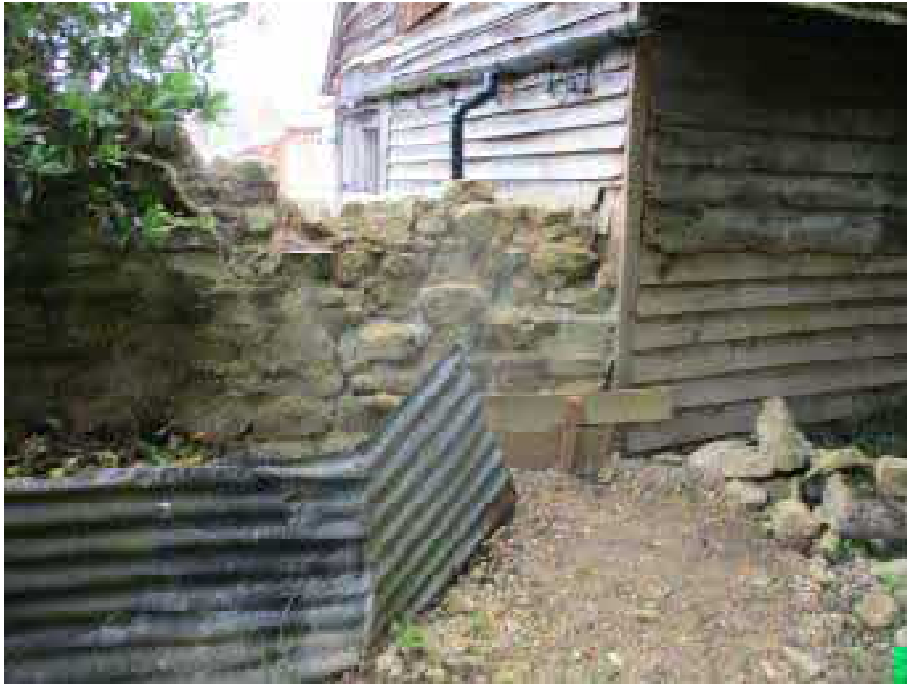
Boundary being rebuilt

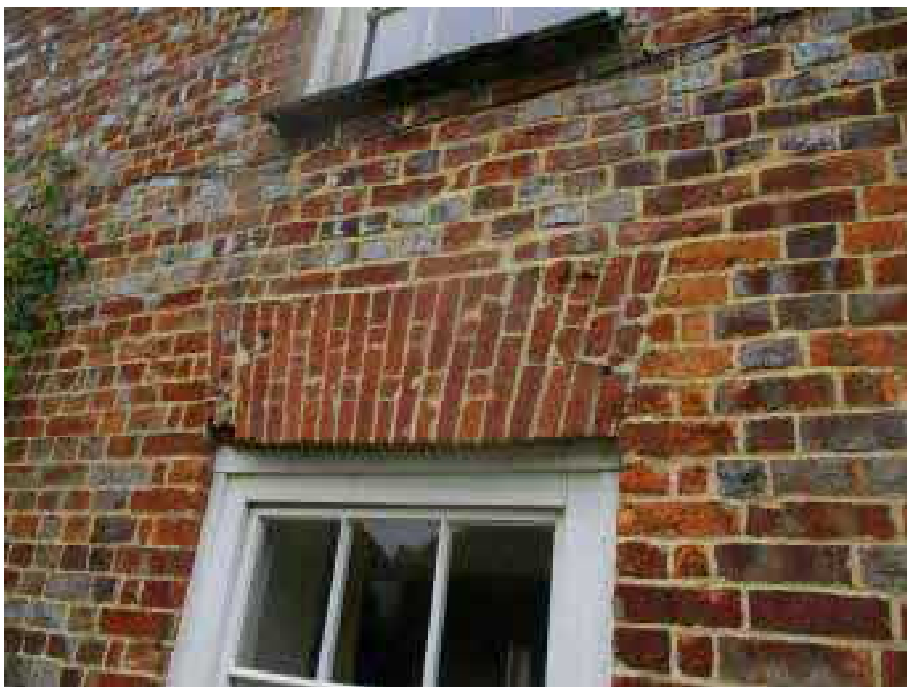
The cracking through the reveal would suggest that there has been slight settlement beneath the lintels and as such, we would recommend that the plaster is carefully removed, so that the condition of the reveals can be assessed and restitched back in.

Lintel dropped right hand side

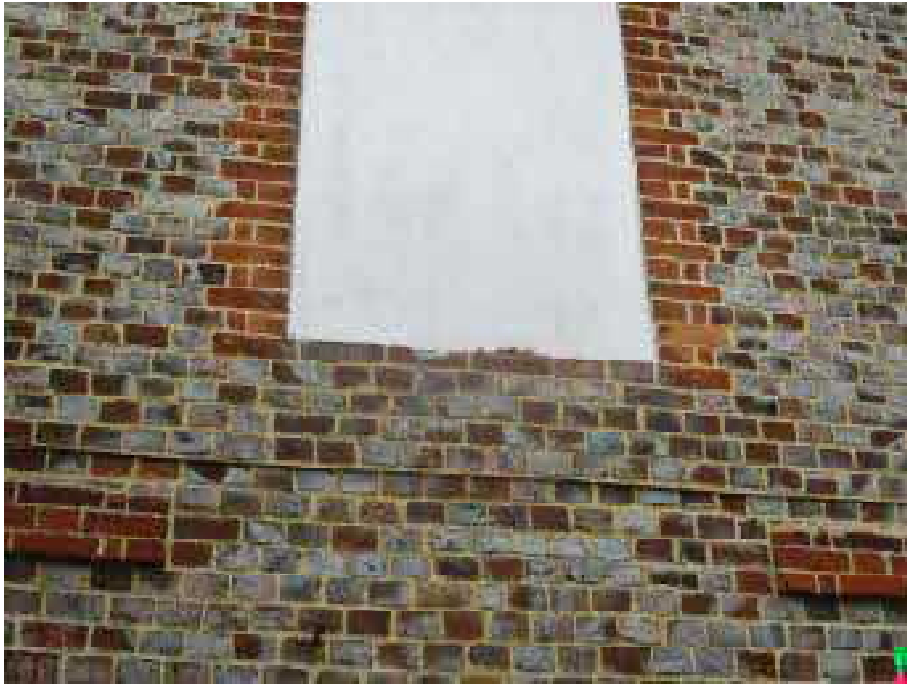
We note the ply panelling to the window infill externally is starting to decay.

Ply panel to window opening

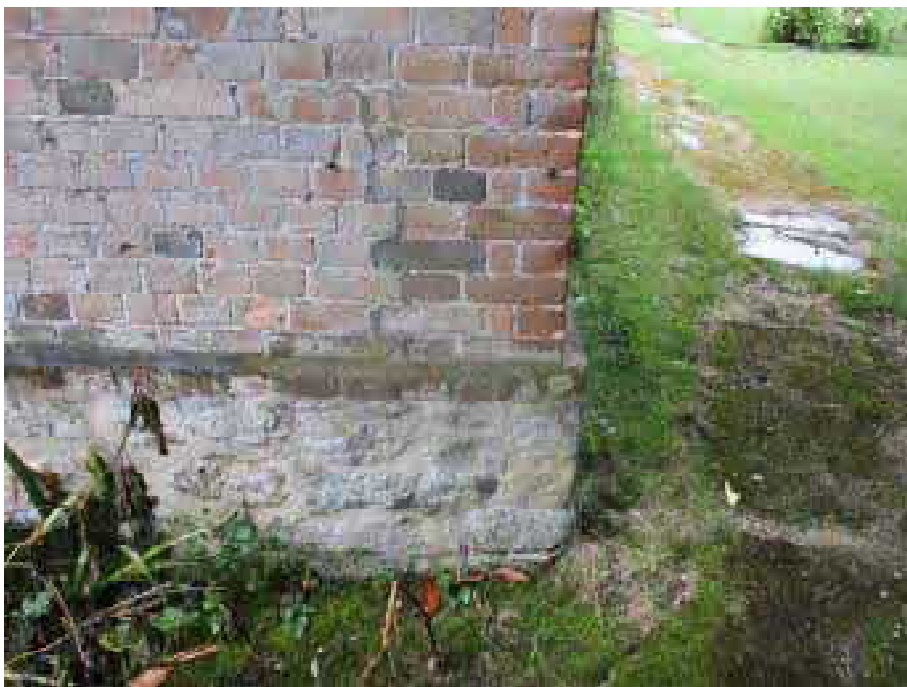
To the front left hand corner there is some very minor cracking where there has been some movement in the past.

Minor movement front left corner

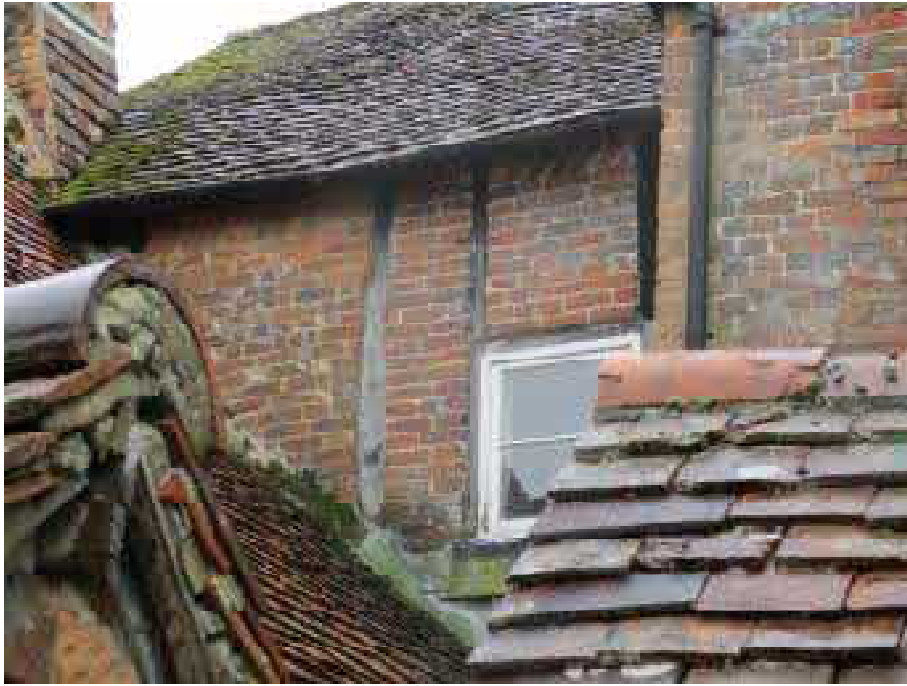
Where the gutters have failed and water is running down the wall, this is leading to saturation of the window and masonry beneath.

Gutters splashing back to walls

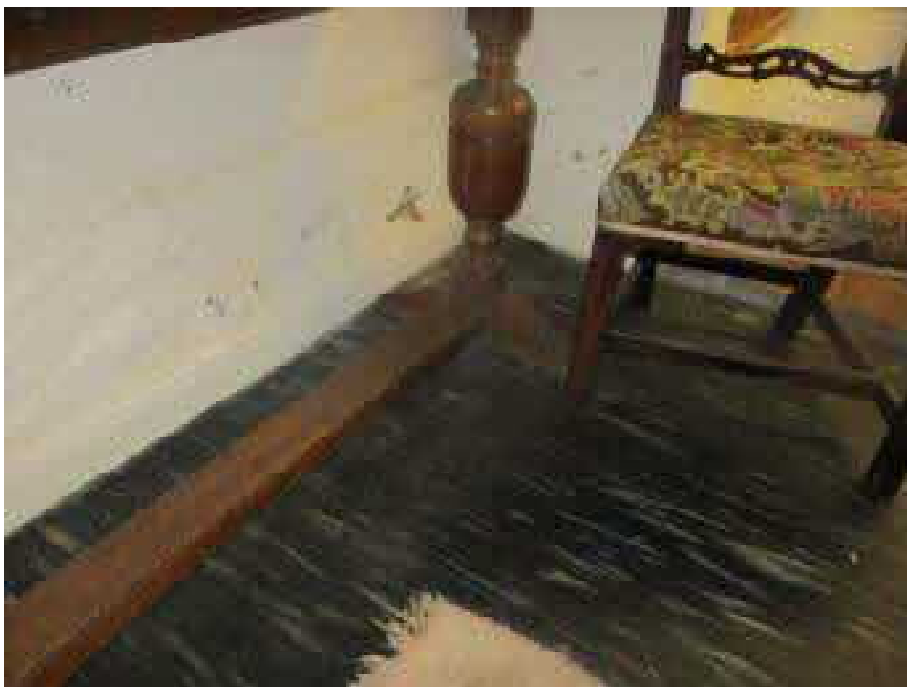
Old linoleum

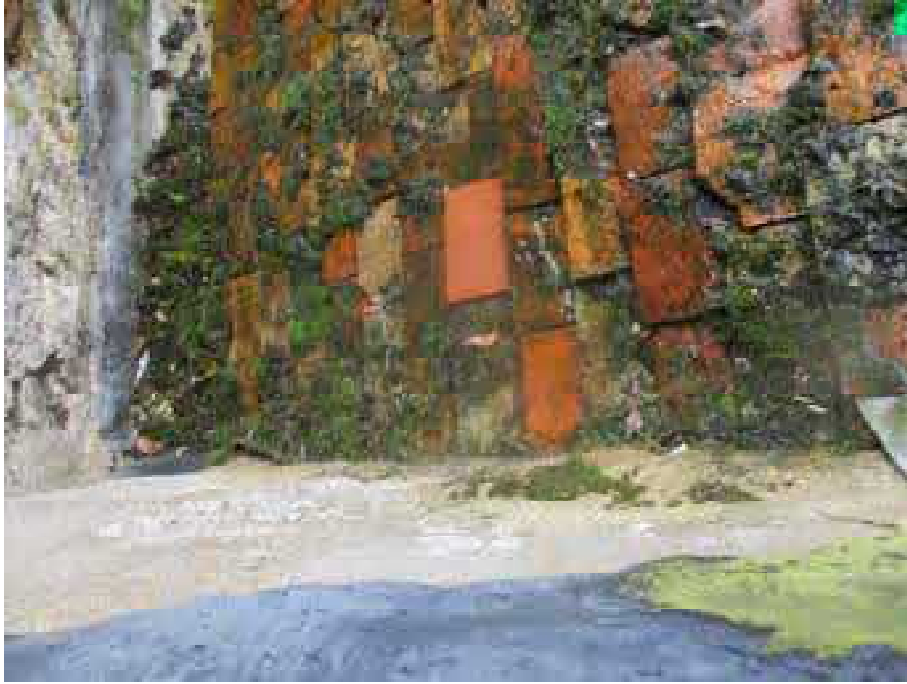
The valley interconnection wanders slightly and is not straight and there is one displaced tile which is allowing moss and debris to back up behind it. This should be removed and replaced.

Frost damage and moss to rear valley

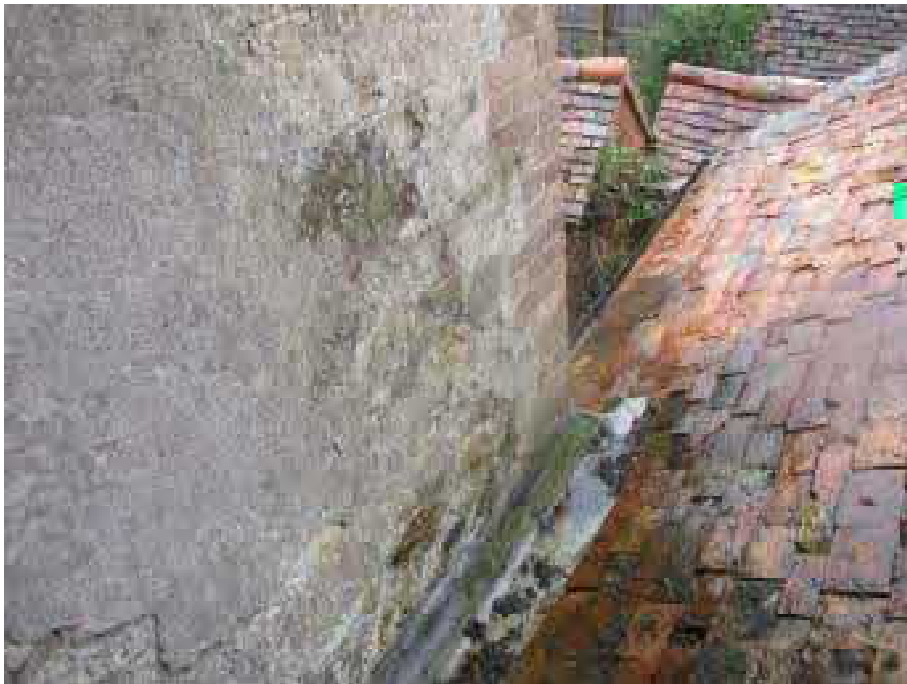
The render is cracked in several places, which is likely to allow moisture to be drawn in behind. This can lead to unseen damage to concealed timber framework behind and as such, whilst it is likely the render was added to try and reduce damp penetration from driving rain, it should have been replaced in lime mortar to allow the wall to breathe.

The render continues down to ground level and as such, this will allow moisture to be wicked back up through the building.

Render to rear wall

You could consider carefully removing the render from the whole of this elevation to expose the surfaces behind, although a significant provisional sum should be allowed for repairs and reinstatement once the render is removed.

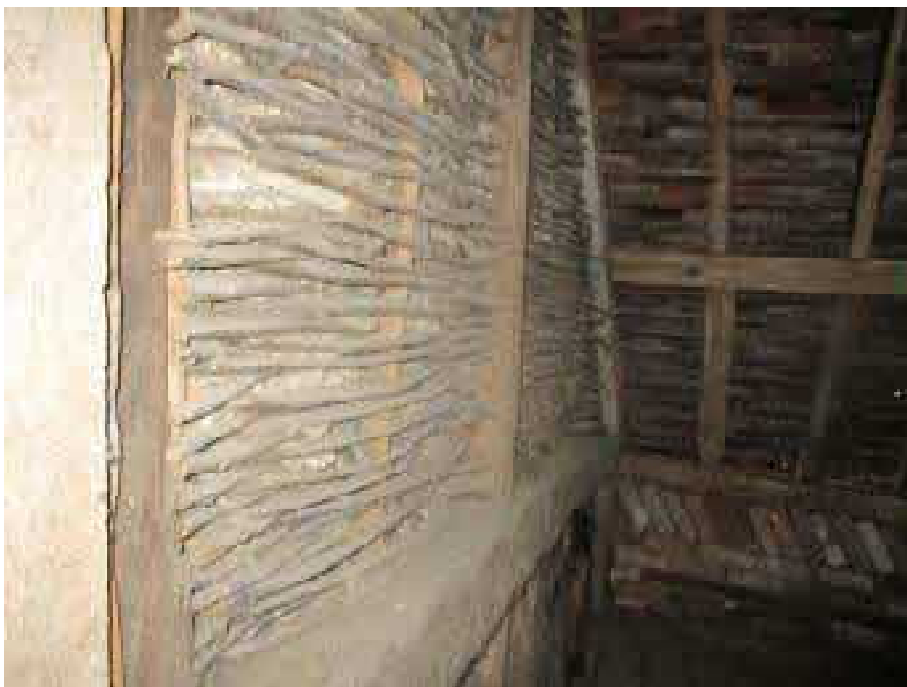
Wattle and daub

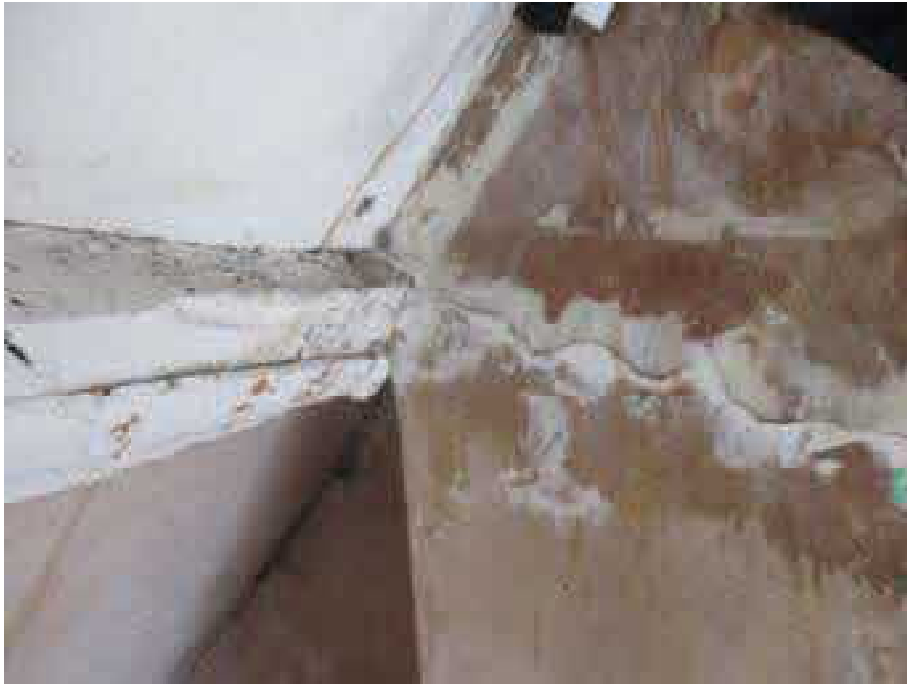
Decay in purlin built into chimney

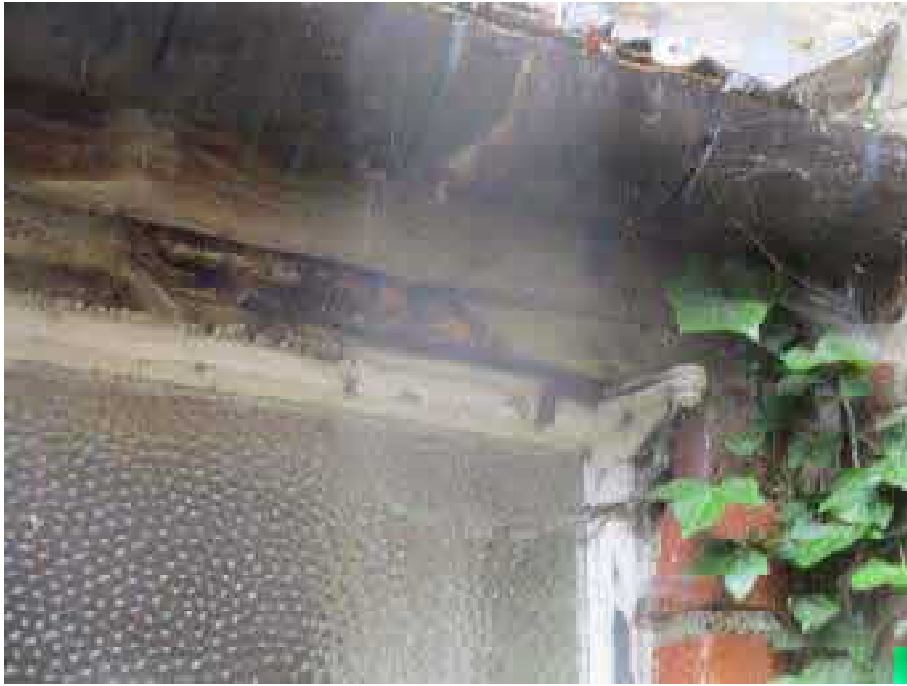
The lintel over the WC window is rotten and failing and requires cutting out and replacement and the ivy which is starting to grow up the wall should be removed.

Rotting lintel over WC window

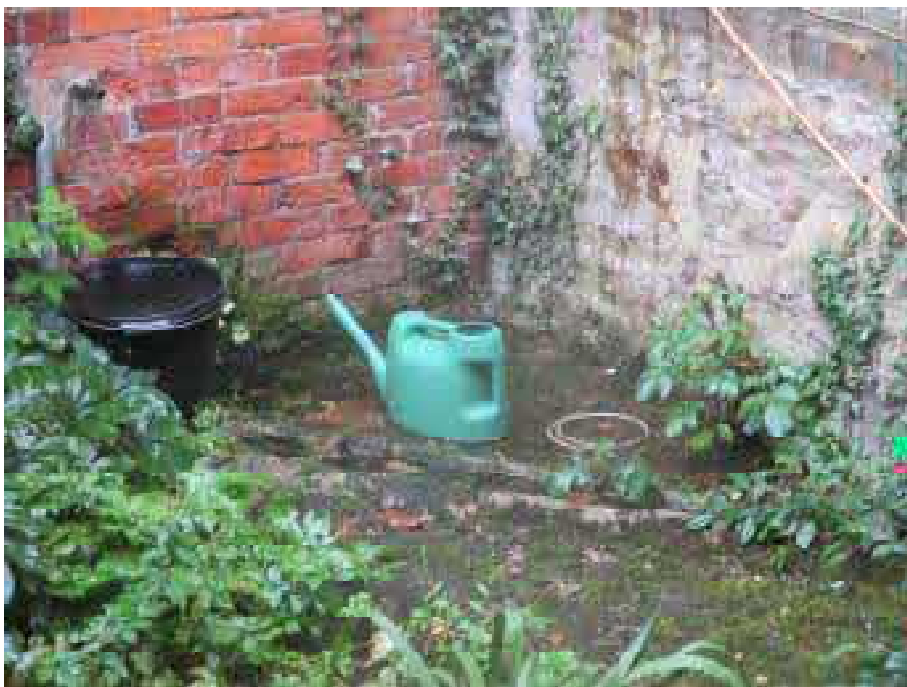
The ground level requires adjusting at this point and we note water is ponding inside the gully which has been formed for the rainwater. However the gully at the base is also leaking and frost has damaged the brickwork where the toilet has overflowed for a considerable period of time.

Water ponding

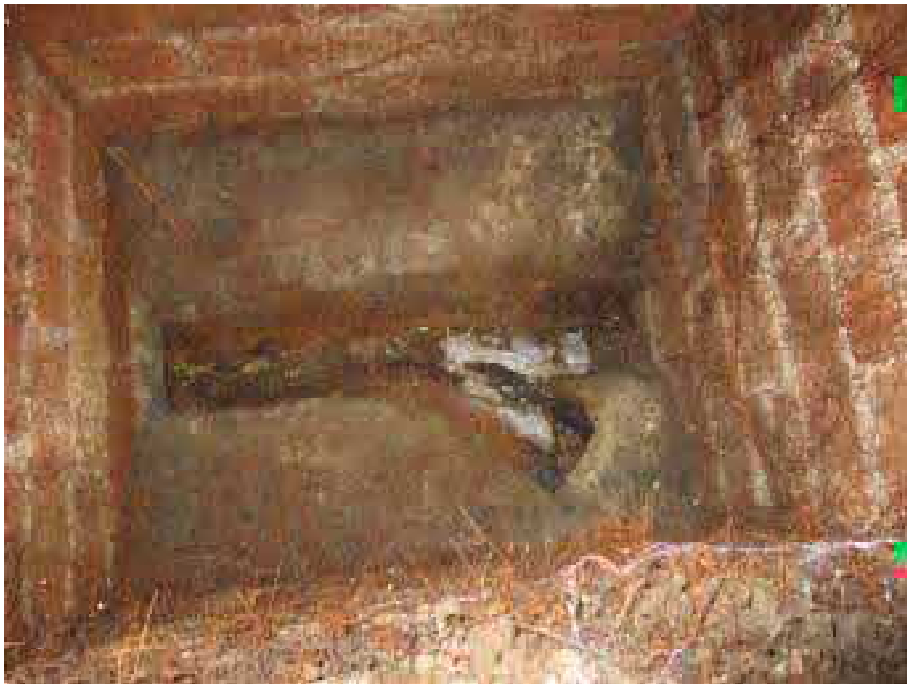
Roots in drain

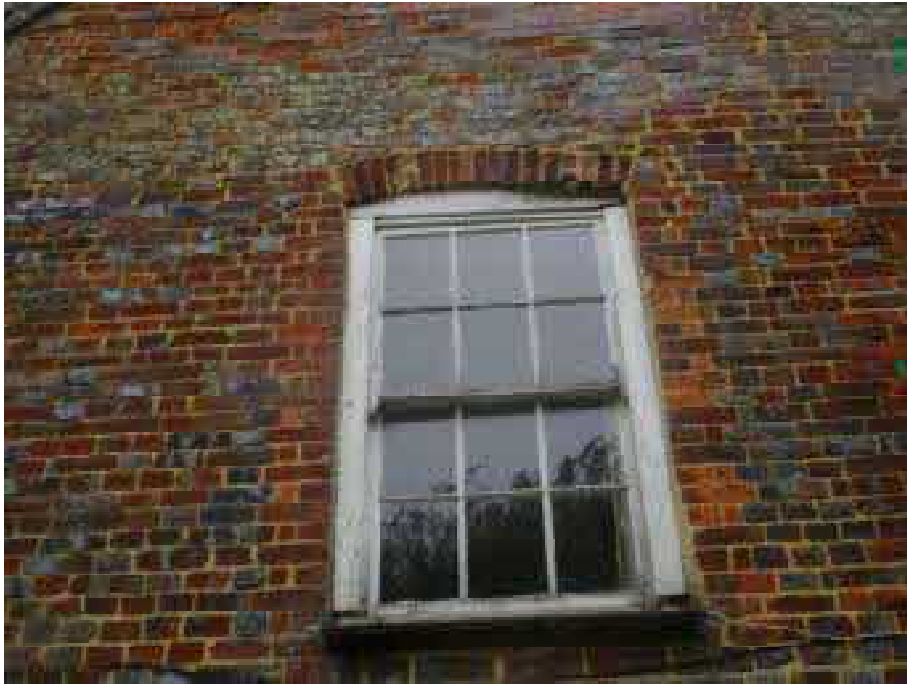
Decay in windows
