Tree Condition Survey Report (VTA)

Site: Wilmington Manor Care Home, Common Lane,
Wilmington, Datford, Kent, DA2 7BA

Client: Bupa

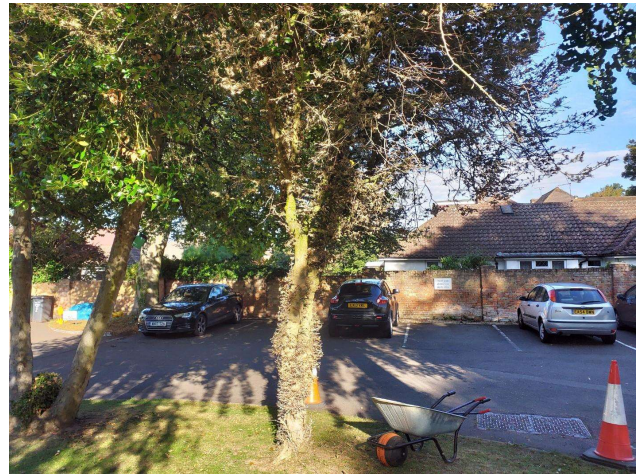
Common beech Tree ID #8

Common Name:	Common beech
Scientific Name:	Fagus sylvatica
Genus:	Fagus
Tree Height [m]:	
Number of Stems:	
Stem Diameter [mm]:	375
(N) Branch Spread [m]:	
(E) Branch Spread [m]:	
(S) Branch Spread [m]:	
(W) Branch Spread [m]:	
Height of First Significant Branch [m]:	
Height of Canopy Above Ground Level [m]:	
Physiological Condition:	Good
Structural Condition:	Good
Quality Category:	
Quality Sub-Category:	
Status:	Alive
Comments:	
Recommendations:

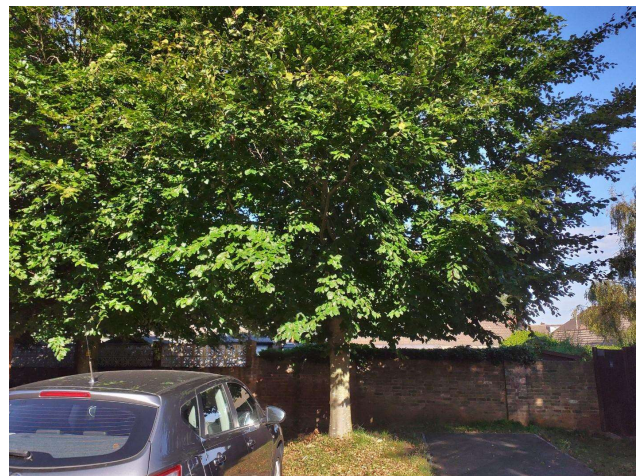
Common beech Tree ID #9

Common Name:	Common beech
Scientific Name:	Fagus sylvatica
Genus:	Fagus
Tree Height [m]:	
Number of Stems:	
Stem Diameter [mm]:	375
(N) Branch Spread [m]:	
(E) Branch Spread [m]:	
(S) Branch Spread [m]:	
(W) Branch Spread [m]:	
Height of First Significant Branch [m]:	
Height of Canopy Above Ground Level [m]:	
Physiological Condition:	Good
Structural Condition:	Good
Quality Category:	
Quality Sub-Category:	
Status:	Alive
Comments:	
Recommendations:

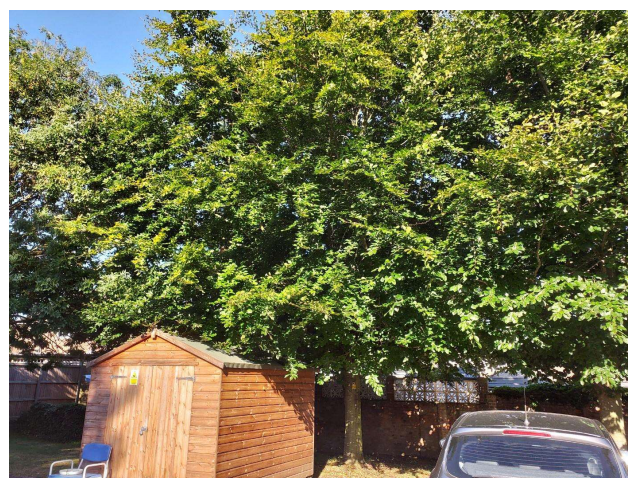
Ash species Tree ID #10

Physiological
Condition: Good

Structural Condition: Good

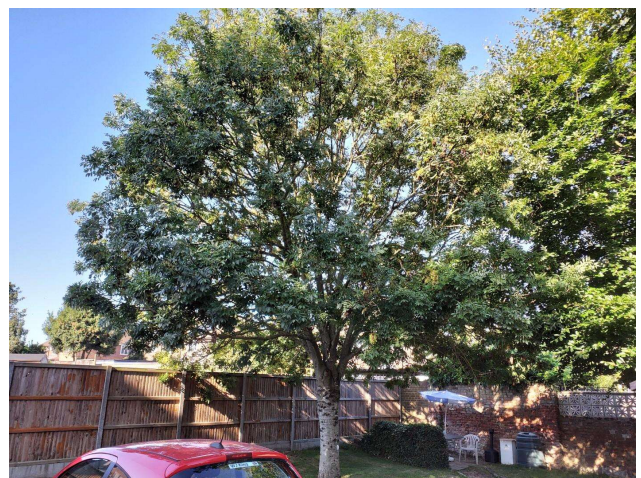
Pedunculate oak Tree ID #21

Common Name:	Pedunculate oak
Scientific Name:	Quercus robur
Genus:	Quercus
Tree Height [m]:	
Number of Stems:	
Stem Diameter [mm]:	700
(N) Branch Spread [m]:	
(E) Branch Spread [m]:	
(S) Branch Spread [m]:	
(W) Branch Spread [m]:	
Height of First Significant Branch [m]:	
Height of Canopy Above Ground Level [m]:	
Physiological Condition:	Fair
Structural Condition:	Fair
Quality Category:	
Quality Sub-Category:	
Status:	Alive
Comments:	
Recommendations:

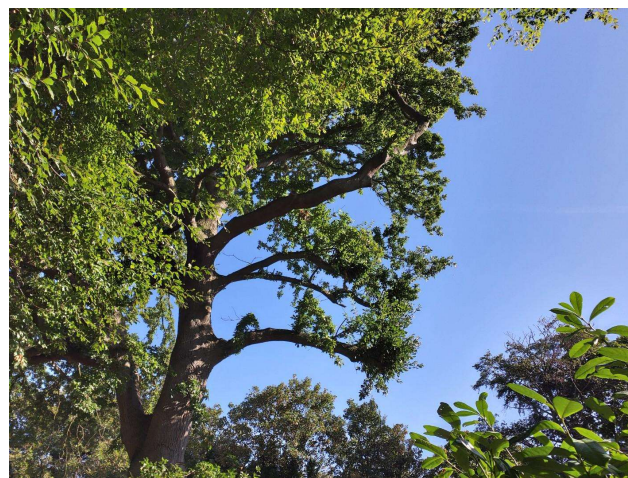
Common beech Tree ID #29

Physiological
Condition: Fair

Structural Condition: Fair

28	Sycamore	Dismantle to ground level	Within 1 - 3 Months	Dismantle to ground level	1705
29	Common beech	Sever and Remove Ivy to 1.5m Above Ground Level	Within 6 - 12 Months	Clear all vegetation from base of tree	533
29	Common beech	Re-Inspect by Arb (Within Specified Timeframe) - Specify reasoning	Within 6 - 12 Months	Reinspect tree once all vegetation is cleared around base of tree	533
