(As Proposed By Architect-Over marked with Structural Recommendations)
(Scale 1:100)

## PROPOSED GROUND FLOOR PLAN

Drw No. 1852 / F02

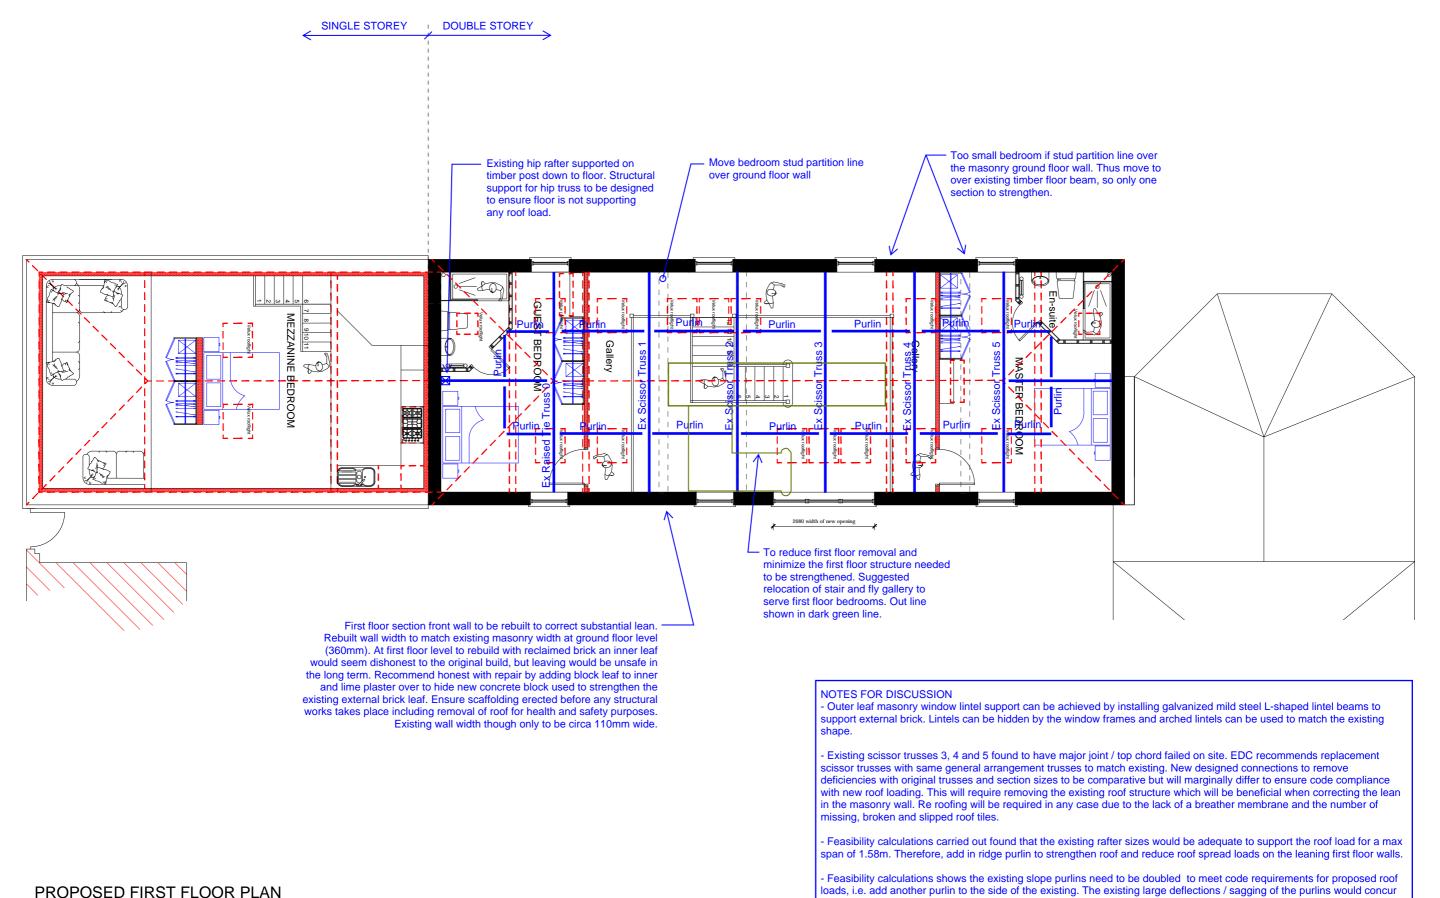
PROPOSED FIRST FLOOR PLAN

External masonry mortar joints significantly weathered away. Joints will require pointing with NHL lime mortar

with the calculated findings. A ridge purlin is required to reduce the load on the slope purlins and to reduce the horizontal thrust at the top of the masonry walls, particularly as a timber ceiling tie are not present.
