Design, Access and  
Heritage Statement

# Wood House Farmhouse

The Design and Access Statement including a Heritage Statement is a requirement of the Local Authority Planning Department for inclusion with a Listed Building Application. It is to form part of the submission of an application to replace the damaged pantile roof and its structure over the single storey kitchen extension to the rear of Wood house Farmhouse, West Newton, East Yorkshire. HU11 4LP.

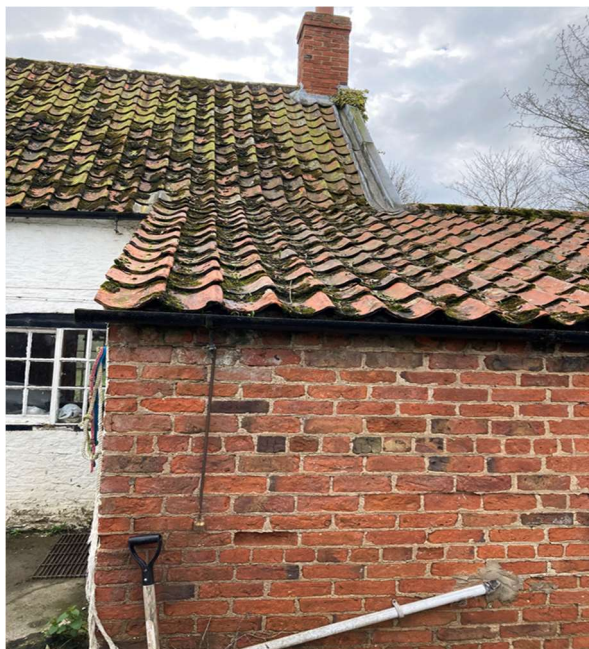
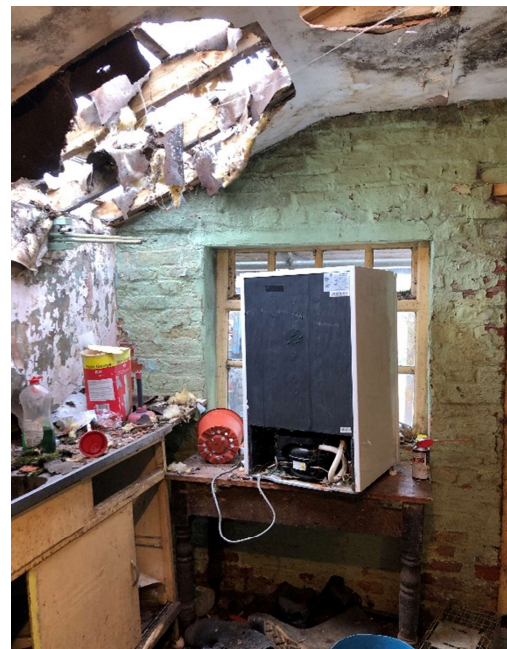
The photographs below highlight the damage that has resulted from broken and dislodged tiles. As a result, water ingress has penetrated the structure causing further damage and the collapse of the underdrawn ceiling.

The extent of the repair work and the specification is detailed on the **Proposed Repairs** drawing attached to this document. On account of the seriousness of the damage caused by water ingress, and the opportunity that fine weather affords, the roof is in the process of being stripped. The photographs below show the extent of the damage throughout the kitchen ceiling. The damage is confined to the roof covering its vapour barrier and the ceiling below. The rafters are in a good state of repair and will therefore remain in position and sprayed against infestation.
