# Structural Report

Property Address	8, Greenside, Waterbeach, Cambridge, CB25 9HP
Client	Mr Theo Anderson
Date of Report	14 November 2023
Project Nr	192603 (23-1009)

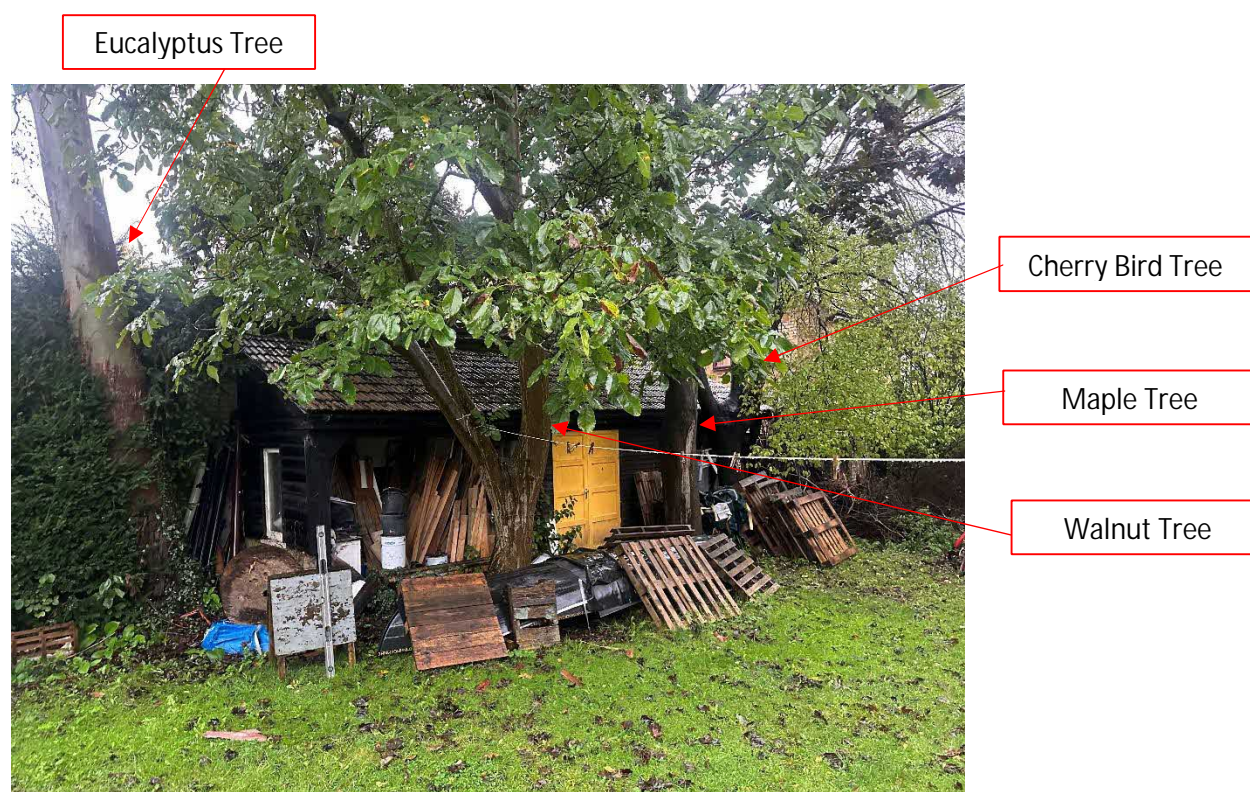
In front of the outbuilding to the northwest is four large trees. The trees in place have been identified as a mature Eucalyptus, a mature Walnut, a mature Maple and a Bird Cherry. The trees vary in distance from the outbuilding but are all within 1m to the side/front elevations. The trees are shown in Fig 1.0 below –

Fig 1.0 Existing Outbuilding with existing trees in the foreground

In order to prevent further damage to the structure, we would recommend that the existing mature trees are significantly reduced in height and then removed in stages. The proposal would be to remove the tree in stages to prevent the effects of ground heave on the outbuilding and any surrounding structures. We would advise that a Arbiculturist confirms how much of the mature trees to remove in the first phase, and then when to remove them completely to negate further movement to the existing Outbuilding. The four existing trees are all likely to have an effect on the structure until they are reduced in height and removed.

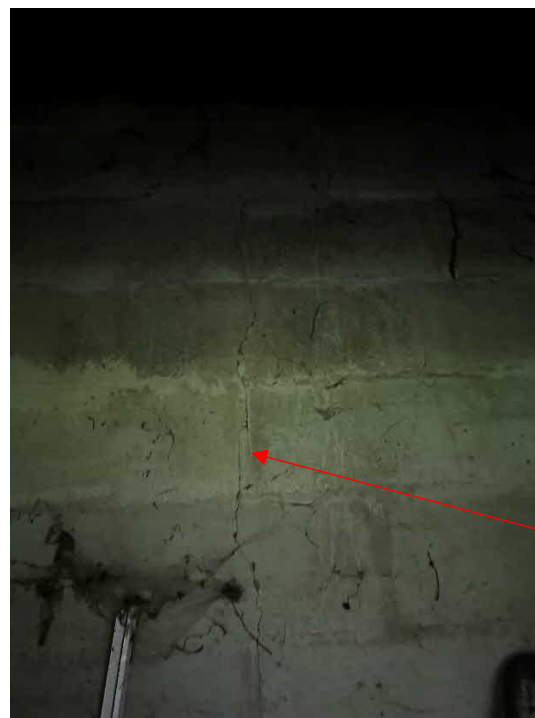
- a) The property was inspected internally, and it was noted that a large vertical crack is in place to the rear of the outbuilding. The vertical crack is through the southeast blockwork boundary wall and measured between 1-3mm in width. The crack was reported to have become apparent over the last few years. The crack location is the bay closest to the existing mature Eucalyptus tree.

Vertical crack to the boundary wall

Fig 1.2 Existing cracking to the rear of the Outbuilding

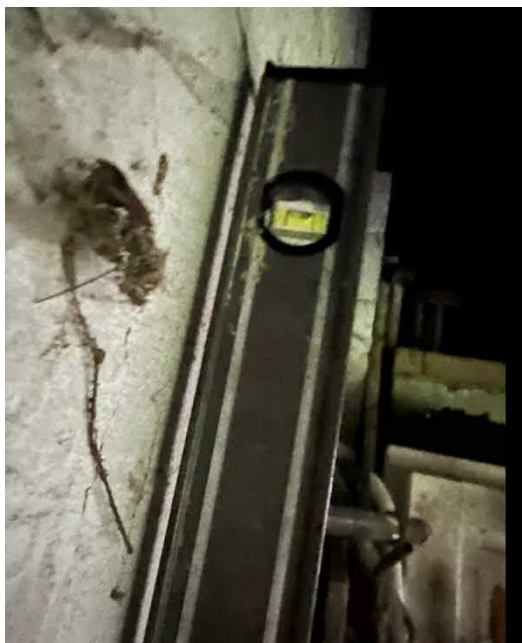
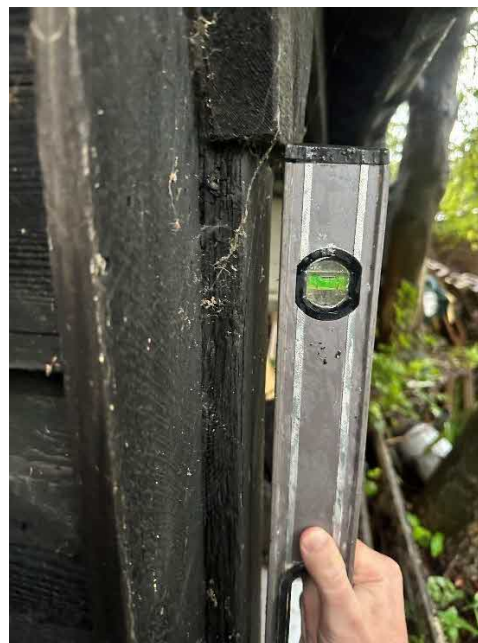
- b) The existing outbuilding structure is significantly out of level as shown in Fig 1.3. A long vertical level was placed on the existing timber post and rear wall and a significant lean was recorded. The structure seems to be approximately 10mm out of level at the head of the wall and posts respectively.

Fig 1.3 Movement to the rear wall and Timber Post structure

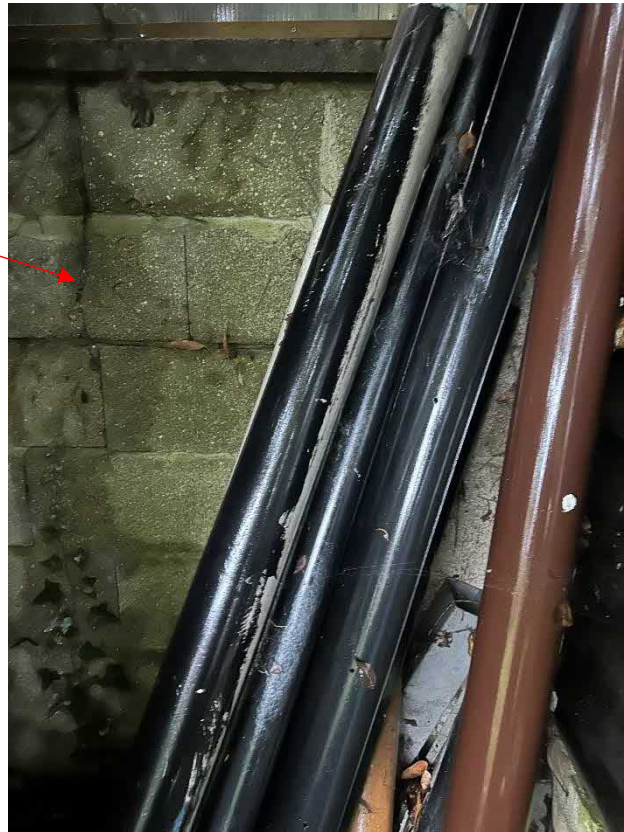
- c) Further vertical movement was noted externally of the outbuilding, again through the boundary wall. The location of the movement through the boundary wall is behind the existing Eucalyptus Tree. The movement measured approx. 1-2mm in width and was noted to full height of the existing wall. Similarly, to the other movements noted, cracking has become apparent over the last few years.

Vertical crack to the  
boundary wall

Fig 1.4 Movement to the rear boundary wall
