November 2023

## Arboricultural Inspection Report

8 Greenside

Waterbeach

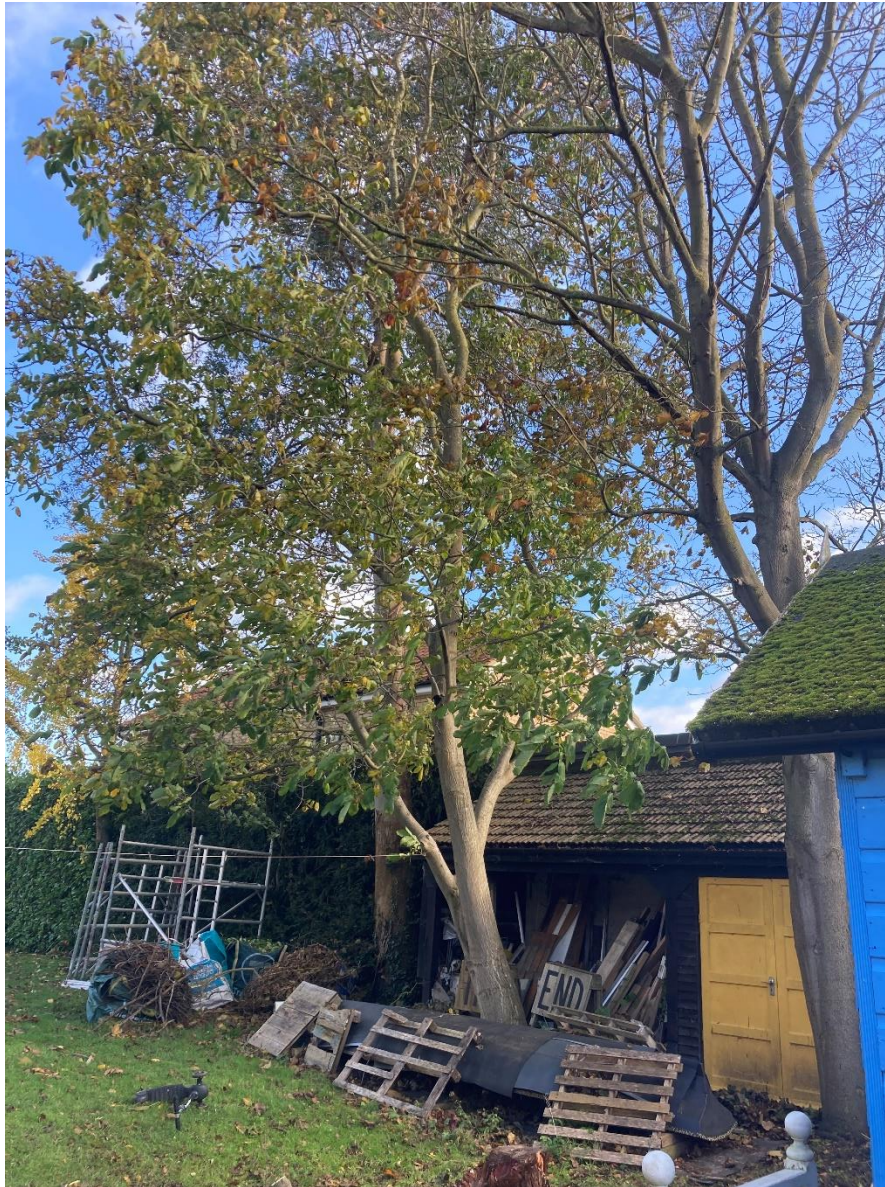
2.2.2 The three trees are forty years old and were planted as screening by the previous occupant. They are now extremely overcrowded with the trees growing into each other and over the outbuilding roof and that of the neighbouring property.

*Photograph 1* General view of three trees (eucalyptus, walnut, maple)

3.2.1. On the basis of my findings, I consider it essential that the trees are removed before further costly damage occurs to the owners' property and that of his neighbour. Reducing the size of the trees would have no effect on the roots and therefore our recommendation is that these trees are felled and replaced with smaller native species more appropriate for the size of the garden and the proximity of buildings. These would be more in keeping with the amenity value of the local trees. There are many other mature trees on the property so there will be no loss of vista from either the green or the property itself.

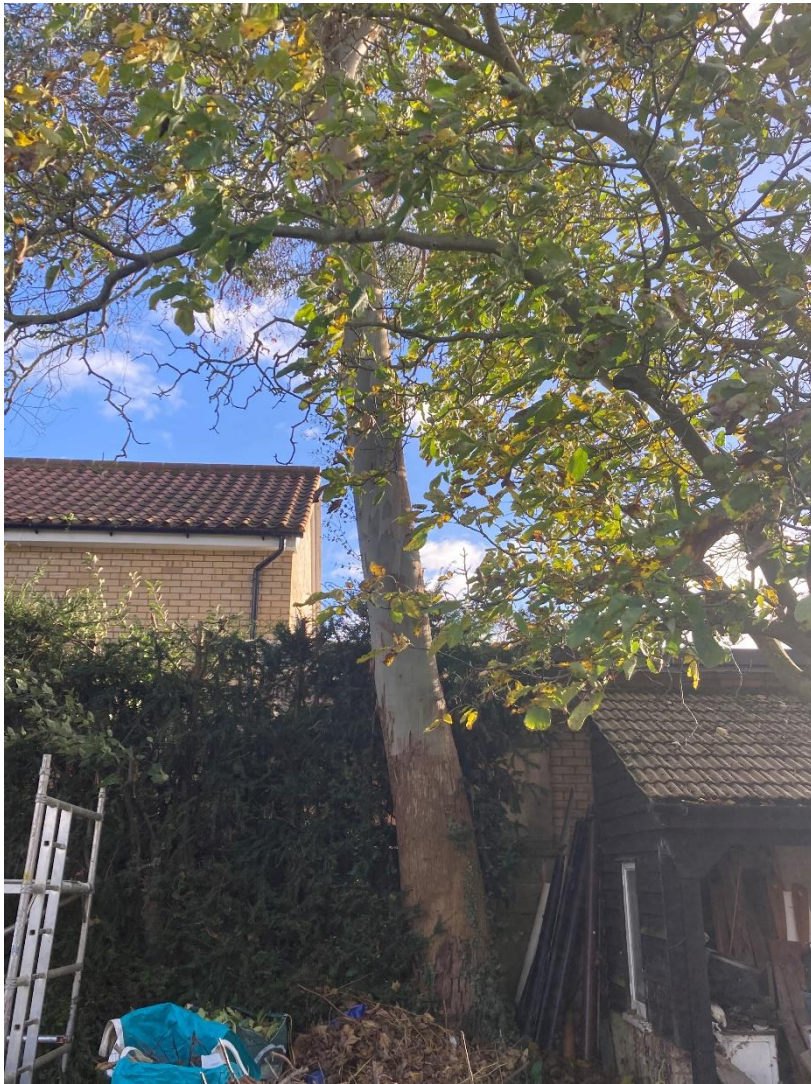
2.2.3 *Structural conditions and details* The eucalyptus is exhibiting a major lean towards the North East over the neighbouring property. It is mis-shapen with many limbs and the overall tree profile malformed.

*Photograph 2* Lean on eucalyptus

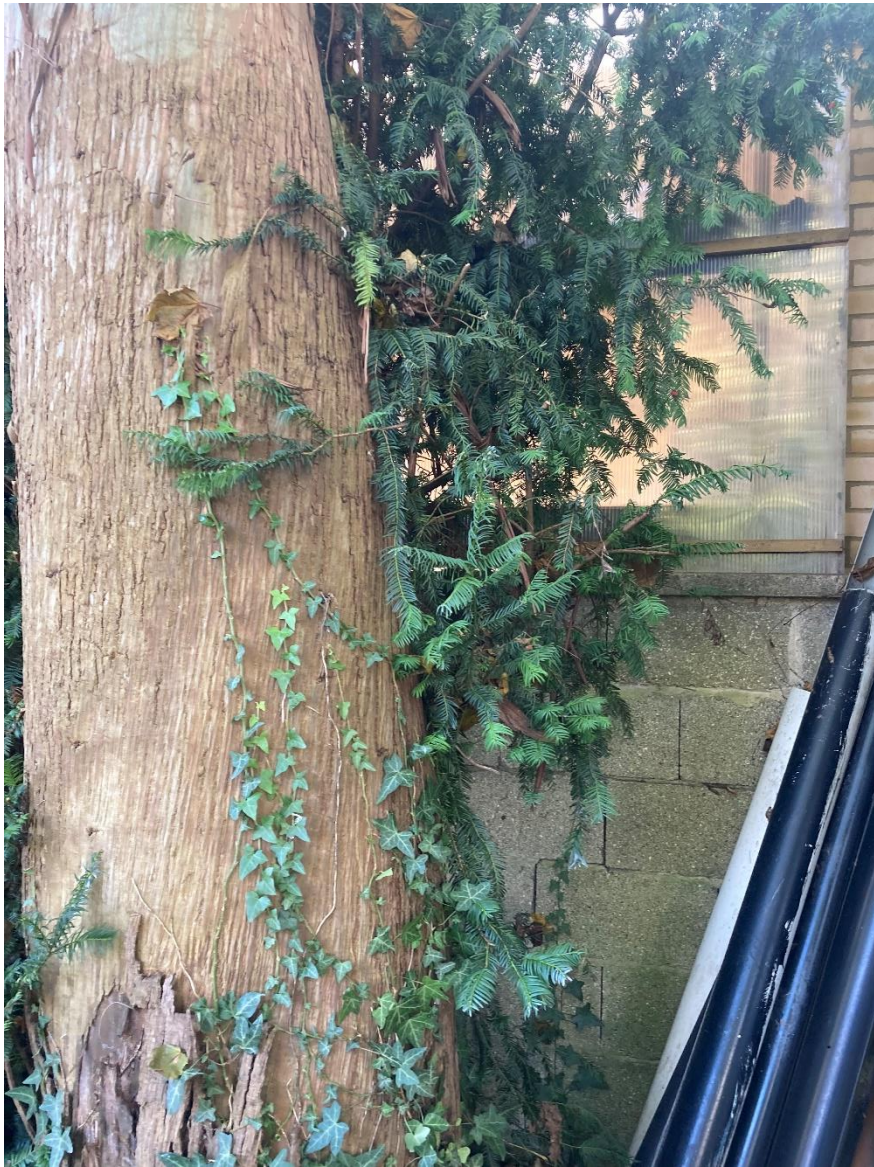
All three trees are showing visible signs of root associated ground-heave which is affecting both the outbuilding and the party wall.

*Photograph 3* Proximity of eucalyptus to party wall

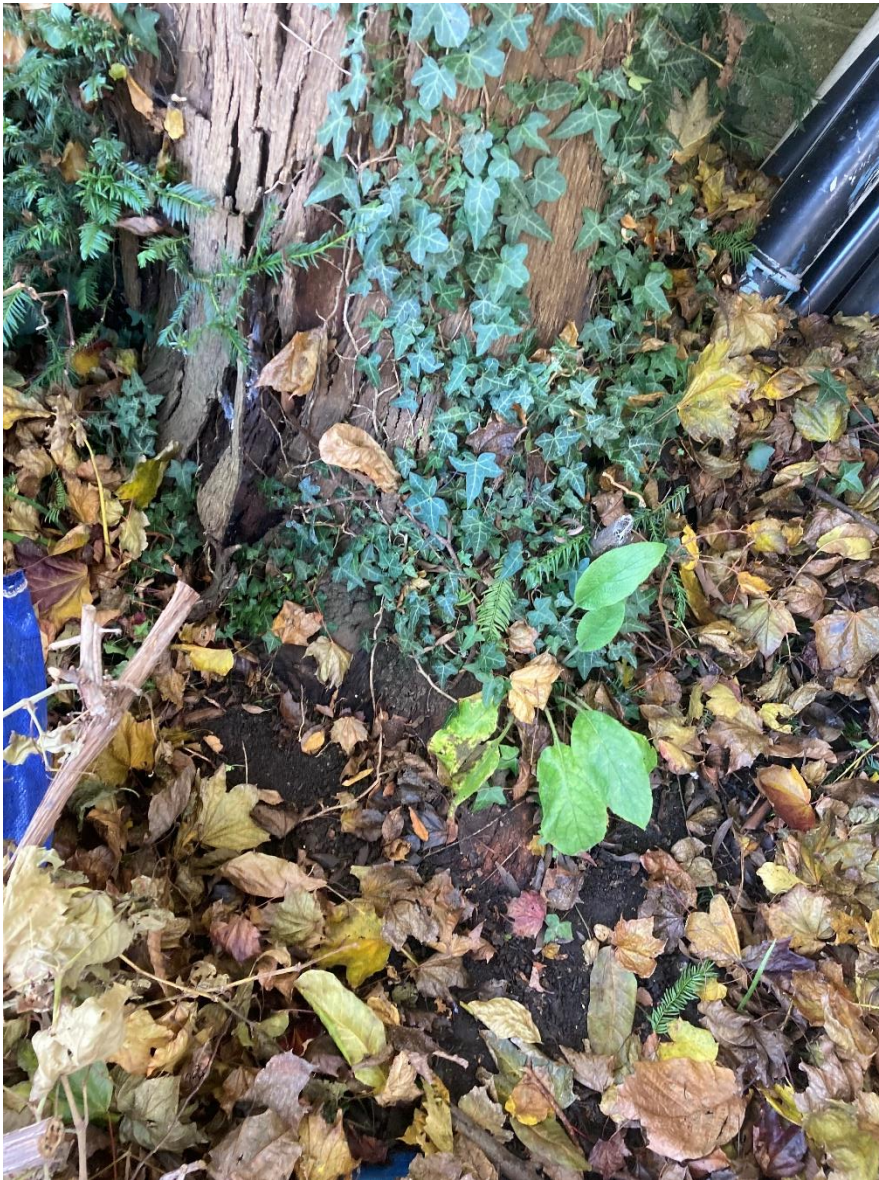
2.2.7 The eucalyptus is showing signs of dieback on the north side with a large percentage of the upper limbs appearing dead and brittle. There are many significant dead branches.

*Photograph 4* Bark delamination on eucalyptus

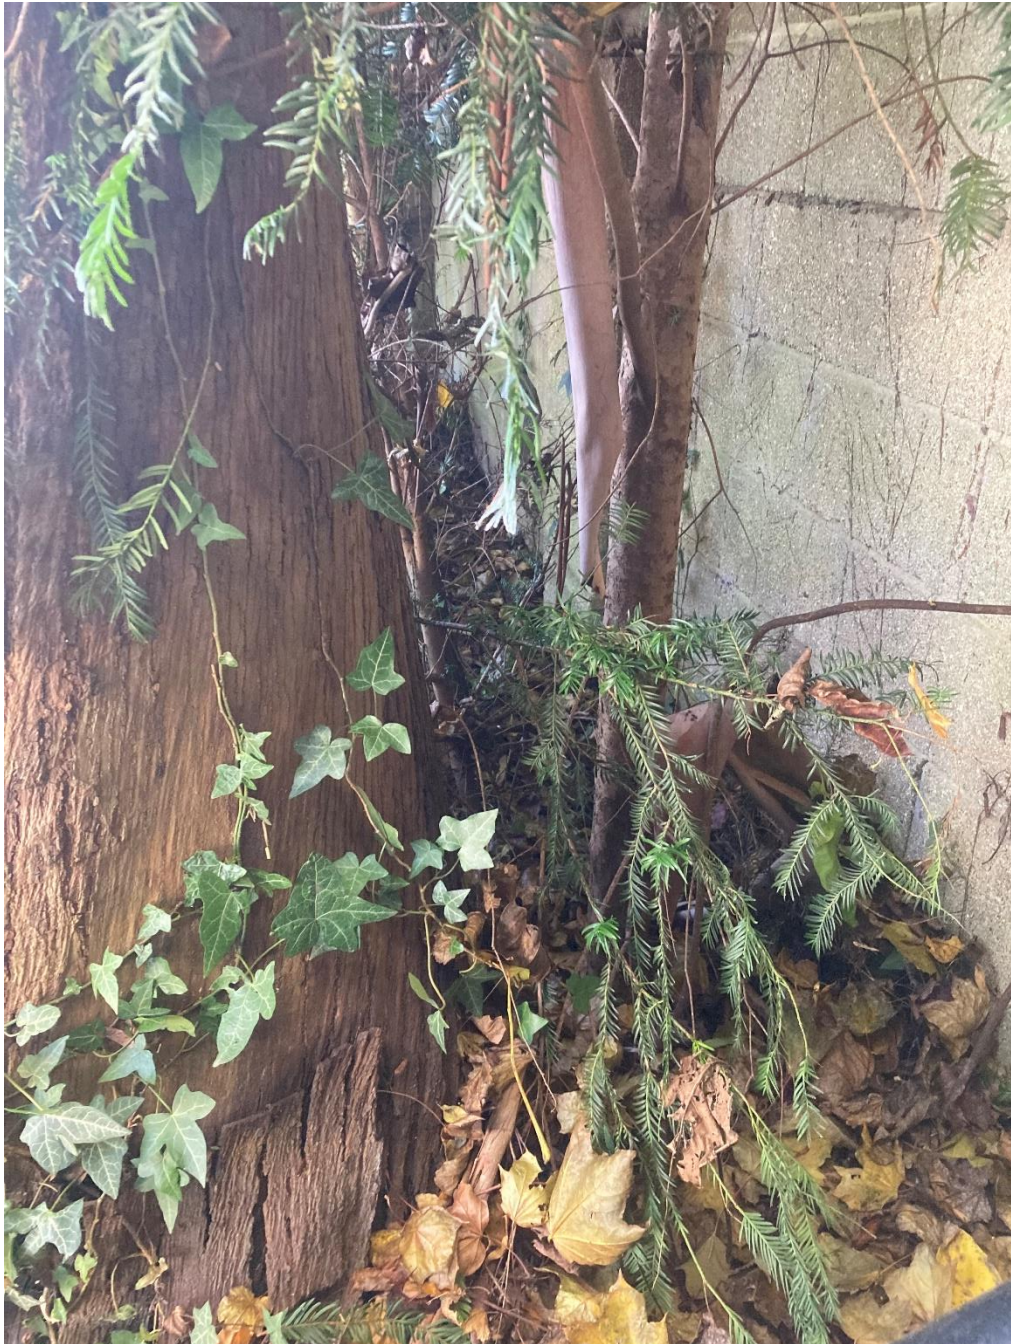
*Photograph 5* Proximity of party wall

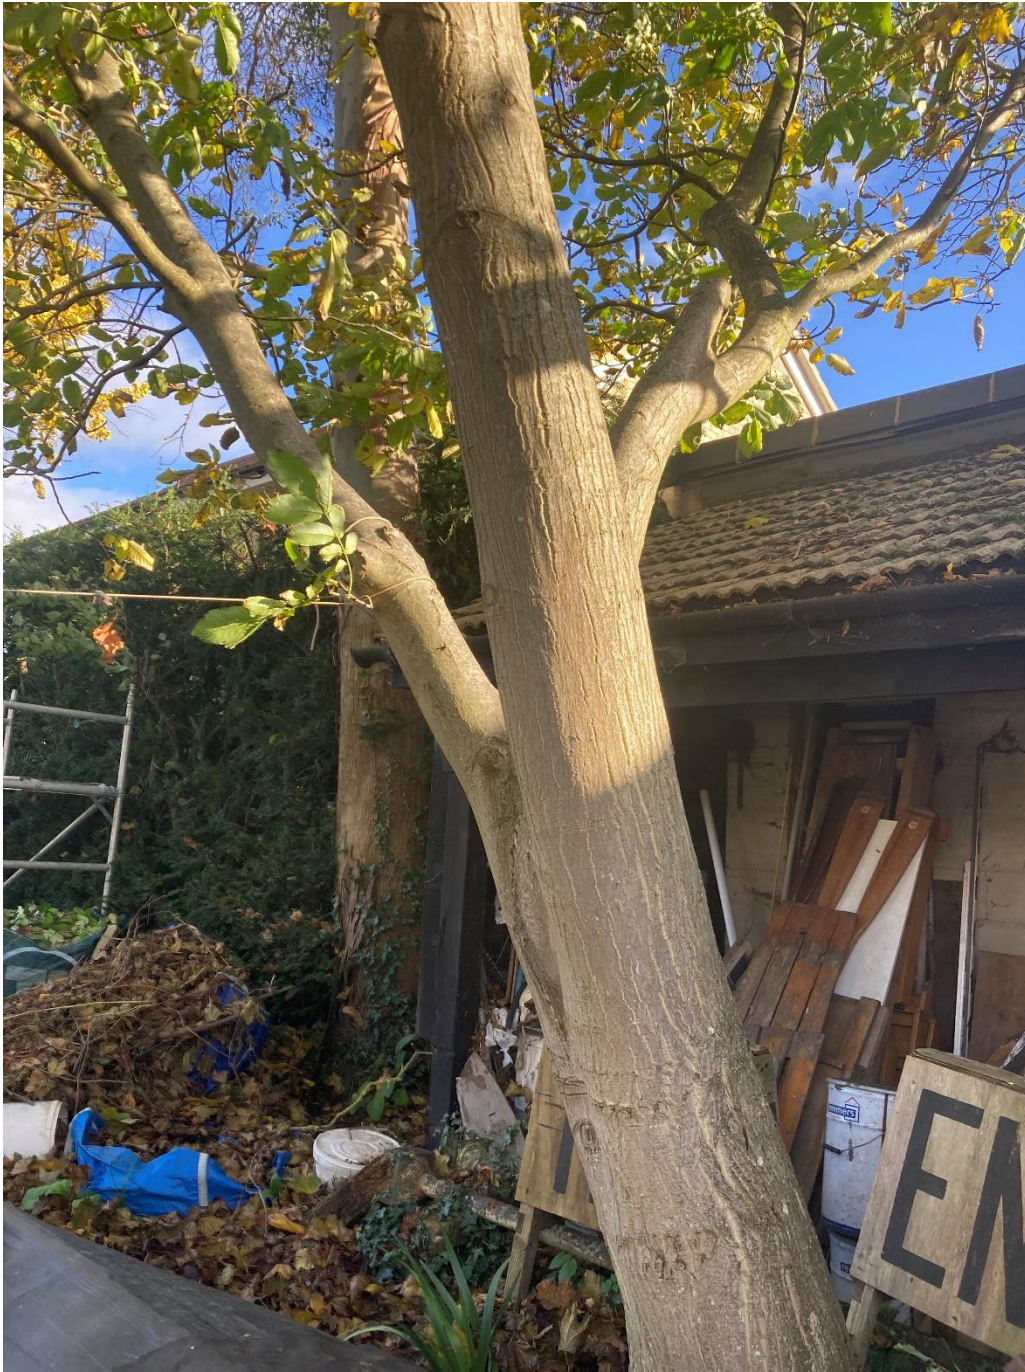
*Photograph 6* Proximity of trees to outbuilding and lean on walnut

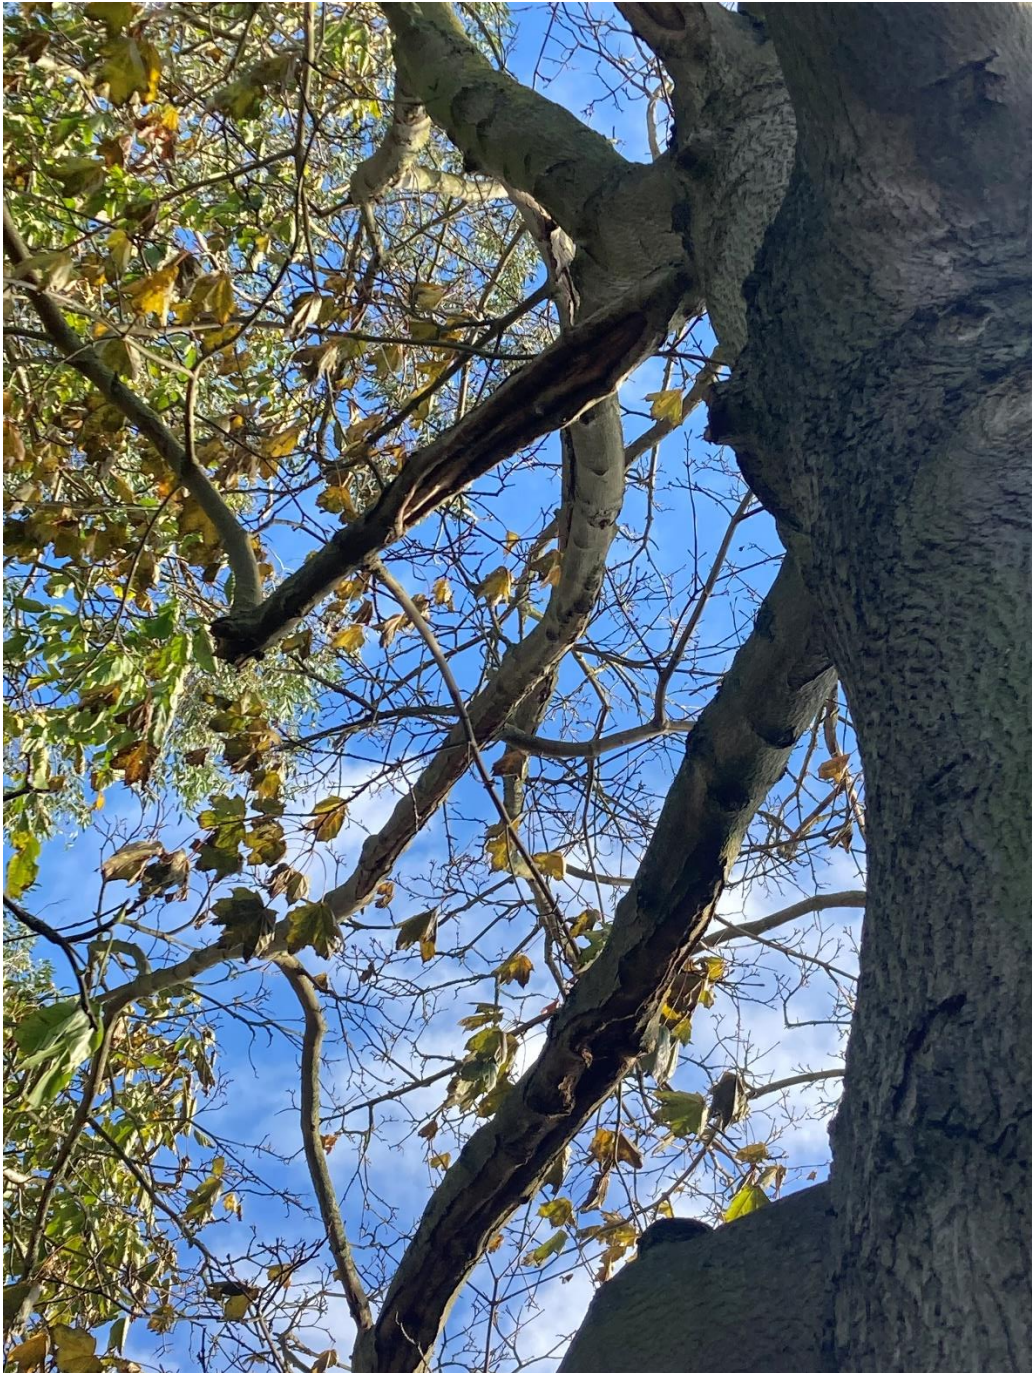
2.2.6 The maple crown shows signs of decline with several significant dead branches and dead wood.

*Photograph 7* Dead branches in maple

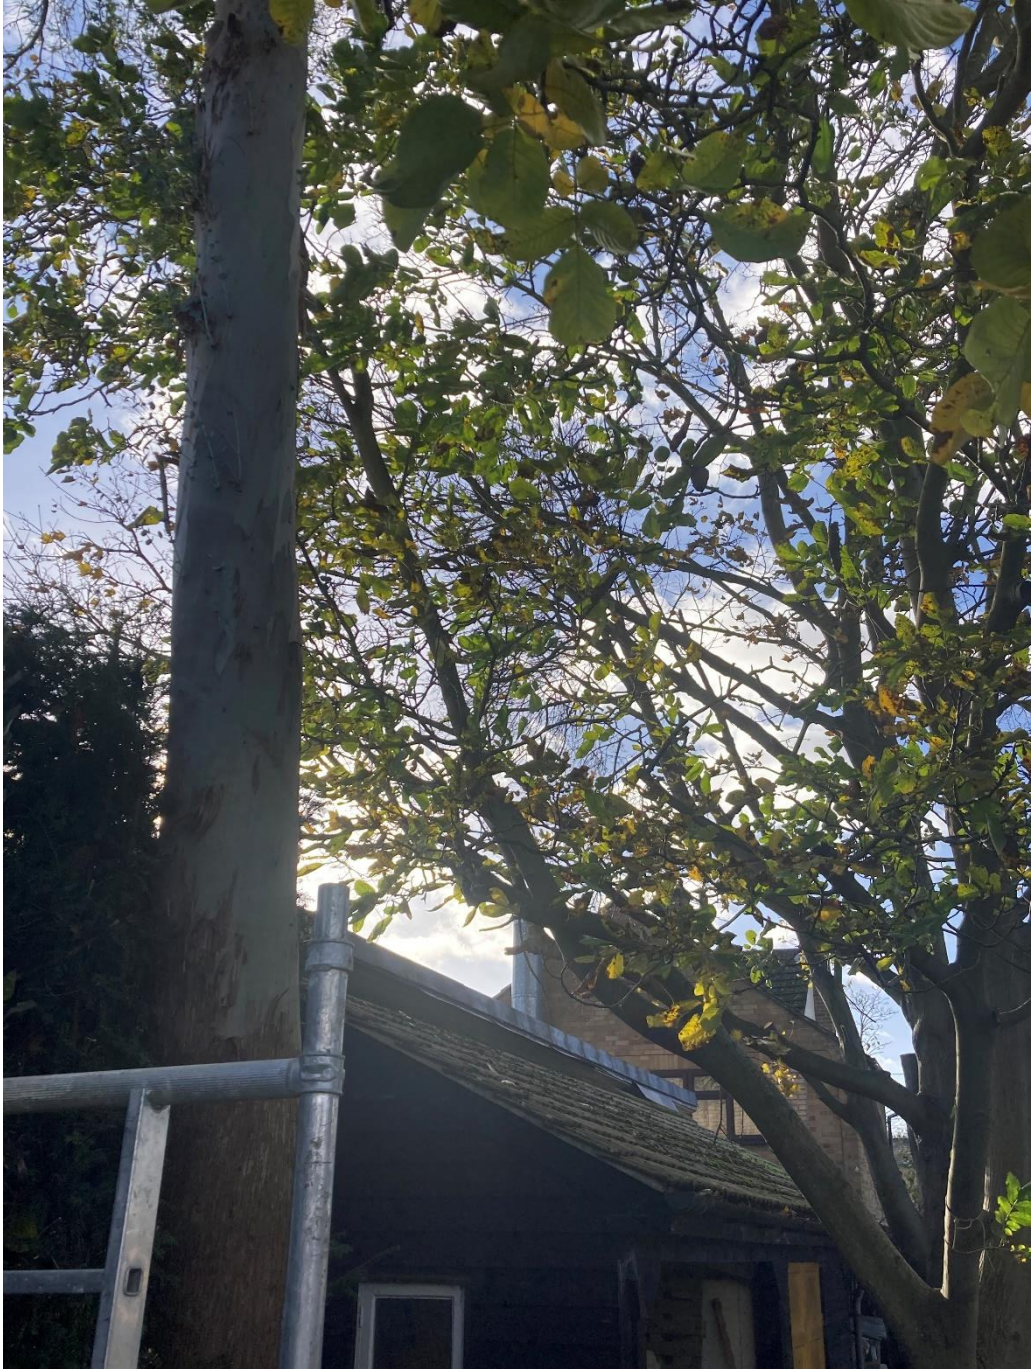
2.2.4 The maple is exhibiting uncharacteristic growth patterns due to its proximity to the other trees and the tall building of the neighbouring property. There are many unnaturally elongated lateral branches which overhang the neighbouring annex and the owner's outbuilding.

*Photograph 8* Limbs overhanging neighbouring property

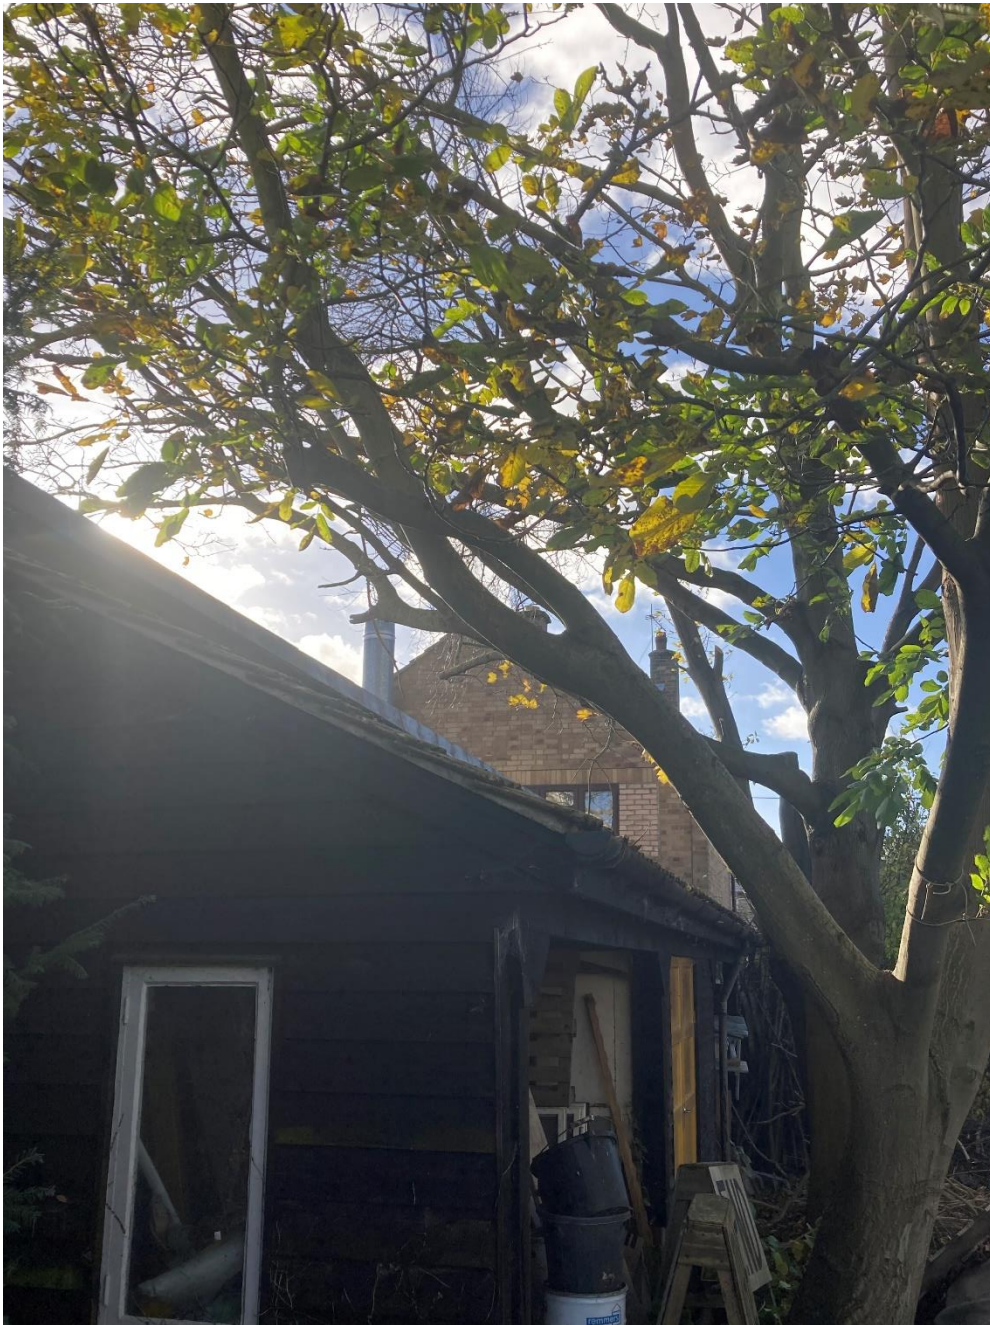
*Photograph 9* Overhanging limbs
