REPORT ON THE PROPOSED CONVERSION OF
OUTBUILDING & CARTLODGE
AT
DILLACKS FARM
ASSINGTON, SUFFOLK

Our ref: TCK/11323/REPORT/ R1.0
Date: 4th October 2023

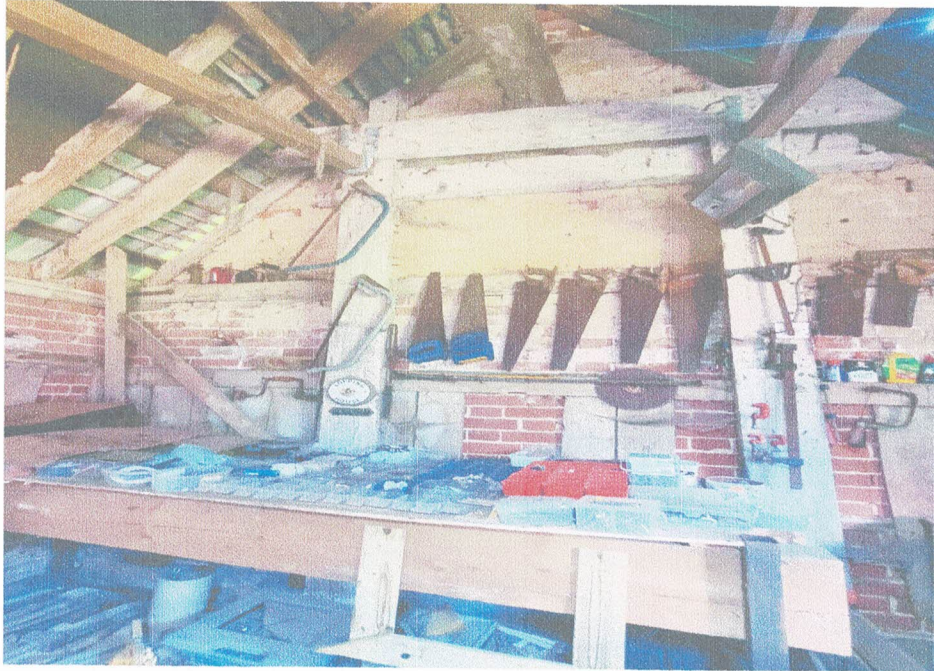
- 4.1.1. The roof to the main workshop / store has "racked" with the triangular section of masonry gable wall that separates the workshop from the log store leaning into the workshop. An arrangement of timber beams and posts have been introduced within the workshop at this end to prop the leaning wall.

P3 – Propping to leaning (inward) south gable between workshop and cart lodge.

- 5.4. We recommend the triangular section of gable wall above plate level be rebuilt to improve its verticality to both the workshop / store and cartlodge. A timber stud wall could be built above the existing timber eaves plate to strengthen the current single outer leaf construction.

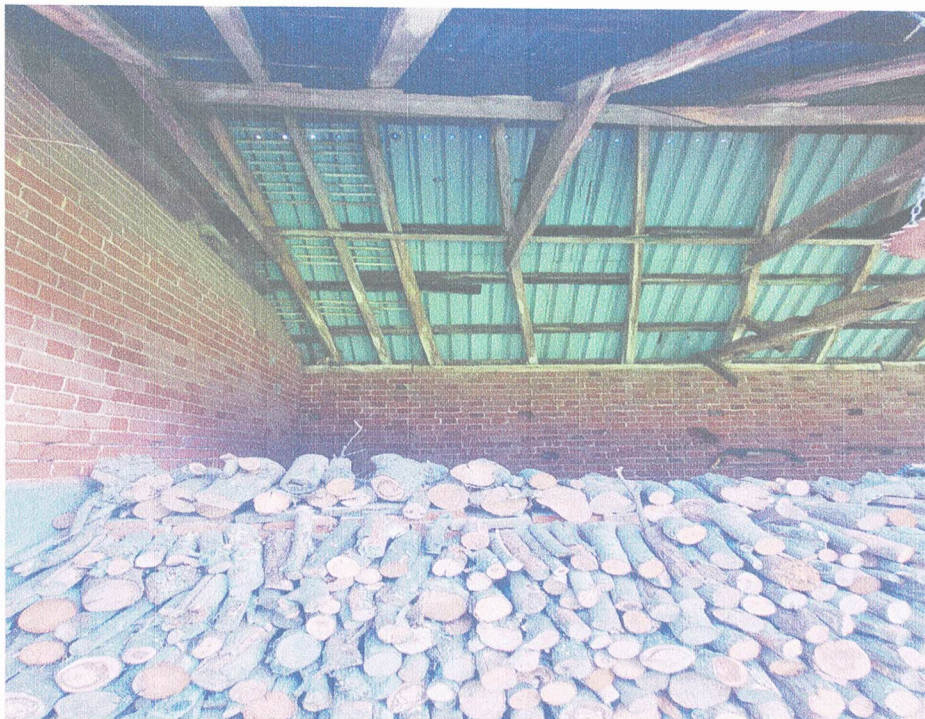
- 4.1.3. These above defects are also apparent to the southern gable wall and rafters to the log store which is not unexpected when noting the purlins are built into the leaning gable wall of the workshop.

- 5.3. The condition of the existing roof framing members is variable, and it is clear the roof has “racked” significantly likely as a result of wind suction on the single skin triangular section of gable wall together with inadequate tying / bracing to the roof structure.

P4 – Skewed rafters to cart lodge due to racking and leaning gable wall of workshop.

- 5.6. We therefore recommend the existing roof is strengthened by the introduction of a structural ridge beam or purlins to provide vertical support to the rafters to prevent further roof spread occurring. The span and size of a ridge beam or purlins could be minimised by providing support via posts hidden in the new internal partition walls. The introduction of a structural ridge beam or purlins will also offer the opportunity for the existing skewed rafters to be realigned.

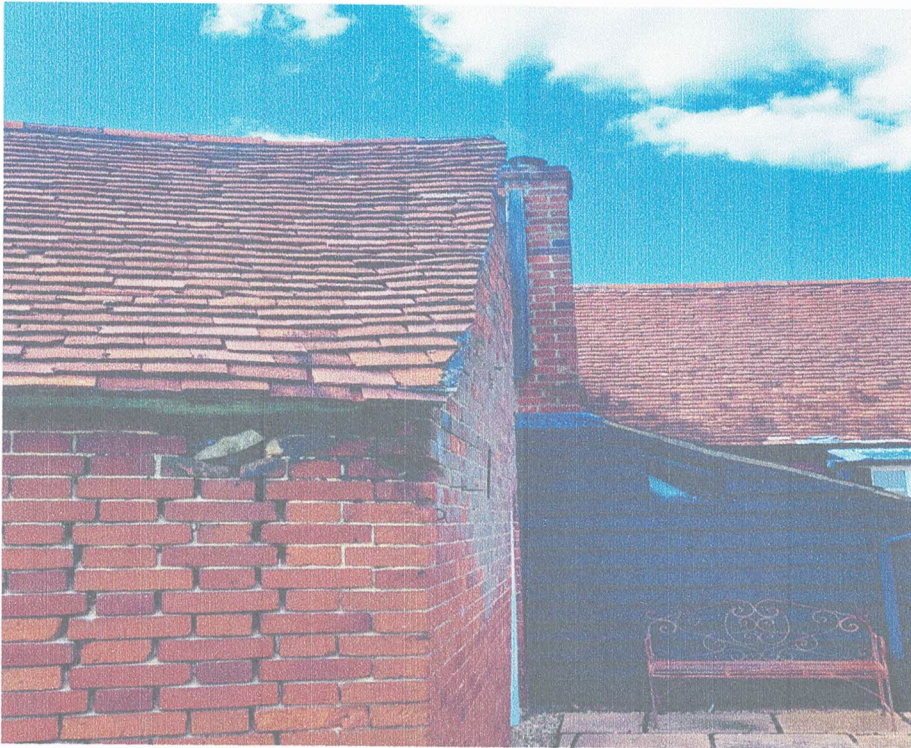
- 4.1.2. Similarly, at the opposite north gable (store end) the triangular section of wall is leaning outward. When viewed internally, the rafters therefore skew in the direction of the north gable elevation.

- 4.2.1. Generally, when viewed externally the solid masonry wall (rear elevation) appears to be in a good condition and structurally robust with isolated areas of spalled brickwork and some localised areas of mortar loss readily apparent. However, at the junction with the north gable wall there is a diagonal crack and part separation of the gable wall with the rear elevation. The likely cause of this is most probably due to the outward rotation of the gable wall as identified above.

P5 –Crack to flank wall and leaning (outward) north gable wall to storeroom.

- 5.7. Generally, we recommend all areas of spalled brickwork are replaced and areas subject to mortar loss repaired with a lime mortar.
- 5.8. In our opinion, the diagonal crack noted to the external wall at the northeast gable is likely to be indicative of the gable wall leaning or rotating as opposed to a localised foundation issue. We would however recommend this area be partially rebuilt or repaired using a heli-bar stitch repair to ensure walls are adequately tied. Similarly, we would recommend a heli bar stitch repair to the arch lintel on the north gable wall.

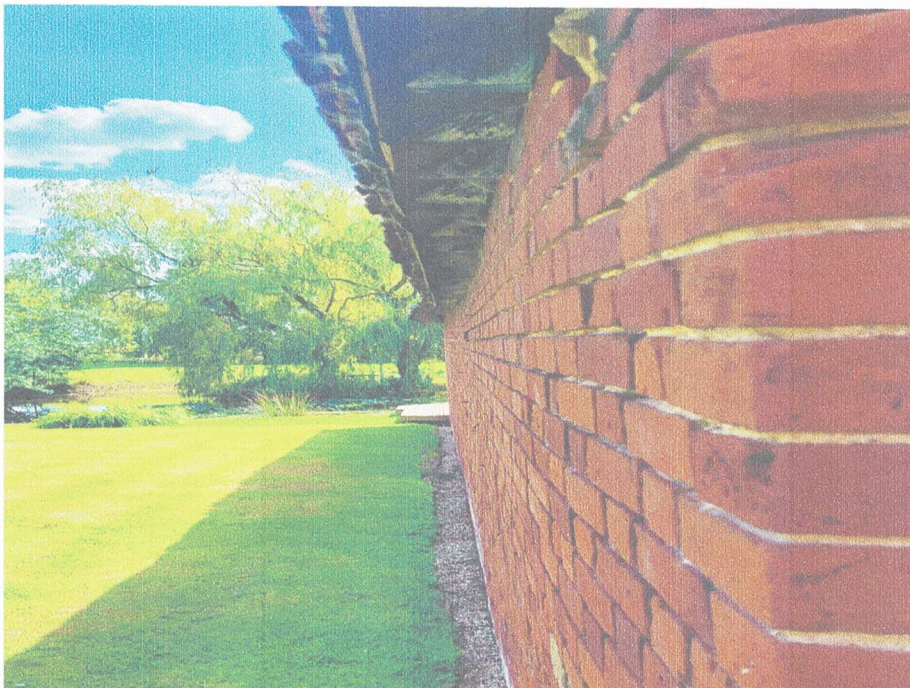
- 4.2.2. When viewed externally the external rear masonry wall appears to slightly out of plumb vertically which would indicate a degree of roof spread has occurred. Furthermore, there appears to be some bulging along the length of the wall.

- 5.5. The structural form of the roof (not triangulated by ceiling joists) means the building has relied upon the wall plate spanning between tie beams to resist the horizontal thrust from the rafter feet. There is evidence that a degree of roof spread has occurred and this together with the racking that has occurred means the existing roof structure is not functioning adequately and requires strengthening.

P6 – Leaning / Bulging rear wall.

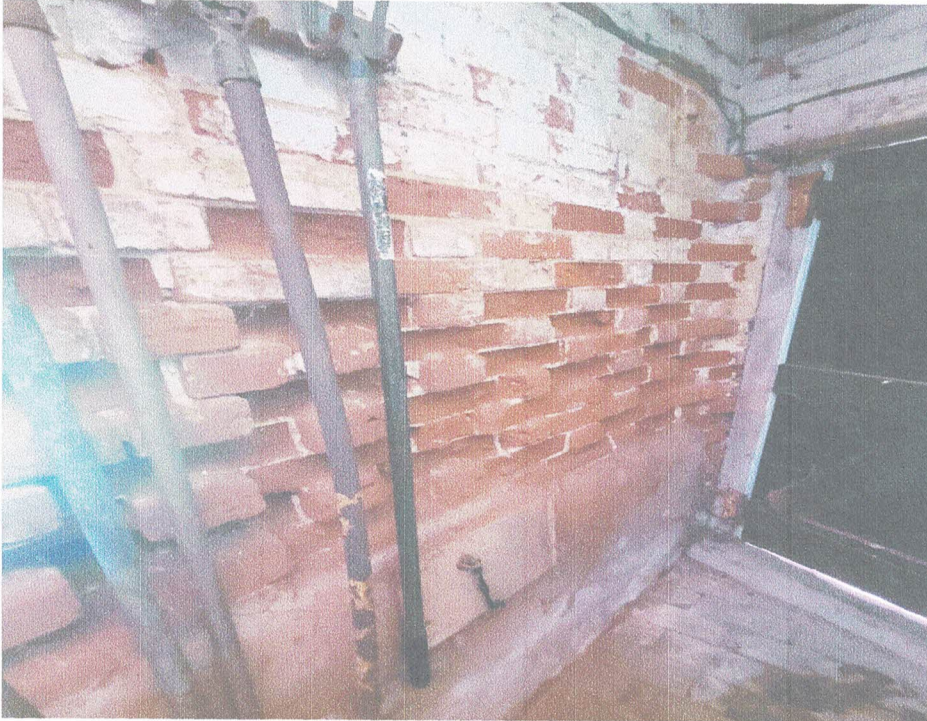
4.2.5. It was not possible to inspect the condition of the external walls in detail internally due to the numerous workbenches, shelves and tools covering their surface. However, it was noted the section of wall between the store and covered patio areas has several bricks missing.

P7- Brick loss storeroom wall adjoining covered patio area.

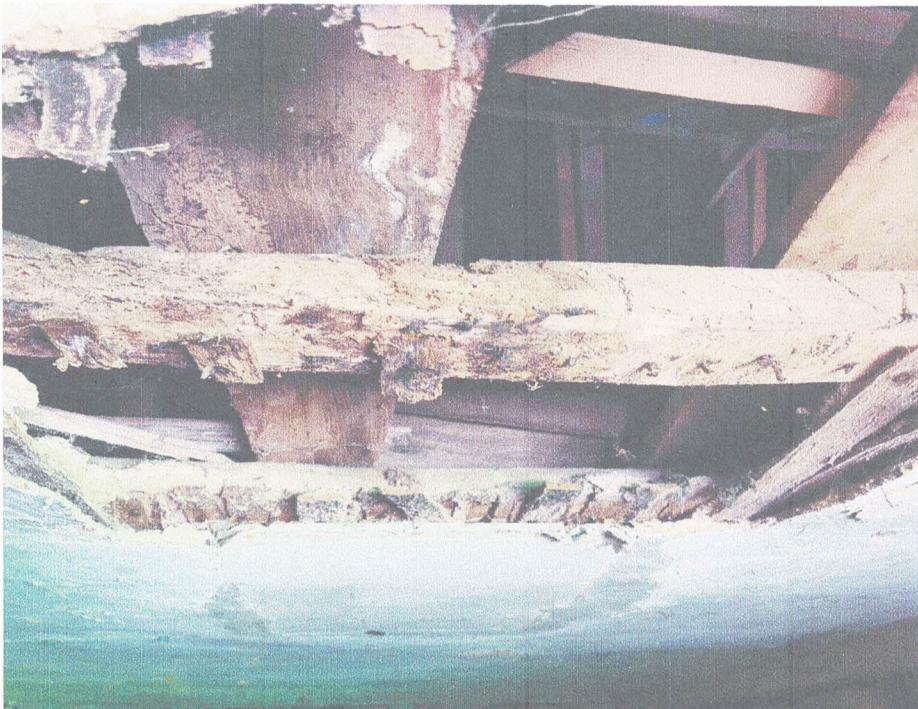
4.3.1. Where the lath and plaster ceiling had deteriorated it was evident some of the original joists had decayed. The stud wall appeared generally in a good condition. In our opinion, the stud wall and header beam appeared to be of original construction.

P8 – Decay to timber ceiling joist over storeroom.

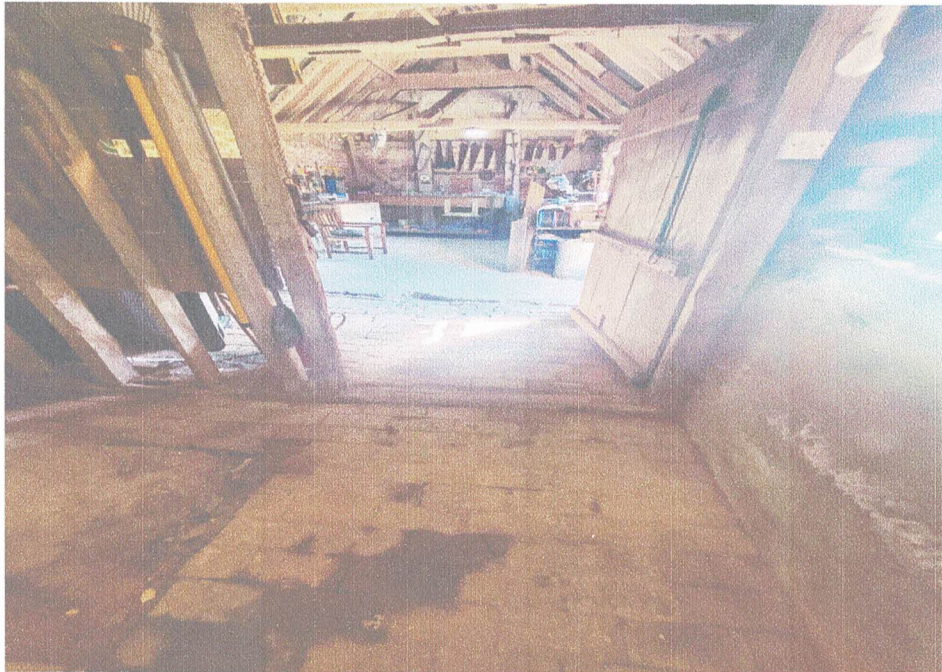
4.4.1. The floor to the storeroom and part of the workshop comprises stone paviours which whilst in some locations undulate underfoot appeared generally in a fair condition. A section of the paviours had been removed in the storeroom.

4.4.2. The remaining section of the workshop floor has a screed finish which appeared to be in a good condition.

P9 – Floor to storeroom with screeded workshop floor beyond.
