Outbuilding at Dillacks Farm, Assington, Suffolk

Heritage Asset Assessment

Outbuilding at Dillacks Farm Colchester Road, Assington, Suffolk

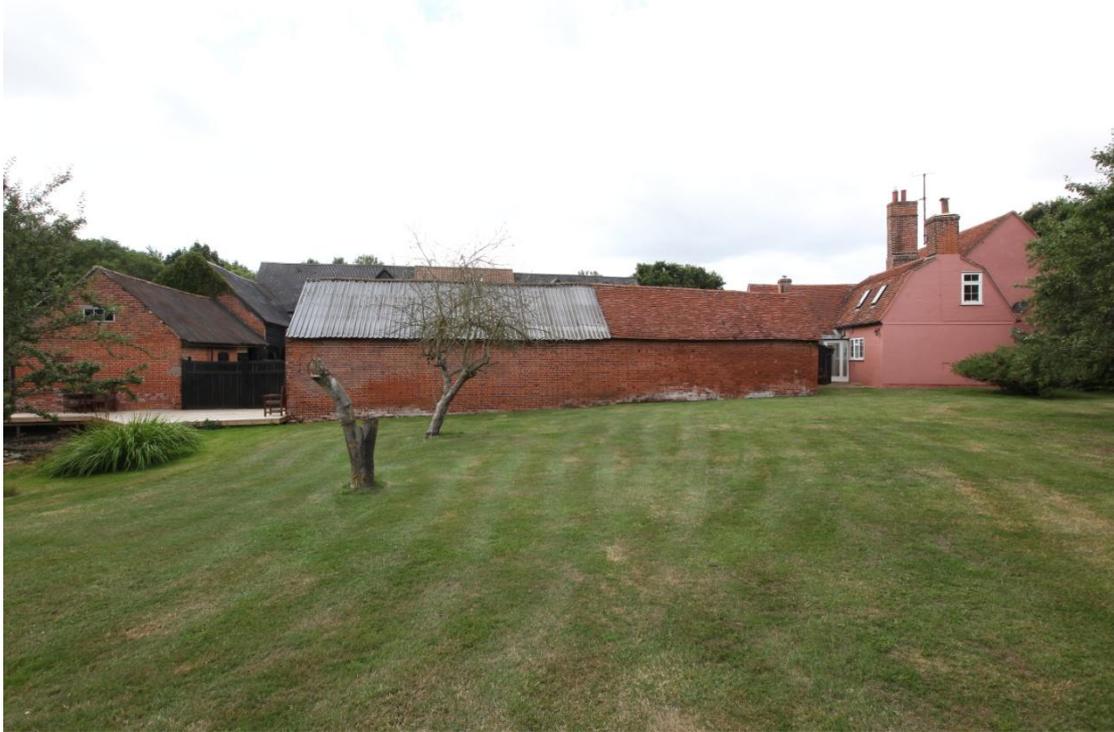
Illus. 9. The brick outbuilding from the east showing the stable on the left and the house to the right. The structurally distinct section of the house with a gambrel roof was added between 1837 and 1885 according to the historic maps. The tiles of the left-hand section of the outbuilding were replaced with corrugated iron between the 1970s and 90s as indicated on the aerial photographs in figure 15.

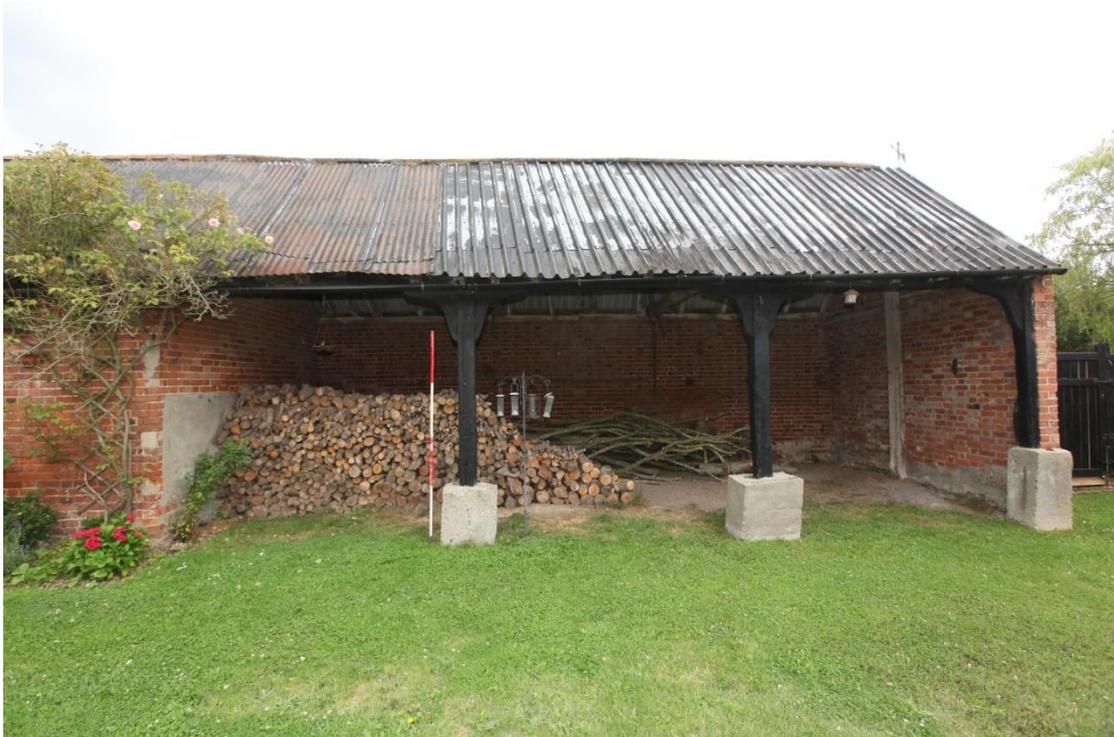
Illus. 13. The open western wall of the three-bay shelter-shed (1) that formerly served the horse yard adjoining the stable (as described in 1938 and shown on the Ordnance Surveys). The two original wooden arcade posts survive along with all four knee-braces, but their feet have been encased in concrete blocks. The roof consists of a mixture of corrugated iron and modern pressed metal.

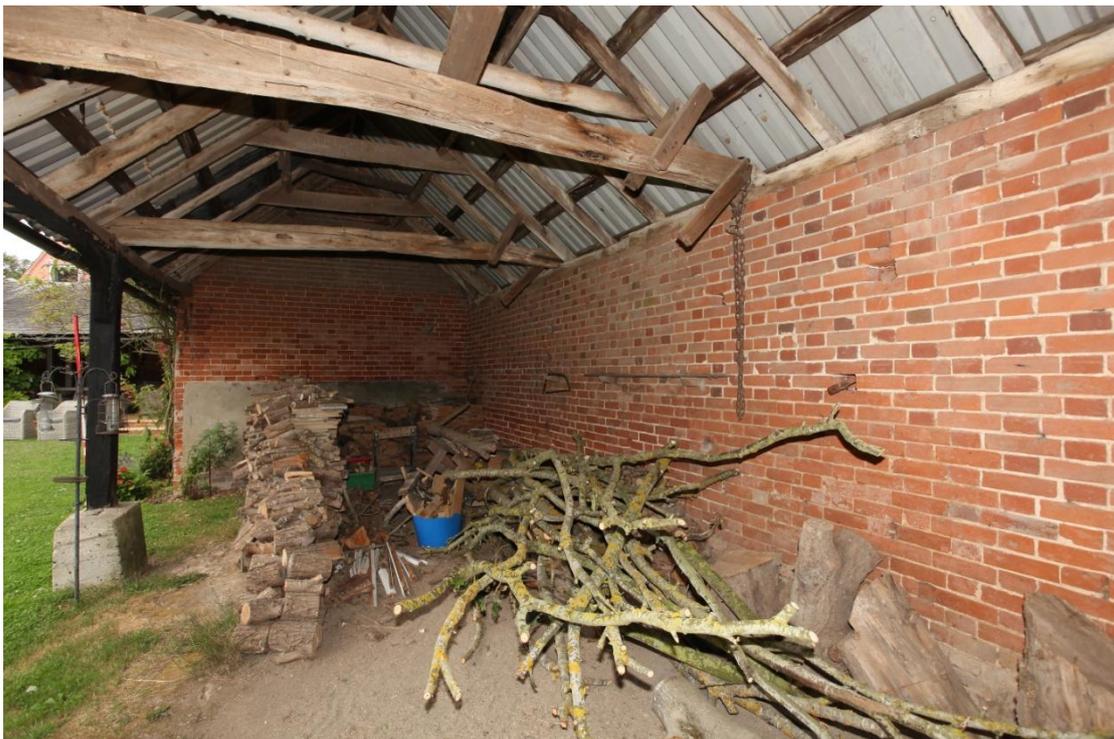
Illus. 14. The interior of the horse shelter-shed (1) from the south showing the re-used timber of its tie-beam that may have been salvaged from the earlier farm buildings on the site. The wooden troughs in the cow shelter-shed (1) are understood to have been removed from this space.

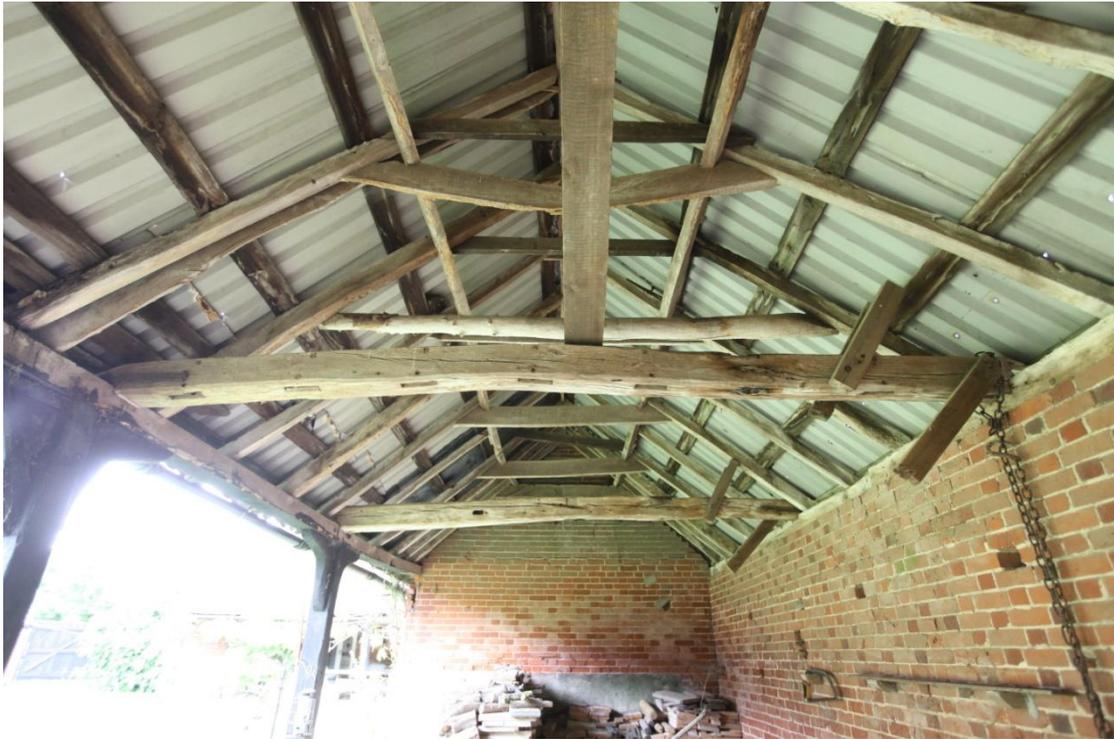
Illus. 15. The roof structure of the horse shelter-shed (1) from the south showing the empty pegged mortices of the 16th or early-17th century re-used tie-beam in the foreground. The original roof collars are nailed rather than pegged and the majority of the rafters have been removed.

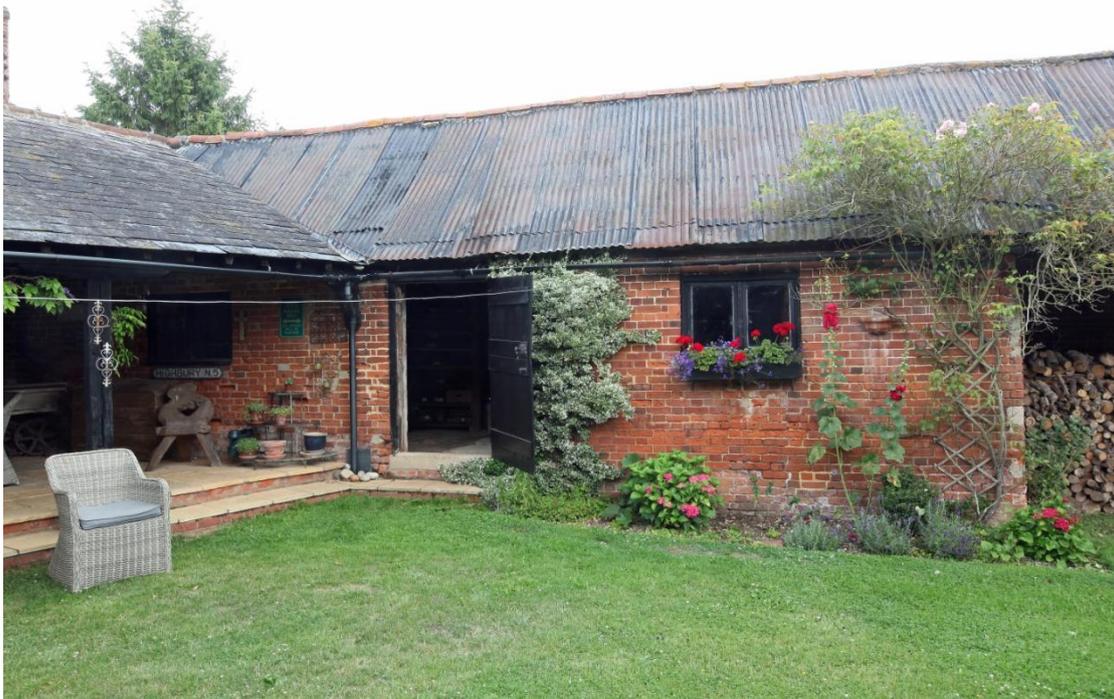
Illus. 17. The western exterior of the brick cow shed (2) showing its wide entrance door on the left. Both the door and window apertures are respected by closers (quarter-bricks) and are original to the wall fabric – although the window and door are modern replacements.

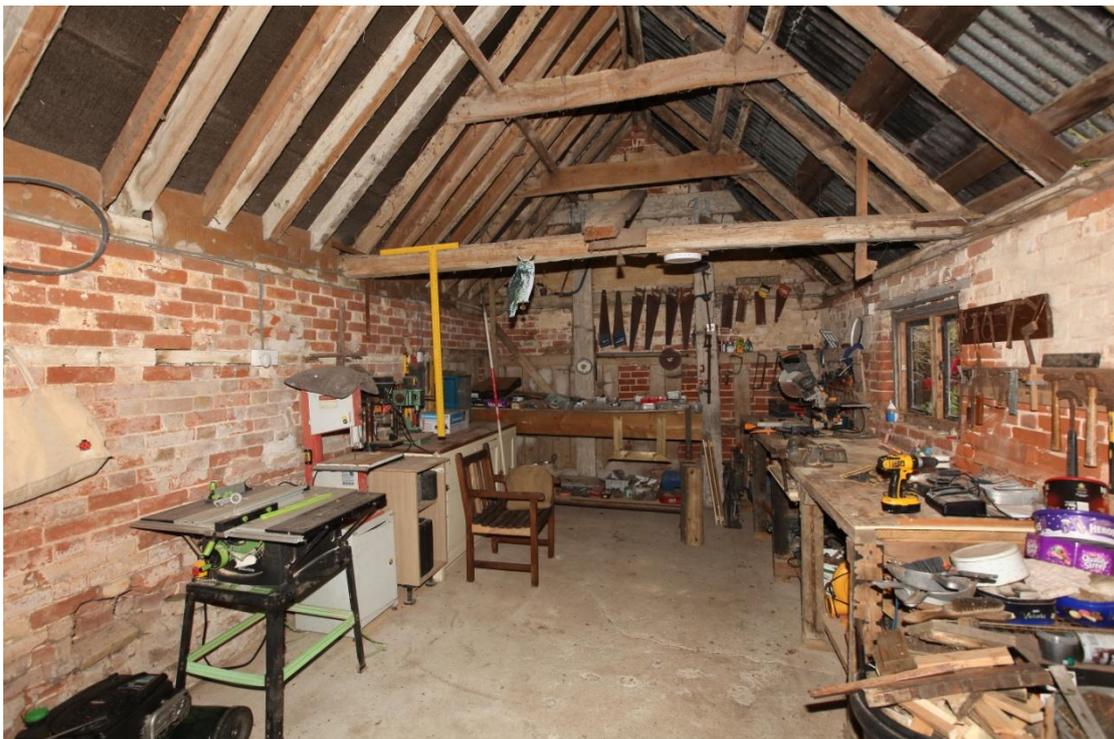
Illus. 18. The interior from the north of the cow shed (2) which has been converted into a workshop with a modern concrete floor. No original fixtures or fittings remain.

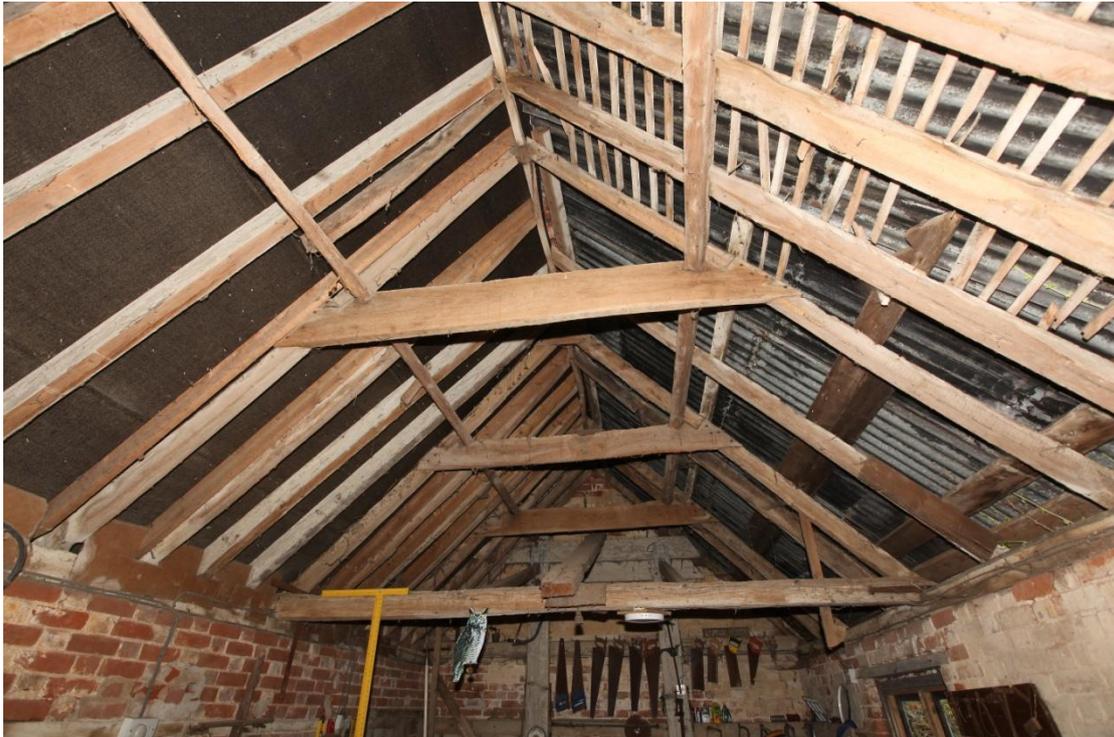
Illus. 19. The partly intact original clasped-purlin roof structure of the cow shed (2) as seen from the north. The rafters rest on a ridge-board and the original collars are nailed rather than pegged as might be expected in a relatively narrow structure. The original tile battens survive to the right.

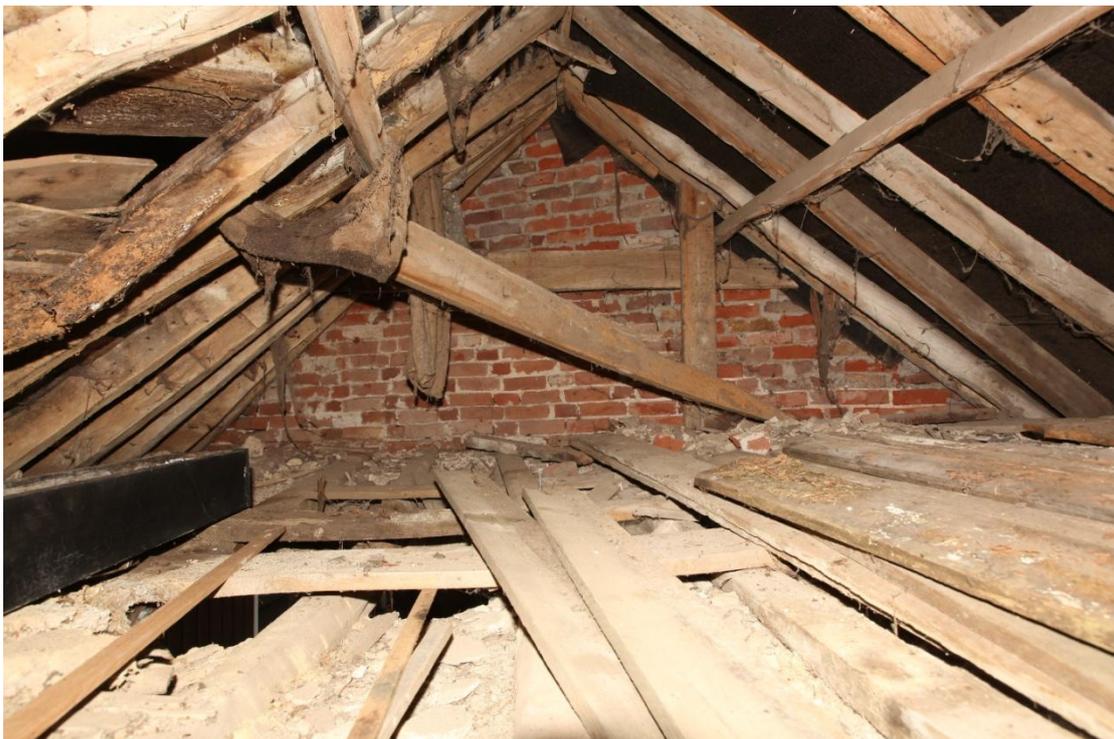
Illus. 24. The roof space above the mixing house (2a) at the northern end of the cow shed showing its gable in the rear. Most of the original clay daub floor in illustration 23 has been lost and boards have been laid across the joists instead. This space appears to have been accessible from the cow house (2) and may have served as a hay or straw loft. The clay floor prevented its contents from damaging the lath-and-plaster beneath.

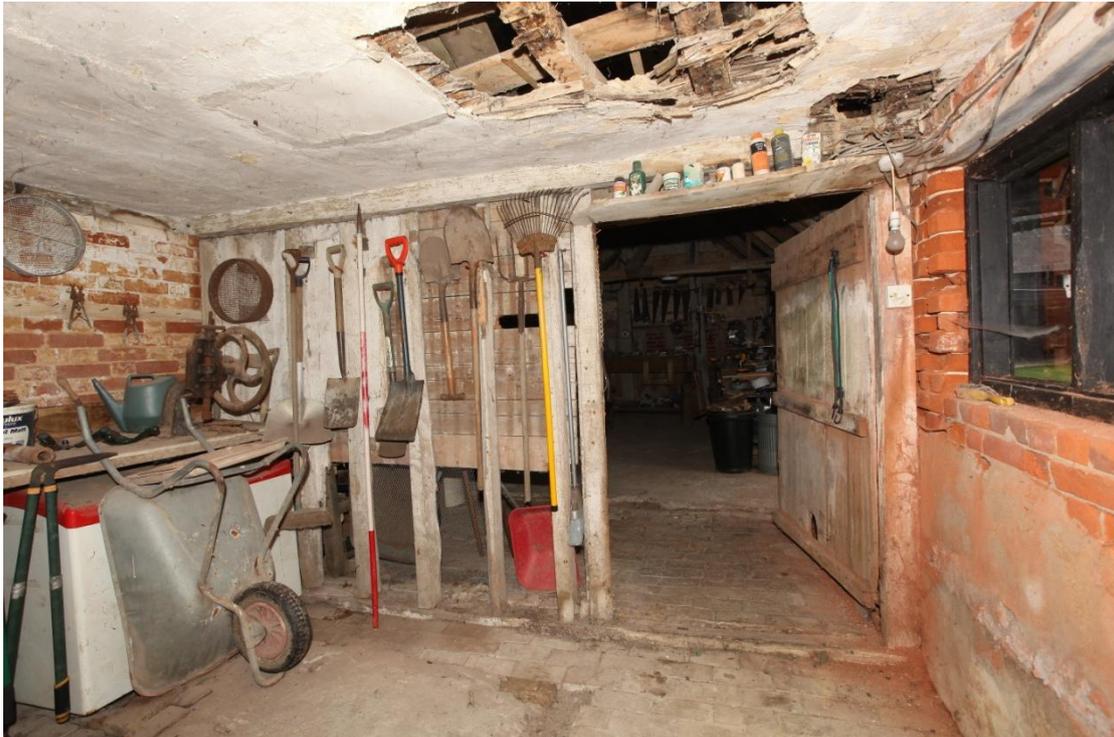
Illus. 27. The southern internal partition of the mixing house (2a) consisting of vertical studs with sections of original plaster surviving to the left. The exposed boards on the right retain the scars of nailed vertical laths to which the plaster was secured. Boarded walls were often sealed or ‘torched’ in this way in the 18th and early-19th centuries.

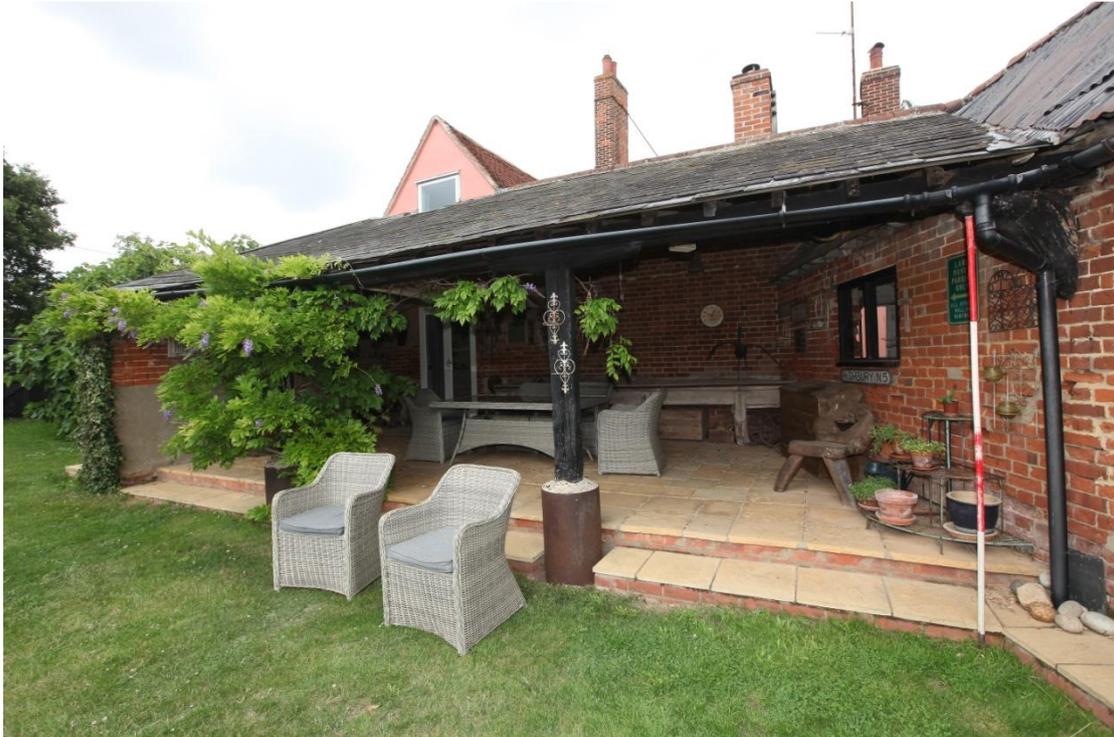
Illus. 31. The southern exterior of the three-bay open-fronted shelter-shed to the former cow yard (3) showing its slate roof and two intact arcade posts on later bases.

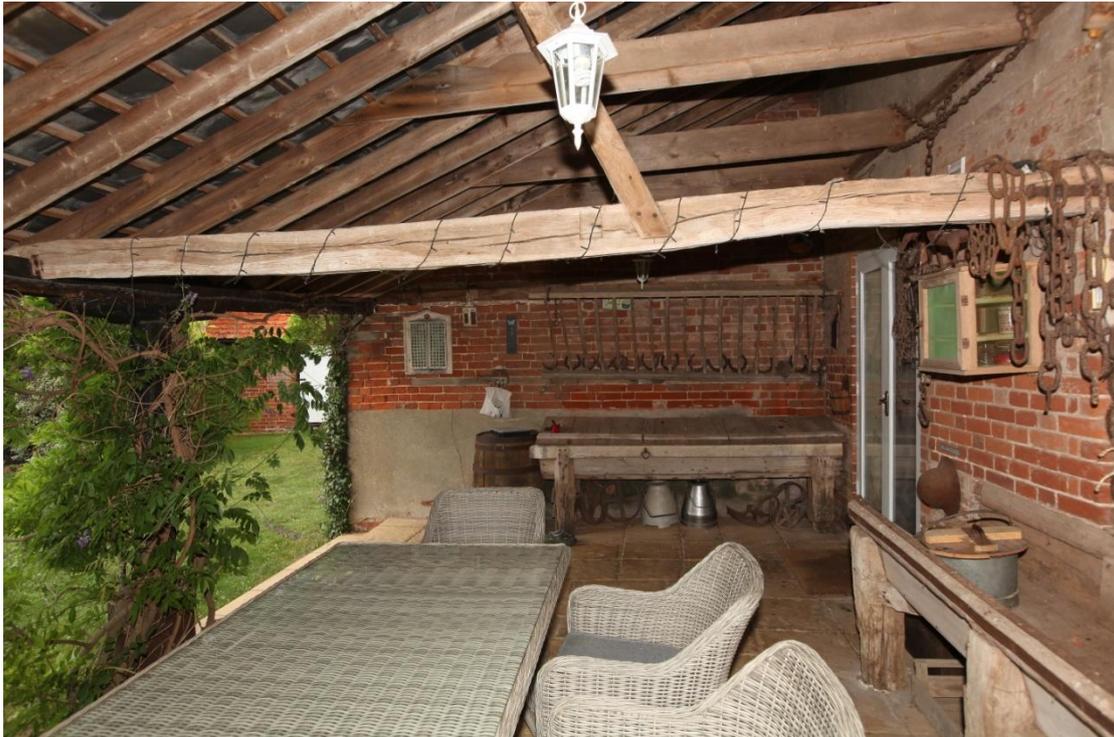
Illus. 35. The interior from the east of the shelter-shed to the cow yard (3) showing its open southern elevation on the left. The narrow-sectioned common rafters are 20th century softwood replacements. This roof is a single-pitch structure adjoining the tall brick wall that divided the farm yard from the house on the right.
