**Tree Inspection Report for
Maltings Cottage, Malt Close, Laxfield. IP13 8DZ**

Date of Inspection: 14/08/2023

Date of Report: 30/08/2023

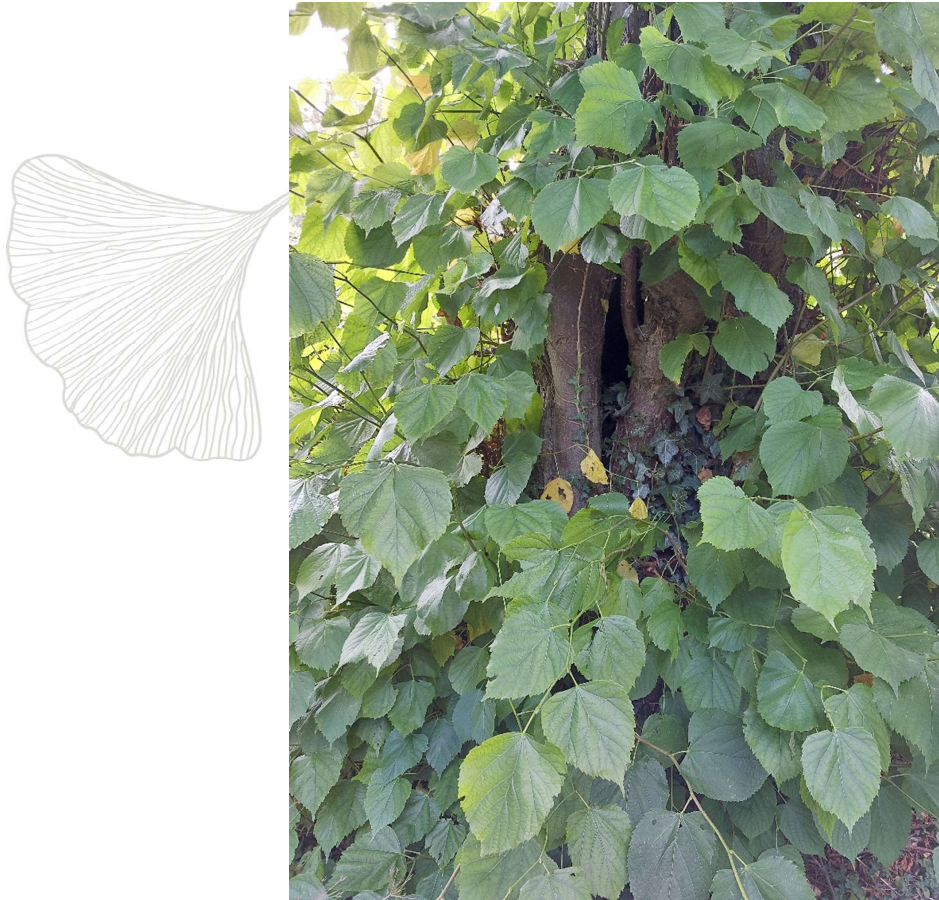
- T1 is a Lime pollard with a major cavity North side from basal area up to 1m with decay extending deep into the stem creating a hollow area. Hammer test gave hollow resonance from basal area up to approximately 2.5m. The tree is situated at the entrance to the site and is within falling distance of the road and entrance driveway. Due to the location and extent of decay this tree is recommended for removal.

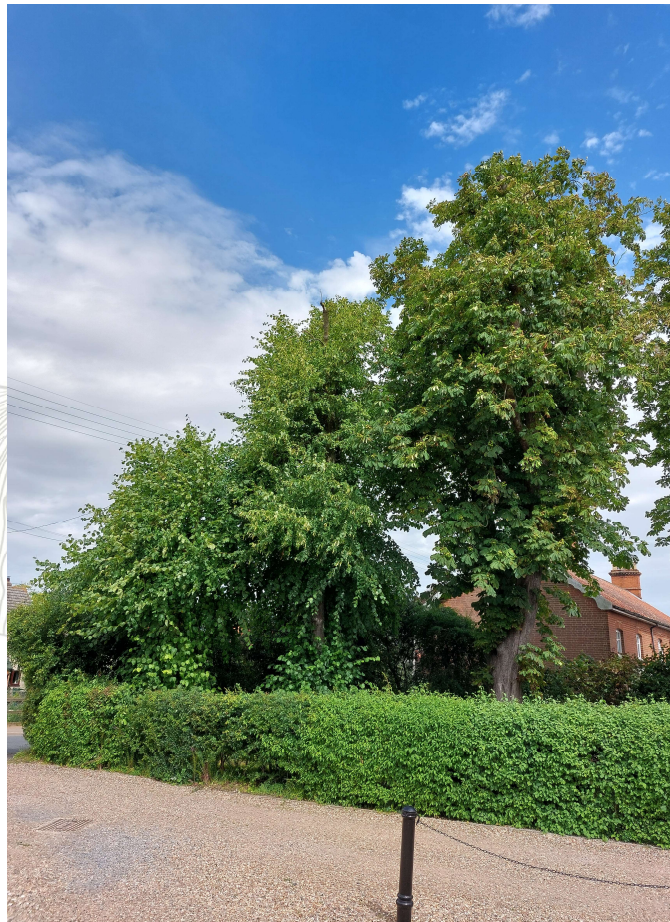
- T2 and 3 are Lime pollards. The original pollard height is 5m, works carried out after reduced them to 10m therefore now have unmanaged growth on old pollard point. Various areas of the original pollard point are showing signs of cavities and decay. T2 has apical dieback with major dead wood and a cavity South side at 4m. T3 has a cavity East at 5m and a failed secondary stem, this tree is also showing early signs of apical dieback. Recommendation for both trees is to re pollard to original pollard height of 5m. There is limited space within the area, this will allow for future growth and development of the trees and enable a future maintenance regime.

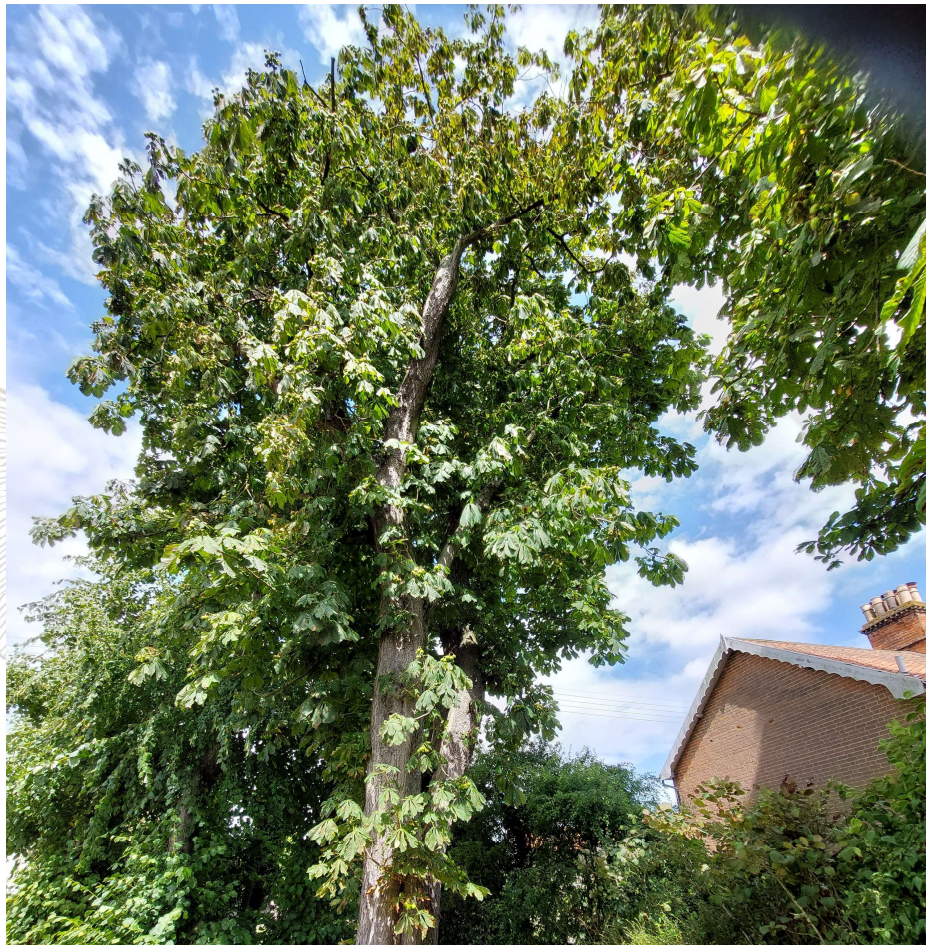
- T4 Horse Chestnut (Height:18m) bifurcates at 2.5m, this tree has previously been reduced. There is major deadwood throughout the crown. There is a cavity West @ 12m showing signs of decay. Visual signs of apical dieback in the canopy. The tree is located 3.8m from the boundary fence with neighbouring properties on the other side. Recommendation would be to reduce limbs past cavities, remove major deadwood and balance crown to shape to allow for future growth, development and light and shading to neighbouring trees and properties.

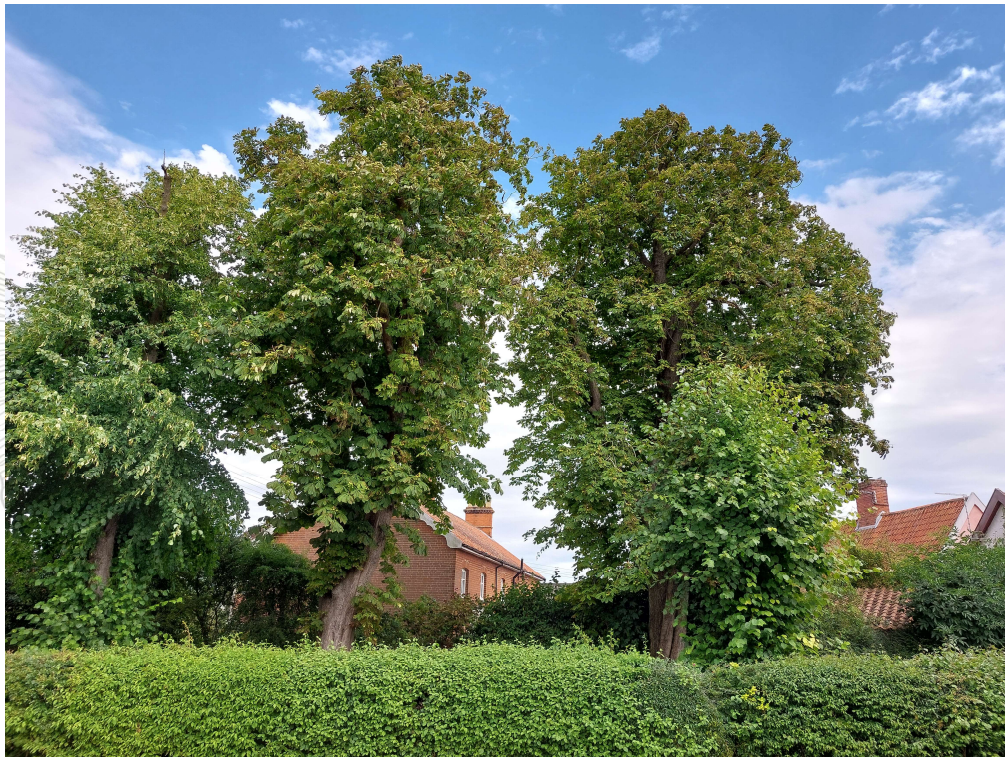
- T5 Horse Chestnut situated on the Eastern edge of the plot growing within the hedge line. The tree is predominately weighted East towards the neighbouring properties. There are major cavities and decayed areas on the South limb 4m and 6m from old pruning wounds. The basal cavity North side was sound with hammer test, the South West basal cavity probed to 20cm. There is an area of bark inclusion West side of stem from basal area up to 2.5m. The tree has previously been reduced some years ago but would benefit from a 20% reduction of the canopy to reduce stress on the area of bark inclusion and removal of the South limb with cavity back to stem to reduce risk of failure over neighbouring properties and driveway.
