Tree Condition Survey Report (VTA)

Site: Brunswick Court Care Home, 62 Stratford Road, Watford
WD17 4JB

Client: Bupa

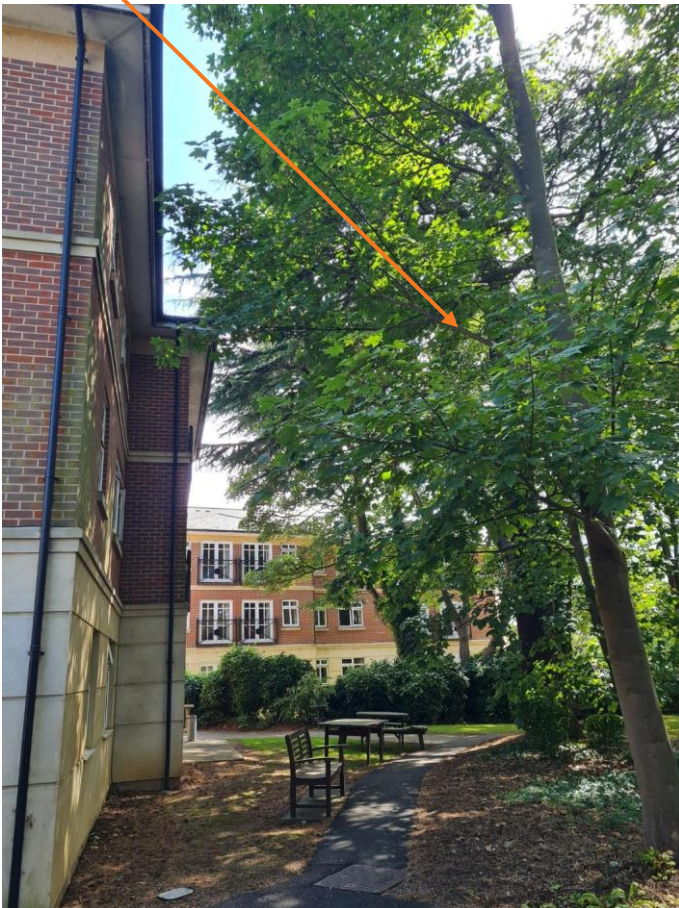
G6 branch to remove

6		Sycamore	<i>Acer pseudoplatanus</i>	5	20+m	450-600mm	Early-mature	Good	Good	Branches close to building. Historical felling of some trees with stumps remaining.	None Significant	No Visible Issues or Defects	Crown Close to Building, Minor Dead Wood Under 50mm Diameter	None Observed	Building, Open space	High	Good	Client

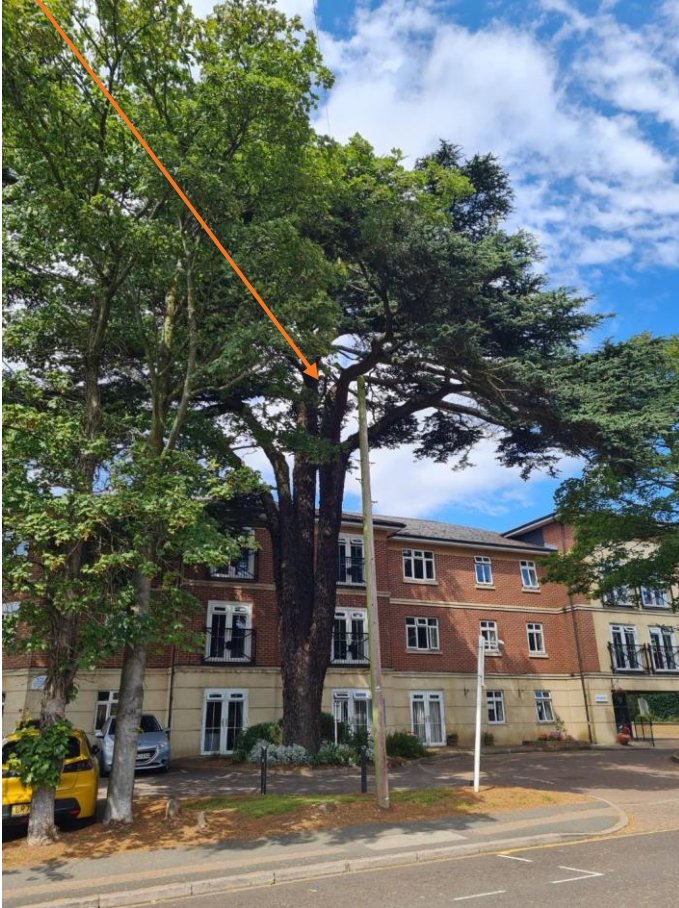
5		Common holly	Ilex aquifolium	0-5m	220	Semi-mature	Good	Good	Suppressed form.	None Significant	Multi-Stem, None Significant	None Significant	None Observed	Car park	High	Good	Client
6	18	Cedar of lebanon	Cedrus libani	16-20m	1400	Mature	Fair	Good	Sparse upper crown. Historical crown lift, unoccluded stem pruning wounds. Occasional scattered dead branches overhanging car park.	None Significant	Occluding Tissues/Wood	Sparse, Major Dead Wood Over 50mm Diameter	None Observed	Building, Car park, Street light/furniture	High	Good	Client
7	19	Sycamore	Acer pseudoplatanus	11-15m	350	Semi-mature	Good	Good	Branches rubbing on telephone cable.	None Significant	None Significant	Crown Close to Building and/or Infrastructure	None Observed	Car park, Road, Street light/furniture, Wires	High	Good	Client
8		Sycamore	Acer pseudoplatanus	11-15m	280	Semi-mature	Good	Good	Historical ivy severance.	None Significant	None Significant	None Significant	None Observed	Car park, Road, Street light/furniture	High	Good	Client

T4	Sycamore	Prune Specific Branch/Limb	Within 3 - 6 Months	Remove lateral branch at 7m south to clear telephone cable. 2022 work recommendations outstanding	
T6	Cedar of lebanon	MEWP required (specify)	Within 3 - 6 Months	25m mewp recommended.	18
T6	Cedar of lebanon	Remove Dead Wood Over 50mm Diameter	Within 3 - 6 Months	2022 work recommendations outstanding	
T7	Sycamore	Prune to Clear structure/wires/buildings by specified amount	Within 3 - 6 Months	Prune to clear telephone cable by 1.5m. 2022 work recommendations outstanding	
T9	Cedar of lebanon	MEWP required (specify)	Within 3 - 6 Months	25m mewp recommended.	20
T9	Cedar of lebanon	Traffic management required	Within 3 - 6 Months		20
T9	Cedar of lebanon	Remove Dead Wood Over 50mm Diameter	Within 3 - 6 Months	Two dead branches at approximately 17-18m south west overhanging highway. 2022 work recommendations outstanding	
T11	Sycamore	Crown Lift to Specified Amount	Within 3 - 6 Months	Crown lift to 3m over footway.	21

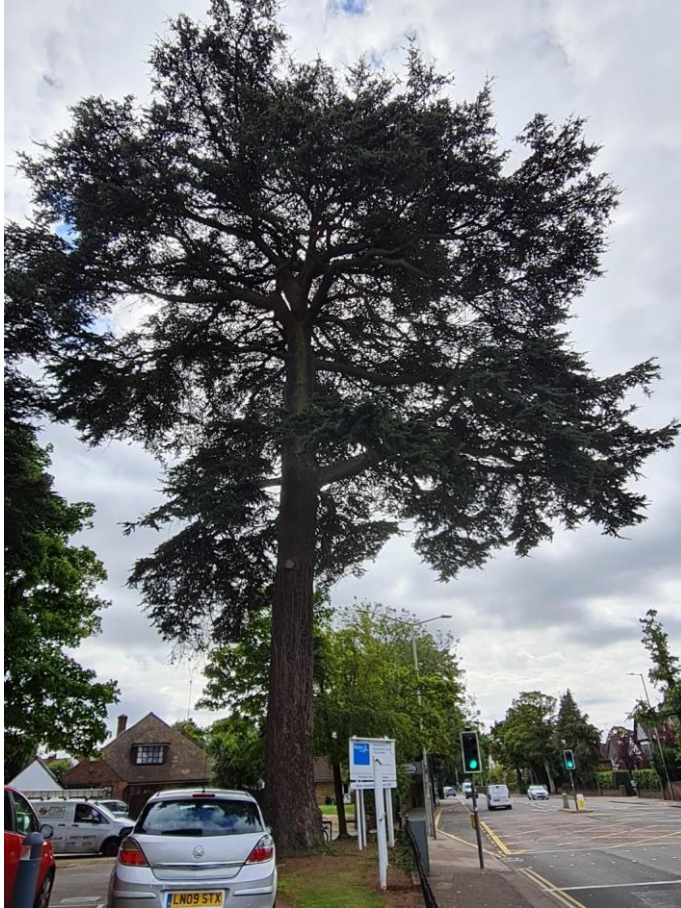
T9

9	20	Cedar of lebanon	Cedrus libani	20+m	1500	Mature	Good	Good	Historical crown lift, unoccluded stem pruning wounds. Two dead branches in mid-crown overhanging highway. Roots lifting car park surface and displacing kerb.	None Significant	Occluding Tissues/Wood	Major Dead Wood Over 50mm Diameter	None Observed	Building, Car park, Infrastructure, Road, Street light/furniture	High	Good	Client
10		Sycamore	Acer pseudoplatanus	5-10m	300	Semi-mature	Good	Good	Tree situated on top of bank, surface roots exposed on slope from soil erosion.	None Significant	None Significant	None Significant	None Observed	Building, Footpath, Road, Wall	High	Good	Client
11	21	Sycamore	Acer pseudoplatanus	16-20m	700	Mature	Good	Good	Branches hanging low over footway.	None Significant	None Significant, Co-dominant Stem	Low Branches	None Observed	Building, Road, Wall	High	Good	Client
12	22	Sycamore	Acer pseudoplatanus	16-20m	850	Mature	Good	Good	Historical crown lift.	None Significant	None Significant, Co-dominant Stem	None Significant, Minor Dead Wood Under 50mm Diameter	None Observed	Building, Fence, Open space	High	Good	Client

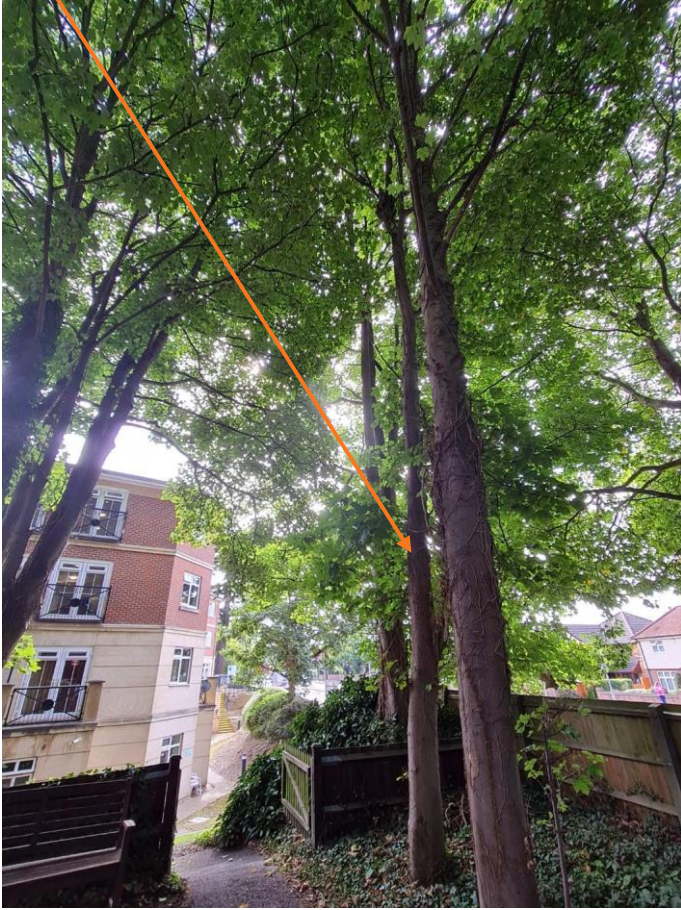
16	26	Sycamore	Acer pseudoplatanus	16-20m	300	Early-mature	Good	Good	One dead branch at approximately 15m south east overhanging site path. Dieback caused by Sooty Bark Disease.	None Significant	None Significant	Major Dead Wood Over 50mm Diameter	None Observed	Fence, Footpath, Open space, Road	High	Good	Client
17	27	Sycamore	Acer pseudoplatanus	20+m	350	Early-mature	Good	Good	Two dead branches at approximately 9-10m north west overhanging site. Dieback caused by Sooty Bark Disease.	None Significant	None Significant	Dieback, None Significant	None Observed	Fence, Footpath, Open space, Seating	High	Good	Client
18	28	Sycamore	Acer pseudoplatanus	20+m	600	Early-mature	Good	Good		None Significant	None Significant	None Significant	None Observed	Fence, Footpath, Open space, Road, Seating	High	Good	Client
19	29	Sycamore	Acer pseudoplatanus	20+m	850	Mature	Good	Good	Historical crown lift.	None Significant	None Significant, Multi-Stem	None Significant	None Observed	Fence, Footpath, Open space, Road, Seating	High	Good	Client

T14	Sycamore	Sever and Remove Ivy to 1.5m Above Ground Level	Within 3 - 6 Months		24
T15	Cedar of lebanon	Prune to Clear structure/wires/buildings by 3m	Within 3 - 6 Months	Tip prune to clear building by 3m.	25
T15	Cedar of lebanon	MEWP required (specify)	Within 3 - 6 Months	25m mewp recommended	25
T15	Cedar of lebanon	Remove Dead Wood Over 50mm Diameter	Within 3 - 6 Months	2022 work recommendations outstanding	
T16	Sycamore	Remove Dead Wood Over 50mm Diameter	Within 3 - 6 Months	2022 work recommendations outstanding
