# Your survey report

80 Granbrook Lane, Mickleton,  
Gloucestershire, GL55 6TF

11th August 2023

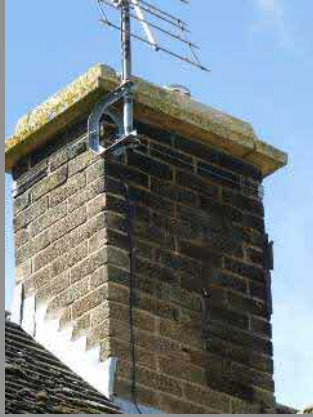
*Photo - 13*

The bricks are badly stained and cracked on the rear face. The stone coping is also open jointed/ loose on the rear. Condition rating 2. This should be repointed soon

The waterproofing to the base of the chimney stack (called the flashing) is worn. Condition rating 2. This should be repaired soon. The roof covering and chimney stack may have to be disturbed to repair the lead, and this can increase the amount of work required.

The mortar to the bricks is eroded. Condition rating 2. This should be repointed soon

The chimney pots are open and vulnerable to rain penetration, which could result in damp penetration internally to the chimney breast in the roof space. Condition rating 2. Open chimney pots can allow rain penetration or can be blocked by nesting birds. To prevent these problems, an appropriate guard should be provided soon.

You should instruct a competent contractor to provide an estimate for these works prior to purchase. To repair the chimney safely and avoid damaging the roof covering, contractors will have to use appropriate access equipment (for example scaffolding, hydraulic platforms, etc.).

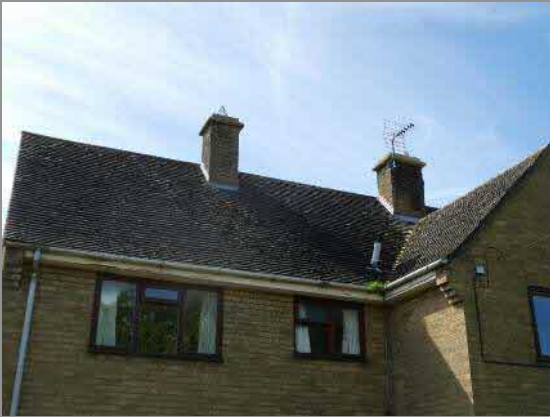
*Photo - 21*

There is a missing tile to the front slope adjoining the west gable. There is a missing tile and two broken tiles to the rear slope adjoining the west gable. Condition rating 2. These should be repaired soon.

There are large gaps to the tiles to front and rear slopes adjoining the edges of the roof (called the verge) of both gables and also to both slopes to the front gable due to lack of lateral restraint between the gable walls and roof structure (see E1 Roof Structure). Condition rating 2. These should be repaired soon. Once the strapping to the gables has been installed, the tiles along the edges of the roof will require stripping back and relaying.

The tiles along the top of the roof (the ridge tiles) are poorly secured. Condition rating 2. These should be repaired soon. Small numbers of ridge tiles can be repaired, but the work may dislodge or damage adjacent tiles. It may be more economical to replace or re-fix all the other ridge tiles at the same time. Loose ridge tiles can be dislodged during stormy weather, causing potential injury to persons or damage to property.

The felt that is exposed to the eaves is now perished and no longer be lapped into the gutters, resulting in water staining to the fascia boards. Condition rating 2. The roofing felt prevents water, which passes through the tiles and runs down the roofing felt, from running down the fascia boards and outside walls, which can result in lateral damp penetration internally and decay to timbers. A closer inspection may also reveal areas of wet rot to timbers, especially behind guttering, and repairs may be required. The lower course of tiles will require stripping back, the perished felt renewed and plastic eaves protectors provided into the gutters soon.

Moss growth is present on the roof slopes. Condition rating 2. This can impede the run-off of rainwater, lead to gutter blockages and cause water penetration, which in turn may lead to rot or other defects in nearby timbers. It would be prudent for all moss growth to be brushed off from the roof slopes and then the guttering cleared.

You should instruct a competent roofing contractor to provide an estimate for these works and any necessary associated repairs prior to exchange of contracts. To repair or replace roofs safely and without damaging the roof covering, contractors will have to use appropriate access equipment (for example scaffolding, hydraulic platforms, etc.).

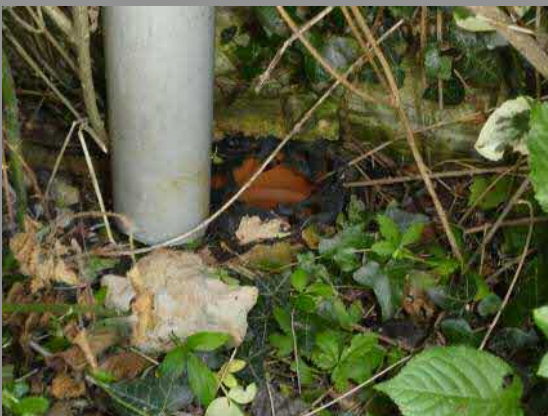
Photo - 45

These defects are causing damp penetration internally and rot to the timber floors (see D4 Main Walls, E3 Walls and Partitions and E4 Floors). Condition rating 3. This should be repaired now. Given the extent of the repairs required, it is likely to be more economical to simply replace all the rainwater goods

You should instruct a competent roofing contractor to provide an estimate for these works and any necessary associated repairs prior to exchange of contracts. To repair or replace rainwater goods safely and without damaging the roof covering, contractors will have to use appropriate access equipment (for example scaffolding, hydraulic platforms, etc.).

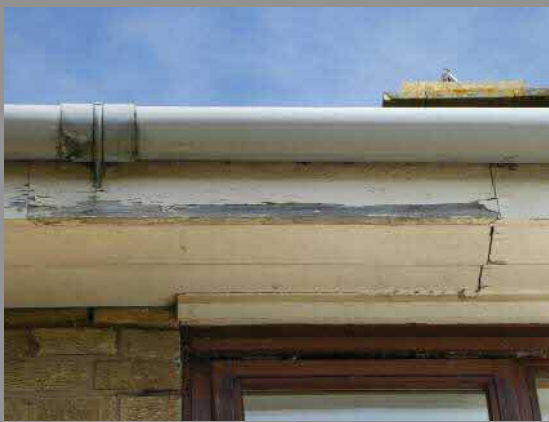
*Photo - 127*

General deterioration was noted from ground level, to eaves level fascia/soffit boards. A closer inspection may also reveal areas of wet rot, especially behind guttering. External timbers at eaves level require regular maintenance to help prevent against rot. Outside decorations help keep the property in satisfactory condition. Without a protective finish, parts will quickly deteriorate, requiring extensive repairs. To prevent this, the external timber surfaces should be redecorated soon if to be retained.

You should obtain an estimate from a reputable contractor for these works prior to purchase. To safely repair parts of the property at higher levels, contractors will have to use appropriate access equipment (for example scaffolding, hydraulic platforms, etc.).

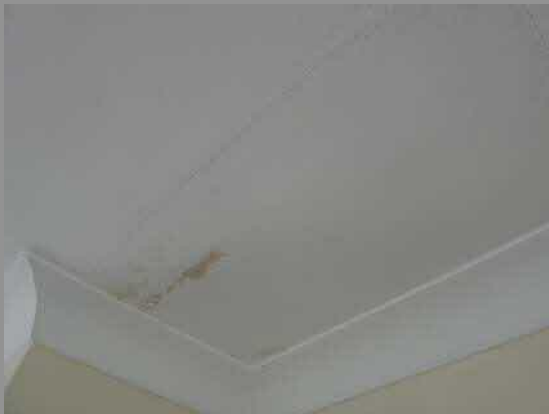
Photo - 156

Cracking at joints was noted in all the rooms except the utility/cloakroom. Condition rating 2. This should be repaired soon. Where cracks are identified to plasterboard ceilings, which often occur at the joints of the plasterboard or where the plasterboard meets the walls, then normally filling and redecoration is all that is required.

Downlighters are provided to the ceiling in the shower room, to which one has come loose. Condition rating 2. This should be repaired soon.

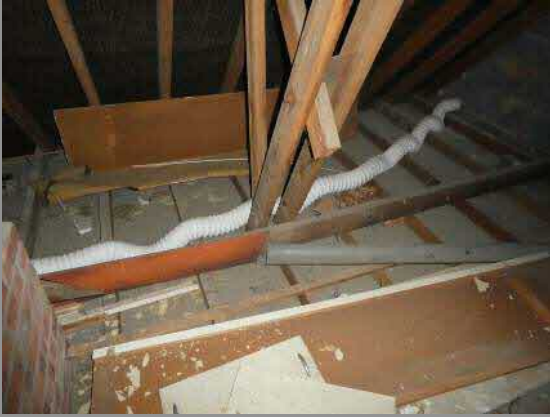
*Photo - 236*

The sanitary fittings are of a modern design, but now worn and only of average quality. The sealants around the edges of the shower and wash hand basins can leak and damage adjacent surfaces. If not repaired quickly, wood rot can soon develop. Check and maintain the seals around the perimeter of the shower tray to prevent an escape of water causing damage to the area below the shower room.

Many properties are affected by condensation and in order to reduce the problem it is necessary to maintain ventilation in the property whilst also ensuring the property is also heated. The flexible ducting for the shower room extractor fan requires insulating to prevent condensation building up in the ducting, which could run back and cause dampness to the ceiling. Ideally long runs of flexible ducting should be avoided and if necessary rigid plastic pipe should be used to allow a better flow of air, which will also require insulating. Ideally, however, a new more powerful humidistat controlled extractor fan should also be fitted venting direct out of the front wall soon.

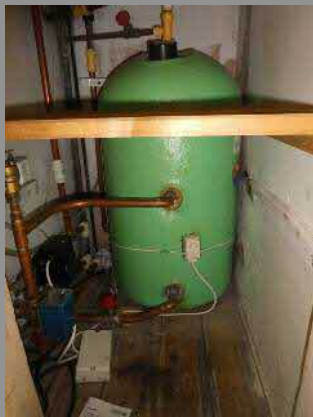
Photo - 253

The copper hot water cylinder is dated, and we would recommend that this is tested prior to use. You may wish to consider replacing the cylinder with a pressurised hot water system to provide a better flow of hot water.
