4D TREE SURVEY

Pre-development tree survey to BS5837 May Cottage
Elston.

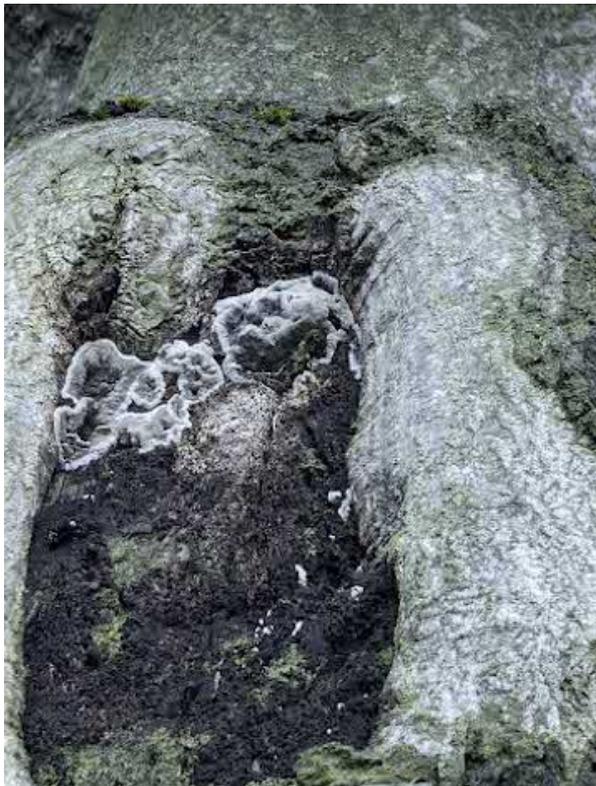
I have also recommended that TU02 is examined by the neighbouring properties appointed tree care professional to ensure that their public liability is maintained. In my opinion the tree is classified as U due to the findings of my visit.

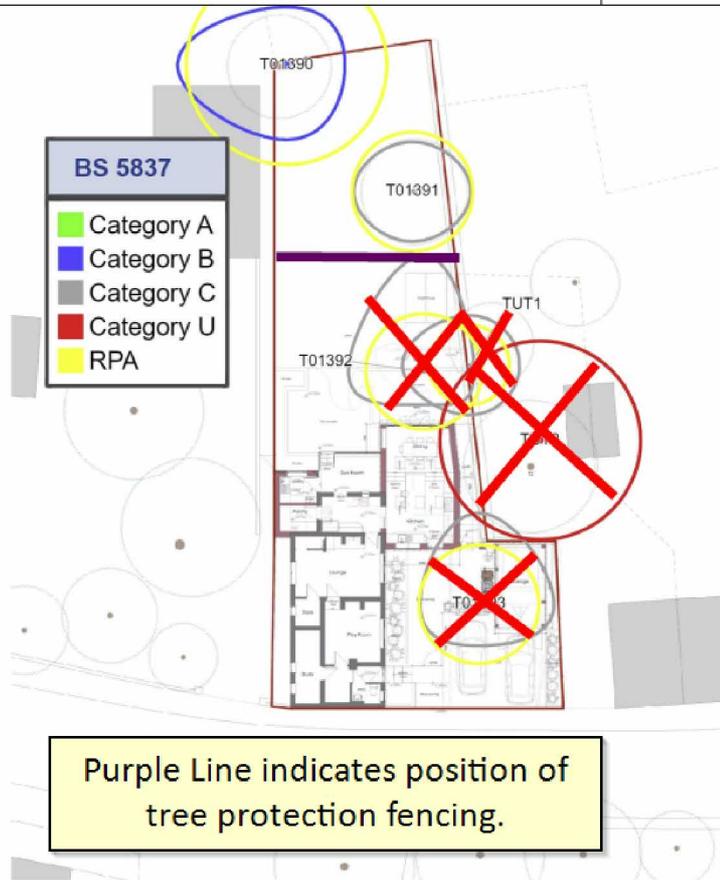
Tree Protection Plan

Purple Line indicates position of tree protection fencing.

The protective fencing for this site should be located as shown on the Tree Constraints/ Protection Plan above (as illustrated with a thick red line).
