ARBORICULTURAL REPORT
at
41 Knox Green
Binfield
Bracknell
Berkshire
RG42 4NZ

- 1.1.1 This arboricultural report is required by our client as part of an investigation into soil shrinkage subsidence damage at:

41 Knox Green, Binfield, Bracknell, Berkshire, RG42 4NZ.

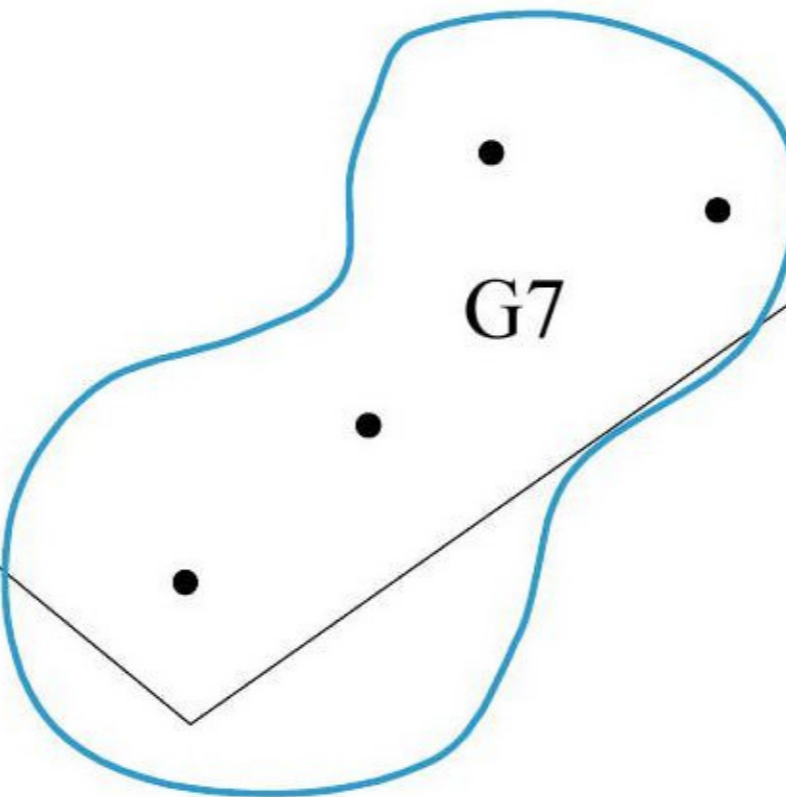
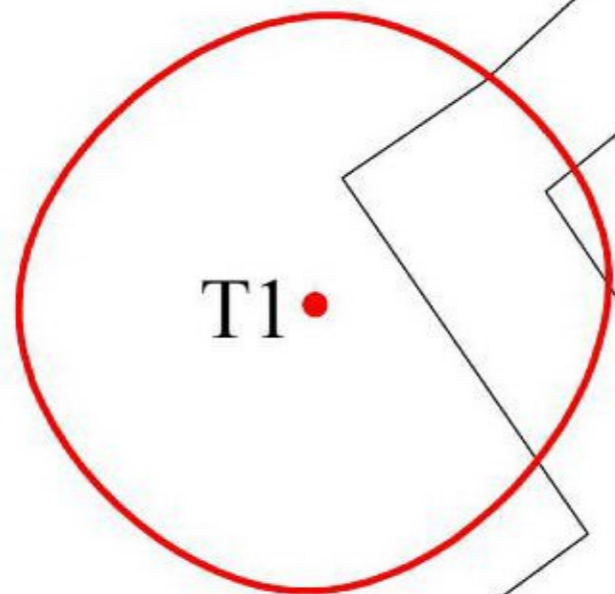
Appendix 2: Site Plan

- 3.2.1 Please refer to the site plan at **Appendix 2** for an indication of the trial pit/borehole location.
- 3.2.2 **Trial pit/borehole 1** revealed a concrete foundation at a maximum depth of 800mm below ground level.

These results indicate that the clay soil found within **Trial Pit/Borehole 1** is of low to medium shrinkability and that the soil is desiccated between the depths of 1-1.5m.

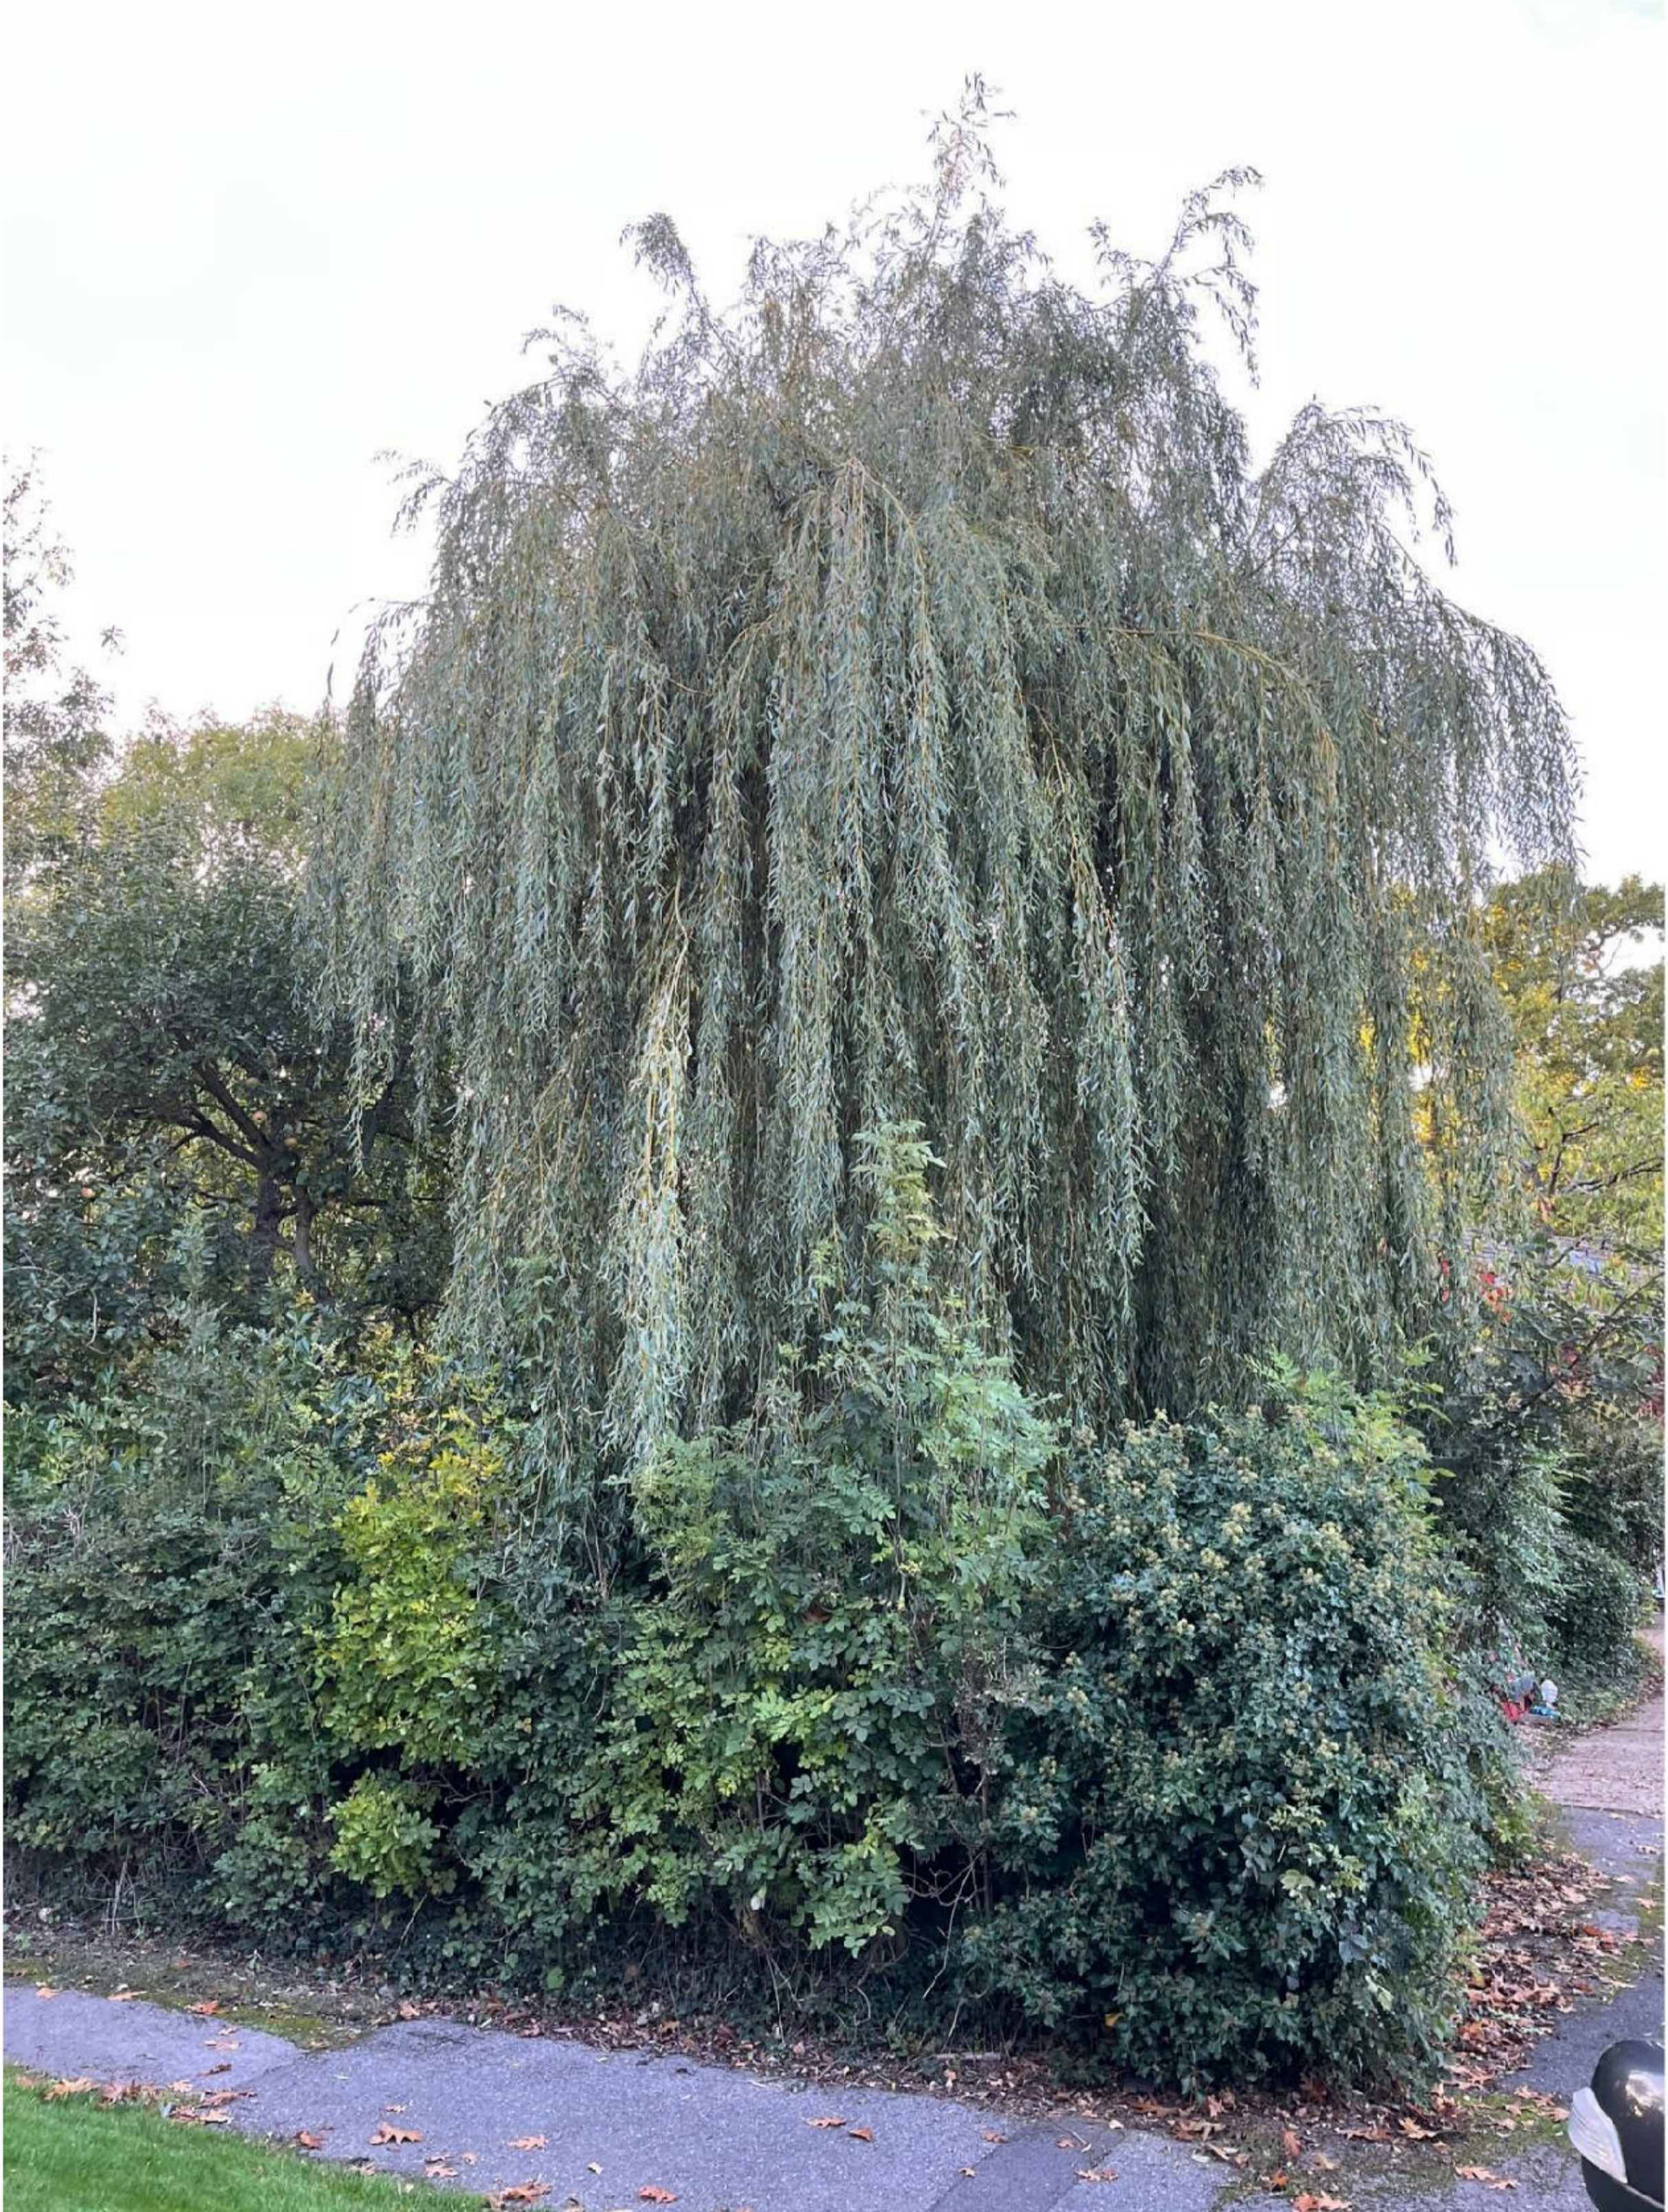
- 6.3 We consider the vegetation identified as **T1** and **T5** to be contributing to the damage observed at the subject property. We have therefore recommended that these two trees be removed to ground level and that the stumps are treated to prevent regrowth.

Photo 1: Showing T1 (Weeping Willow)

Item	Species	Recommended Action	Location/ Ownership	Planning Restriction
T1	Weeping Willow	Remove to ground level and treat the stump to prevent regrowth.	No. 42 Knox Green	Yes - TPO
S2	Buddleja	Remove to ground level and treat the stump to prevent regrowth.	Subject Property	None
G3	Mixed Shrubs	Maintain at current size over the forthcoming years.	Subject Property	None
T4	Snowy Mespilus	Maintain at current size over the forthcoming years.	Subject Property	Possibly TPO
T5	Common Ash	Remove to ground level and treat the stump to prevent regrowth.	Subject Property	Yes - TPO
G6	Mixed Shrubs	Maintain at current size over the forthcoming years.	Subject Property	None
G7	Mixed Trees	Maintain at current size over the forthcoming years.	Subject Property	Possibly TPO

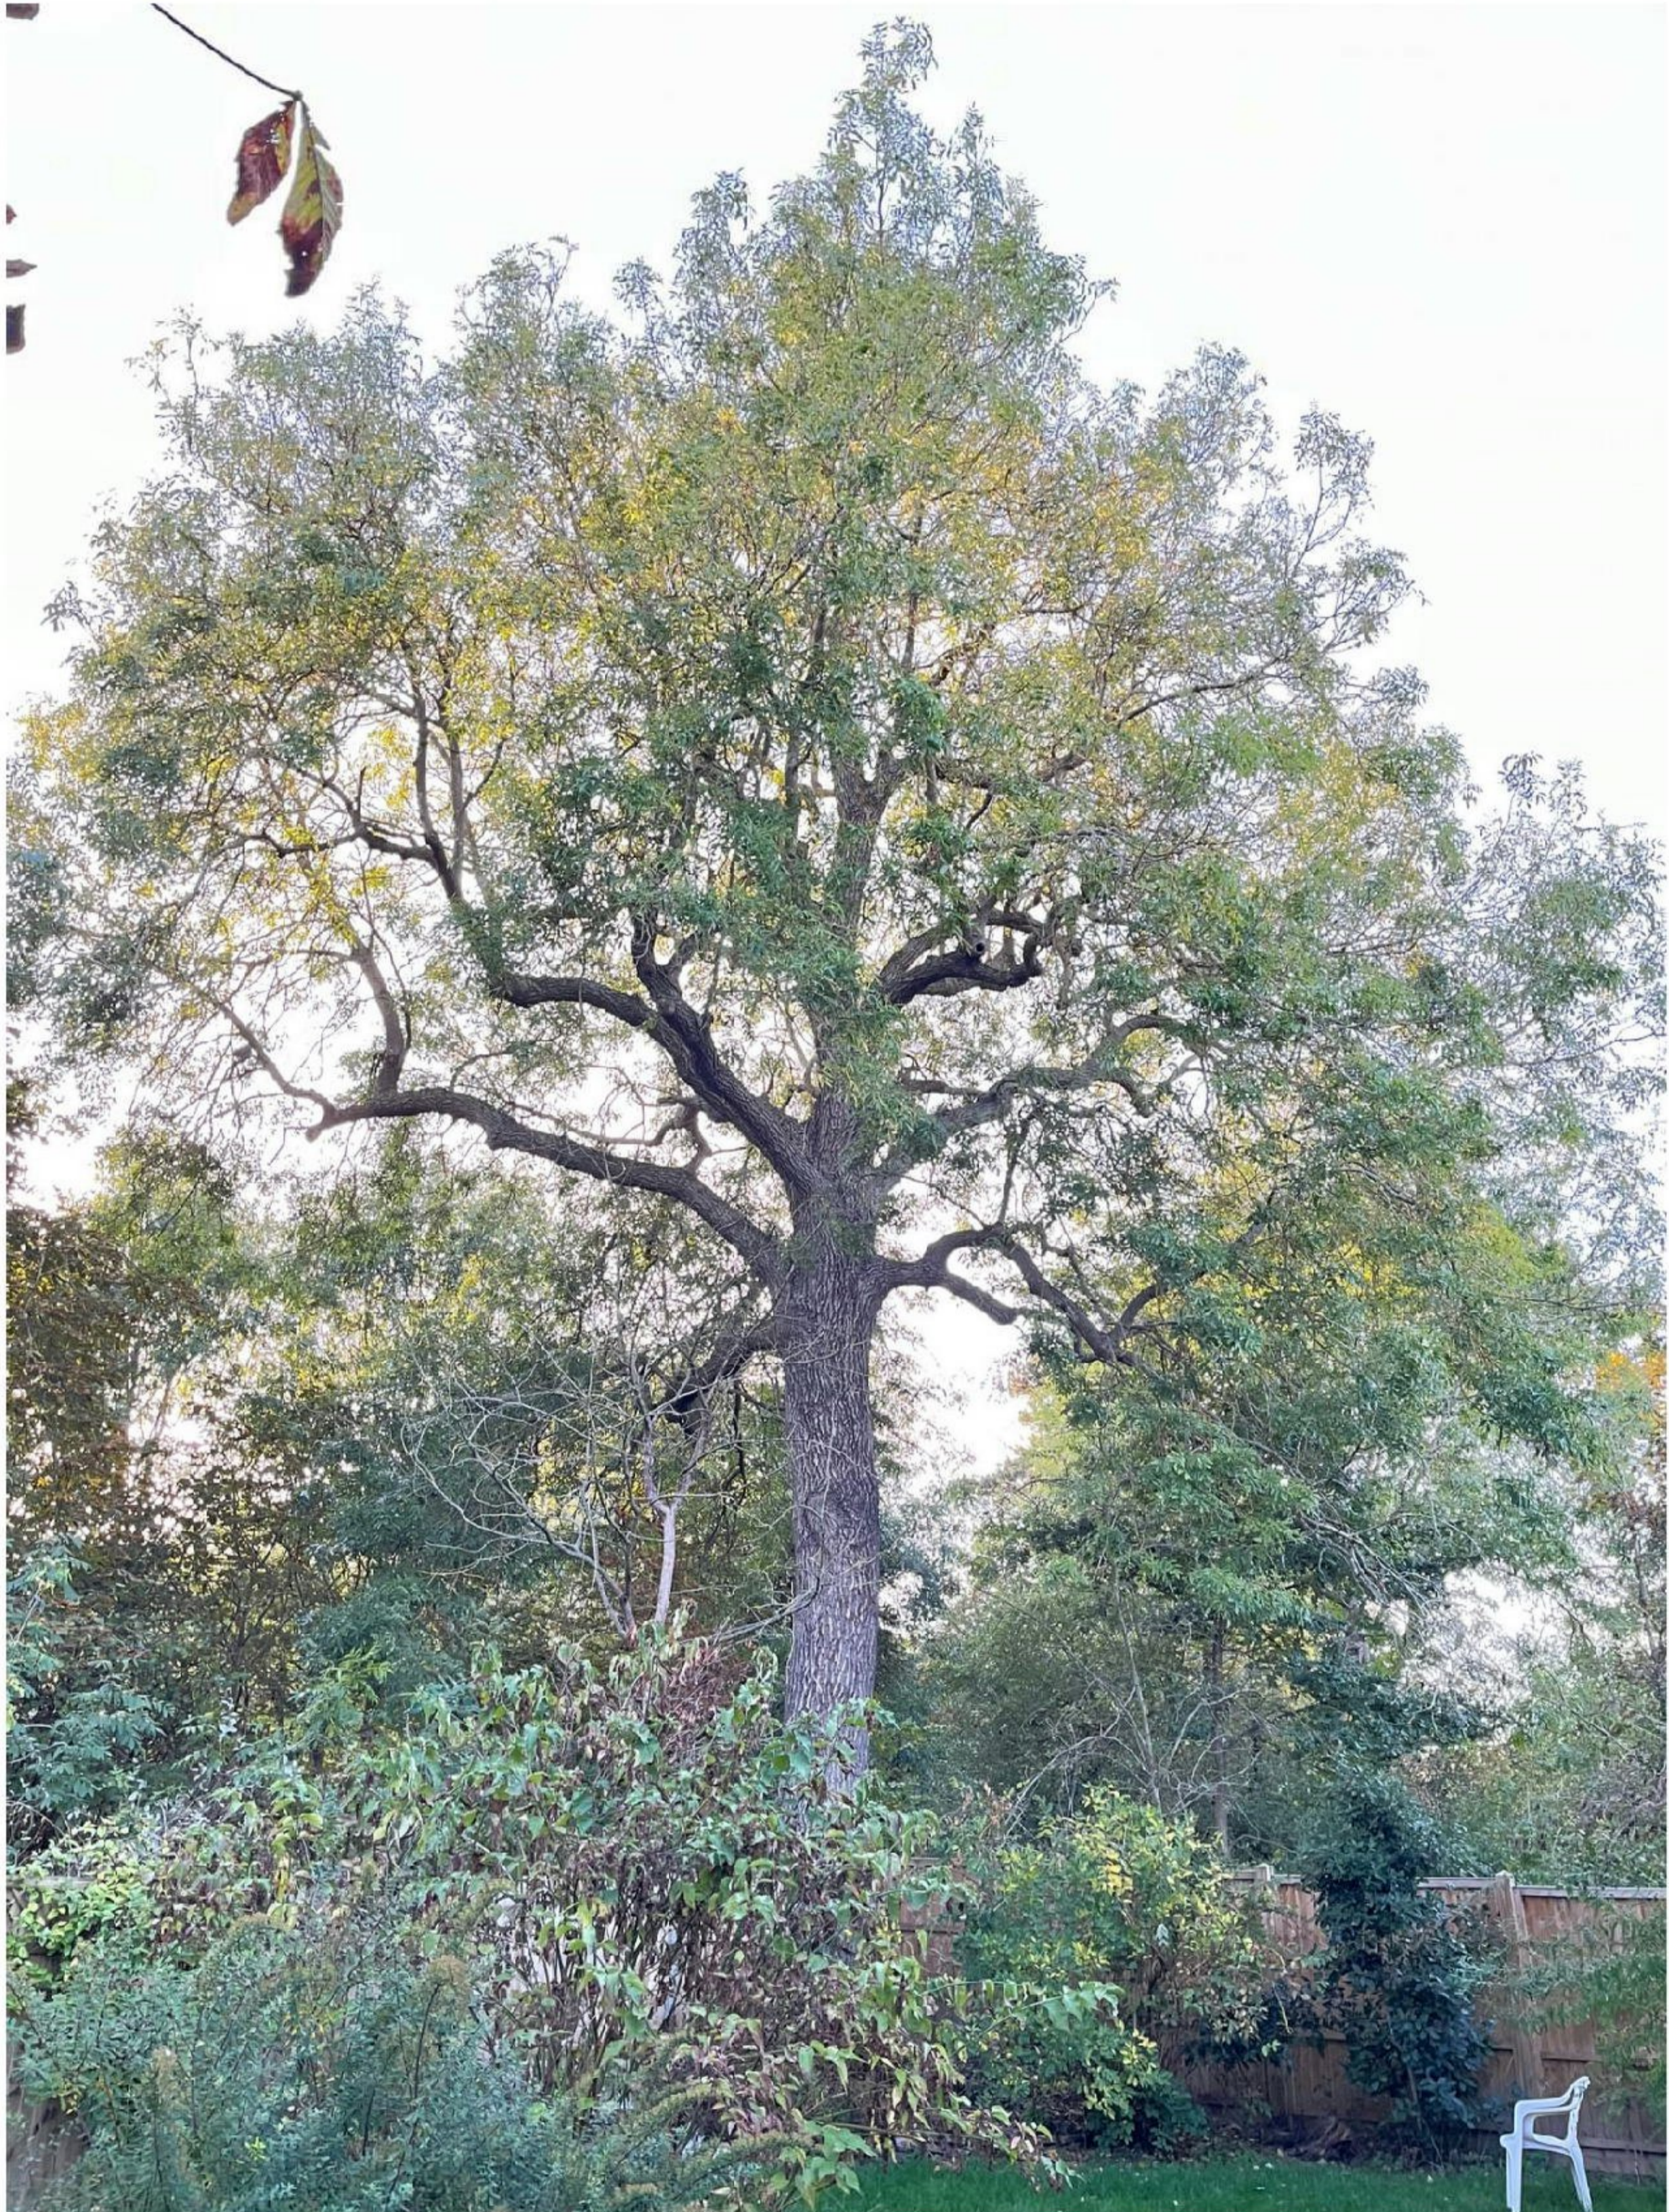
- 4.1 A Tree Preservation Order (TPO) and Conservation Area check was made in September 2022 with **Bracknell Forest Council**.
- 4.2 We are informed that the property is situated within an Area Tree Preservation Order (TPO) and that **T5** (Ash) is protected by an individual TPO.
- 4.3 Before any tree works are undertaken to protected trees, written consent from the Local Authority must first be obtained. An application for tree works form must therefore be completed and submitted to the Local Authority outlining all the proposed works along with a suitable justification. A waiting period of eight weeks is then required.
- 4.4 *No work must be done to protected trees until permission has been granted.*

Photo 2: Showing T5 (Common Ash)

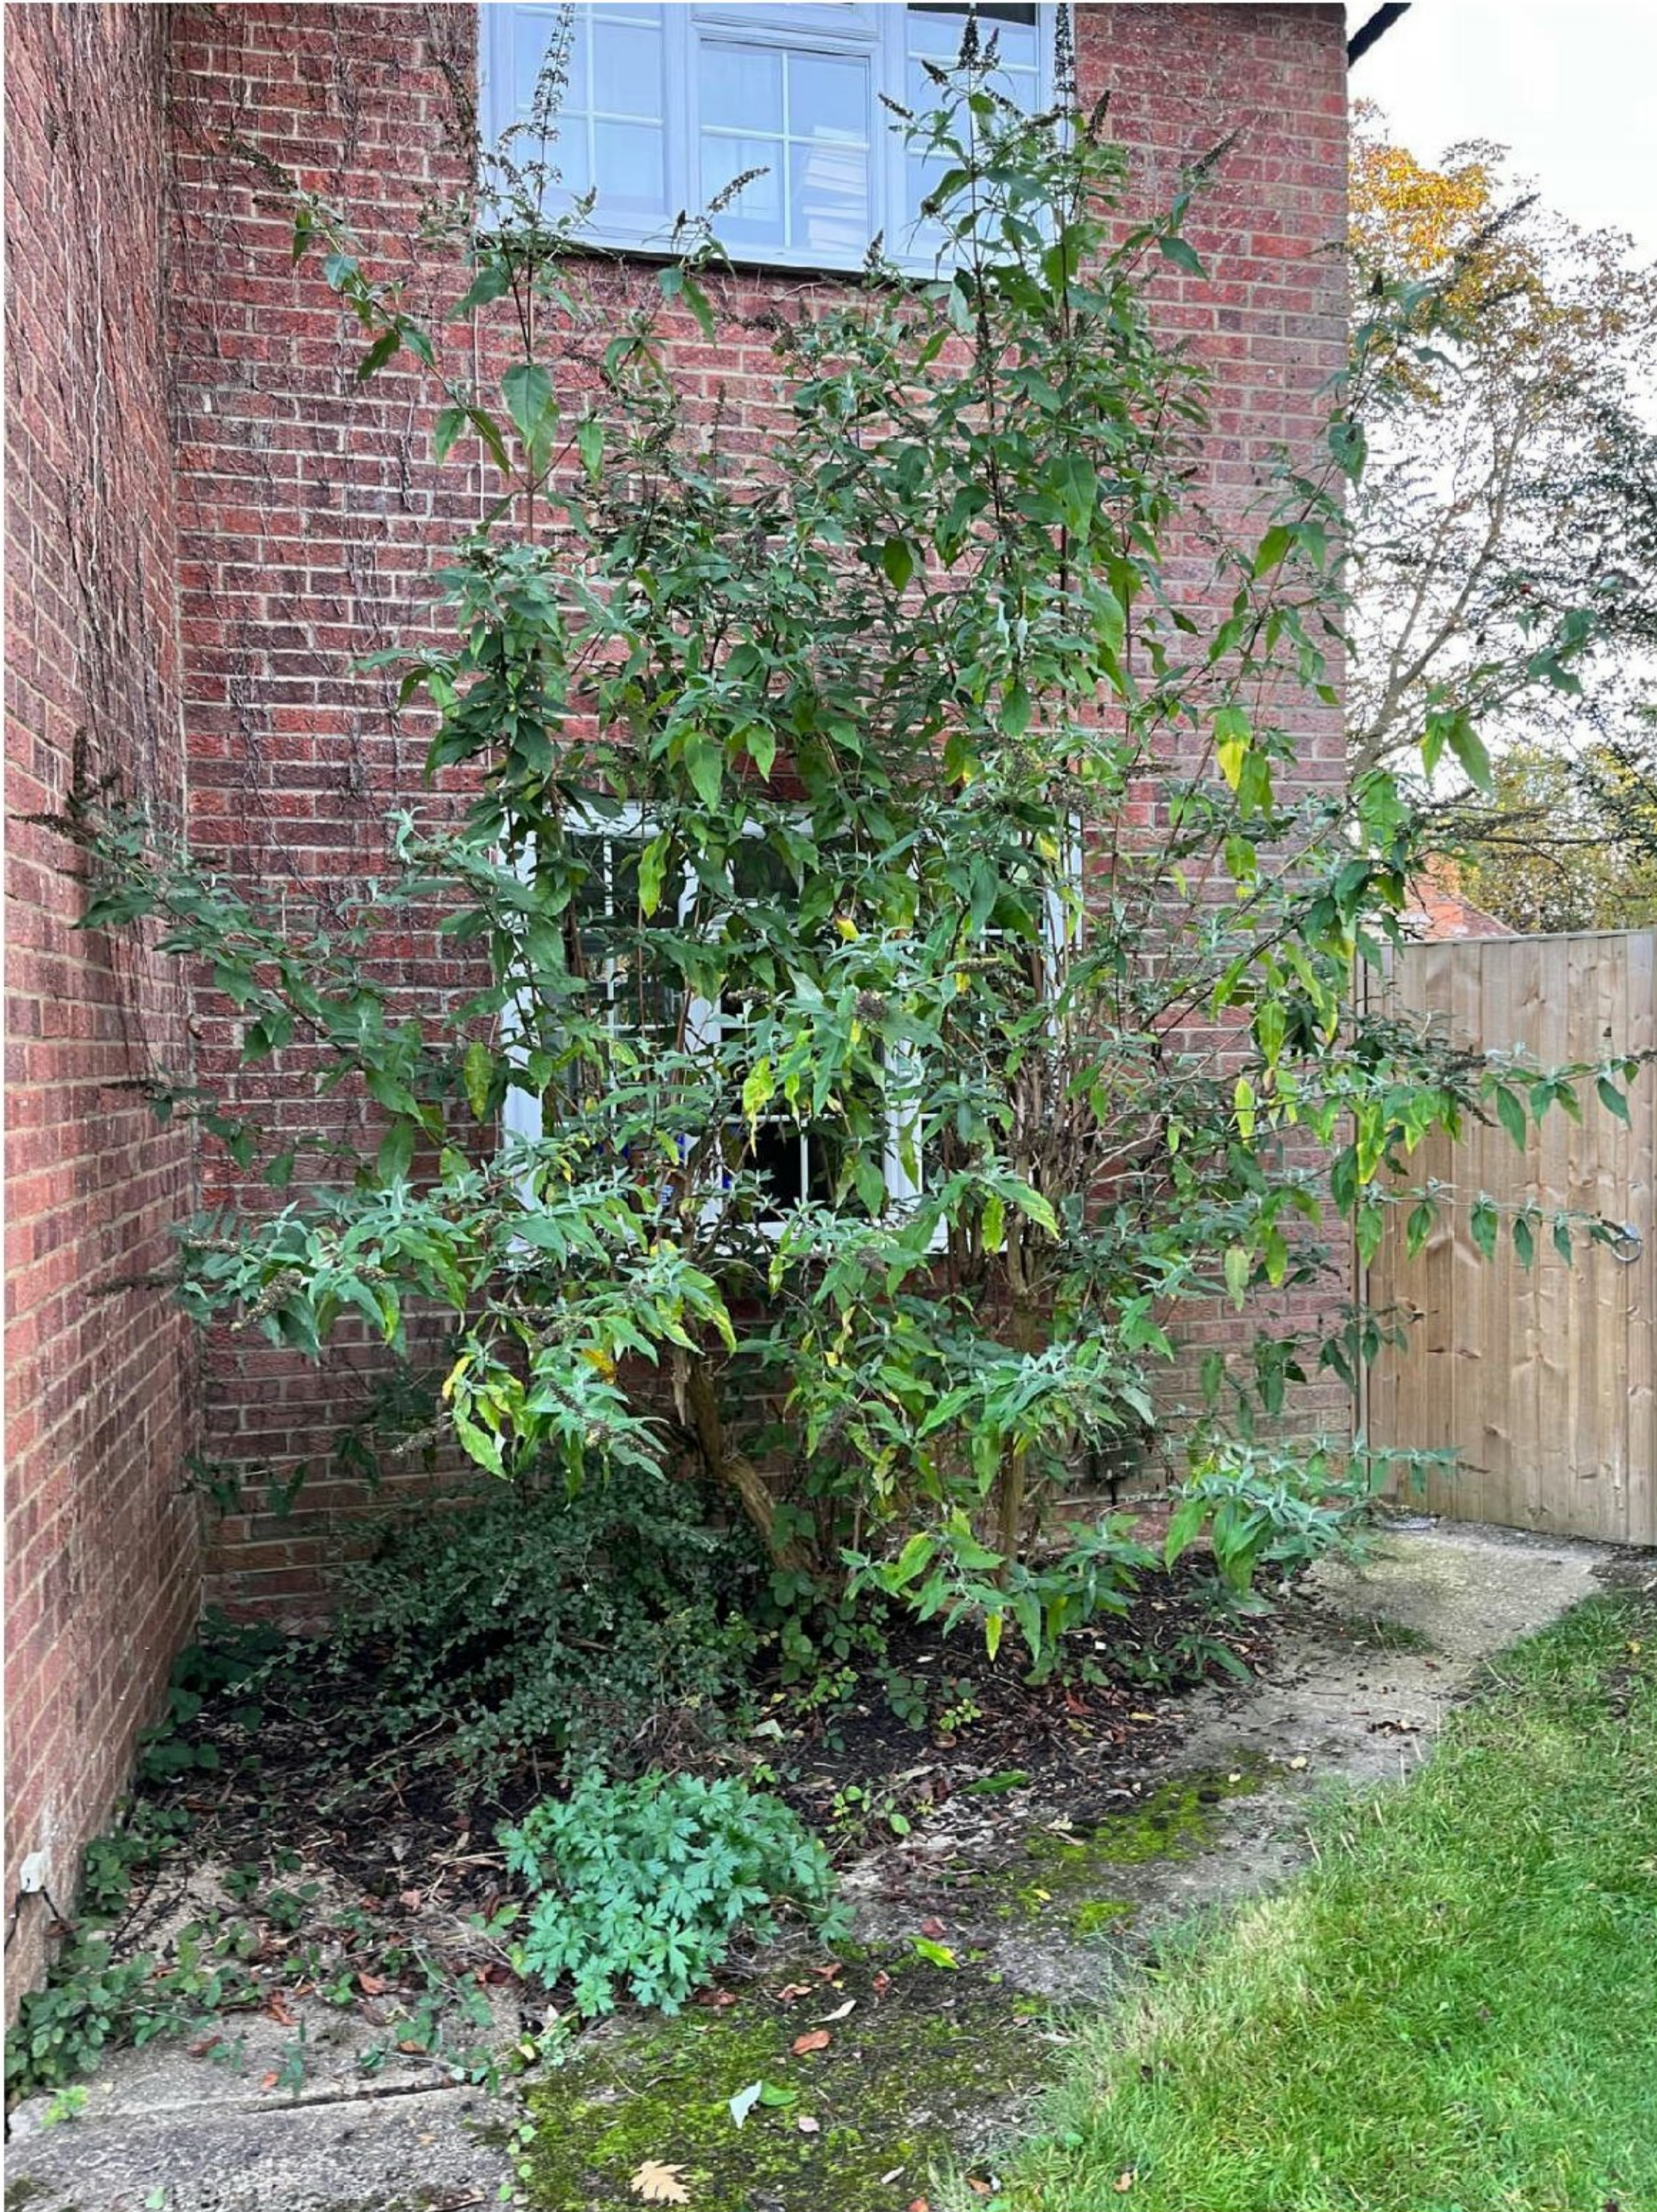
- 6.4 In addition to the above, we have also advised the removal of **S2** due to its close proximity to the house and to prevent future issues. The stump will need treating/grinding out to prevent regrowth.

Photo 3: Showing S2 (Buddleja)
